# Incident Technical Report: Sliding Bearing Failure in Starboard Propulsion Shaft of Naval Vessel (September 2014)

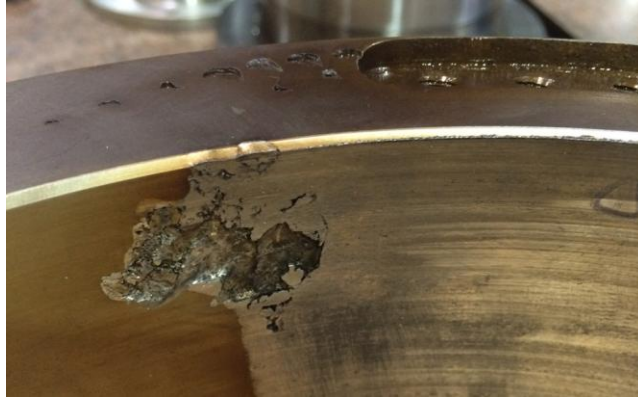
**Figure 1: The failure bearing.**

At 10:30, the vessel was lifted at the shipyard platform to allow safe access for inspection and repair operations. The mechanical crew, along with mechanics from the mechanical laboratory, secured the starboard shaft using adjustable support brackets and safety blocks. Lubrication system was fully isolated in preparation for disassembly. At 11:00, work on the bearing housing began. Removal of the upper bearing shell revealed extensive scoring and blue discoloration on the white-metal surface, indicative of localized overheating. Visual inspection identified wiped zones—typical of hydrodynamic film collapse. At 12:30, the lower bearing shell was extracted. The surface displayed spalling and clear evidence of thermal fatigue damage.

The root cause was determined to be a loss of hydrodynamic film due to eccentric shaft loading. Secondary contributors included one mounting bolt discovered post-failure to have <60% of required preload, likely leading to partial bearing tilt.

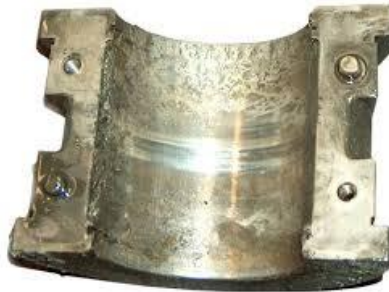
**Figure 2: Failure bearing housing.**

As observed, the bearing was worn out.
