## MANUFACTURES INSPECTION REPORT 1-9-26

Manufacturer Evaluation Inspection Report with Specifications for the  
Roof Shield Coating System for a sq ft (1 Story) S Tile (Closed Valleys) Roof System.

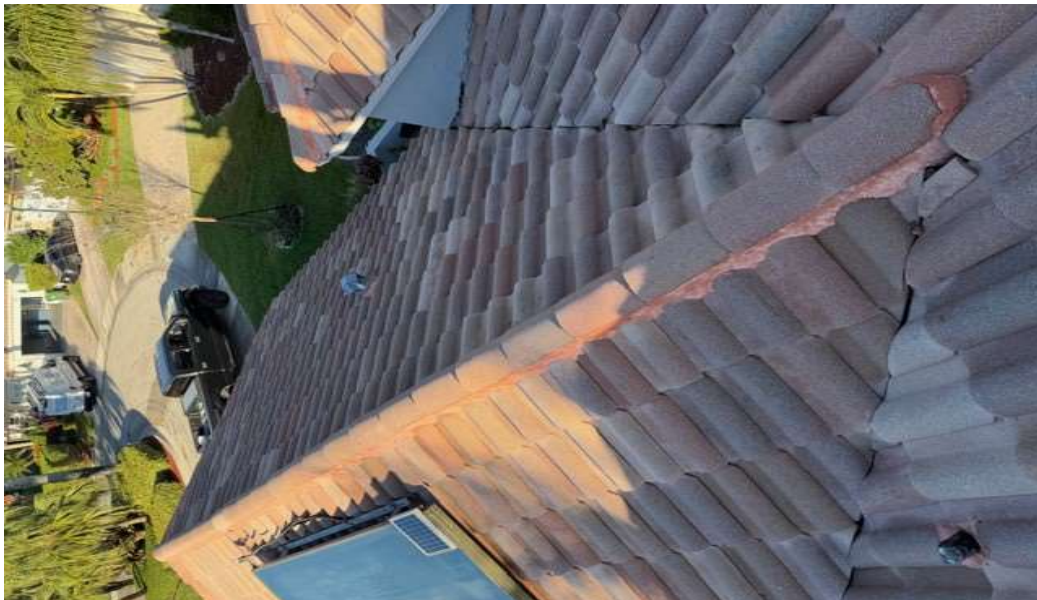
(See Drawing)

Owner reported possible Leak Moisture near left front entrance in bedroom area.  
(Exact location has not been determined )

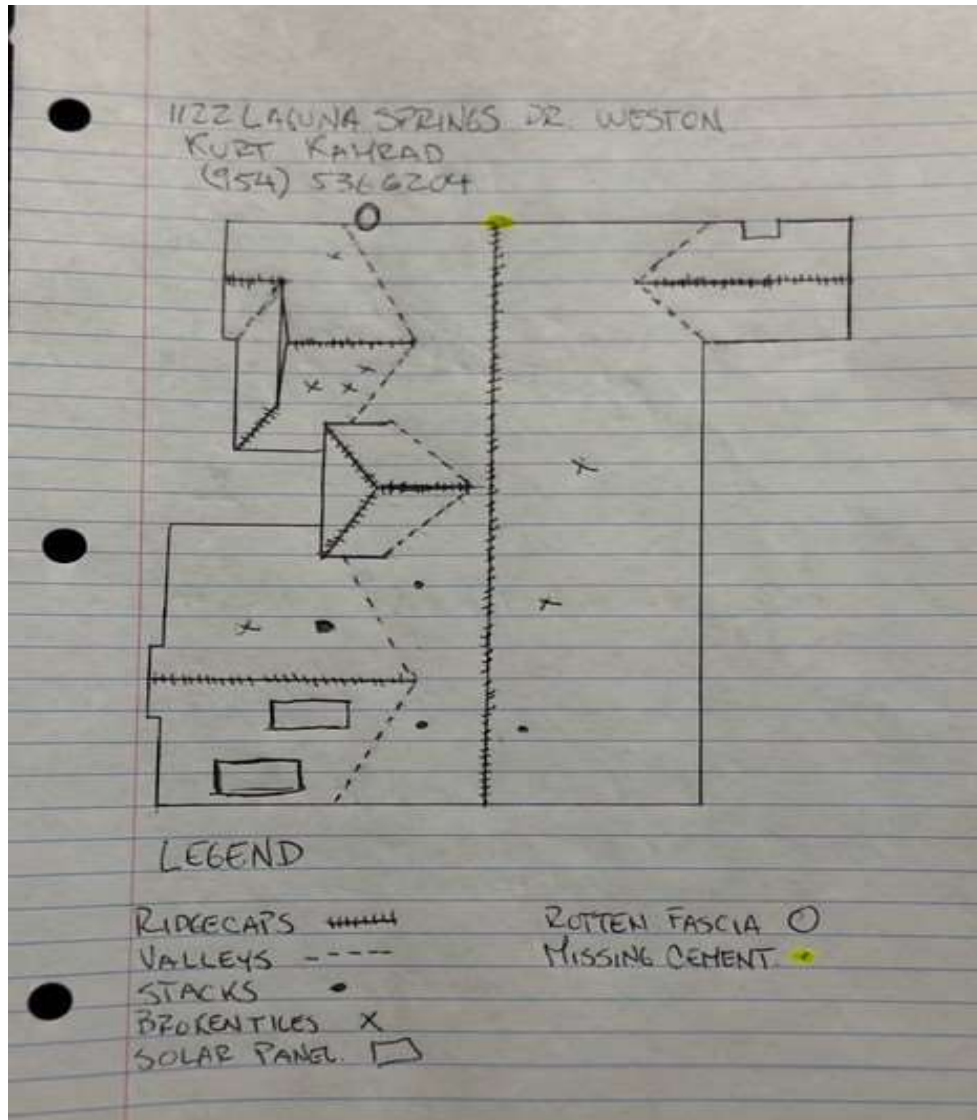
Common Area Tile ( R slope ) cracked Tile & chipped Corners

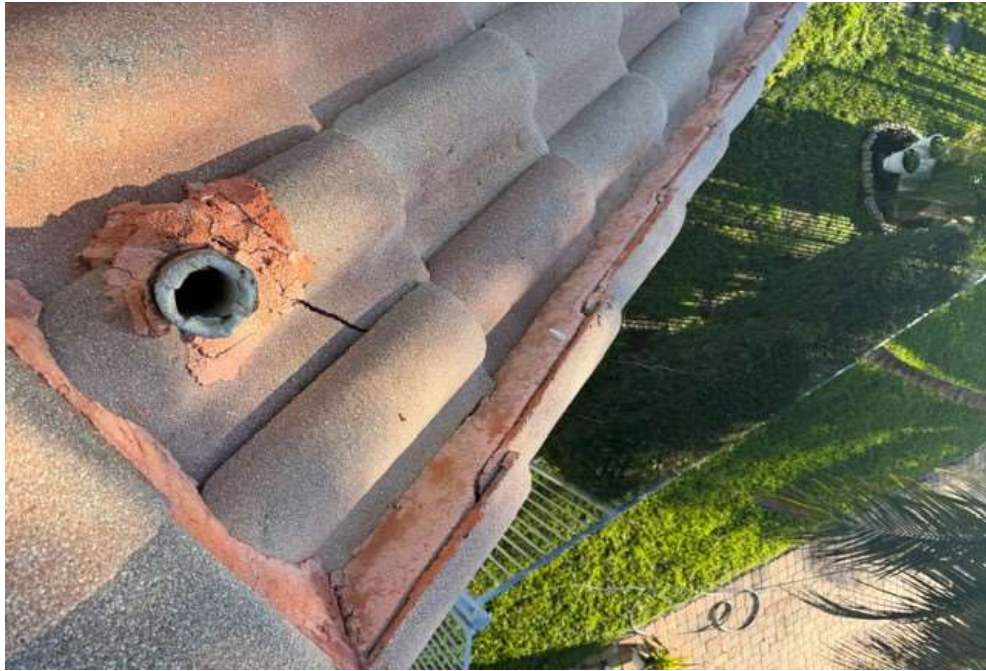
End Cap on Ridege Crushed – Missing Cement
