Onehunga Aquifer & ‘Green Stream’ Contamination

Former NZ Farmers Fertiliser Site

Presented by Sharon Vujnovich, ARC

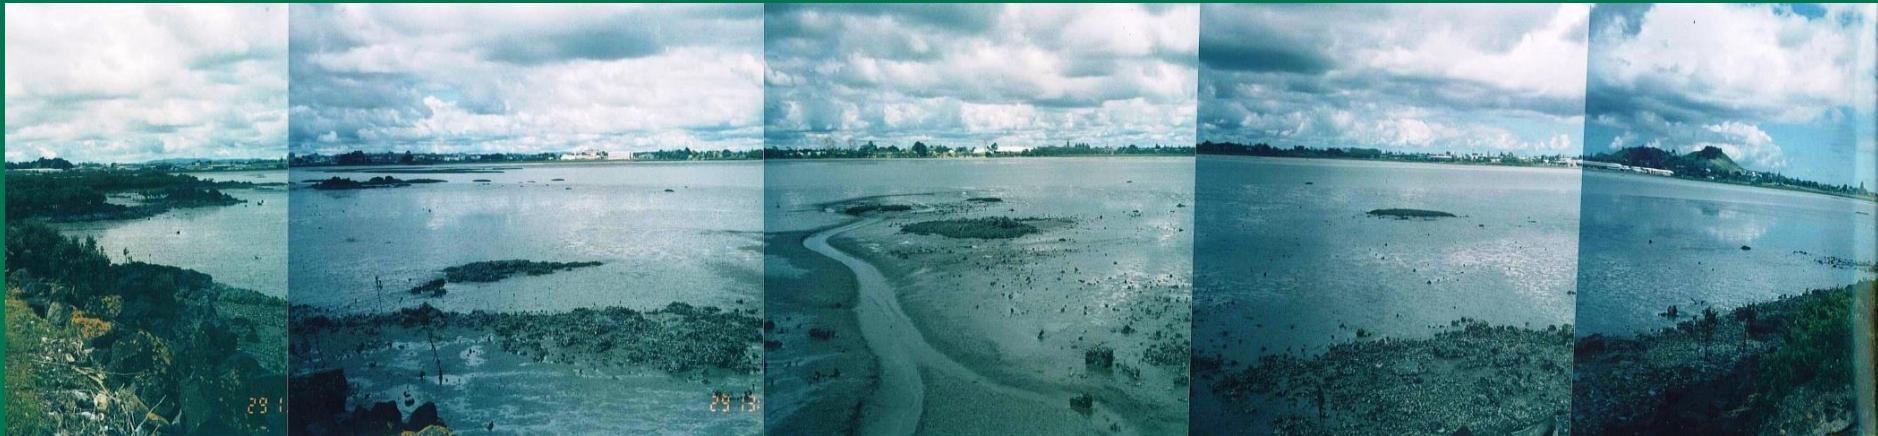
Green Stream Discharge to Mangere Inlet

- Manukau Harbour consists of tidal mudflats fringed by mangroves, supporting fish & numerous invertebrate species including oysters
- Manukau Harbour is culturally and historically significant as a source of seafood to many iwi and particularly important to the people of the Tainui waka.
- A valued recreational and aesthetic resource, including boating, fishing, shellfish gathering and walking

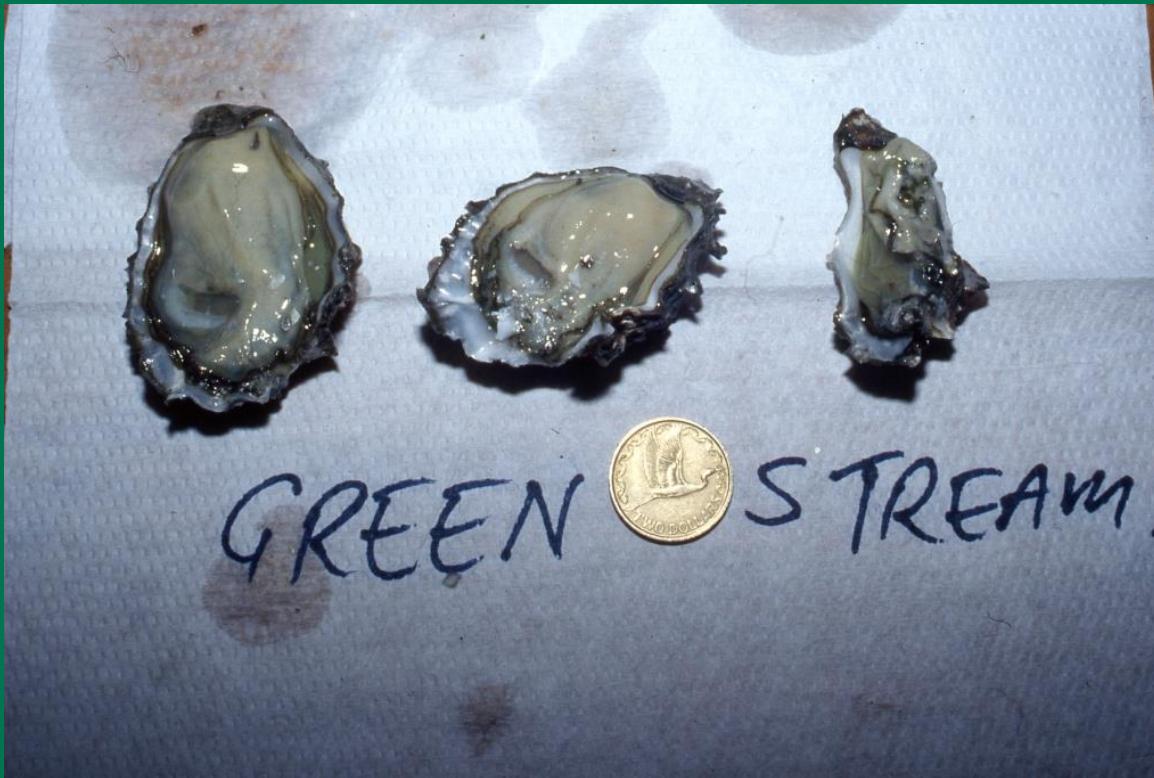
The Green Oysters

- At Green Streem discharge outfall there are many oyster beds
- Oysters - green on the inside
- Elevated copper, cadmium and chromium

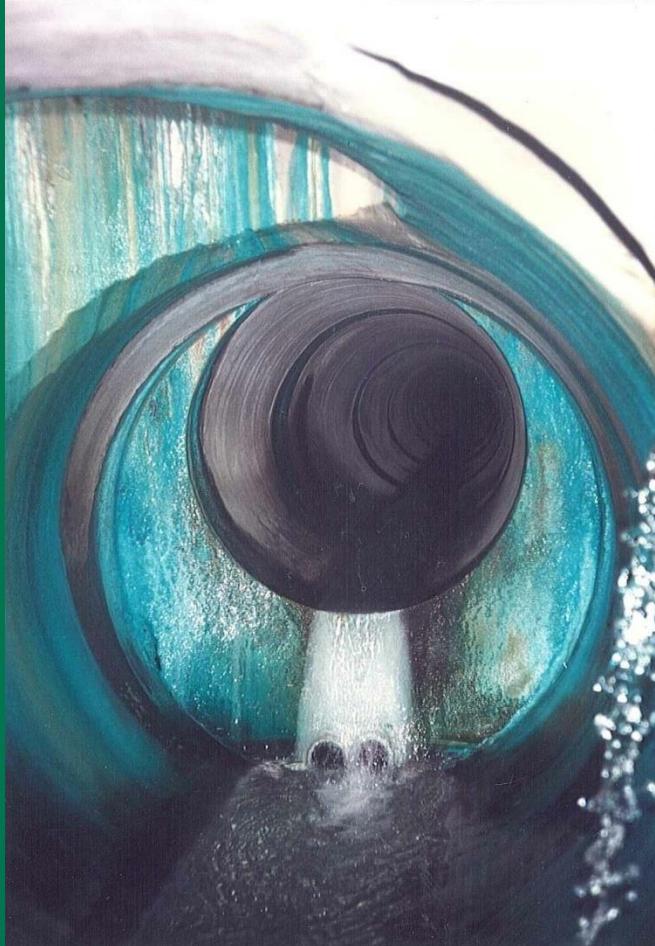
Patrick Street Stormwater Line

- Contamination was traced up-gradient to Patrick St. stormwater line, where contaminated groundwater was seen leaking into the pipe
- Many potential polluters were investigated, such as nearby electroplaters but the source of the contamination could not be found
- Note, the NZ Farmers Fertiliser site was gone at this stage i.e. subdivided and redeveloped

- The Patrick St. stormwater line acts as a major preferential pathway for contaminant migration due to its poor integrity from both age and acidic corrosion and it's location in the heart of the natural channel preferential pathway in the tuff

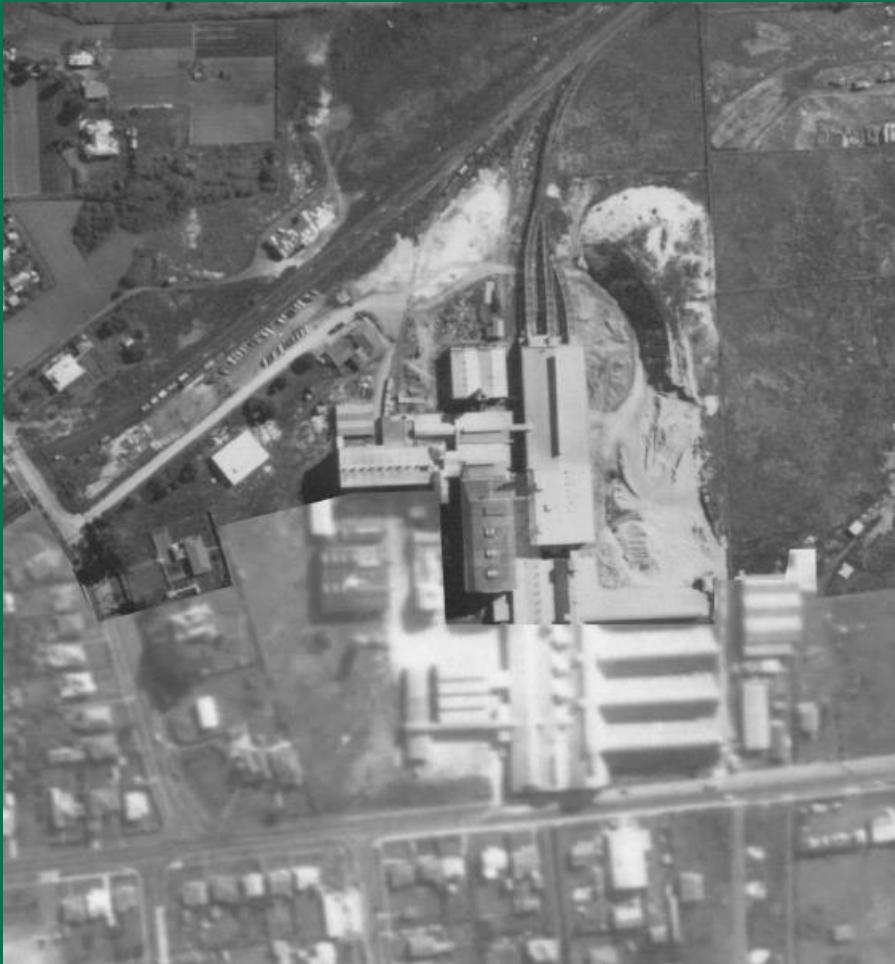
The NZFF Site Operations (Photo 1959)

- Operated for 74 years from 1910-1984
- Manufactured, stored and handled fertiliser products
- Principal process was conversion of rock phosphate to superphosphate fertiliser using sulphuric acid
- Rock phosphate (high in fluoride) was stored in uncovered stockpiles
- Sulphur, serpentine, potassium (potash) & acid salts were also stored on-site
- Sulphuric acid and hydrofluorosilicic acid were stored in silos
- Stormwater was disposed via on-site soakage holes and sumps
- Potential contaminants from NZFF site: copper, sulphate, cadmium, fluoride, phosphorus & low pH
