| LSD-47 | USS RUSHMORE | | <del>38E9213601</del> | | |

TITLE: Nonskid Deck Covering and Deck Plate at 06 Level Weather Deck; replace  
Rev-01(FO1)~Deck Coaming on 06 Level Weather Deck; repair

## JOB SPECIFICATION

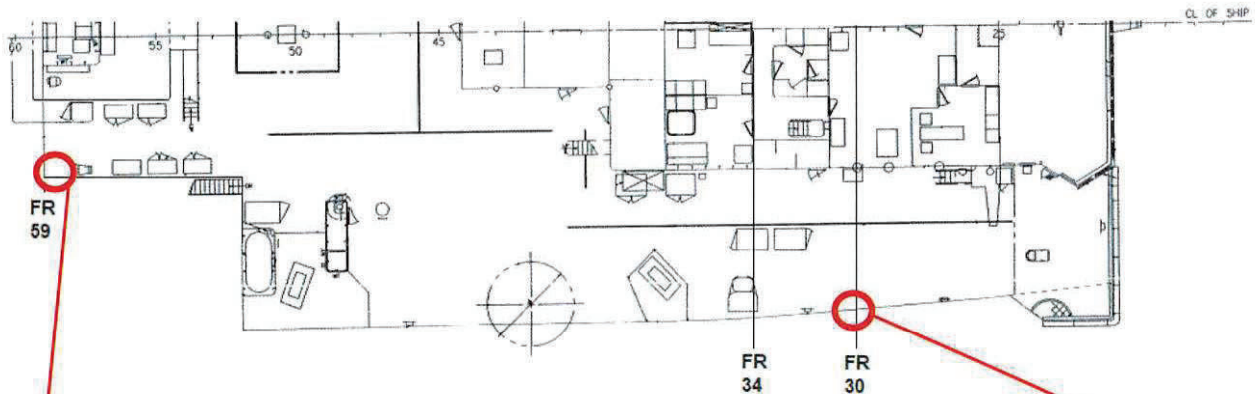
## Plan (STBD) : 06 Level Weather Deck

4.1 Initial Condition - Several corrosion holes there are deck edge coaming and MISC portable davit socket located in 06 level weather deck.

<Finding 1-a-2 in CCIMS report>

Tow holes, 6" LG x 1/2" dia, in deck coaming as a part of the longitudinal watertight bulkhead at 20'-0" STBD of CL, located at 9" and 13" FWD of FR 59, respectively. And 2" dia hole in outboard brace of deck socket for MISC portable davit.

<Finding 1-a-1 in CCIMS report>

2" LG x 1/2"H hole in deck coaming as a part of the deck house side starboard at 9" FWD of FR 30.5 and 1" above 06 level. It is located inside of the liferail for NULKA Launcher #1B.

3.1.1 Remove each damaged, fabricate and install each new deck coaming listed in 1.3.1 out of each new 3/16 inch thick mild steel plate conforming to ASTM A36.

3.1.2 Remove each damaged, fabricate and install each new brace of MISC portable davit socket listed in 1.3.2 out of each new 1/4 inch thick mild steel plate conforming to ASTM A36.
