# **Hazardous Materials Report for Guard Shack, Generator Building, and TE Building**

## **FY 26 MCON Project P1360, Mulpoint Joint Maritime Facility SMIG PRI Engineering Services**

NAVFAC Atlantic

Date: March 1, 2024

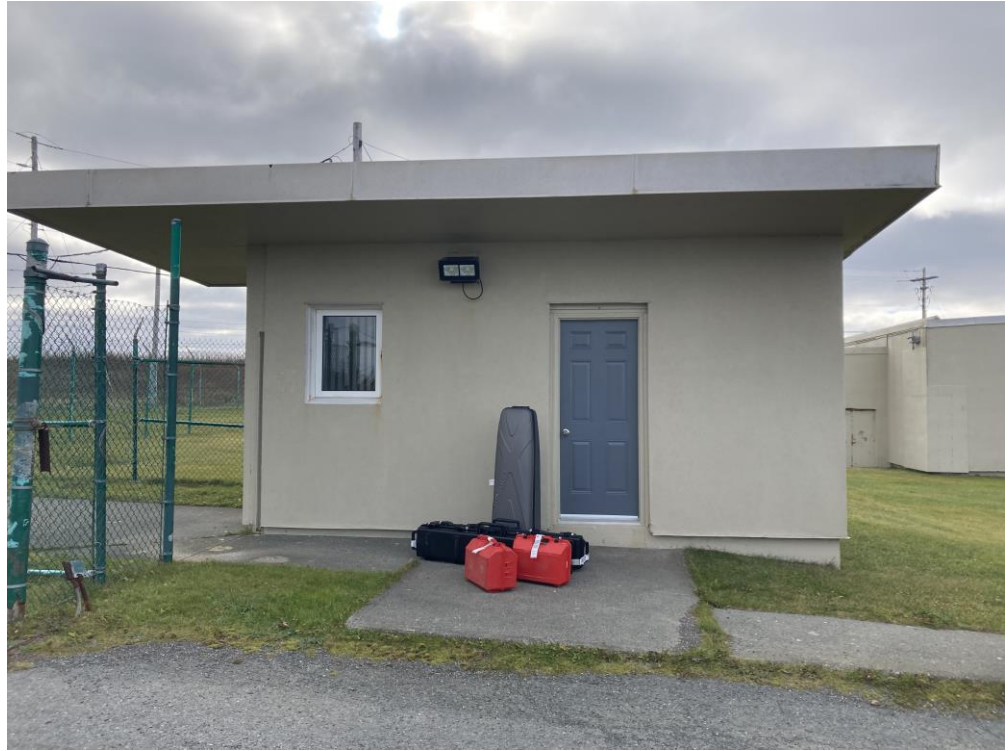
**Comments: Front of Guard Shack**

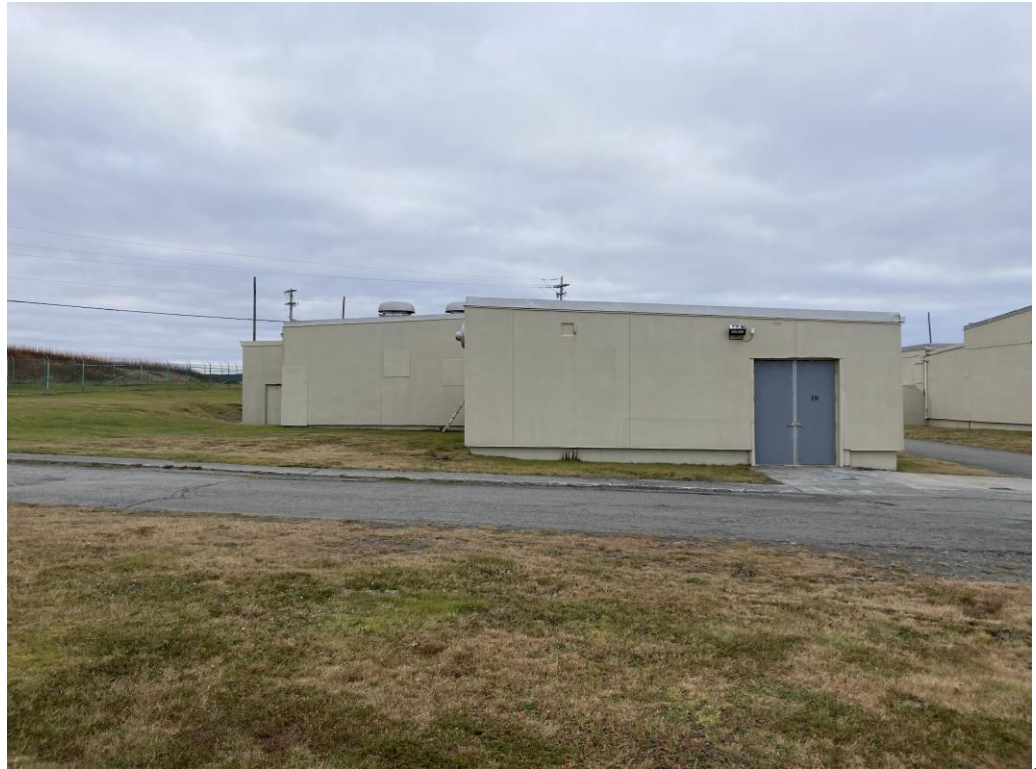
**Comments: Front of Generator Building**

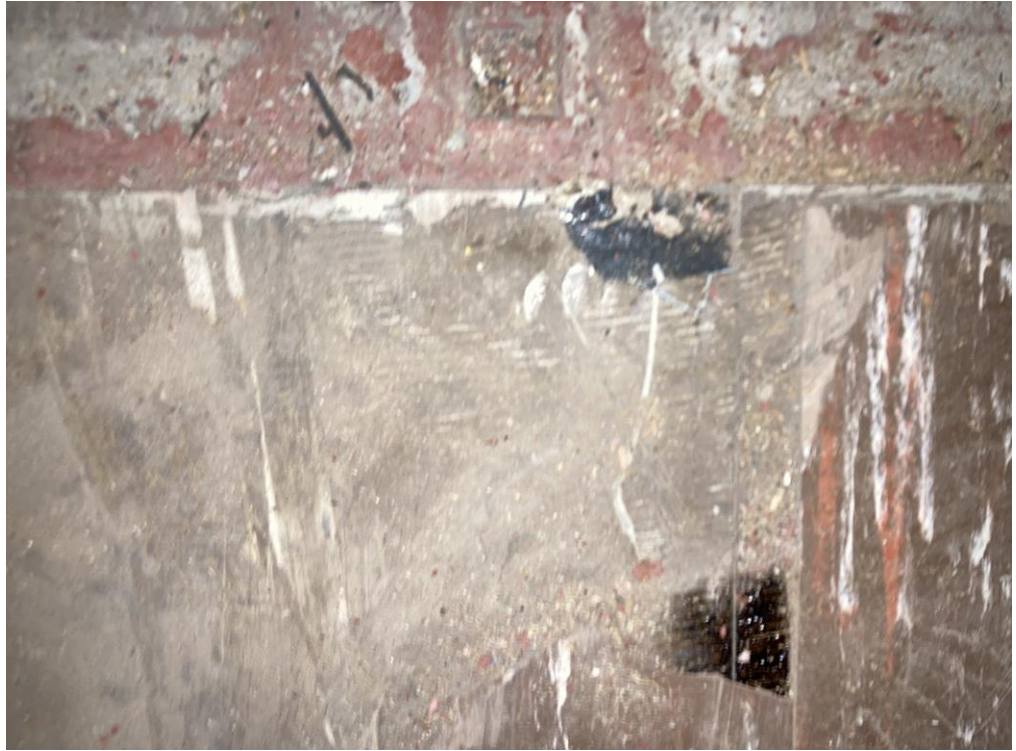
| Homogeneous Material Number | Material Type | Material Description | Category of ACM | Approximate Quantity of Asbestos | Condition of Material |
|---|---|---|---|---|---|
| 12 | Vinyl Floor Tile and Floor Adhesive | 12' x 12' Brown with White Streaks VFT and Tan FA | Non-Friable, Category II ACM | 480 Square Feet | Damaged |

**Comments: ACM – 12" x 12" Brown with White Streaks VFT and Black FA**

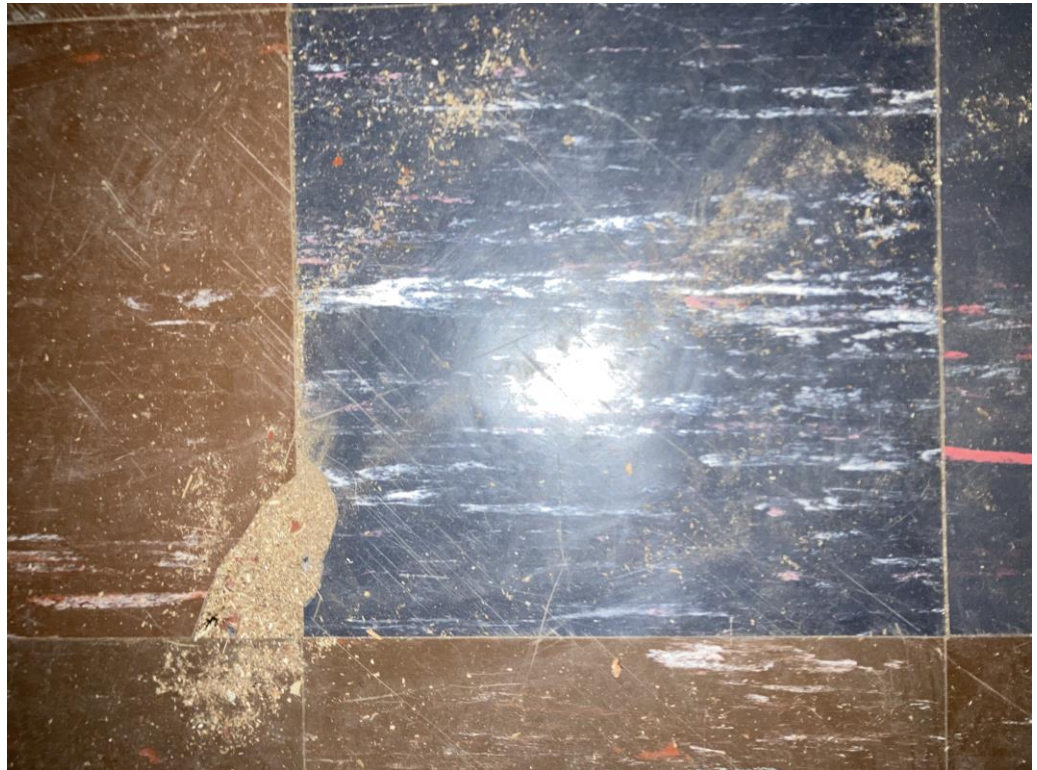
| Homogeneous Material Number | Material Type | Material Description | Category of ACM | Approximate Quantity of Asbestos | Condition of Material |
|---|---|---|---|---|---|
| 14 | Vinyl Floor Tile and Floor Adhesive | 12' x 12' Black VFT and Tan FA | Non-Friable, Category II ACM | 61 Square Feet | Damaged |

**Comments: ACM – 12" x 12" Black VFT and Black FA**

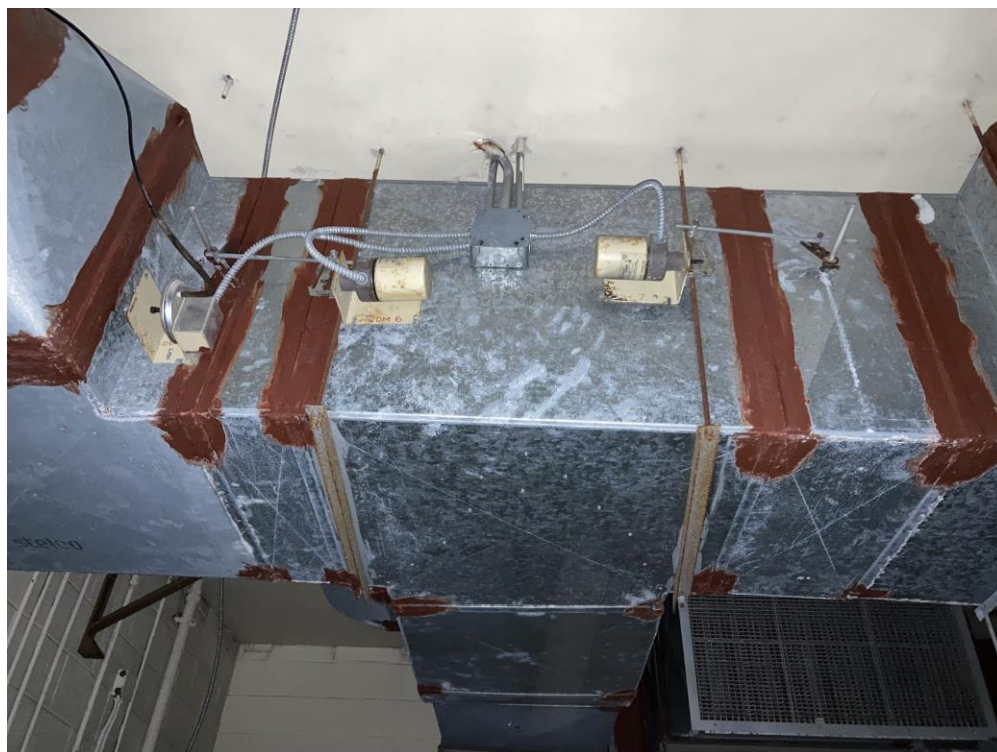
| Homogeneous Material Number | Material Type | Material Description | Category of ACM | Approximate Quantity of Asbestos | Condition of Material |
|---|---|---|---|---|---|
| 15 | Sealant | Red, on HVAC equipment | Non-Friable, Category II ACM | 75 Square Feet | Damaged |

**Comments: ACM – Red Sealant on HVAC Ductwork**

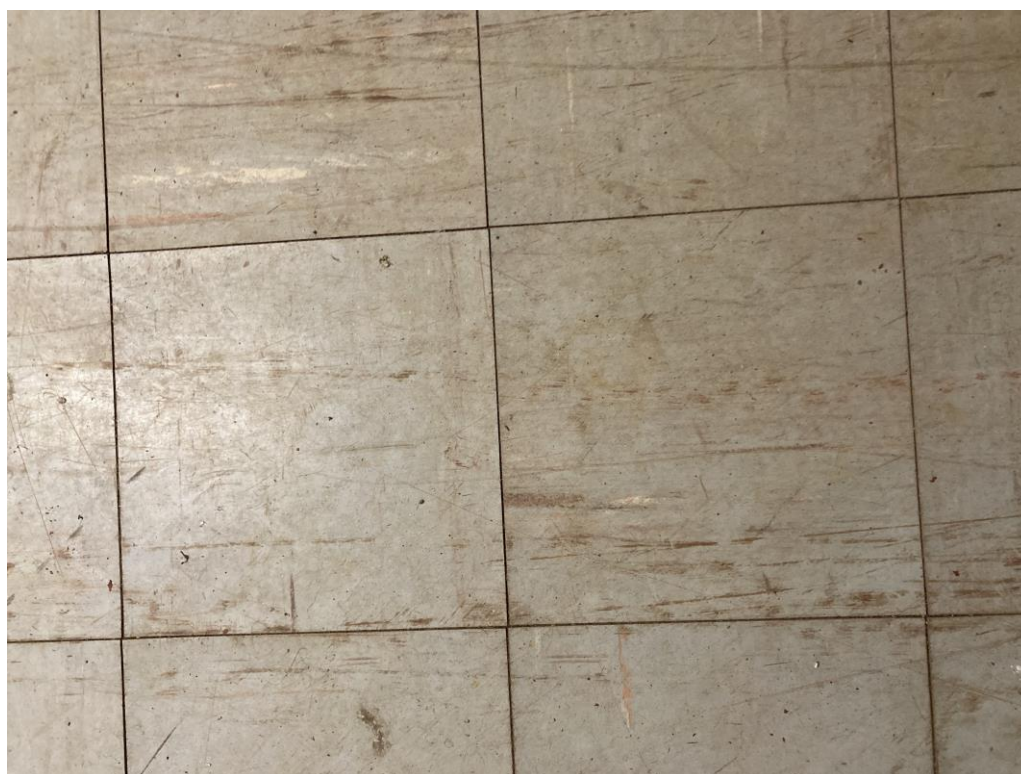
| Homogeneous Material Number | Material Type | Material Description | Category of ACM | Approximate Quantity of Asbestos | Condition of Material |
|---|---|---|---|---|---|
| 17 | Vinyl Floor Tile and Floor Adhesive | 12' x 12' Gray with Brown Streaks VFT and Tan FA | Non-Friable, Category II ACM | 1,112 Square Feet | Damaged |

**Comments: ACM – 12"x12" Gray with Brown VFT and Tan FA**

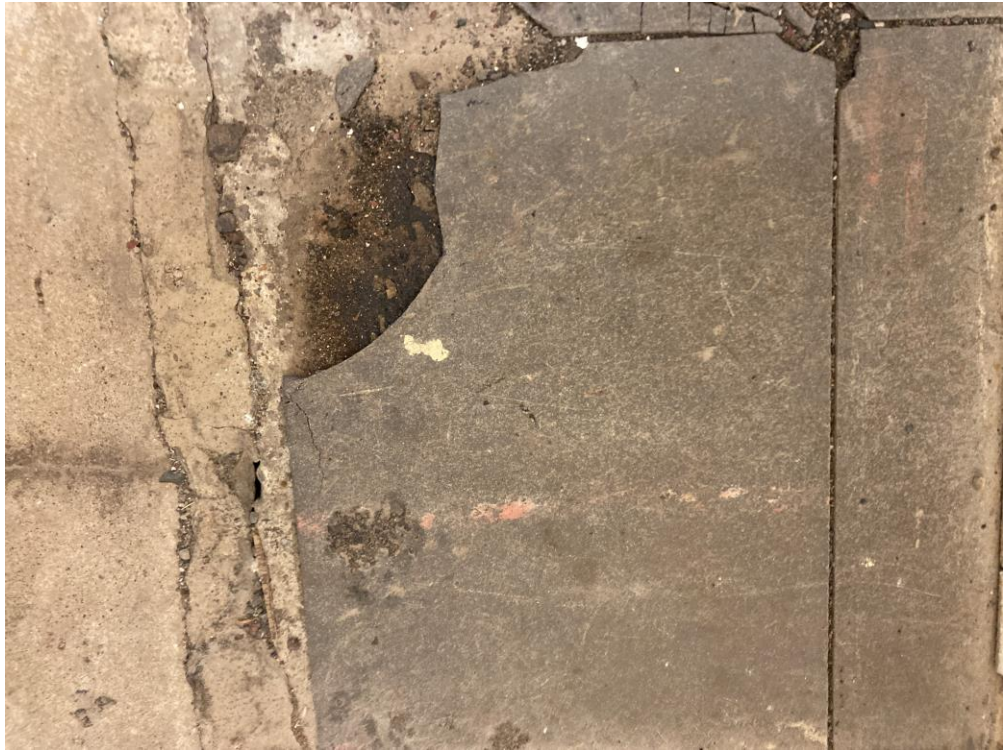
**Comments: ACM – 12"x12" Dark Gray VFT and Tan FA**

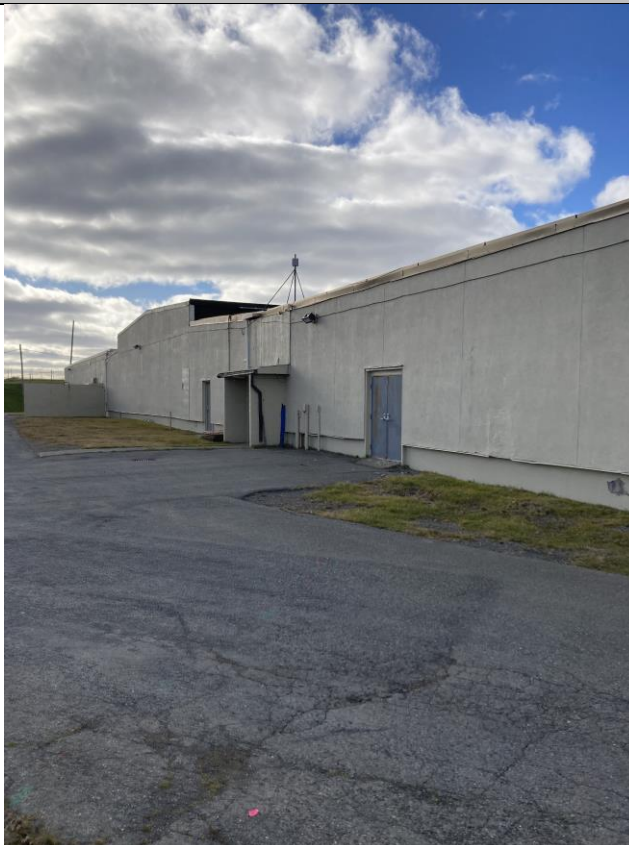
**Comments: Front of TE Building**

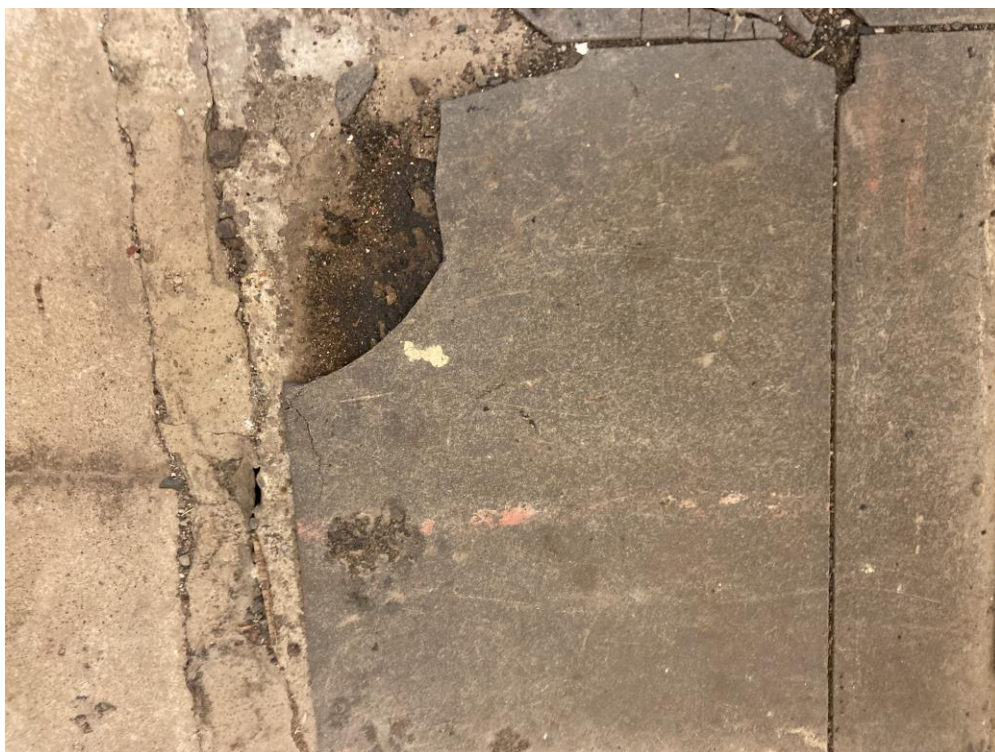
**Comments: ACM – 12"x12" Dark Gray VFT and Tan FA**

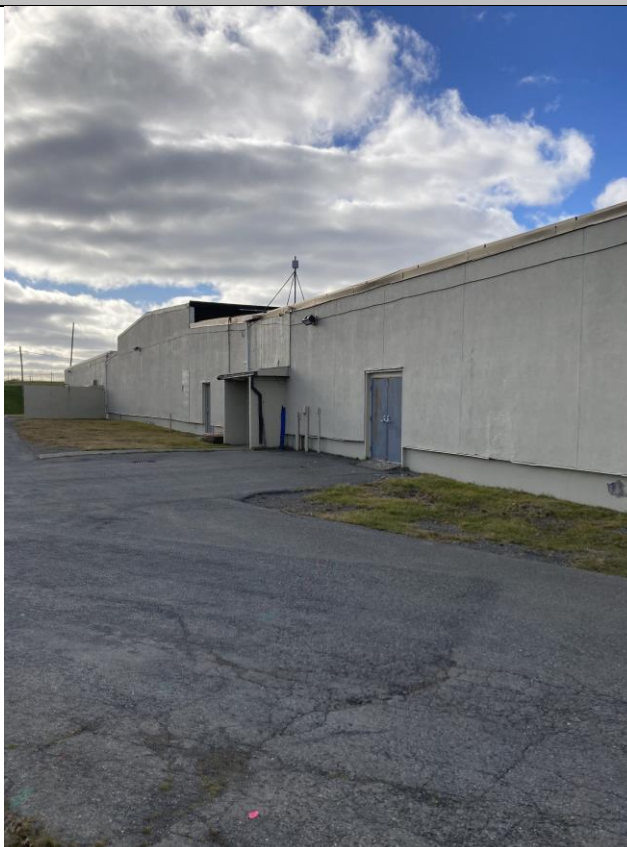
**Comments: Front of TE Building**

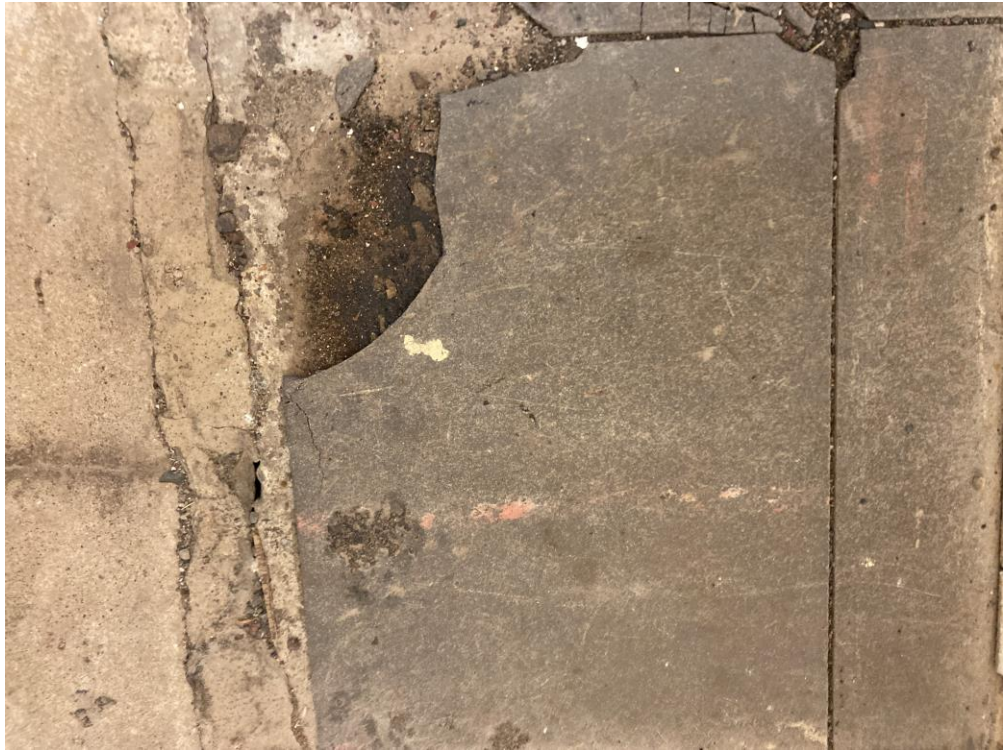
**Comments: ACM – 12"x12" Dark Gray VFT and Tan FA**

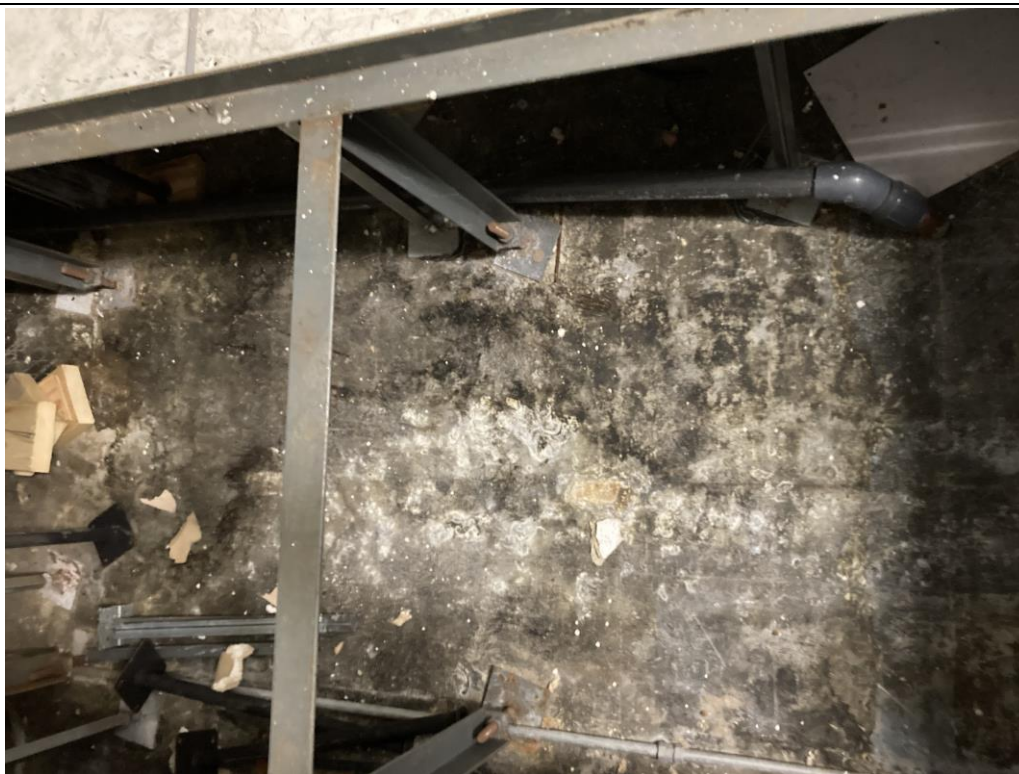
| <b>Homogeneous Material Number</b> | <b>Material Type</b> | <b>Material Description</b> | <b>Category of ACM</b> | <b>Approximate Quantity of Asbestos</b> | <b>Condition of Material</b> |
|---|---|---|---|---|---|
| 30 | Floor Adhesive | Black Residual Adhesive | Non-Friable, Category II ACM | 11,880 Square Feet | Damaged |

**Comments: ACM – Residual FA**

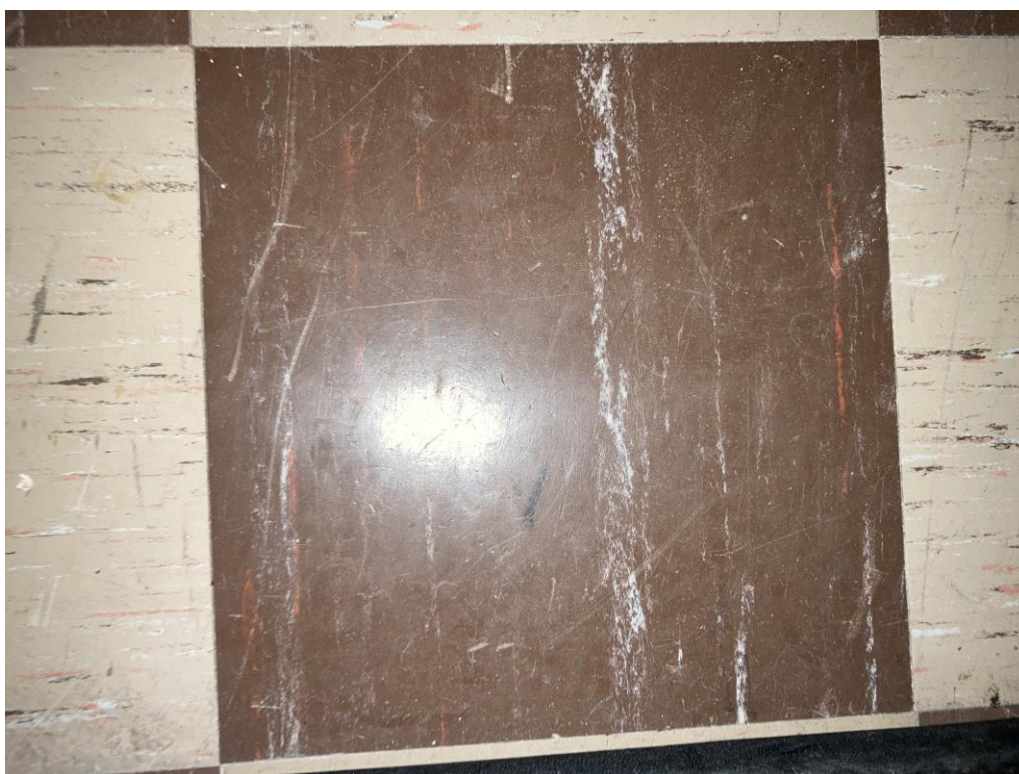
| <b>Homogeneous Material Number</b> | <b>Material Type</b> | <b>Material Description</b> | <b>Category of ACM</b> | <b>Approximate Quantity of Asbestos</b> | <b>Condition of Material</b> |
|---|---|---|---|---|---|
| 34 | Vinyl Floor Tile and Floor Adhesive | 12" x 12" Brown Vinyl Floor Tile with Black Floor Adhesive | Non-Friable, Category II ACM | 1,640 Square Feet | Damaged |

**Comments: ACM – 12"x12" Brown VFT and Tan FA**

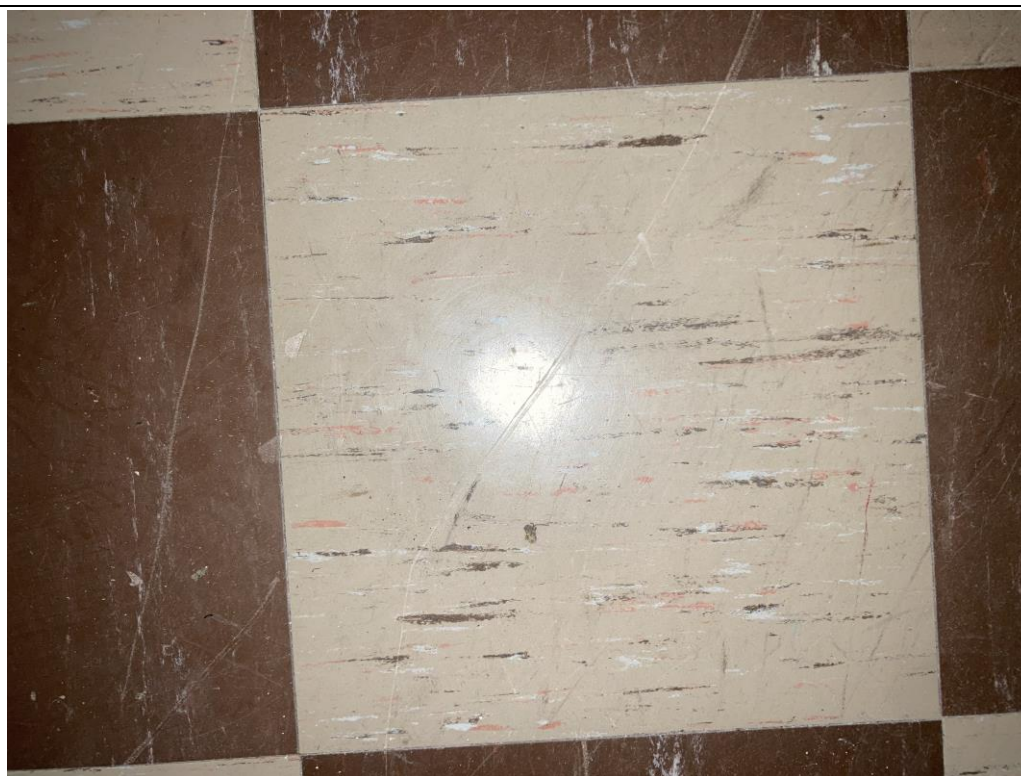
| <b>Homogeneous Material Number</b> | <b>Material Type</b> | <b>Material Description</b> | <b>Category of ACM</b> | <b>Approximate Quantity of Asbestos</b> | <b>Condition of Material</b> |
|---|---|---|---|---|---|
| 35 | Vinyl Floor Tile and Floor Adhesive | 12" x 12" Tan Vinyl Floor Tile with Black Floor Adhesive | Non-Friable, Category II ACM | 5,600 Square Feet | Damaged |

**Comments: ACM – 12"x12" Tan VFT and Tan FA**

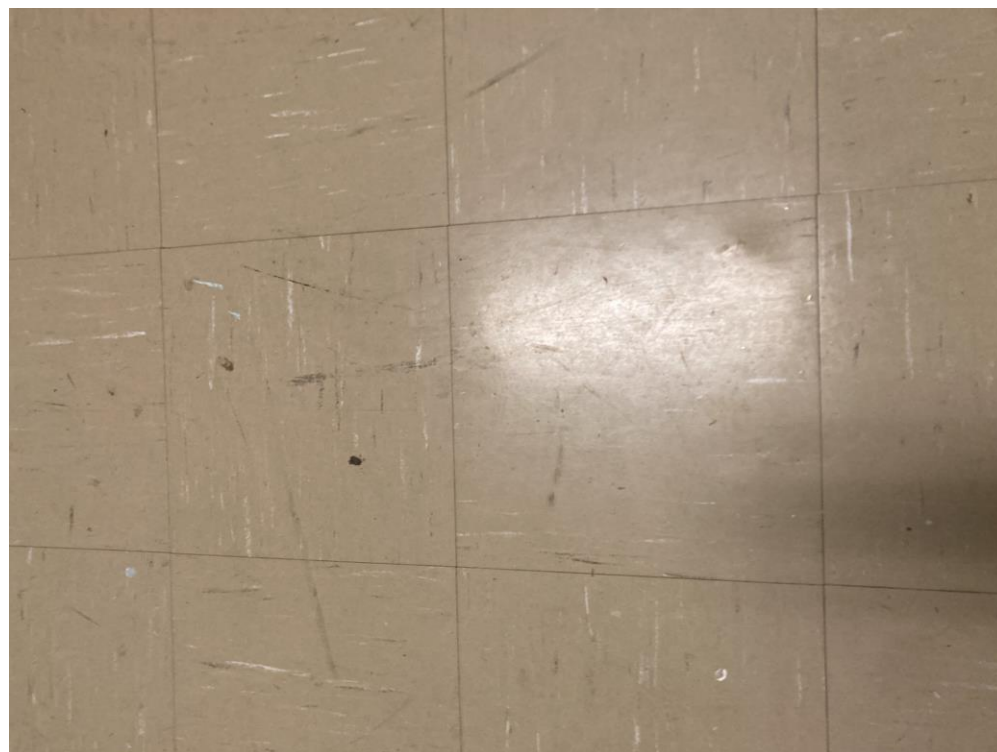
**Comments: ACM – 12"x12" Tan with White Streaks VFT and Tan FA**

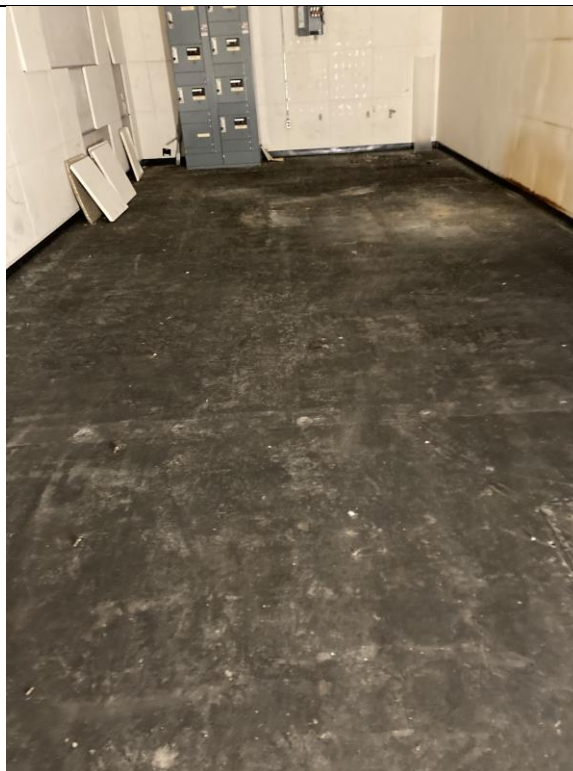
**Comments: ACM – Residual Black FA**

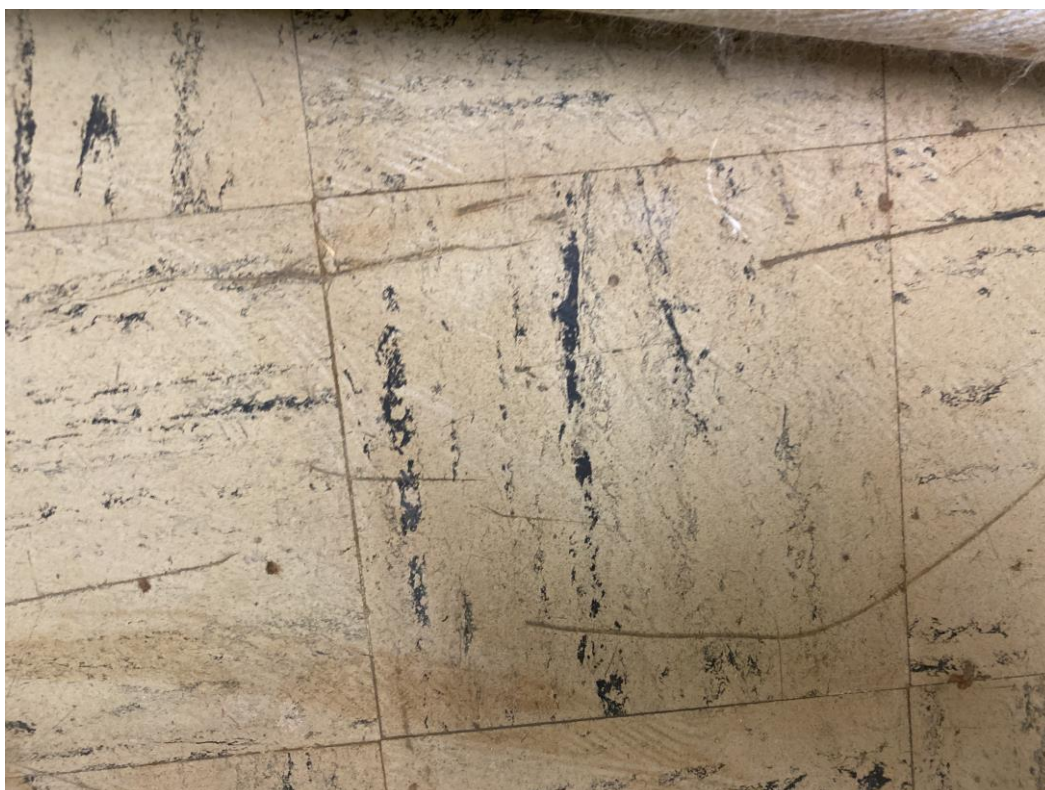
**Comments: ACM – 9”x 9” White VFT and Black FA**

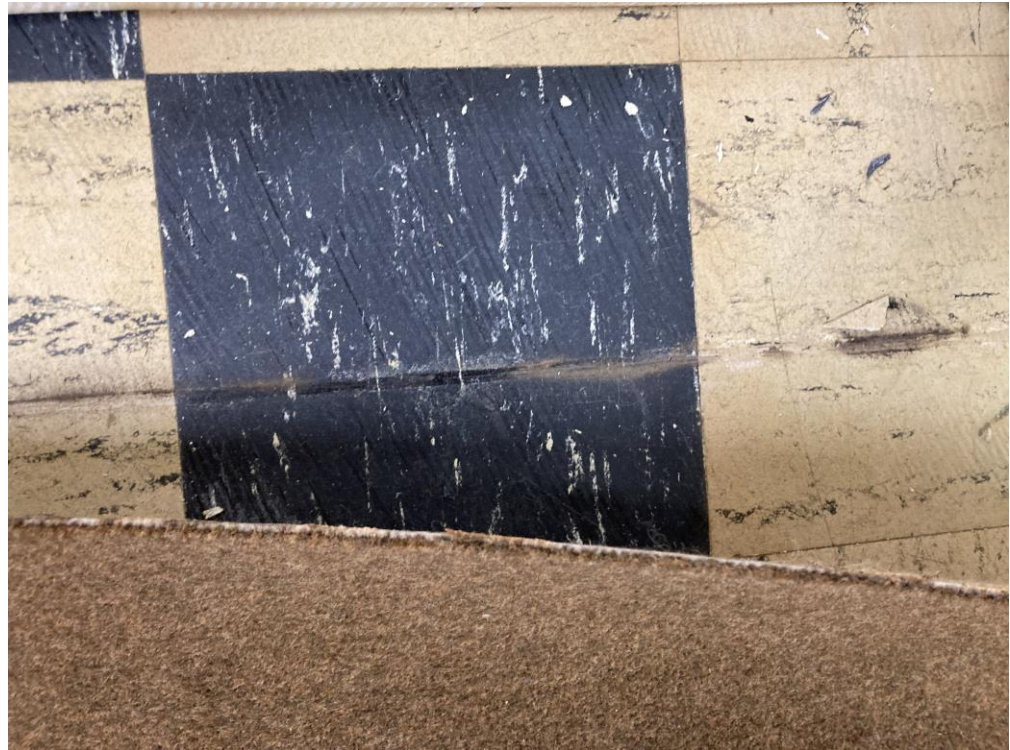
**Comments: ACM – 9”x 9” Blue VFT and Black FA**

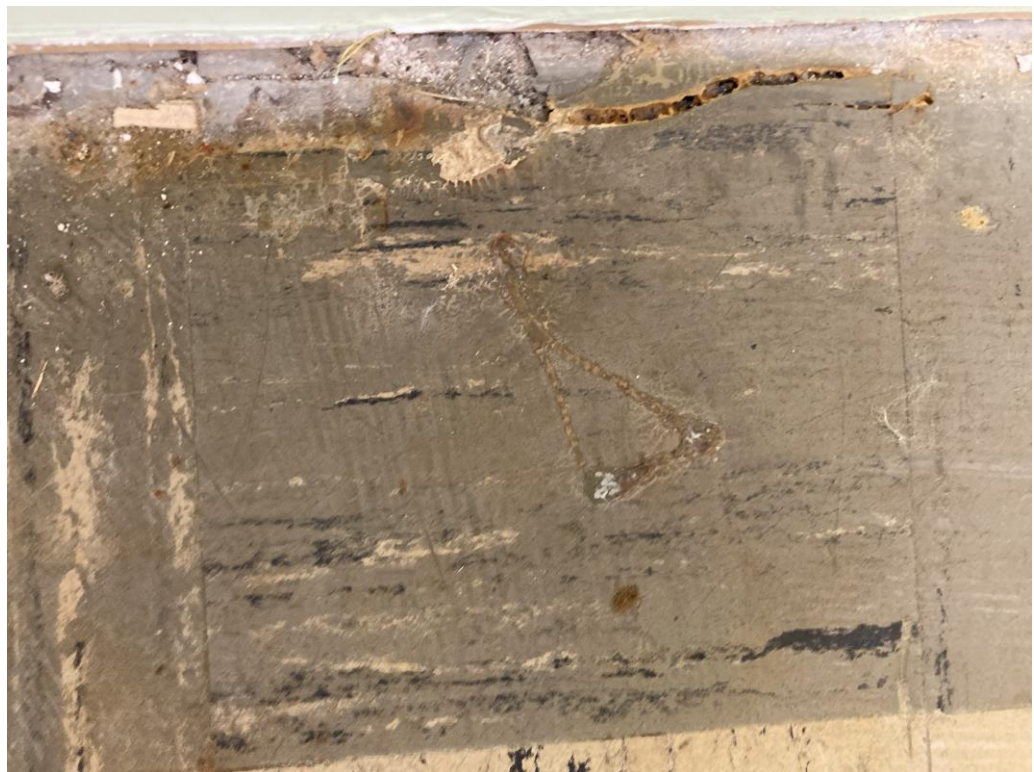
**Comments: ACM – 9”x 9” Gray VFT and Black FA**

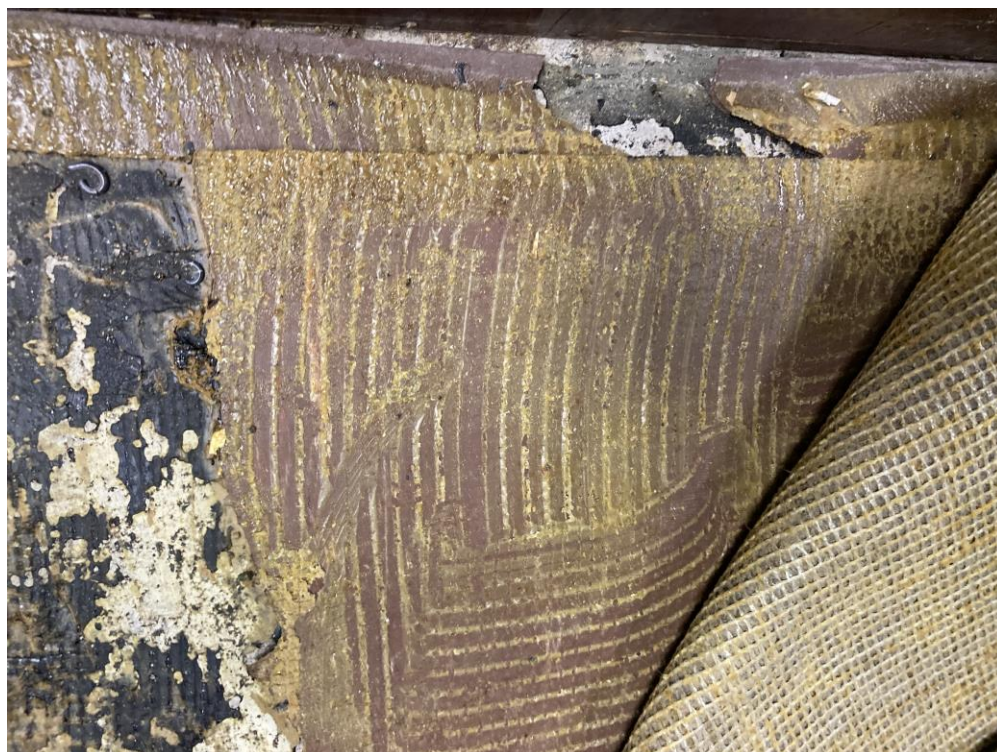
**Comments: ACM– 9”x 9” Brown VFT and Black FA**

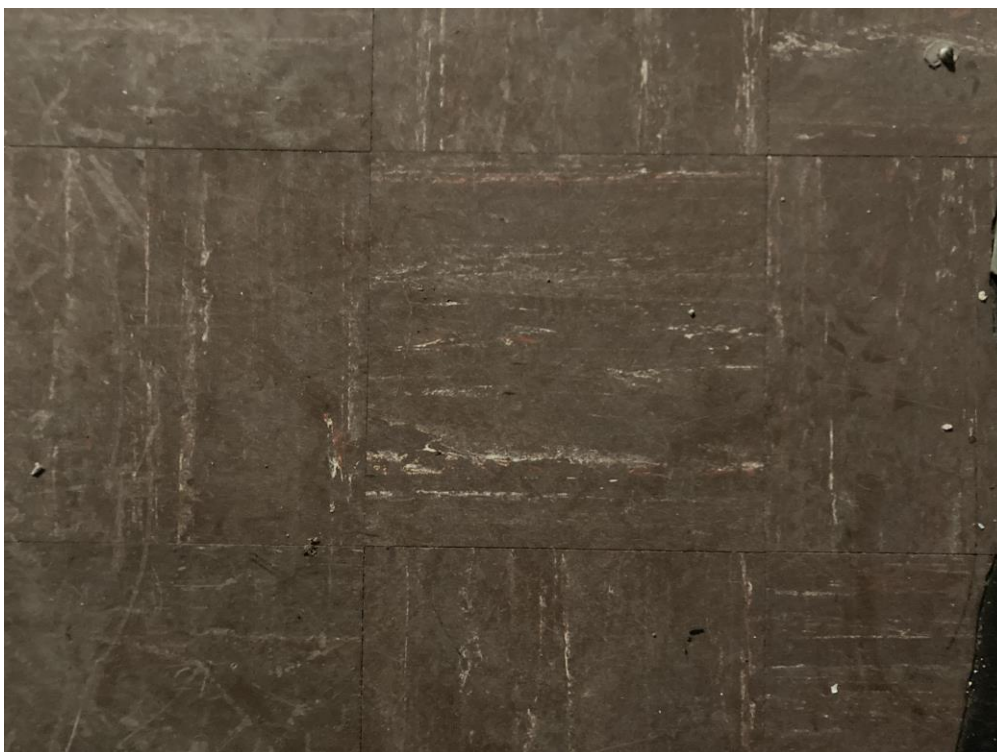
**Comments: ACM– 9”x 9” Black VFT and Black FA**

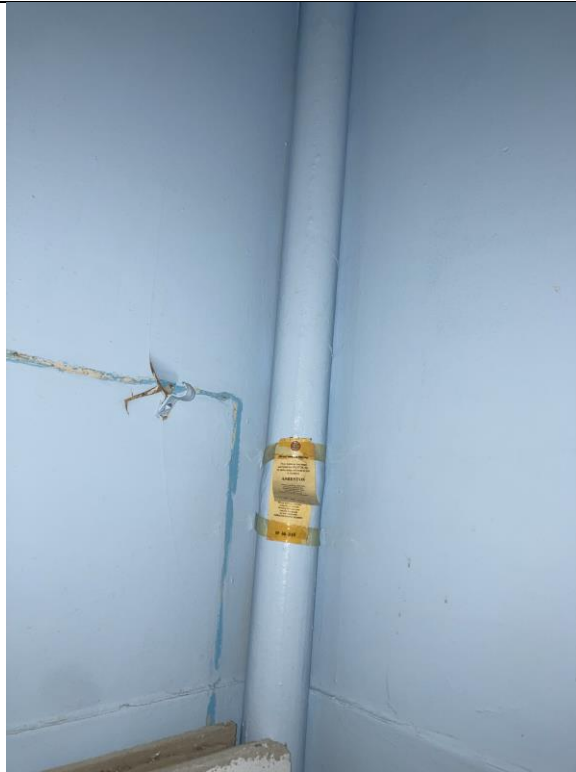
**Comments: ACM – Thermal Pipe Insulation**

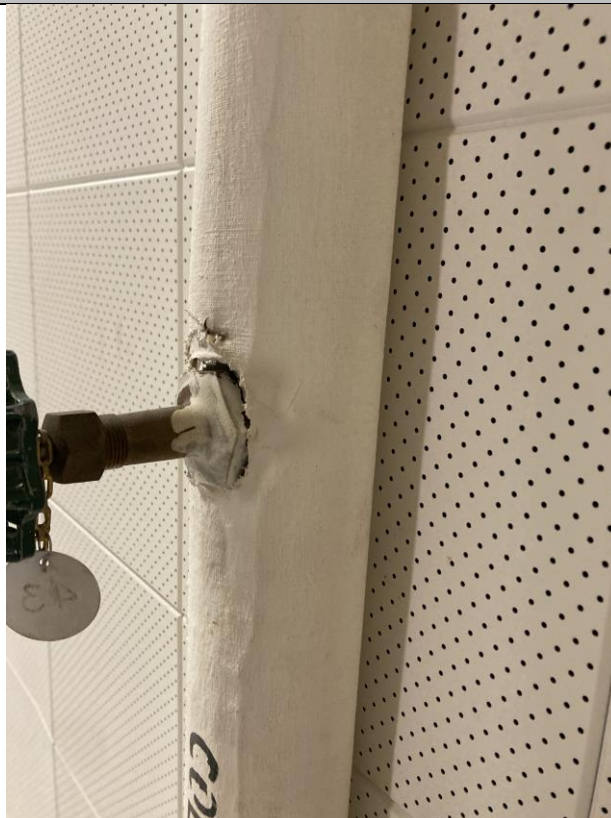
**Comments: ACM – Thermal Pipe Fitting Insulation - small**

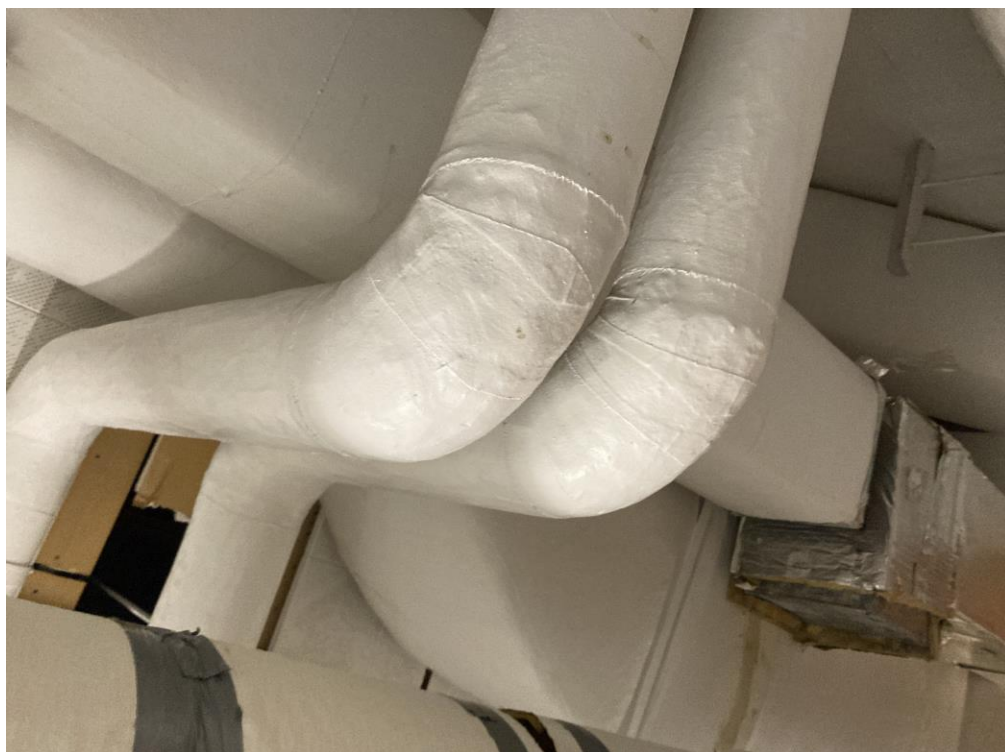
**Comments: ACM – Thermal Pipe Fitting Insulation - large**

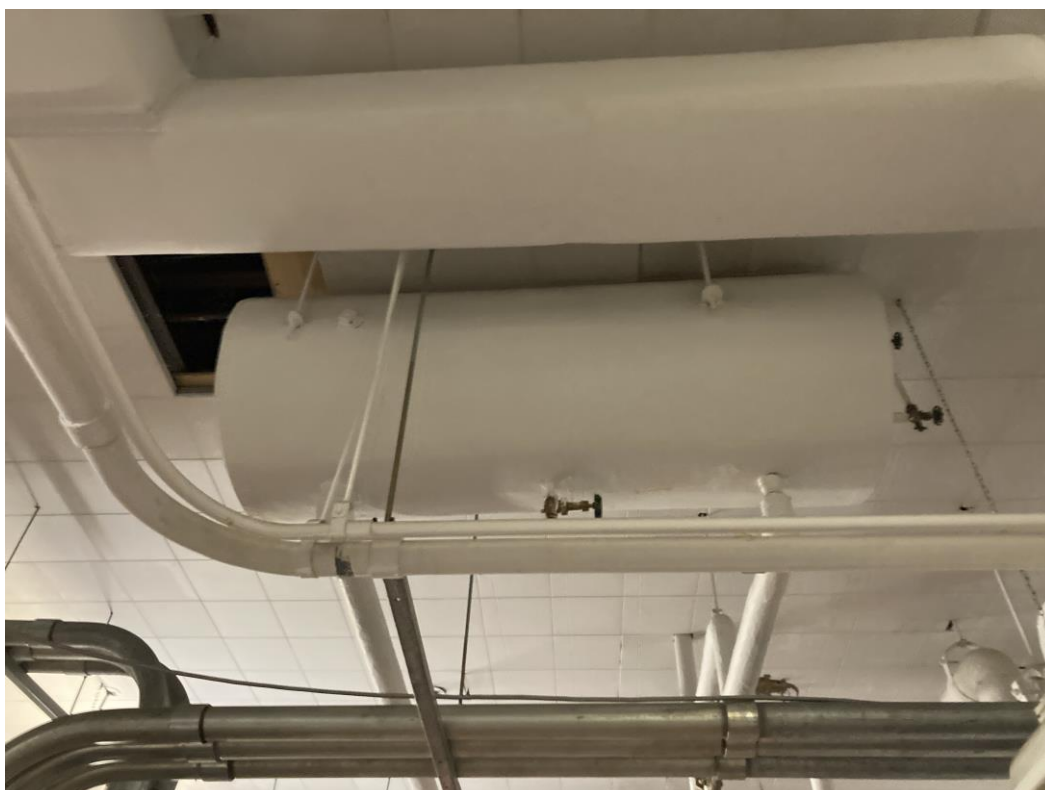
**Comments: ACM – Thermal Tank Insulation**

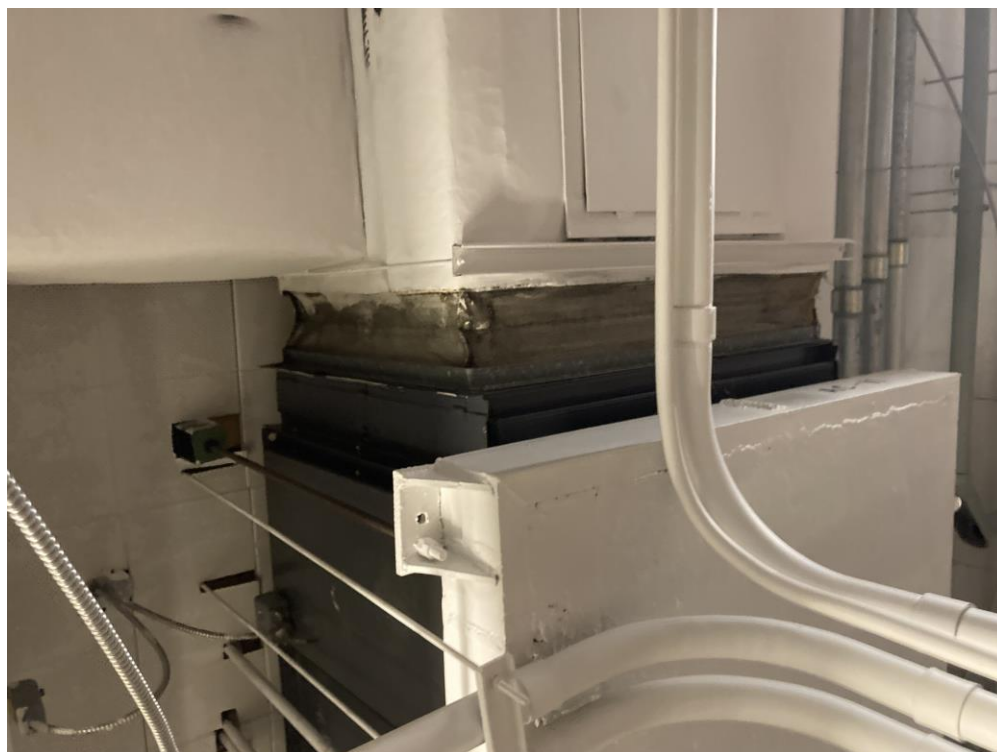
**Comments: ACM – Flex Connector**

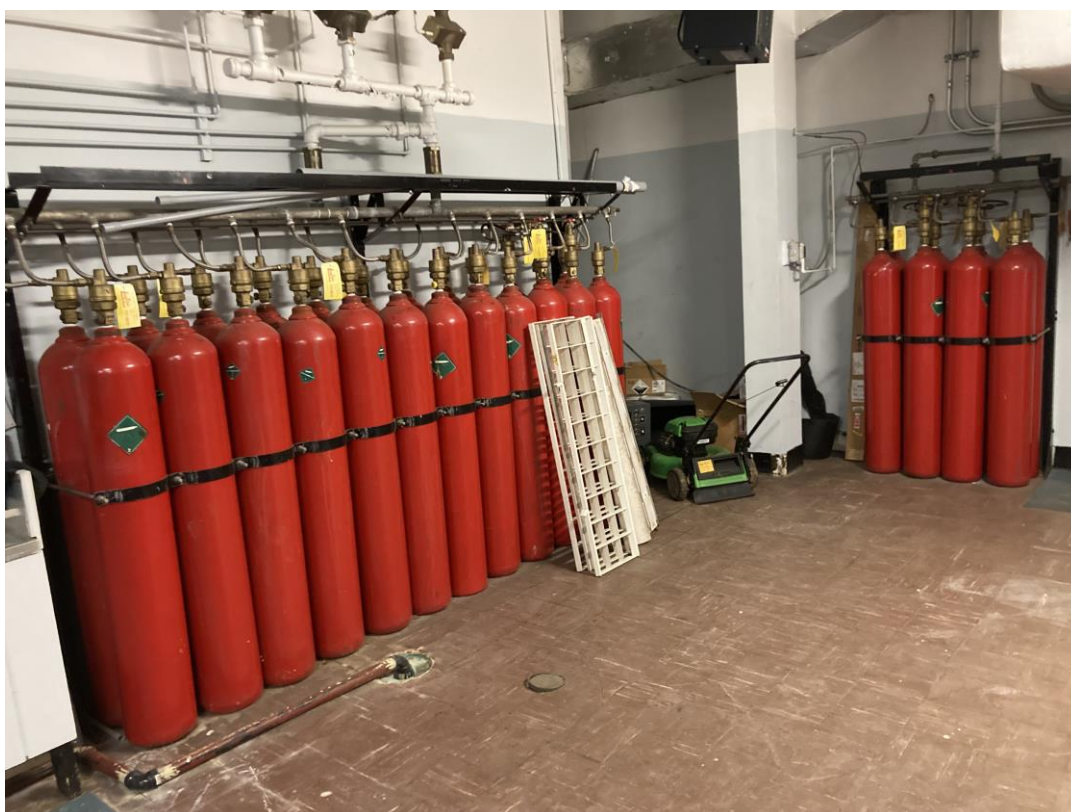
**Comments: Tanks located in Room 51**

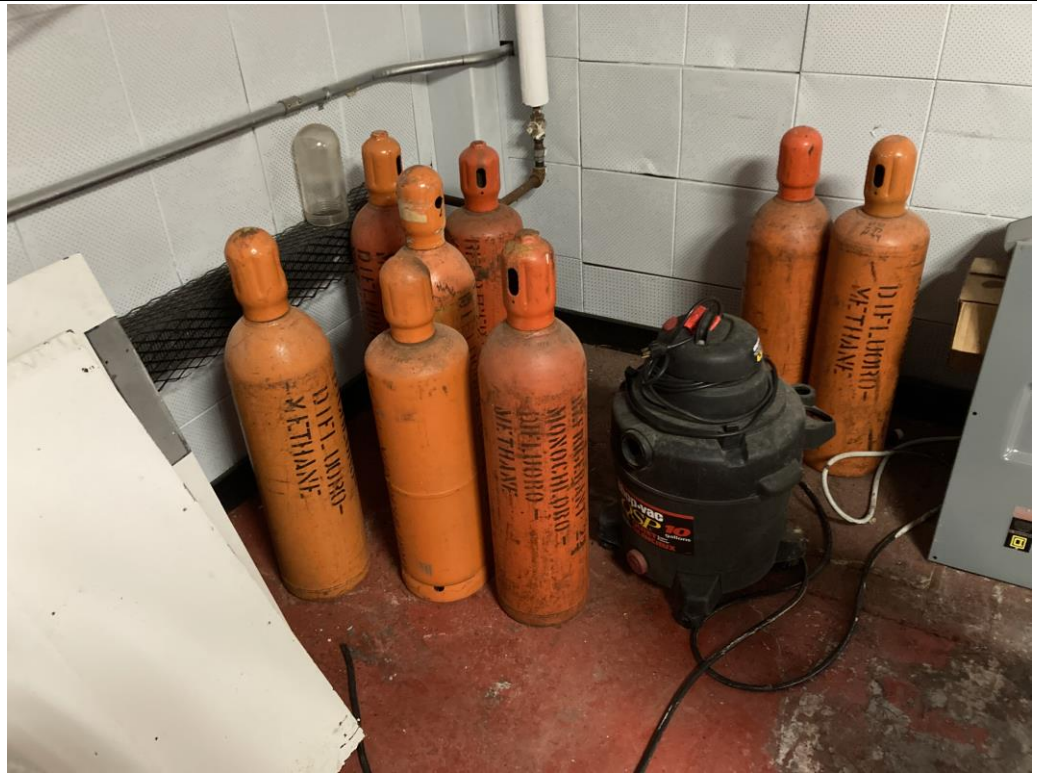
**Comments: Tanks located in Room 52**
