## TECHNICAL MEMORANDUM

**DATE** 03 February 2026

**WSP Project No.** CA0037087.2445

### **PAINT SAMPLING FOR LEAD, MERCURY, AND PCBS AT MOLL POINT JOINT MARITIME FACILITY, ARGENTIA NAVAL AIR STATION, ARGENTIA, NEWFOUNDLAND AND LABRADOR (NAVFAC ATLANTIC PROJECT NO. FY26 MCON PROJECT P1360)**

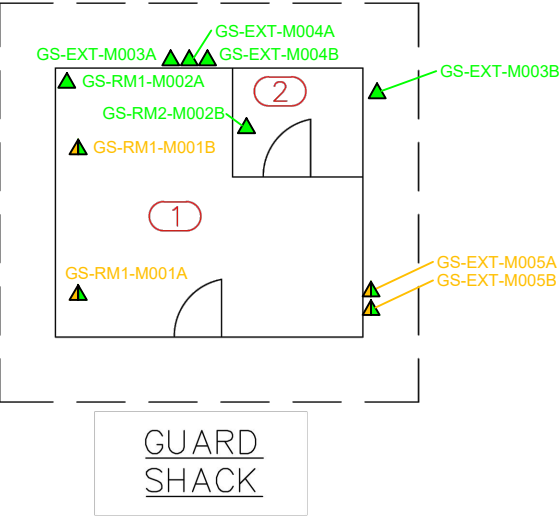
- In the TE Building, mercury was identified above 10 ppm in paints at 14 locations in a variety of colours applied to a variety of substrates.
- In the Generator Building, mercury was identified above 10 ppm in white paint on drywall and concrete block, and blue paint applied to metal doors and frames.
- All paints tested in the Guardhouse contained less than 10 ppm mercury.

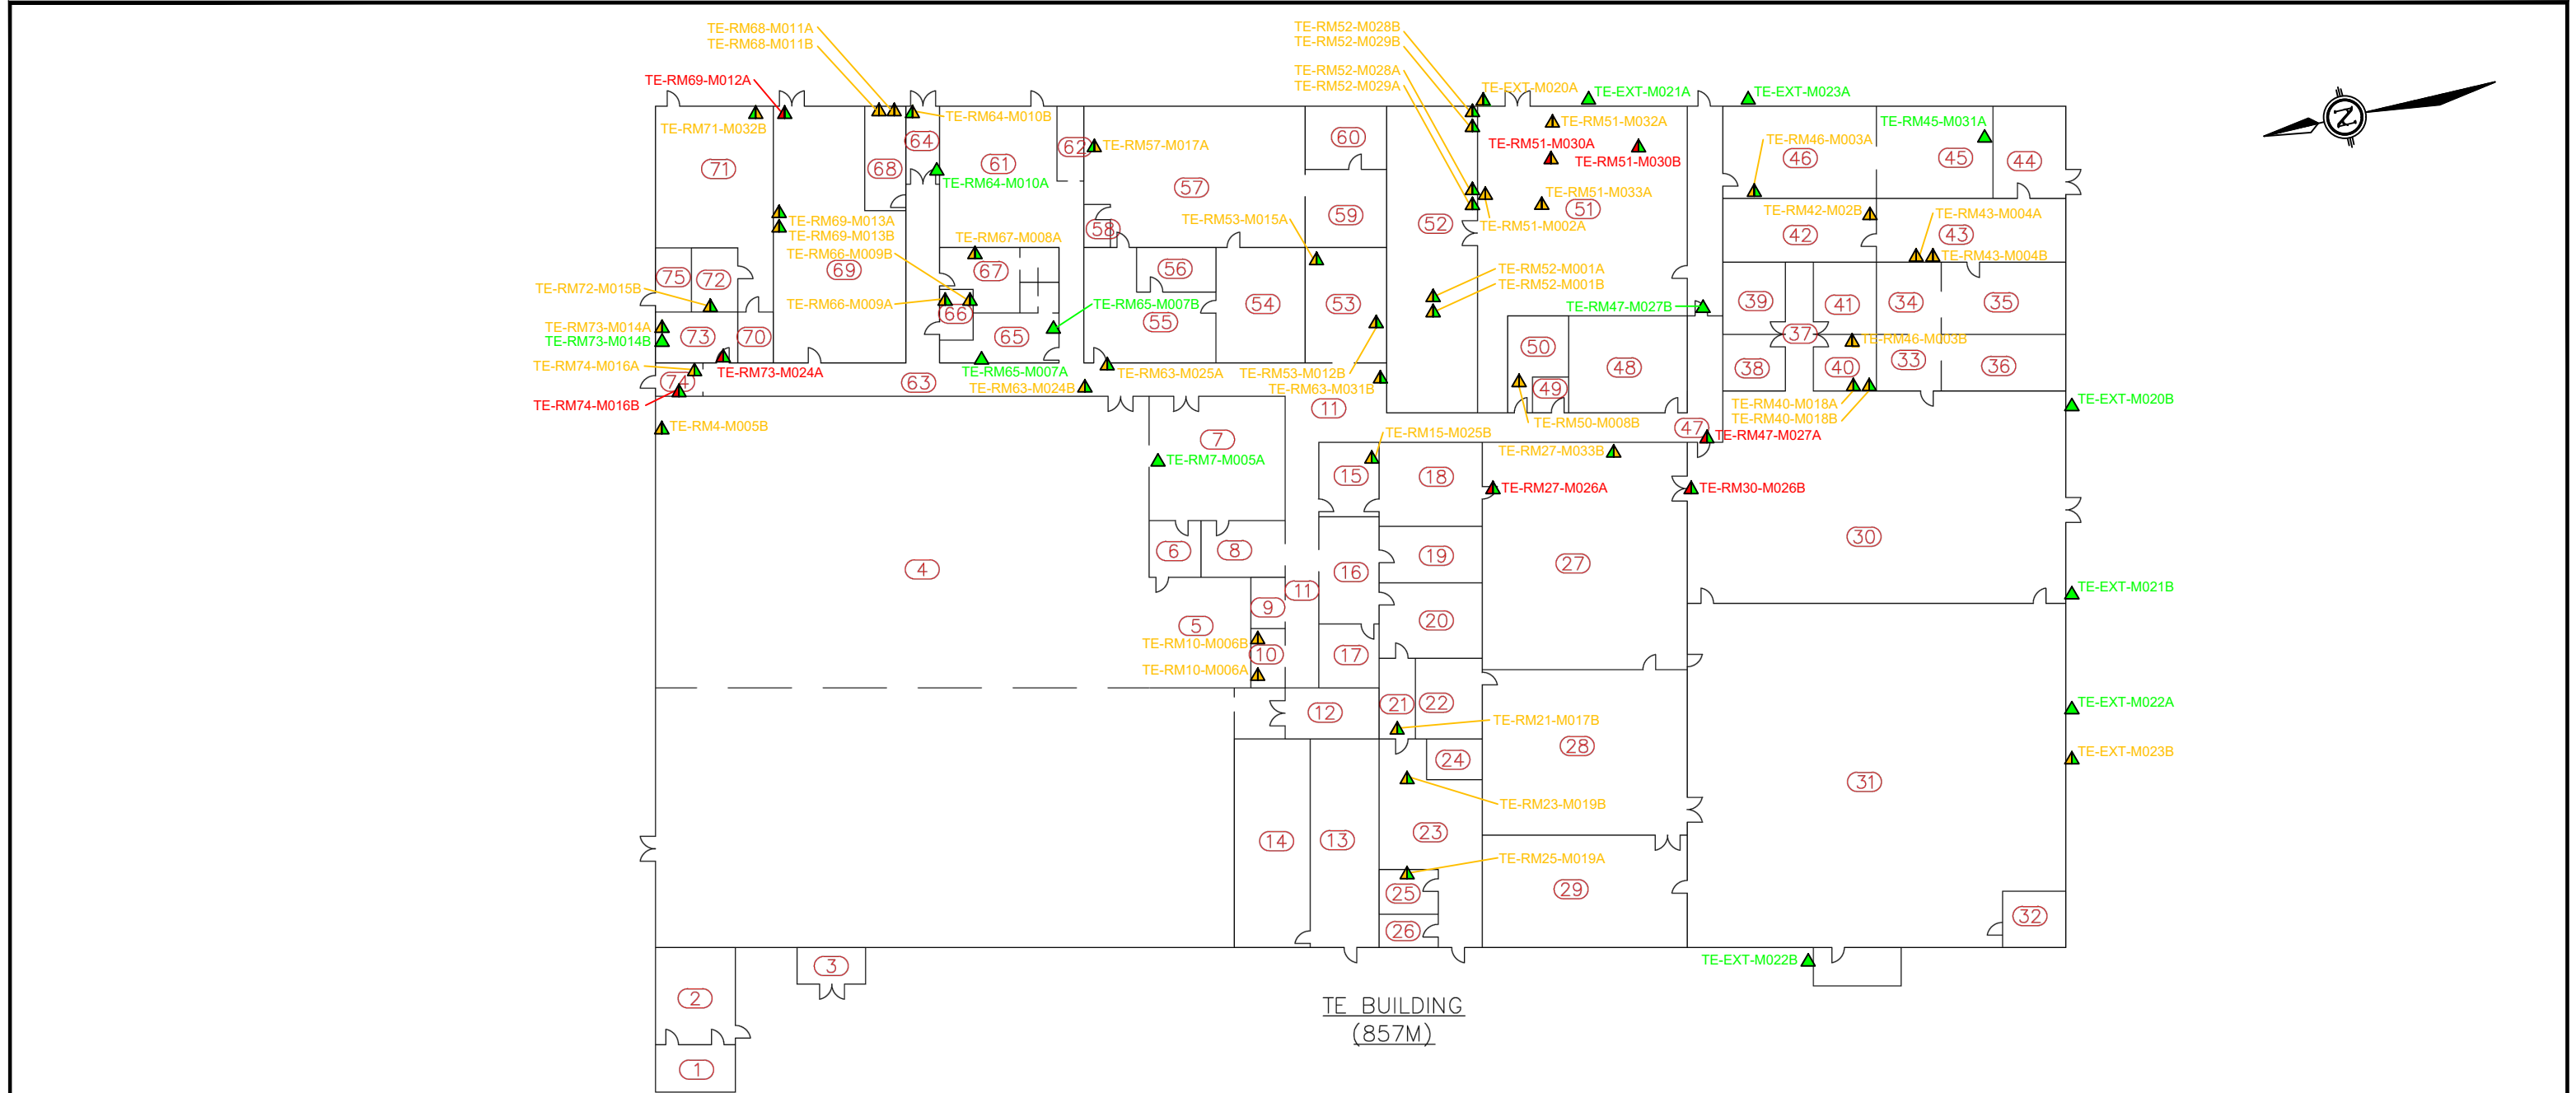
- In the TE Building, lead was identified above 90 ppm in paints at 38 locations in a variety of colours applied to a variety of substrates.
- In the Generator Building, lead was identified above 90 ppm in paints at 16 locations in a variety of colours applied to a variety of substrates.
- In the Guard Shack lead was identified above 90 ppm in off white paint on drywall and light brown paint on exterior piping.

- Very light brown paint on plaster wall in Room 69 in the TE Building (sample TE-Rm69-M012A)
- Very light green paint on plaster wall in Room 74 in the TE Building (sample TE-Rm74-M016B)
- Dark grey paint on metal door and frame in Room 73 in the TE Building (sample TE-Rm73-M024A)
- Light grey paint on metal generator housing in Room 10 in the Generator Building (sample GB-Rm10-M008A)
- Light grey paint on metal generator housing in Room 10 in the Generator Building (sample GB-Rm10-M008B)

- Black paint on metal door and frame, Rooms 27 and 30 of the TE Building – 180 mg/L (samples TE-Rm27-M026A and TE-Rm30-M026B – samples were combined for leachate analysis due to limited available mass)
- Green paint on metal door and frame, Room 47 of the TE Building – 22 mg/L (sample TE-Rm47-M027A)
- Black paint on concrete and metal pad, Room 51 of the TE Building – 6.1 mg/L (samples TE-Rm51-M030A)
- Black paint on concrete and metal pad, Room 51 of the TE Building – 8.9 mg/L (samples TE-Rm51-M030B)

- Disturbance of building materials coated with lead-containing paints during renovation/demolition operations should be conducted following the Environmental Abatement Council of Canada (EACC) *Lead Guideline for Construction, Renovation, Maintenance or Repair* (2025) Class 2A Operations, and must be conducted so as not to expose workers to airborne lead in excess of 50 ug/m<sup>3</sup> as specified by *Canada Occupational Health and Safety Regulations* (SOR/86-304). Disturbance

- If leachate extraction was above 5 mg/L, the painted building material is considered a hazardous waste and must be disposed of at an approved waste disposal site.
