# **AIRFIELD PAVEMENT CONDITION INDEX SURVEY REPORT**

## **MAXWELL AIR FORCE BASE, AL March 2019**

**June 2020  
Final Report**

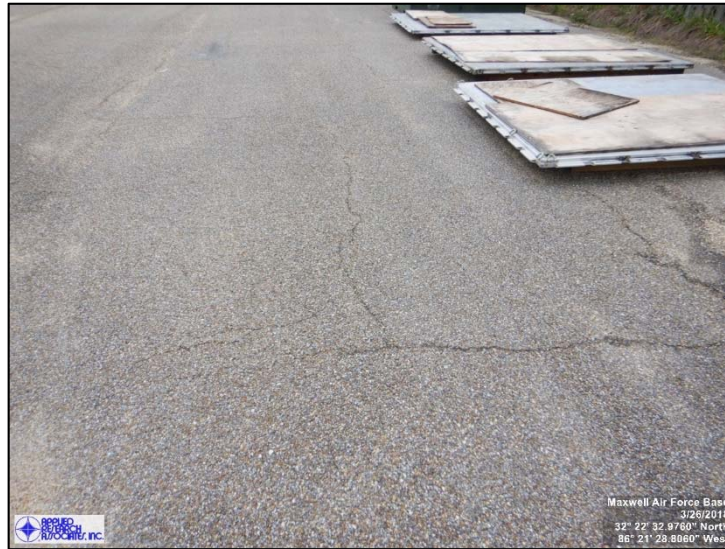
- AC Section A12 had a PCI of 65-Fair and an area of 30,392 ft<sup>2</sup>. Distresses with the highest deduct were medium-severity weathering, medium-severity L&T cracking and medium-severity patching. Localized preventive maintenance actions include crack sealing and deep patching. A mill and overlay is recommended in FY 2024.
- AC Section A13 had a PCI of 66-Fair and an area of 54,563 ft<sup>2</sup>. Distresses with the highest deduct were medium-severity L&T cracking and medium-severity weathering. Crack sealing is the only preventive maintenance recommended. A mill and overlay is recommended in FY 2024. Photograph 2.2 on the following page shows medium-severity L&T cracking in Section A13 of the AGE Storage Lot.

Photograph 2.2. AGE Storage Lot, Section A13, Medium-Severity L&T Cracking.

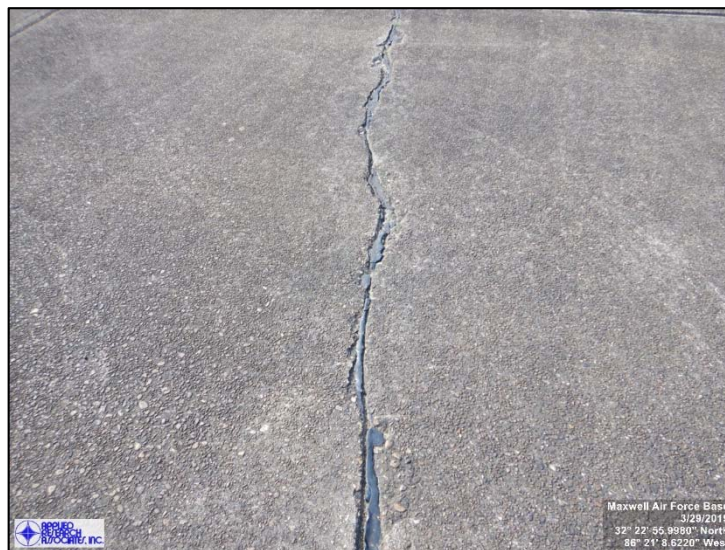
- PCC Section A01B had a PCI of 84-Good and an area of 274,393 ft<sup>2</sup>. Distresses with the highest deduction include medium-severity joint seal damage, medium-severity linear cracks, and low-severity large patches. Localized preventive maintenance actions include crack sealing, joint seal replacement, and partial-depth patching. Photograph 2.4 below shows a medium-severity linear crack in Section A01B of the North Apron.

Photograph 2.4. North Apron, Section A01B, Medium-severity Linear Crack.

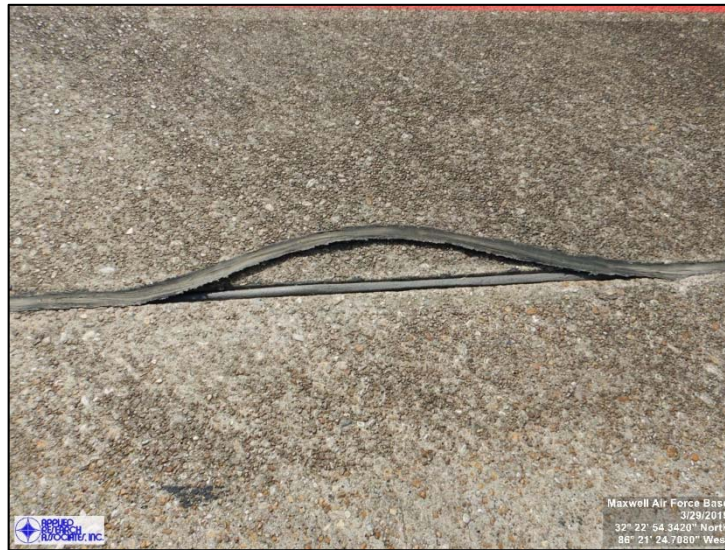
- PCC Section A08B had a PCI of 99-Good and an area of 26,000 ft<sup>2</sup>. The only two distresses were low-severity small patches and shrinkage cracks. No maintenance is recommended at this time.
- PCC Section T02B had a PCI of 85-Good and an area of 211,267 ft<sup>2</sup>. Distresses with the highest deduct include high-severity joint seal damage, medium-severity joint seal damage, and medium-severity linear cracks. There was a decrease in the quantity of corner breaks in section T02B since the previous inspection. Localized preventive maintenance actions include crack sealing, grinding, joint seal replacement, and partial-depth patching. Photograph 2.5 below shows high-severity joint seal damage in Section T02B of the North Apron.

Photograph 2.5. North Apron, Section T02B, High-severity Joint Seal Damage.

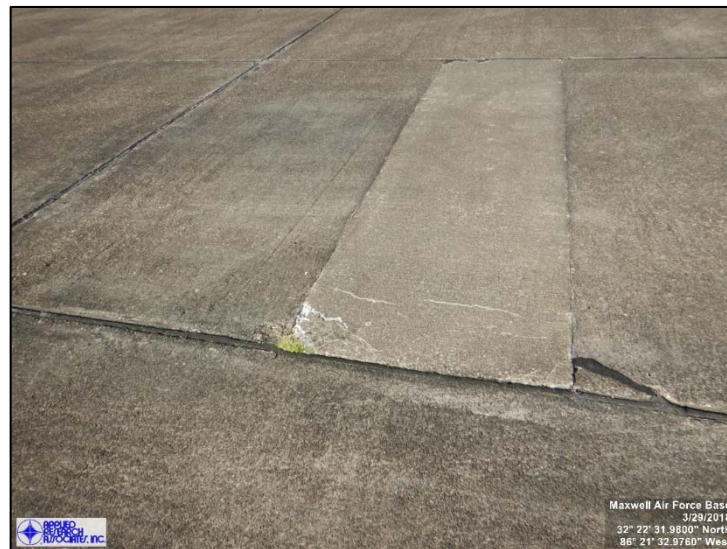
and medium-severity large patches. Faulting, pumping and scaling were not observed in the 2019 inspection. Localized preventive maintenance actions include crack sealing, joint seal replacement, full-depth patching, and partial-depth patching. Photograph 2.6 below shows a medium-severity large patch in Section A05B of the West Apron.

Photograph 2.6. West Apron, Section A05B, Medium-severity Large Patch.

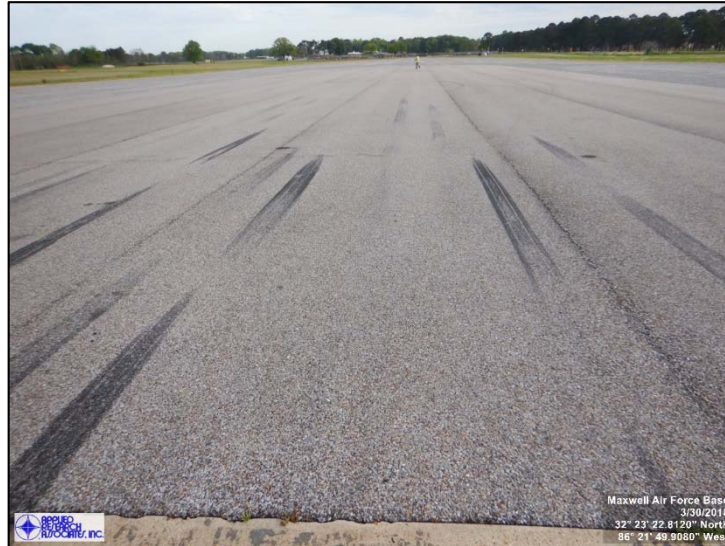
- AC Section O02C had a PCI of 79-Good and an area of 19,810 ft<sup>2</sup>. Distresses with the highest deduction include low-severity L&T cracking, weathering, and swelling. Section O02C has experienced a higher than average deterioration rate since the last inspection due to an increase in quantity of L&T cracking and the development of weathering. A surface treatment is recommended in FY 2024. Photograph 2.7 below shows an overview of Section O02C of the Overrun Runway 009/189.

Photograph 2.7. Overrun Runway 009/189, Section O02C, Overview.

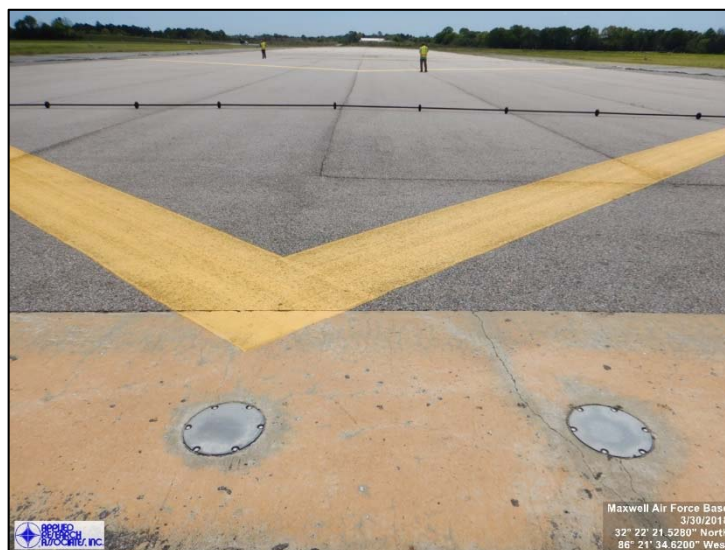
- Section O05C had a PCI of 78-Good and an area of 22,508 ft<sup>2</sup>. Distresses with the highest deduction include low-severity L&T cracking and low-severity weathering. Section O05C has experienced a higher than average deterioration rate since the last inspection due to the development of these distresses. A surface treatment is recommended in FY 2024. Photograph 2.8 below shows an overview of Section O05C of the Overrun Runway 15/33.

Photograph 2.8. Overrun Runway 15/33, Section O05C, Overview.

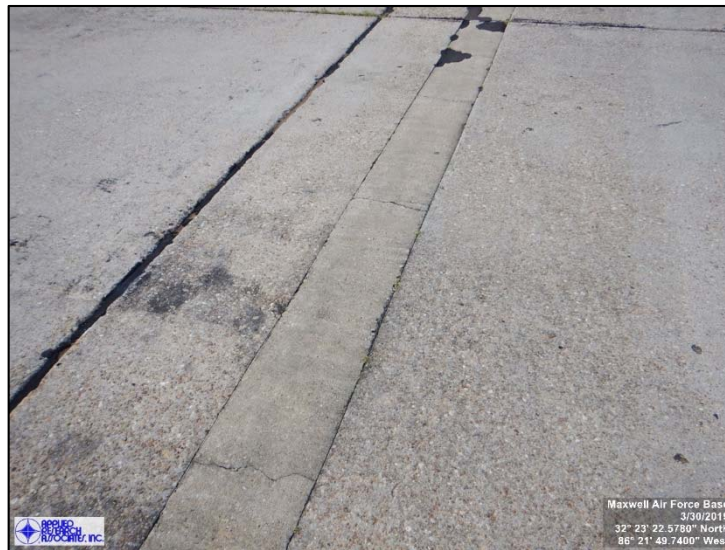
- PCC Section R01A had a PCI of 93-Good and an area of 110,851 ft<sup>2</sup>. Distresses with the highest deduction include medium-severity large patches, low-severity large patches, and medium-severity faulting. Medium-and high-severity joint seal damage were not observed in the 2019 inspection. Localized preventive maintenance actions include crack sealing, grinding, and partial-depth patching. Photograph 2.9 below shows a medium-severity large patch in Section R01A of Runway 009/189.

Photograph 2.9. Runway 009/189, Section R01A, Medium-severity Large Patch.

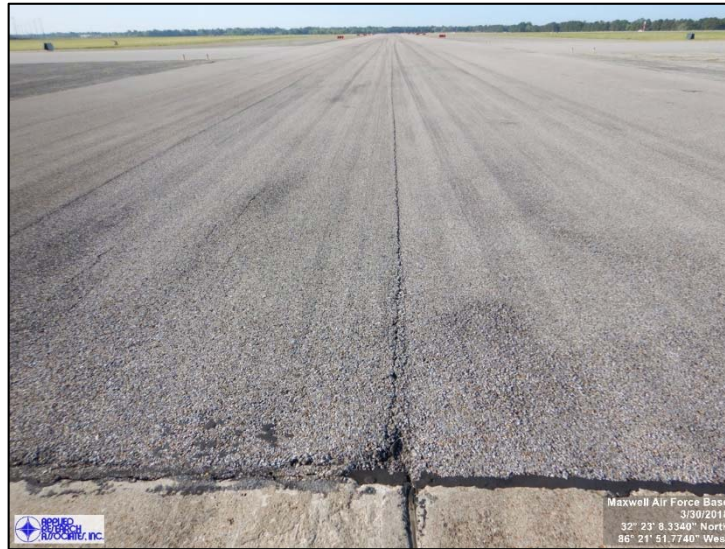
- AC Section R02A had a PCI of 75-Good and an area of 107,583 ft<sup>2</sup>. Distresses with the highest deduction include low-severity L&T cracking, medium-severity L&T cracking, and low-severity weathering. Crack sealing is the only preventive maintenance recommended at this time. A mill and overlay is recommended in FY 2028. Photograph 2.10 on the following page shows an overview of Section R02A of the Runway 009/189.

Photograph 2.10. Runway 009/189, Section R02A, Overview.

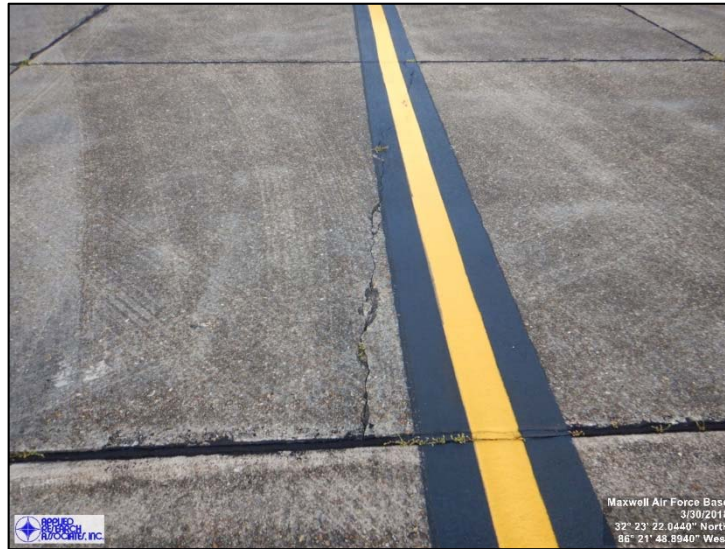
- PCC Section T33A had a PCI of 85-Good and an area of 22,276 ft<sup>2</sup>. Distresses with the highest deduction include high-severity joint seal damage, medium-severity joint seal damage and low-severity linear cracks. Section T33A has experienced a higher than average deterioration rate since the previous inspection due to the development of high-severity joint seal damage and an increase in the quantity of low-severity linear cracks. Localized preventive maintenance actions include crack sealing, joint seal replacement and partial-depth patching. Photograph 2.20 on the following page shows a medium-severity linear crack in Section T33A of Taxiway A Northwest.

Photograph 2.20. Taxiway A Northwest, Section T33A, Medium-severity Linear Crack.
