## WebAIM Short Form TASK GROUP INSTRUCTION

| SHIP/HULL NO:<br><b>DDG-76</b> | SHIP/HULL NAME:<br><b>USS HIGGINS</b> | PROJECT:<br><b>KB3</b> | SYSTEM: | PLANT ID: | CASREP CAT: |
| CU PHASE TITLE: F/O - REPAIR INTAKE AND UPTAKE LOUVERS | | | | | |
| CU PHASE DESCRIPTION:<br>1. SCOPE/PURPOSE:<br><br>1.1 Title: Intake and Uptake Louver; repair<br><br>1.2 Location of Work:<br><br>1.2.1 Intake Engine Room No. 2 (02-275-0-Q)<br><br>1.2.2 Uptake Engine Room No. 2 (02-242-0-Q)<br><br>1.2.3 Ship Service Gas Turbine Generator Intake (01-260-1-Q)<br><br>1.2.4 02 Level Weather, Frames between 275 and 280, Starboard (Stbd)<br><br>1.2.5 03 Level Weather, Frames between 246 and 268, Port and Stbd<br><br>1.2.6 Intake Trunk (A) Engine Room No. 2 (1-289-2-Q) | | | | | |

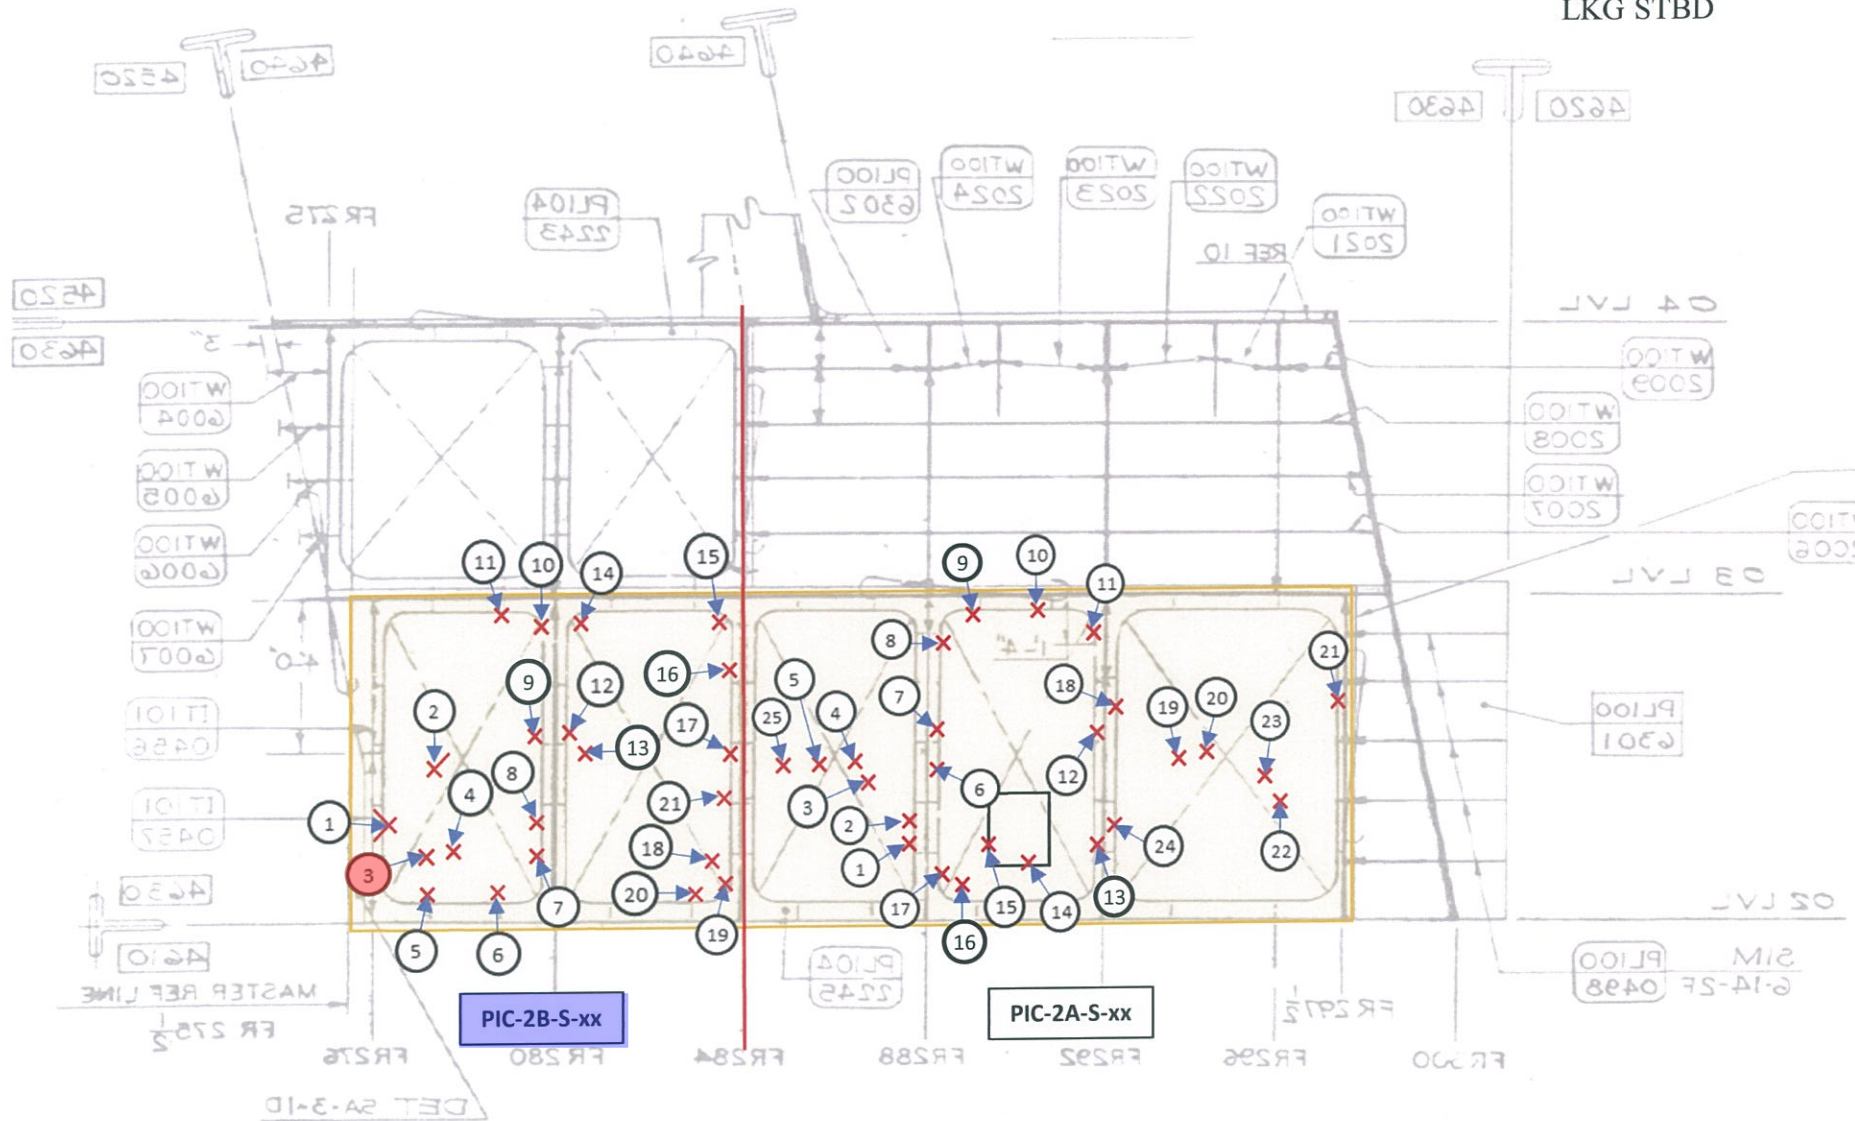
Intake Engine Room No. 2  
 (02-275-0-Q) (02-284-0-Q) Louver, STBD  
 LKG STBD

| PIC NO. | Condtion | Size(SF) | Reference |
|---|---|---|---|
| PIC-2B-S-20 | Corroded Area (Area circled in red) | 0.007 | See Attachment-4 and 9 |

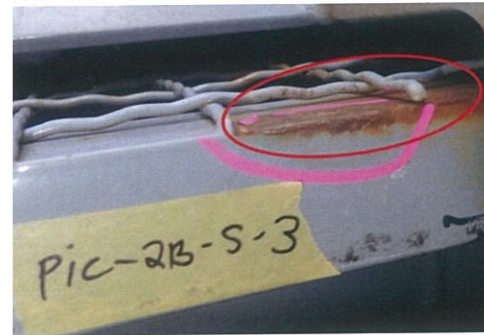
1.3.1 Quantity (One Lot), Foreign Object Damage (FOD) Screen Frame of Louver in 02-275-0-Q

FOD Screen Frame; CRES 316, 1-1/2 Inch x 1-1/2 Inch x 3/16 Inch Thickness Angle

| PIC NO. | Condtion | Size(SF) | Reference |
|---|---|---|---|
| PIC-2B-S-3 | Corroded & Crack (Area circled in red) | 0.007 | See Attachment-4 and 8 |

PIC-2B-S-3  
(Red circled areas are corroded areas.)

2.2 Accomplish weld repair of deficient weld on screen frame, corrosion hole and mechanical damage on each existing louver listed in 1.3.1 through 1.3.4, using Ref. No. 4 for guidance.

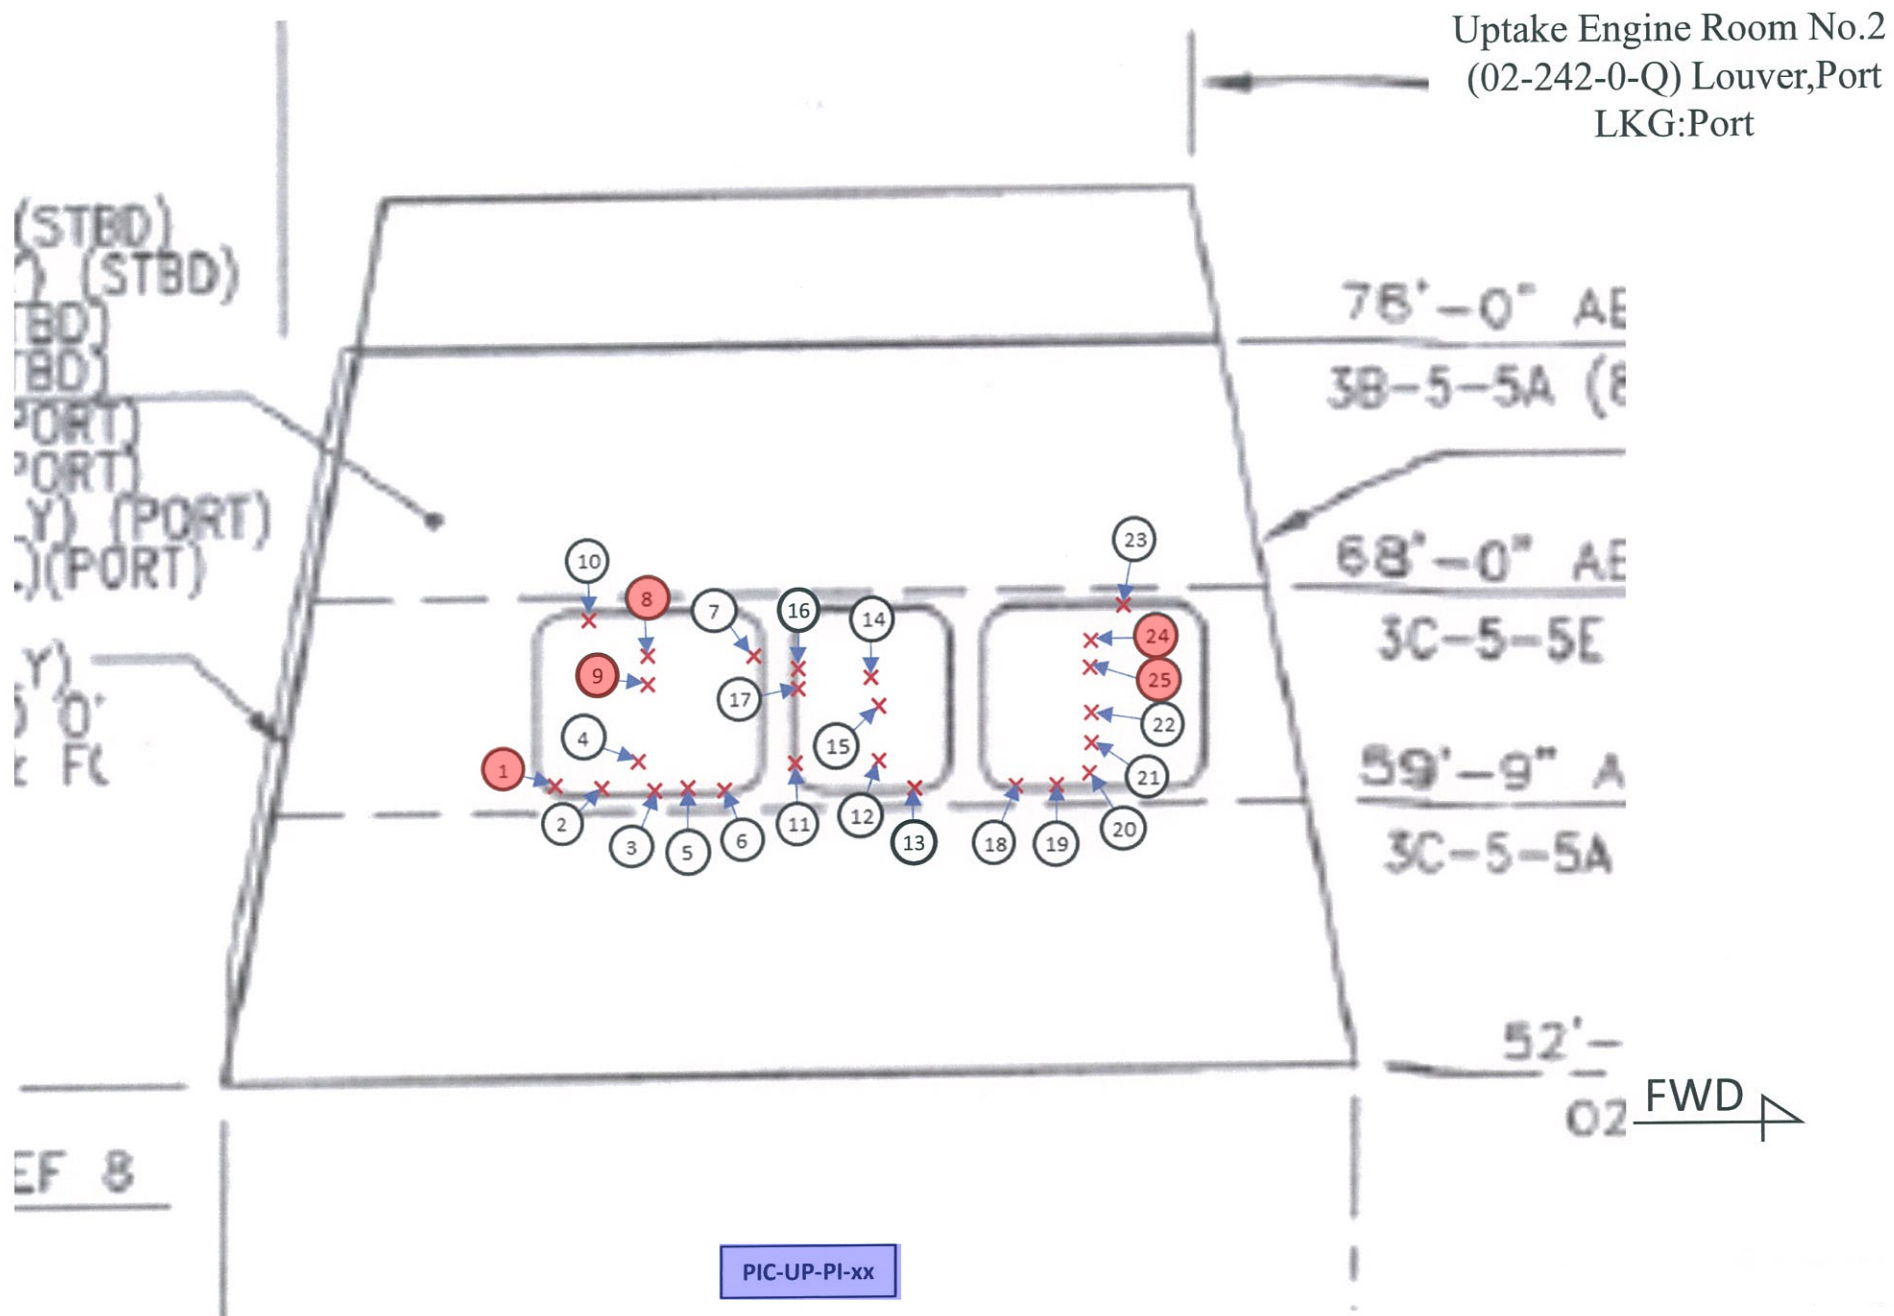
# VISUAL INSPECTION RECORD

| PIC NO. | Condition | Size(SF) | Reference |
|---|---|---|---|
| PIC-UP-PI-1 | Corrosion hole (Area circled in red) | 1/4" | See Attachment-87 and 88 |
| PIC-UP-PI-2 | Corroded Area (Area circled in red) | 0.056 | See Attachment-87 and 88 |
| PIC-UP-PI-3 | Corroded Area (Area circled in red) | 0.021 | See Attachment-87 and 88 |
| PIC-UP-PI-4 | Mechanical Damage (Area circled in red) | 1/2" x 2EA | See Attachment-87 and 88 |
| PIC-UP-PI-5 | Corroded Area (Area circled in red) | 0.007 | See Attachment-87 and 88 |
| PIC-UP-PI-6 | Corroded Area (Area circled in red) | 0.028 | See Attachment-87 and 88 |
| PIC-UP-PI-7 | Corroded Area (Area circled in red) | 0.002 | See Attachment-87 and 88 |
| PIC-UP-PI-8 | Mechanical Damage (Area circled in red) | 1/2" | See Attachment-87 and 88 |
| PIC-UP-PI-9 | Mechanical Damage (Area circled in red) | 1/2" | See Attachment-87 and 88 |
| PIC-UP-PI-10 | Corroded Area (Area circled in red) | 0.003 | See Attachment-87 and 88 |
| PIC-UP-PI-11 | Corroded Area (Area circled in red) | 0.003 | See Attachment-87 and 88 |
| PIC-UP-PI-12 | Corroded Area (Area circled in red) | 0.002 | See Attachment-87 and 88 |
| PIC-UP-PI-13 | Corroded Area (Area circled in red) | 0.139 | See Attachment-87 and 89 |
| PIC-UP-PI-14 | Corroded Area (Area circled in red) | 0.002 | See Attachment-87 and 89 |
| PIC-UP-PI-15 | Corroded Area (Area circled in red) | 0.002 | See Attachment-87 and 89 |
| PIC-UP-PI-16 | Corroded Area (Area circled in red) | 0.003 | See Attachment-87 and 89 |
| PIC-UP-PI-17 | Corroded Area (Area circled in red) | 0.017 | See Attachment-87 and 89 |
| PIC-UP-PI-18 | Corroded Area (Area circled in red) | 0.042 | See Attachment-87 and 89 |
| PIC-UP-PI-19 | Corroded Area (Area circled in red) | 0.003 | See Attachment-87 and 89 |
| PIC-UP-PI-20 | Corroded Area (Area circled in red) | 0.035 | See Attachment-87 and 89 |
| PIC-UP-PI-21 | Corroded Area (Area circled in red) | 0.007 | See Attachment-87 and 89 |

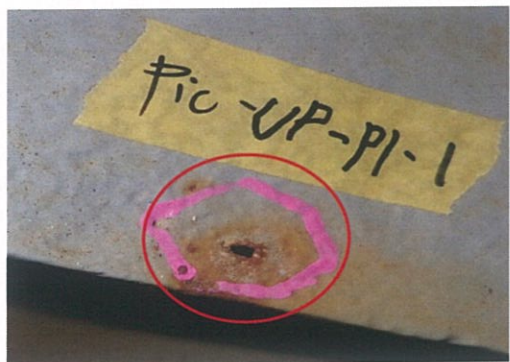
1.3.2 Quantity (One Lot), Louver in 02-242-0-Q, Port

Base Material: HTS, MIL-S-22698, GR DH-36, 15.3 LBs Plate

PIC-UP-PI-1  
(Red circled areas are corroded areas.)

- 2.2.1 Drill 1/2 inch diameter hole on corrosion hole of each louver listed in 1.3.2.
- 2.2.1.1 Shape remaining hole to minimum 20 degrees countersink.

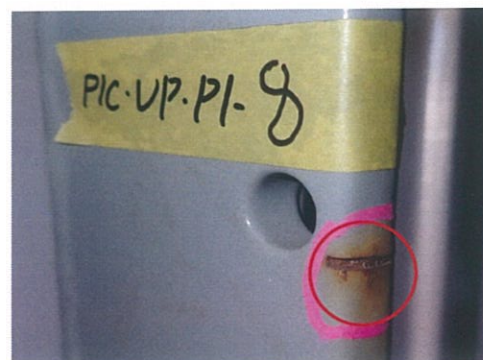
1.3.3 Quantity (One Lot), Louver in 02-242-0-Q, Port

PIC-UP-PI-8  
(Red circled areas are corroded areas.)

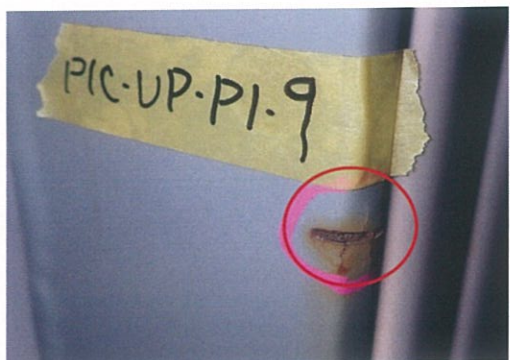
PIC-UP-PI-9  
(Red circled areas are corroded areas.)

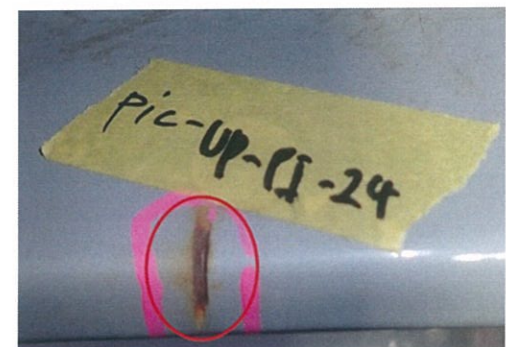
PIC-UP-PI-24  
(Red circled areas are Mechanical Damage.)

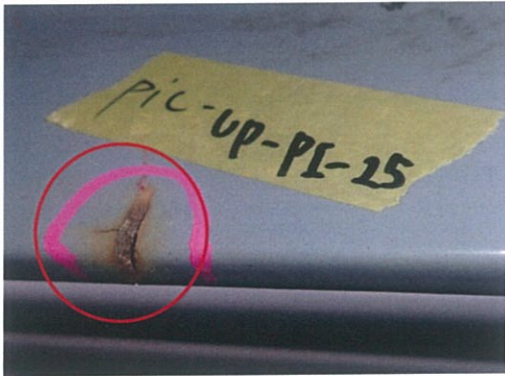
PIC-UP-PI-25  
(Red circled areas are Mechanical Damage.)

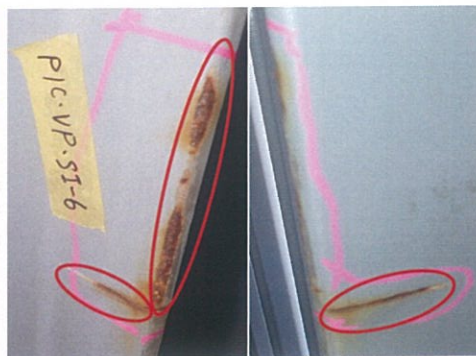
1.3.4 Quantity (One Lot), Louver in 02-242-0-Q, Stbd

| PIC NO. | Condition | Size(SF) | Reference |
|---|---|---|---|
| PIC-UP-SI-6 | Corroded & Mechanical Damage (Area circled in red) | 0.017SF, 2" x 2EA | See Attachment-98 and 99 |

PIC-UP-SI-6  
(Red circled areas are Corroded & Mechanical Damage.)

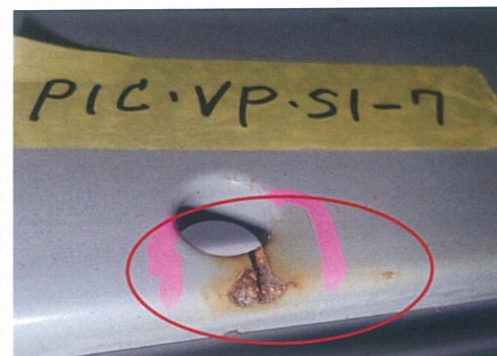
| PIC NO. | Condition | Size(SF) | Reference |
|---|---|---|---|
| PIC-UP-SI-7 | Mechanical Damage (Area circled in red) | 1/4" | See Attachment-98 and 99 |

PIC-UP-SI-7  
(Red circled areas are Mechanical Damage.)

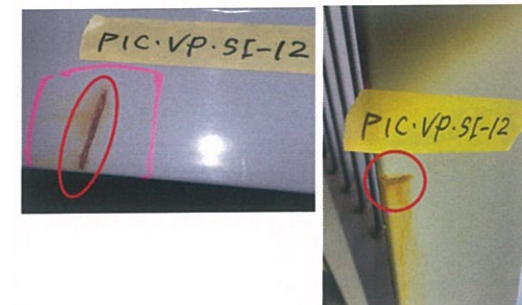
| PIC NO. | Condition | Size(SF) | Reference |
|---|---|---|---|
| PIC-UP-SI-12 | Mechanical Damage (Area circled in red) | 2" , 1/2" | See Attachment-98 and 99 |

PIC-UP-SI-12  
(Red circled areas are Mechanical Damage.)

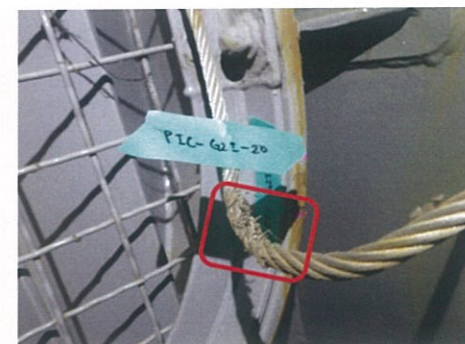
1.3.5 Quantity (One Lot), Bonding Strap on Louver in 01-260-1-Q, Stbd

| PIC NO. | Condition | Size(SF) | Reference |
|---|---|---|---|
| PIC-G2I-20 | Bonding strap is damaged (Area circled in red) | - | See Attachment-108 and 112 |

PIC-G2I-20  
(Bonding strap is damaged.)

- 2.2.2 Accomplish the requirements of 009-012 of Ref. No. One, including Table 2, Column(s) A and D, Lines One through 7.
- 2.3 Remove existing and install new each bonding strap listed in 1.3.5 in accordance with Ref. No. 5.
