# AIRFIELD PAVEMENT EVALUATION

**Maxwell AFB, Alabama**

**January 2016**

# AFCEC

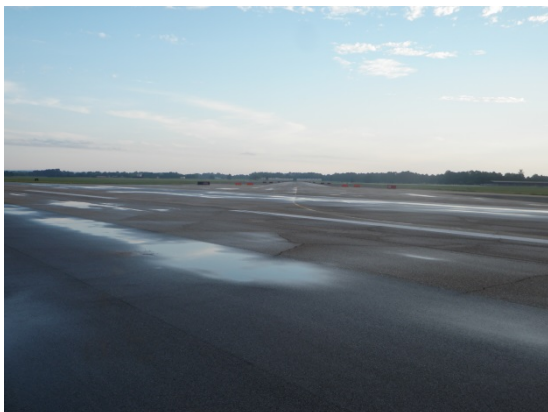
**Water:** Soils under the pavements were saturated in some areas. The water table at Maxwell AFB is relatively shallow and has been reported at depths between 20 and 23 feet below the ground surface. Subsurface drainage problems have been previously reported, but

are believed to have been corrected by earlier maintenance and construction efforts. Previous evaluations have determined soil moisture contents well above the optimum. As seen in Figure 3 and Figure 4, some ponding of water was noticed during the evaluation on sections of Runway 15/33 and Assault Landing Zone 009/189 (including shoulders), the North Apron, and Taxiway Alpha. However, the presence of shallow groundwater does provide some limited potential for a sufficient amount of water to be available for the formation of frost lenses in the pavement system, leading to vertical displacements at the surface.

Figure 3—Ponding on Runway 15/33 (R04C2)

- f. Program a demolition project to selectively remove portions of closed asphalt pavements adjacent to operational surfaces. Removing these pavement sections will prevent excess moisture from infiltrating into the subgrade and becoming trapped in the pavement structure. Additionally, removing these non-operational pavements will allow for re-grading efforts along Runway 15/33 and Assault Runway 009/189 that should mitigate current ponding issues on shoulder pavements.

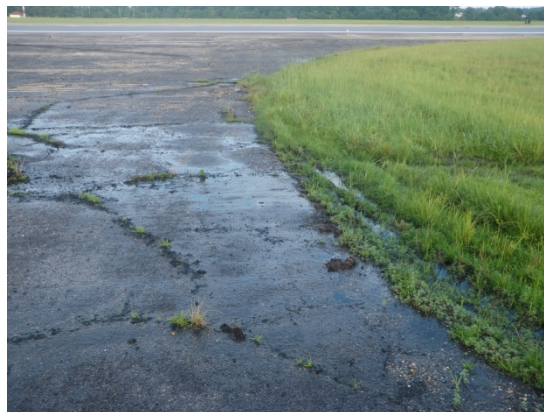
Figure 4—Ponding Near Section T06A

Section T06A is the sole taxiway section rated FAIR; it provides access to the ALZ runway from the main runway. The primary distresses on this section are block cracking and weathering (Figure 18—Overview Runway 009/189 Turn Around (T11A), Block Cracking). A mill and overlay project should be programmed to repair this section. Any resurfacing project should pay particular attention to correcting slope deficiencies in this area and mitigate current ponding issues.

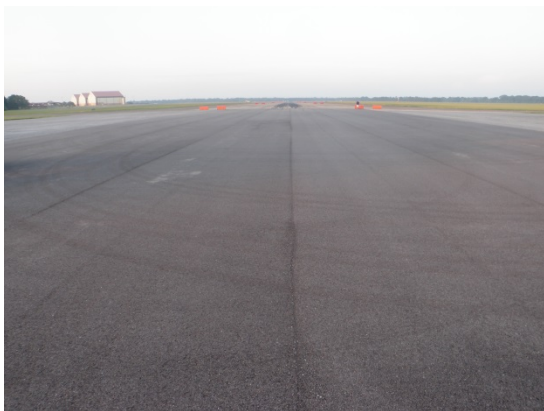
The lowest-rated runway or overrun sections were the DBST overrun section on ALZ 009/189, section O01C. Besides this overrun section, sections R04C1, R05A1, and R09C on Runway 15/33 rate FAIR. These sections are weathered, with low-severity block cracking beginning to degrade to medium severity. The taxiway lighting and markings on Runway 15/33 have been moved in to decrease the operational width of the runway from 300 to 150 feet. Joint sealant is in poor or non-existent condition in the PCC shoulder sections; the AC shoulder pavements are weathered and experiencing high-severity block cracking. A project should be programmed to replace joint sealant as well as route and seal cracks on the shoulder areas to prevent moisture from infiltrating through the pavement and becoming trapped in the base and subgrade. Maintain the AC surfaces outside of the 150 feet wide markings with sprayed asphalt surface treatments in order to seal cracks and slow the rate of FOD generation.

Figure 9—Overrun, ALZ Runway 009/189 (O02C)

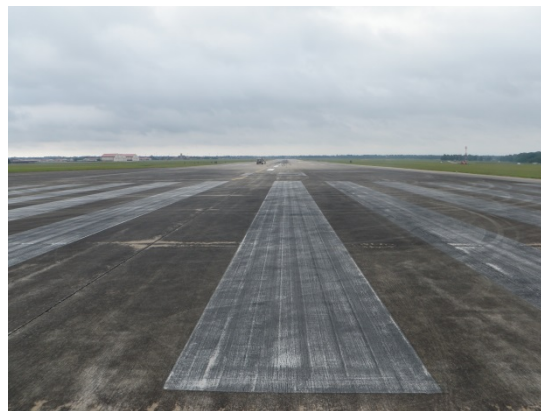
Runway 15/33 is structurally sound, with no AGL limitations for assigned mission aircraft. Figure 10 shows an overview of the north end of Runway 15/33. The PCC sections of Runway 15/33 are all rated in GOOD condition; however, the joint sealant in most of these sections is generally damaged. For example, in Section R06A1, the compression sealant does not adequately prevent incompressible material from becoming deposited in the joints, which have begun to spall and produce FOD (Figure 11). The silicone joint sealant in Section R03A1 is in considerably worse shape, and is non-existent in some areas (Figure 12). Maintaining good sealant is paramount to prevent moisture infiltration from the surface into the underlying base

Figure 10—Overview Runway 15/33 (R06A1)

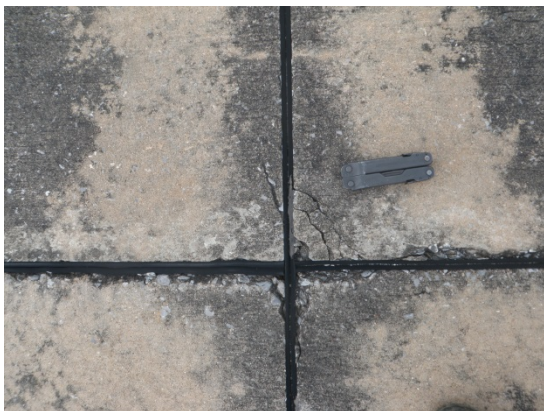
Figure 11—Damaged Joint Sealant (R06A1)

- a. If not already programmed, schedule a project to provide M&R of global crack and joint sealant on all PCC pavement sections identified with medium- and high-severity longitudinal/transverse cracking or joint sealant damage. This will slow deterioration of the PCC pavement and reduce spalling. See the extrapolated distress report in Appendix F to identify concrete pavements with Distress Code 63 or 65 at high or medium severity. Focus efforts on Runway 15/33, Assault Runway 009/189, the Maintenance Hangar Access Apron, the West Apron, Taxiway Alpha, and the North Apron.

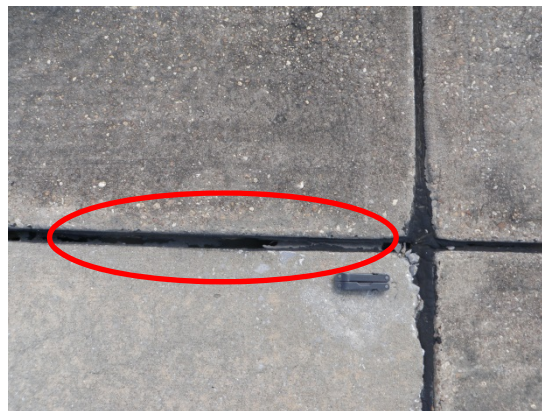
Figure 12—Joint Seal Damage (R03A)

- b. Continue replacing slabs as necessary and sealing cracks on various pavement sections, focusing funds on the Runway 15/33 (R03A1) and the West Apron (A05B).

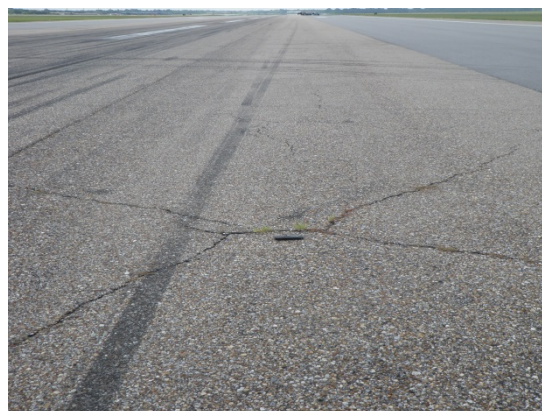
Figure 14— Block Cracking/ Weathering (R09C)

- a. Reconstruct Taxiway A section T19A to provide long-term structural support for mission aircraft (C-130H).
- b. Accomplish a mill and overlay project on Runway 15/33 sections R05A1, R04C1, and R09C.
- c. Accomplish a selective crack-sealing project on Assault Runway 009/189 (R02A), including the turn-around taxiway (T06A).
- d. Program a mill and overlay project for section T06A in FY17. Particular attention should be paid to correcting slope deficiencies between the Assault Runway and Runway 15/33 to restore positive drainage.
- e. Apply an asphalt surface treatment to the shoulder sections of Runway 15/33 and shoulders of Assault Runway 009/189.

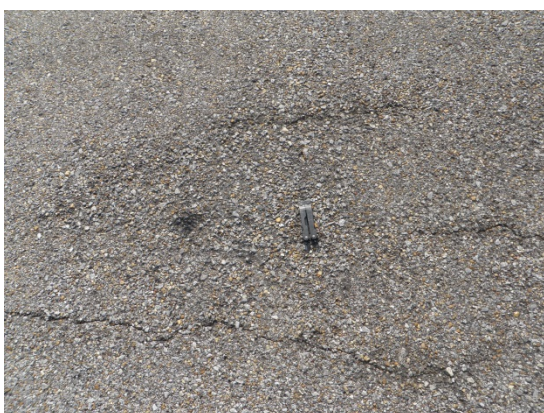
Figure 15— Weathering/ Longitudinal Cracking (R02A)

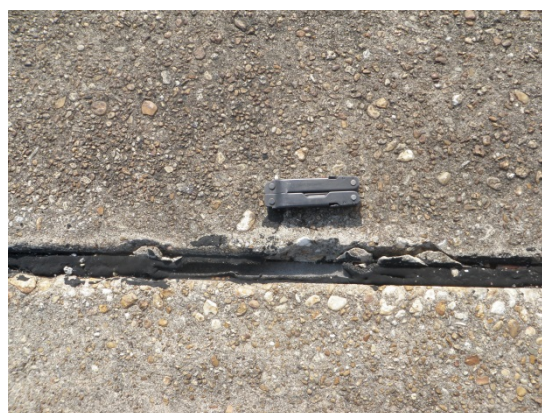
There are also no AGL limitations for assigned mission aircraft on the Assault Strip Runway 009/189. Similar to the main runway, the ALZ is composed of both AC and PCC sections. The primary distresses observed on the AC sections were weathering and longitudinal/transverse cracking, all of which are progressing from low to medium severity (Figure 15). Joint and corner spalling is prevalent in the PCC section (R01A) and is likely exacerbated by the relatively poor condition of the joint sealant in this section (Figure 16).

Figure 16—Joint Spalling and Joint Seal Damage

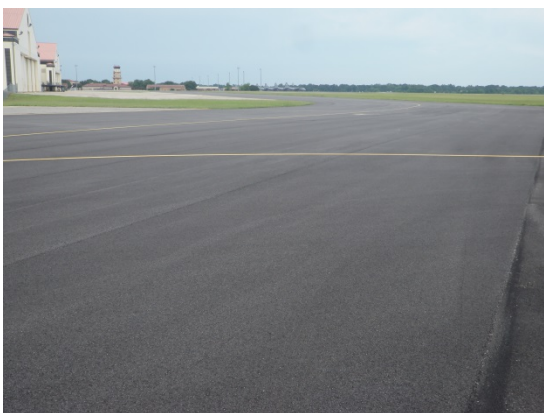
Of the entire pavement area, the open taxiways account for approximately 22 percent of the total airfield and include 17 surveyed sections. The PCI breakout by area is fairly uniform in this branch, with 94 percent of taxiway pavement sections by area rated either GOOD or SATISFACTORY and the remaining 6 percent rating FAIR. This is largely due to an extensive series of mill and overlay projects completed in December 2014 to correct pavement surface deficiencies on the AC portions of Taxiways Alpha, Bravo, Charlie, Delta, and Echo. Figure 17 depicts an example of this recently completed work.

*Figure 17—Overview, Taxiway Alpha (T04A)*

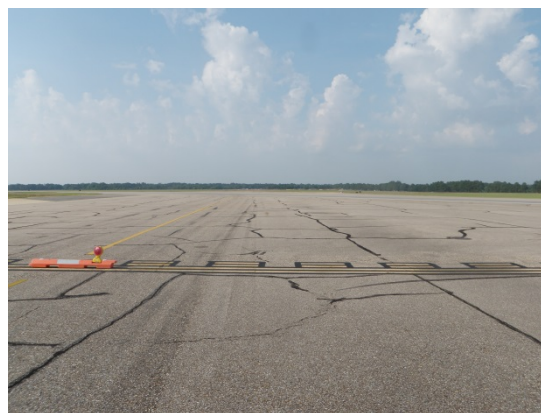
A recent mill and overlay project on the AC sections outside of the runway keel has increased the rating of these pavement sections from FAIR to GOOD. Unfortunately, environmental distresses such as weathering and block cracking have degraded the condition of the AC keel sections of the runway from GOOD to FAIR. In some cases, the cracks have become wide enough for vegetation to appear (Figure 18).

*Figure 18—Overview Runway 009/189 Turn Around (T11A), Block Cracking*

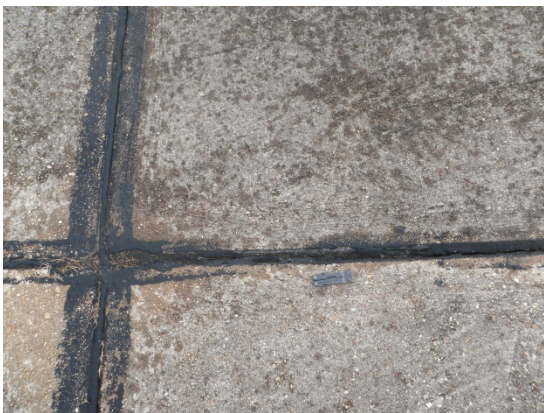
The majority of Taxiway Alpha is composed of PCC pavements; the predominant distresses in these sections are joint seal damage, small and large patching, and faulting. Figure 19 and Figure 20 illustrate the typical high severity of damage to the joint sealant on Taxiway Alpha. The current condition of the joint sealant does not provide adequate protection against moisture intrusion into the base material and subsequently into the highly expansive subgrade. As a result, considerable faulting is present throughout these sections (Figure 19). Correcting joint sealant deficiencies is imperative to maintaining the structural life of these pavement sections and should be conducted as soon as practical via a programmed contract effort and/or an in-house phased maintenance effort.

Figure 19—Joint Seal Damage (T03A)

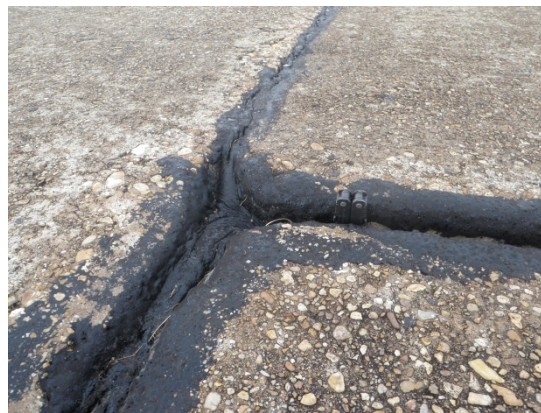
Figure 20—Joint Seal Damage and Faulting (T03A)

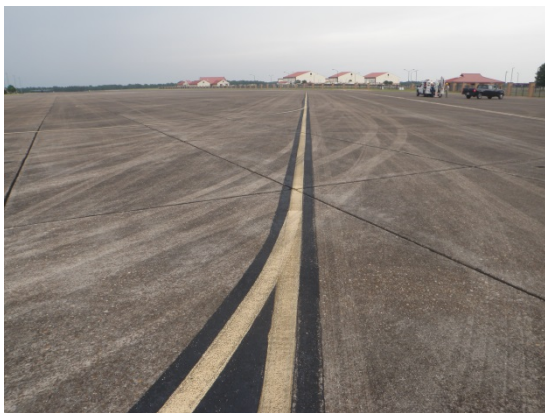
The large interconnected apron sections rate GOOD (West Apron) and SATISFACTORY (North Apron). Figure 21 shows an overview of the North Apron, which suffered from higher severity distresses including joint and corner spalling as well as linear cracking and patching (Figure 24). The predominant distresses on the West Apron consist of large and small patching, as well as low- and medium-severity corner spalling (Figure 23). A thin surface treatment has previously been applied to sections of the North and West Aprons, presumably to mitigate additional growth of shrinkage cracks present on the surface. This treatment (which gives the finished concrete an odd yellow color) is beginning to degrade, and shrinkage cracks are noticeably beginning to migrate and grow (Figure 24). Although not an immediate structural concern, a reapplication of the initial surface treatment could be performed to prevent additional pavement surface damage. It should be noted that no shattered slabs were encountered on either of these aprons, indicating that the pavement is structurally capable to support mission-assigned aircraft.

Figure 21—Overview North Apron (A04B)

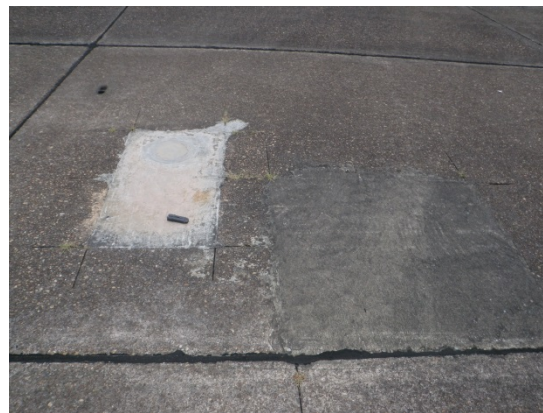
Figure 22—Medium Severity Patching on North Apron (A04B)

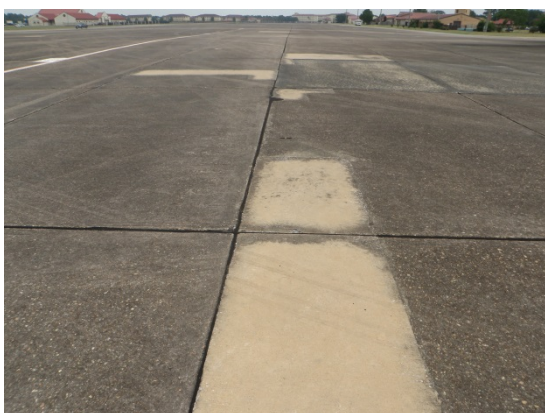
Figure 23—Low Severity Patching on West Apron (A05B)

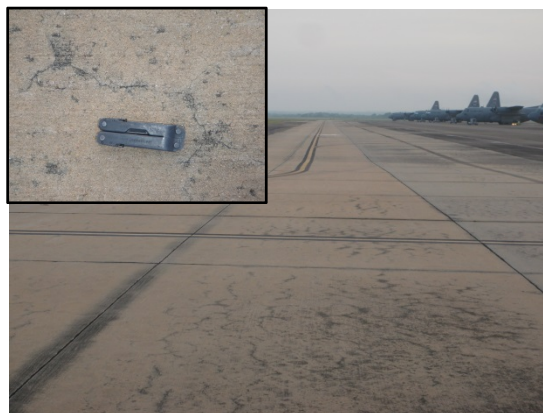
Figure 24—Shrinkage Cracking, West Apron (T29B, A05B)

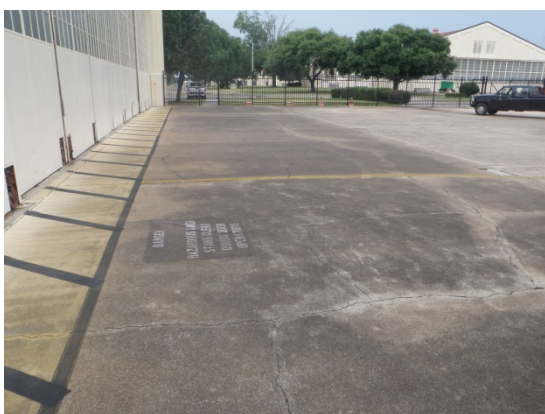
Figure 25 and Figure 26 are taken on the Aero Club Apron that rates SERIOUS overall due to low- and medium-severity linear cracking and low- and medium-severity shattered slabs. This apron is primarily used by small-frame Civil Air Patrol and Aero Club aircraft. Despite the extensive damage in this section, there are no AGL restrictions for Group 1 aircraft. No major M&R project is recommended for this section (A10C) at this time, primarily due to pavement use.

Figure 25—Shattered Slabs, Aero Club Apron (A10C)

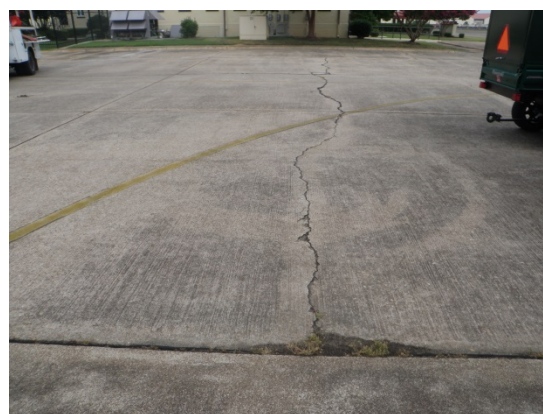
Figure 26—Medium Severity Transverse Cracking, Aero Club Apron (A10C)
