| LCU-1651 | NBU-7 | | 38NBA10032 | | A01 |

Exterior Hull; repair

## JOB SPECIFICATION

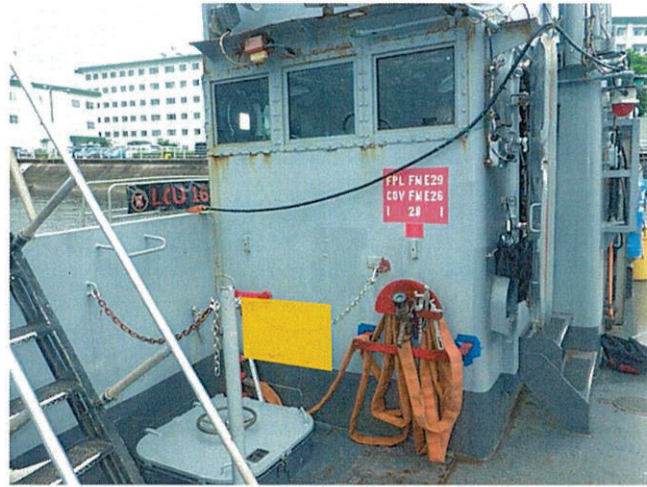
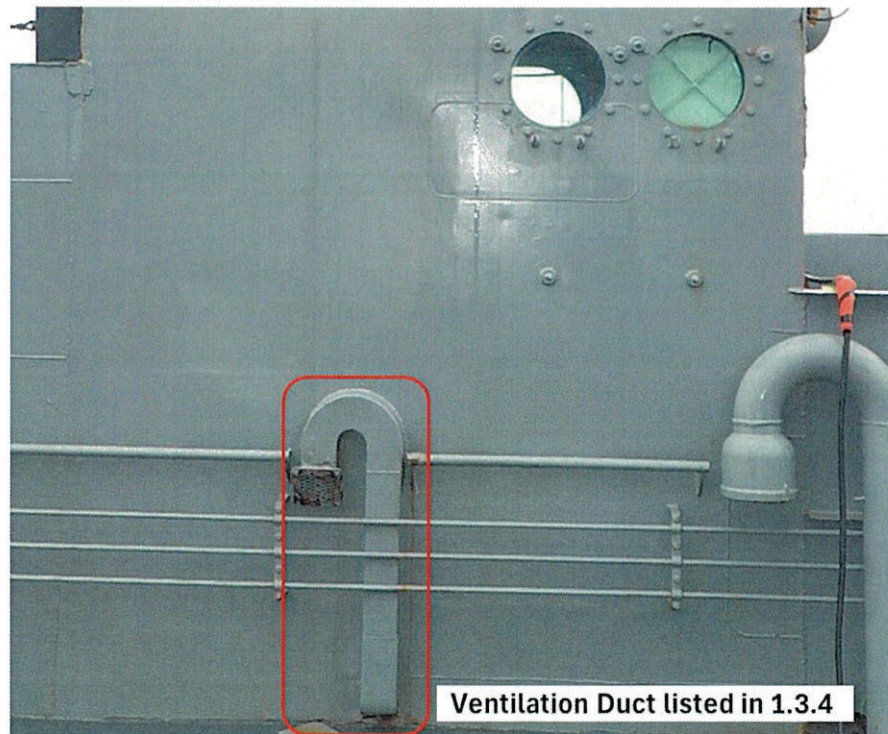
**VIEW "A-A"**

4.1 Initial Condition - It was discovered natural vent duct and FWD bulkhead of pilot house are heavily corroded, and required to repair them.

**Yellow Box** : Damaged Bulkhead of FWD Pilot House listed in 1.3.3

3.4.1 Remove each damaged existing, template, fabricate and install each new bulkhead plating listed in 1.3.3 out of new 3/16 inch thick mild steel plate conforming to ABS Grade A.
