Subject: Mann-Grandstaff Veterans Administration (VA) Roofing Project  
"Good Faith" Asbestos Investigation- Building 1  
4815 North Assembly Street, Spokane, Washington  
Med-Tox Northwest Project No. 9139.1

Hazardous Building Materials Survey— Renovation Specific  
Mann-Grandstaff VA Roofing Project - Building 1

*Mann-Grandstaff VA Roofing Project*  
*"Good Faith" Asbestos Investigation- Building 1*

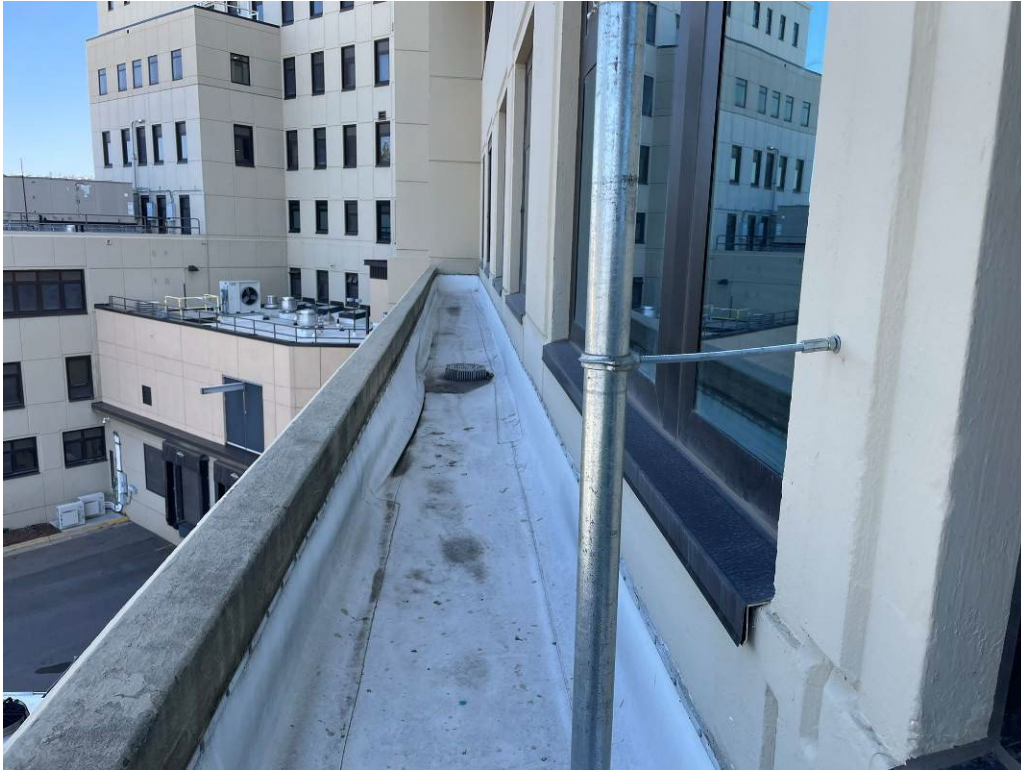
| <b>Material</b> | <b>Location</b> | <b>Friable</b> | <b>Quantity</b> |
|---|---|---|---|
| Built-up roofing with gravel ballast (HM-03) | B397 | No | 290 SF |

| Sample | Material | Location | AHERA Type | HM | Result |
|---|---|---|---|---|---|
| <b>9243.1-397-003</b> | <b>Built-up roofing</b> | <b>B397</b> | <b>Misc.</b> | <b>03</b> | <b>Layer 1: 2% CHR<br/>Layer 2: 2% CHR</b> |

Photo 1: Building 1 B397 roof. The built-up roofing under the white membrane roof is asbestos containing.

Med-Tox Northwest recommends, and state law requires, that all asbestos materials identified in **Table 1** be removed prior to renovation or demolition.

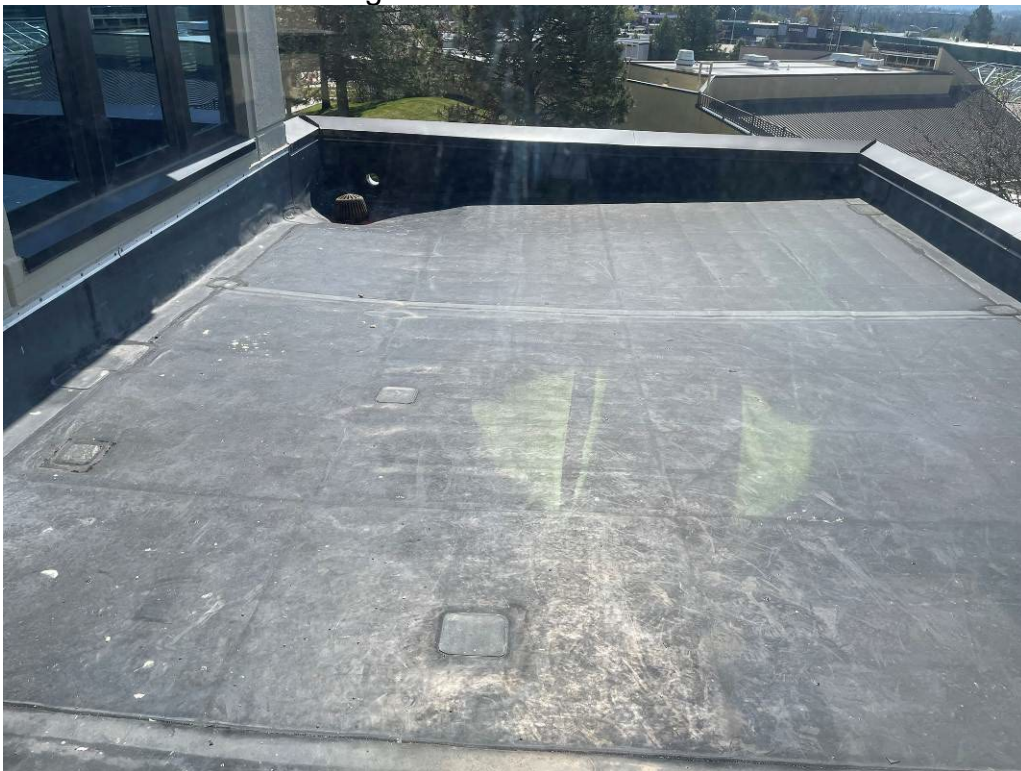
| <b>Material</b> | <b>Location</b> | <b>Friable</b> | <b>Quantity</b> |
|---|---|---|---|
| Built-up roofing with gravel ballast (HM-06) | B399 | No | 400 SF |

| Sample | Material | Location | AHERA Type | HM | Result |
|---|---|---|---|---|---|
| <b>9243.1-399-007</b> | <b>Built-up roofing</b> | <b>B399</b> | <b>Misc.</b> | <b>06</b> | <b>2% CHR</b> |

Photo 2: Building 1 B399 roof. The built-up roofing under the black membrane roof is asbestos containing.

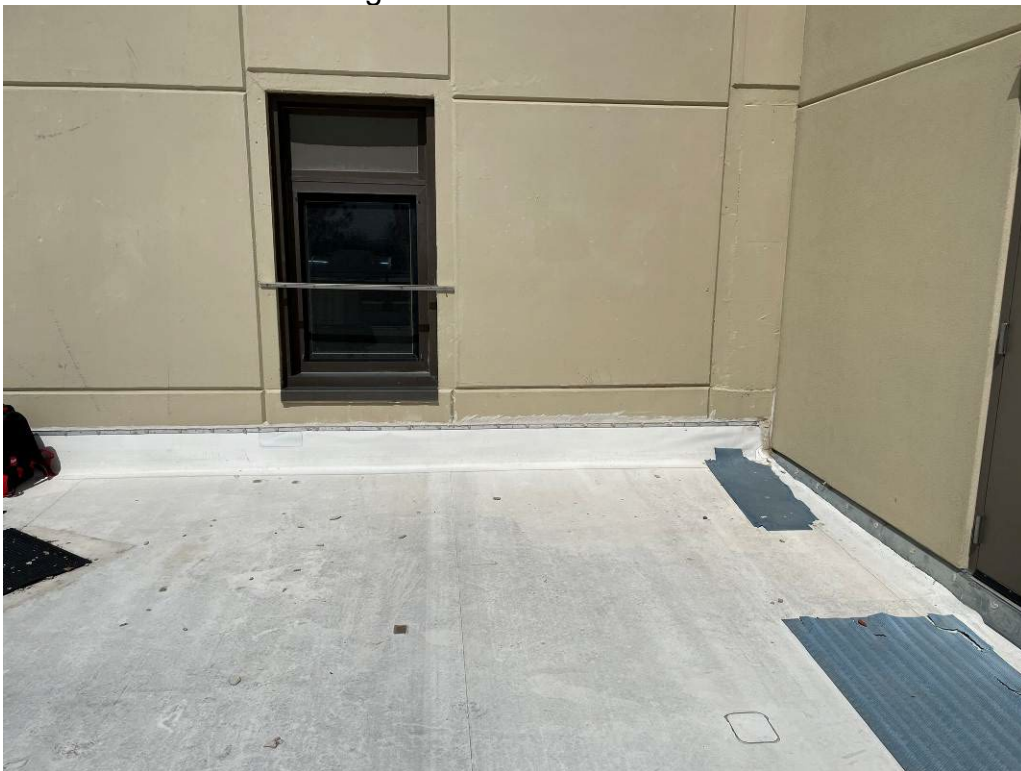
| <b>Material</b> | <b>Location</b> | <b>Friable</b> | <b>Quantity</b> |
|---|---|---|---|
| Built-up roofing (HM-09) | B298 | No | 1,290 SF |

| Sample | Material | Location | AHERA Type | HM | Result |
|---|---|---|---|---|---|
| <b>9243.1-298-016</b> | <b>Built-up roofing</b> | <b>B298</b> | <b>Misc.</b> | <b>09</b> | <b>2% CHR</b> |

Photo 4: Building 1 B298 roof. The built-up roofing under the white membrane roof is asbestos containing.

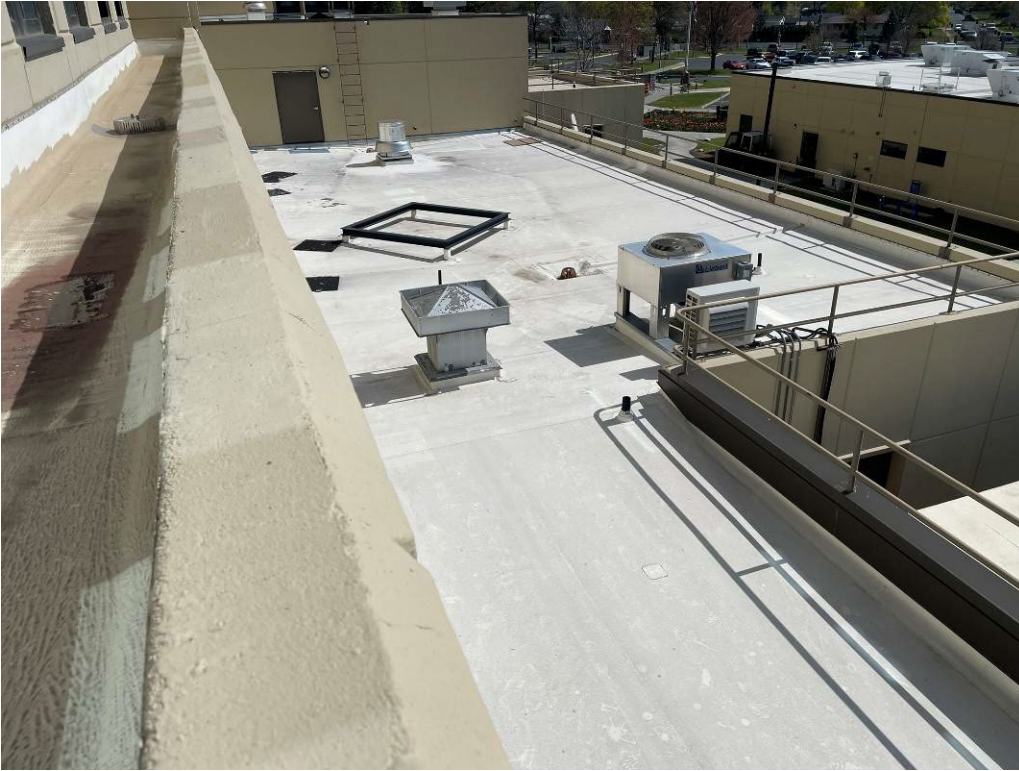
| <b>Material</b> | <b>Location</b> | <b>Friable</b> | <b>Quantity</b> |
|---|---|---|---|
| Built-up roofing with gravel ballast under white membrane roofing (HM-12 and HM-13*) | B299 | No | 2,716 SF |

| Sample | Material | Location | AHERA Type | HM | Result |
|---|---|---|---|---|---|
| <b>9243.1-299-021</b> | <b>Built-up roofing with gravel ballast under white membrane roofing</b> | <b>B299- south end by drain</b> | <b>Misc.</b> | <b>12</b> | <b>2% CHR</b> |

Photo 5: Building 1 B299 roof. The built-up roofing under the white membrane roof is asbestos containing.
