Subject: Mann-Grandstaff Veterans Administration (VA) Roofing Project  
"Good Faith" Asbestos Investigation- Building 2  
4815 North Assembly Street, Spokane, Washington  
Med-Tox Northwest Project No. 9139.1

*Mann-Grandstaff VA Roofing Project*  
*"Good Faith" Asbestos Investigation- Building 2*

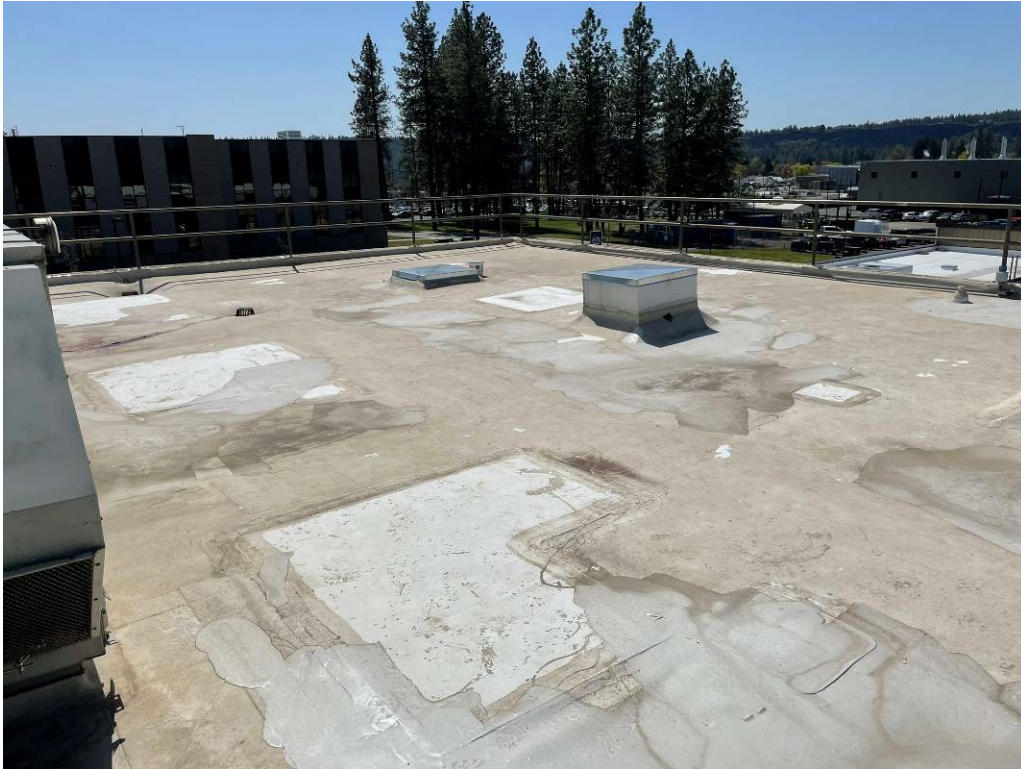
Photo 1: Building 2 top roof. There were no asbestos containing materials identified at building 2.

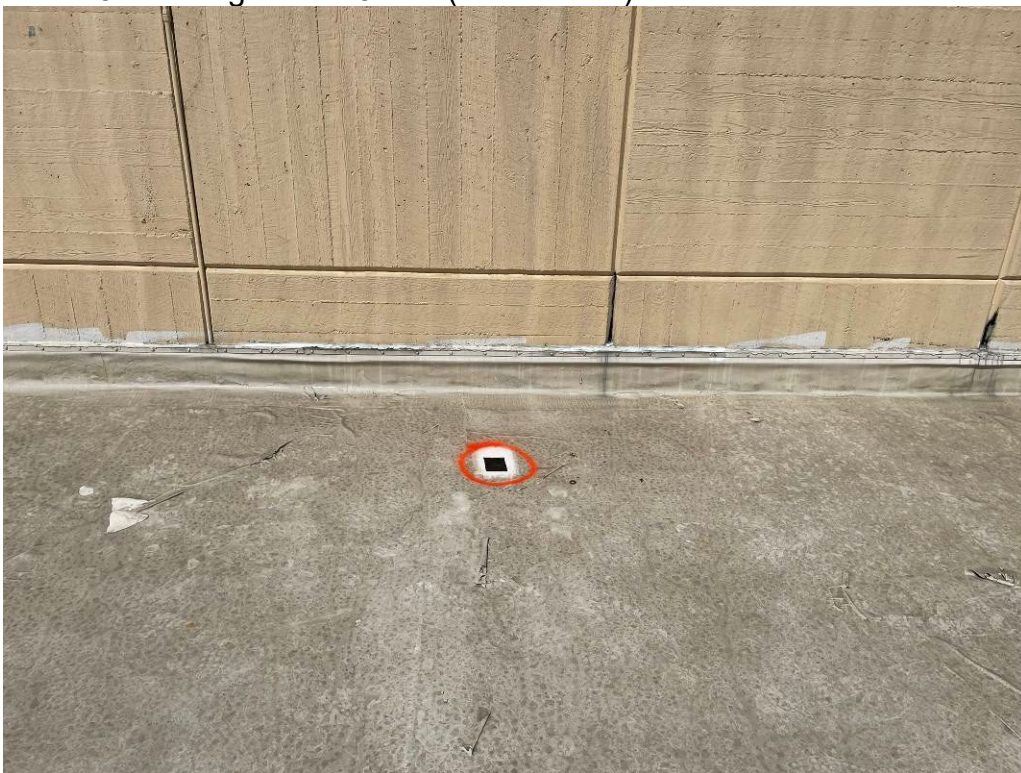
| <b>Material Description</b> | <b>Location</b> |
|---|---|
| White/gray parapet flashing sealant (HM-29) | All levels |

| Sample | Material | Location | AHERA Type | HM | Result |
|---|---|---|---|---|---|
| 9243.1-2-048 | White/gray flashing sealant | B2 evel 3 roof | Misc. | 29 | 2% CHR<br>PC: 0.75% CHR |

Photo 6: White/gray flashing sealant was determined to contain <1% asbestos,

The material identified in **Table 3** was found to contain 1% or less Chrysotile asbestos. **Materials with asbestos content 1% or less will require special handling during removal** and/or demolition as detailed in Washington Industrial Safety and Health Act (WISHA) Regional Directive (WRD) 23.10, *Occupational Exposure to Asbestos*.
