May 12, 2025

Subject: Mann-Grandstaff Veterans Administration (VA) Roofing Project  
"Good Faith" Asbestos Investigation- Building 3  
4815 North Assembly Street, Spokane, Washington  
Med-Tox Northwest Project No. 9139.1

Mann-Grandstaff VA Roofing Project  
"Good Faith" Asbestos Investigation - Building 3  
MTNW 9243.1  
May 2025

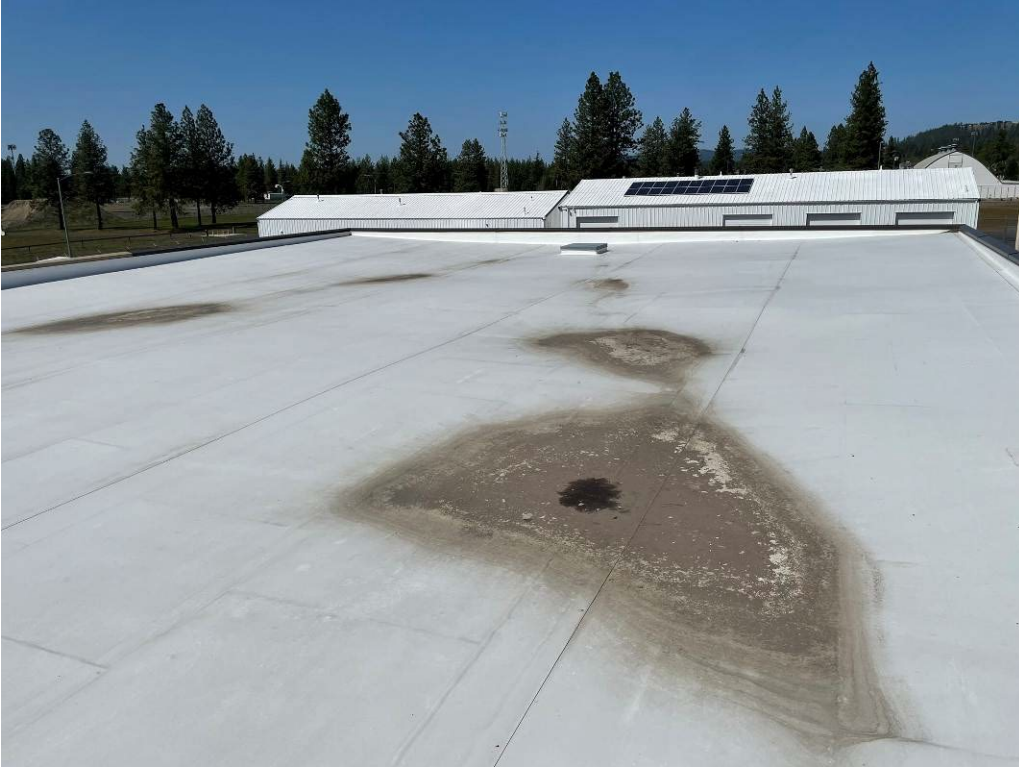
| Material Description | Material Description |
|---|---|
| Gypsum board over insulation board and built-up roofing (HM-30) | |

Photo 1: Building 3 top roof. The roofing is not asbestos containing.

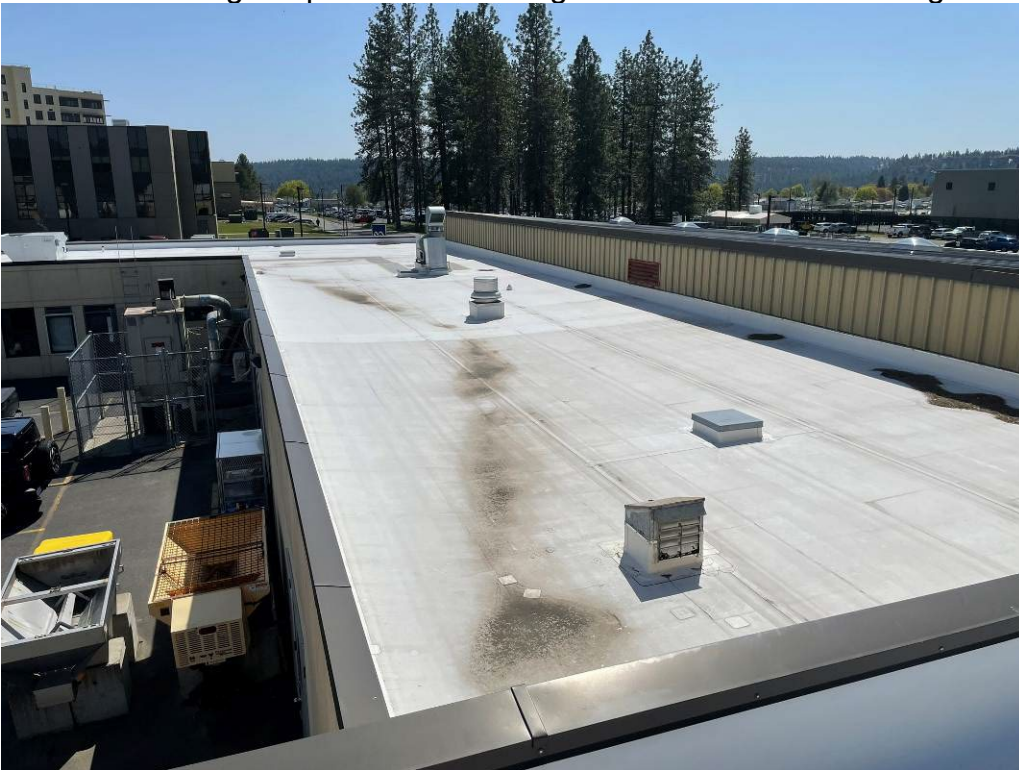
| Material Description | Material Description |
|---|---|
| Gypsum board over insulation board and built-up roofing (HM-31) | |

Photo 2: Building 3 lower roof. The roofing is not asbestos containing.

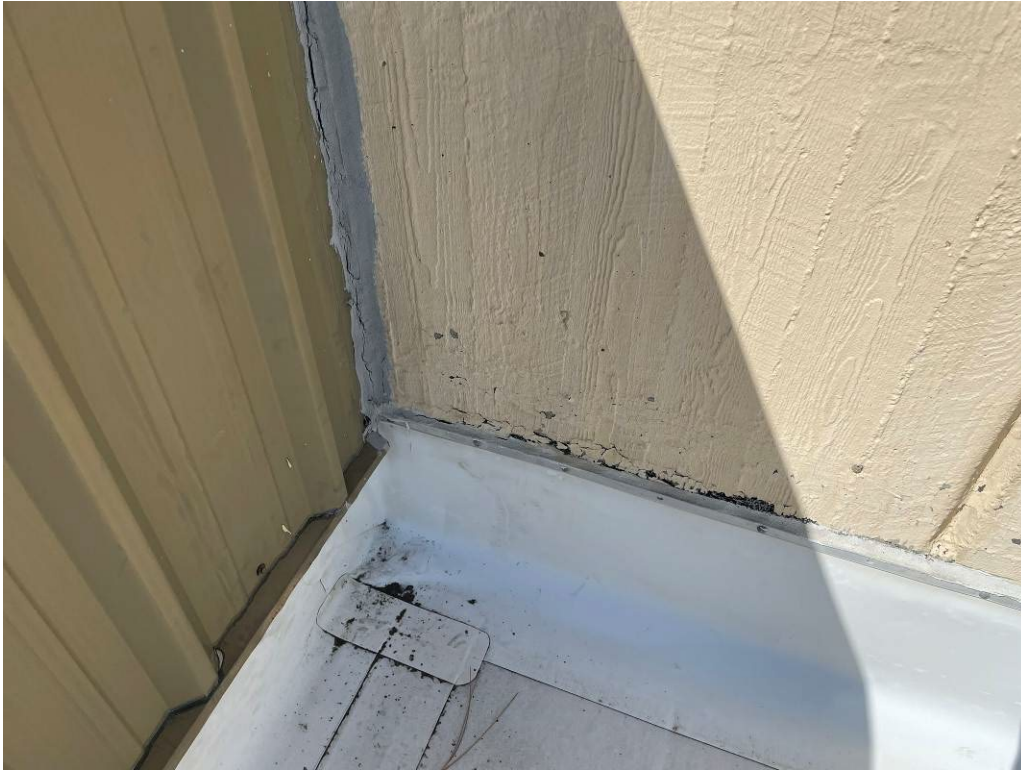
Samples were collected from the parapet flashing sealant, corrugated metal flashing sealant, gray vent sealant and white wall flashing sealant. There were two samples collected of the gray parapet flashing sealant. Both samples were determined to contain 2% Chrysotile asbestos. Sample 9243.1-3-051 was then re-analyzed by the more stringent EPA 400 Point Count Method. The sample was determined to contain 1.25% Chrysotile which is a regulated asbestos containing material.

| Material | Location | Friable | Quantity |
|---|---|---|---|
| Gray parapet flashing sealant (HM-32) | North concrete wall between top roof and lower roof | No | 30 LF |

Photo 3: Building 3 asbestos containing gray parapet flashing sealant.

Med-Tox Northwest recommends, and state law requires, that all asbestos materials identified in **Table 1** be removed prior to renovation or demolition.
