Subject: Mann-Grandstaff Veterans Administration (VA) Roofing Project  
"Good Faith" Asbestos Investigation- Building 31  
4815 North Assembly Street, Spokane, Washington  
Med-Tox Northwest Project No. 9139.1

MA Architects, Inc.  
Mann-Grandstaff VA Roofing Project- Building 31  
May 12, 2025  
Med-Tox Northwest Project No. 9243.1  
Page 2

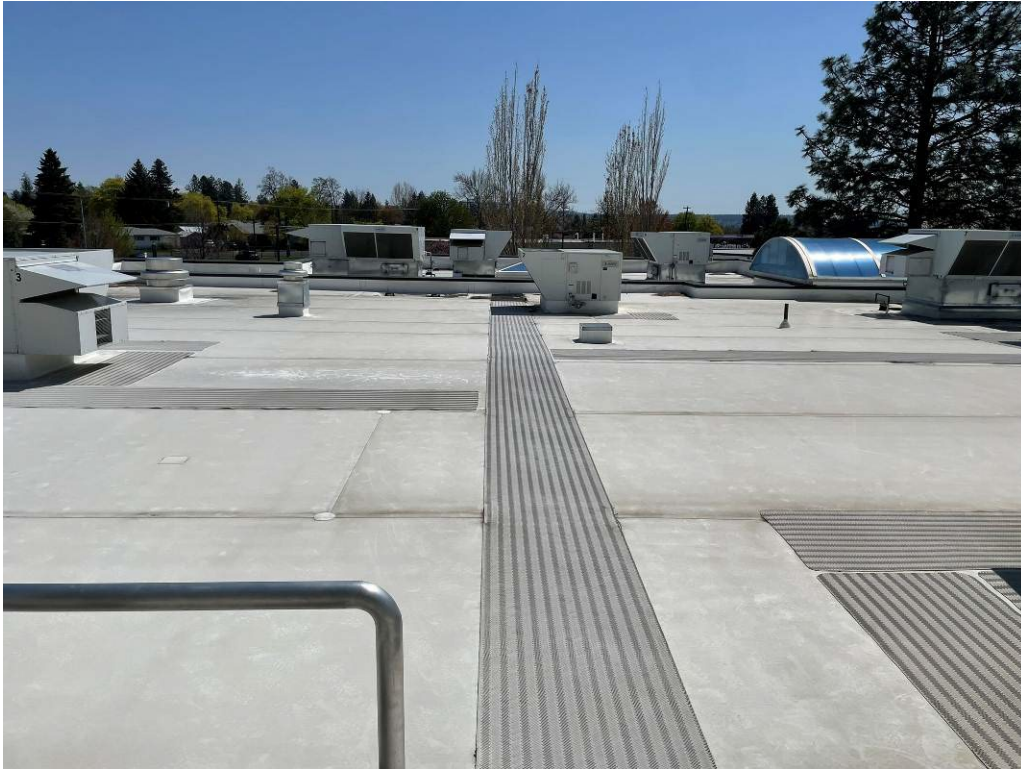
Photo 1: Building 31 old roof. There were no asbestos containing materials identified.

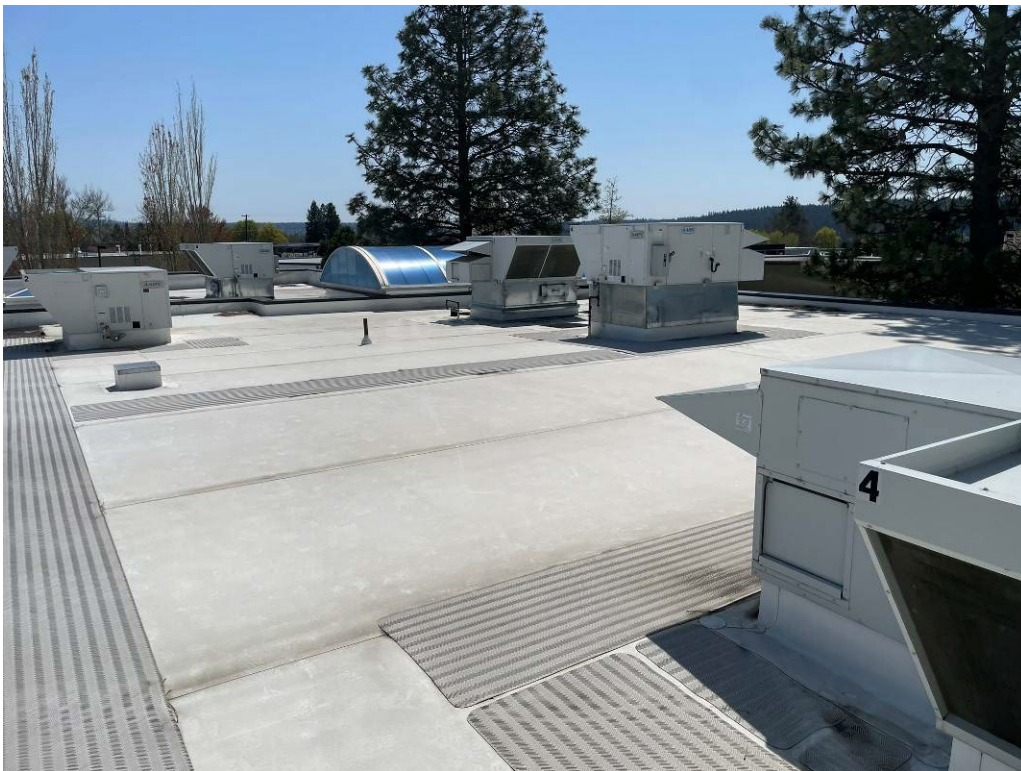
Photo 2: Building 31 new roof. There were no asbestos containing materials identified.
