## Waterfront Facilities Inspections &amp; Assessments at Naval Station Norfolk

CR-NAVFAC EXWC-CIOFP - DRAFT

Naval Station Norfolk  
Norfolk, VA**Section 3.28 - Q58 Data Concentrator Shed****Contract:** N39430-15-D-1623**Inspection Date:** 03/05/2019**Contractor:** Collins Engineers, Inc.  
123 N. Wacker Drive, Suite 900  
Chicago, IL 60606**Facility:** Q58 Data Concentrator Shed**INFADS:** NFA100001163536**PRN:** 201157**Location:** [36.97745, -76.315354](#)**Estimated Repair Cost\*:** \$ 129,920\*Repair cost includes Design Allowances, Contractor Overhead & Profit, and Inflation Allowances.  
See Appendix C - Cost Estimate for detailed analysis.

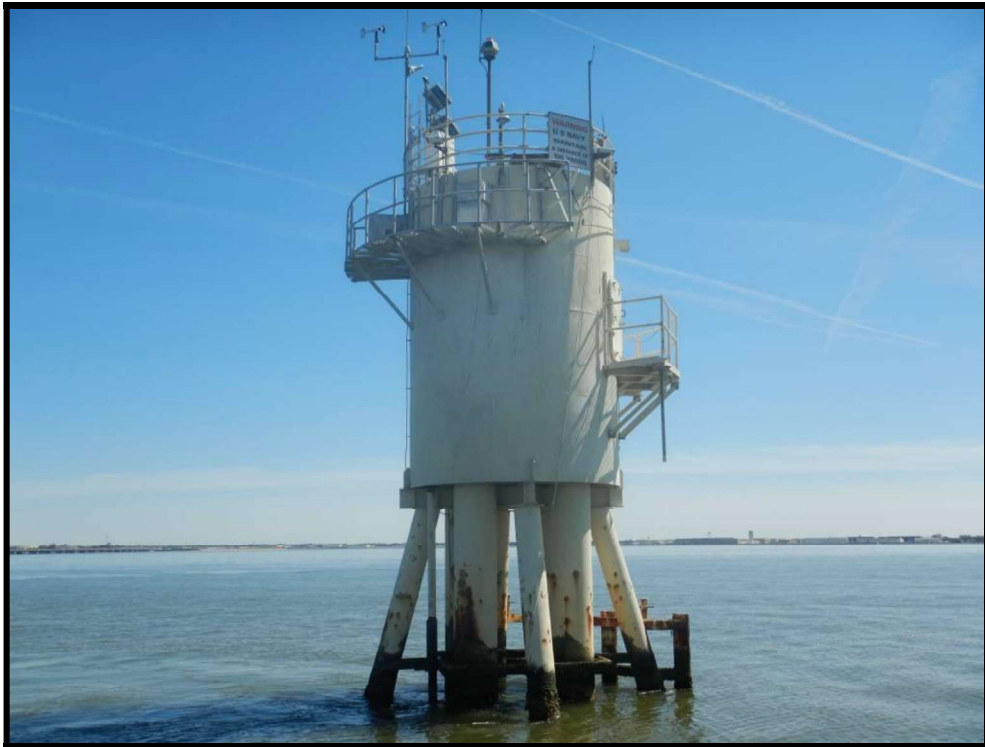
Photo 3.28-2: Overall view of Q58 Data Concentrator Shed, looking south.

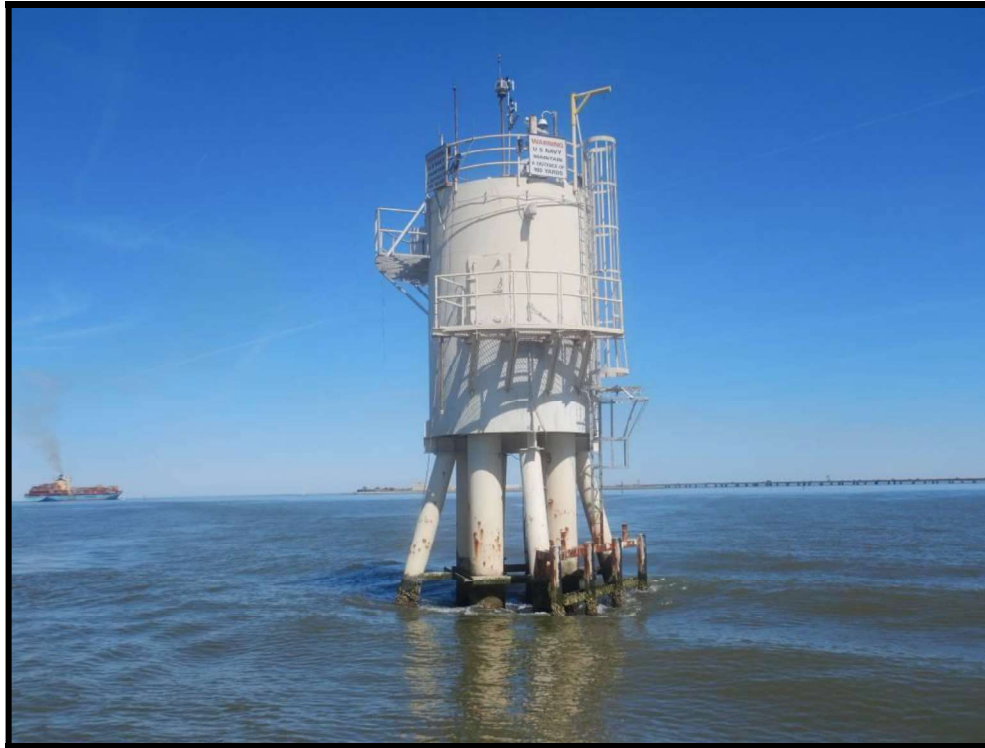
Photo 3.28-3: Overall view of Q58 Data Concentrator Shed, looking northeast.

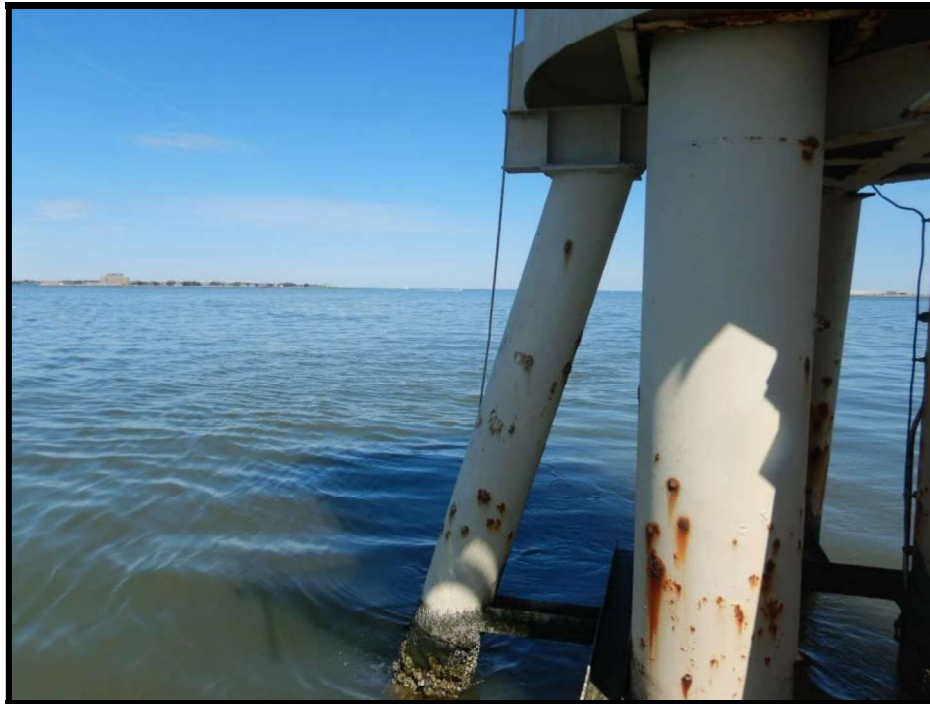
Photo Type: Typical      UFII/Asset Type: H10100101\_PB

| Findings | The steel piles are in Satisfactory Condition. There are four battered 18 in. steel piles. The steel piles have minor coating failure on up to 10% of the surface area and light surface corrosion in the tidal zone. Ultrasonic thickness measurement readings taken at the piles range between 0.480 in. and 0.495 in., and the potential reading is -0.680 volts. The anode sled was not located and is believed to be buried under silt and/or the cable bundles below the shed. There are no other notable defects. | | |

Photo 3.28-4: View of the typical condition of the steel batter piles.

| Recommendations | It is recommended that the steel piles be cleaned and recoated above MLW. It is also recommended that further investigations should be conducted to determine the location and condition of the anode sled. | | |

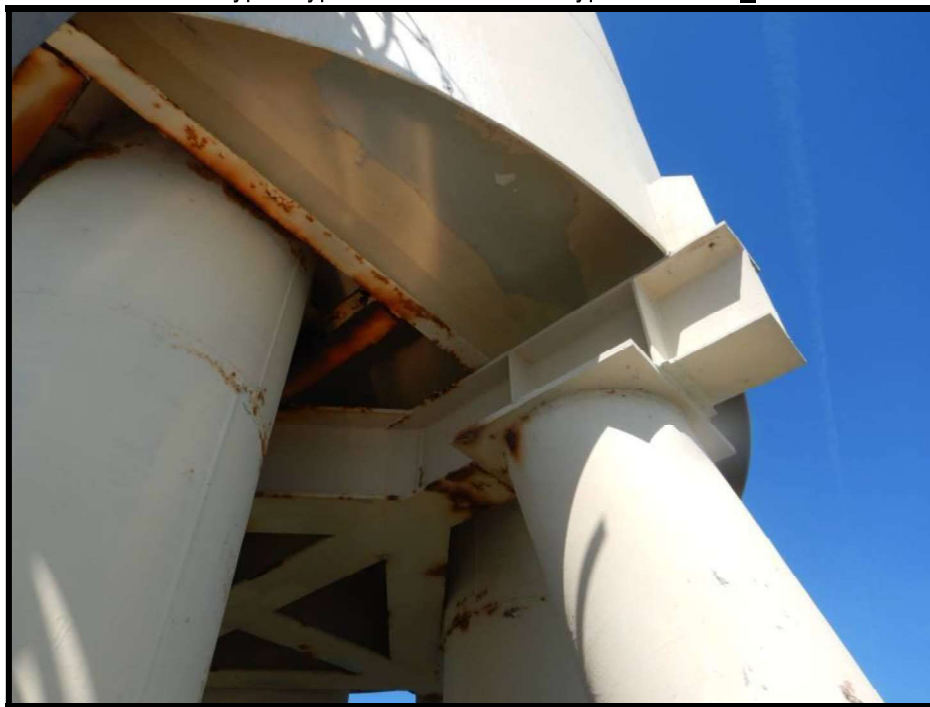
Photo Type: Typical      UFII/Asset Type: H101002\_PC1

| Findings | The steel pile caps are in Satisfactory Condition. There are two steel pile caps that are 15 ft long by 6 in wide. The pile caps have minor coating failure on up to 10% of the surface with light surface corrosion. There are no other notable defects. | | |

Photo 3.28-5: View of the typical condition of the steel pile caps.

| Recommendations | It is recommended that the steel pile caps be cleaned and recoated. | | |

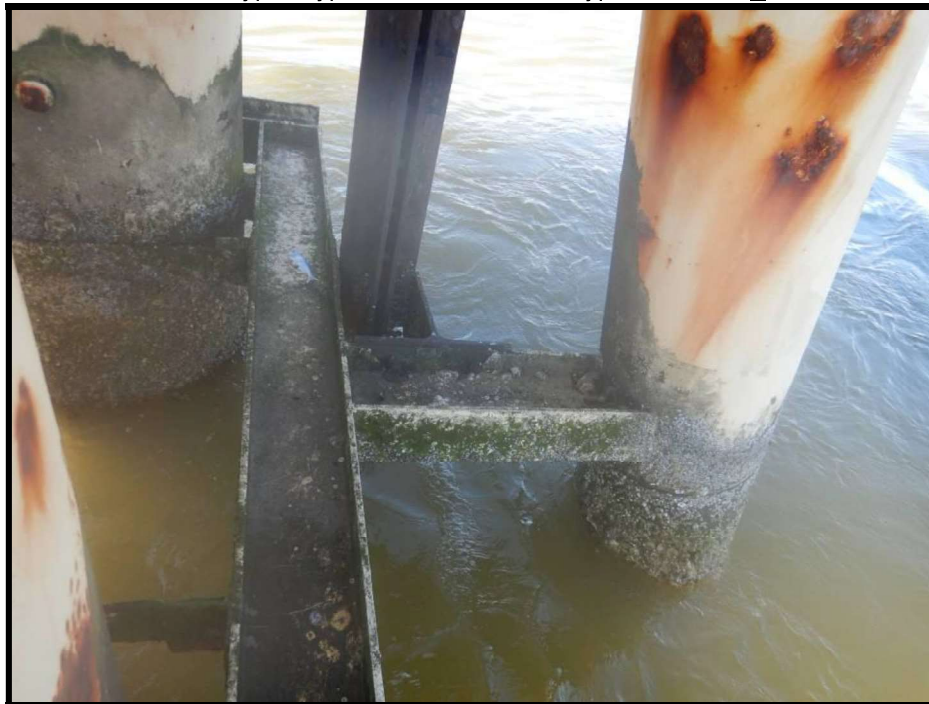
Photo Type: Typical      UFII/Asset Type: H102001\_B1

| Findings | The steel beams are in Satisfactory Condition. There are eight steel beams. The beams and girders have minor coating failure on up to 10% of the surface area with light surface corrosion. There are no other notable defects. | | |

Photo 3.28-6: View of the typical condition of the lower steel beams.

| Recommendations | It is recommended that the steel beams be cleaned and recoated. | | |

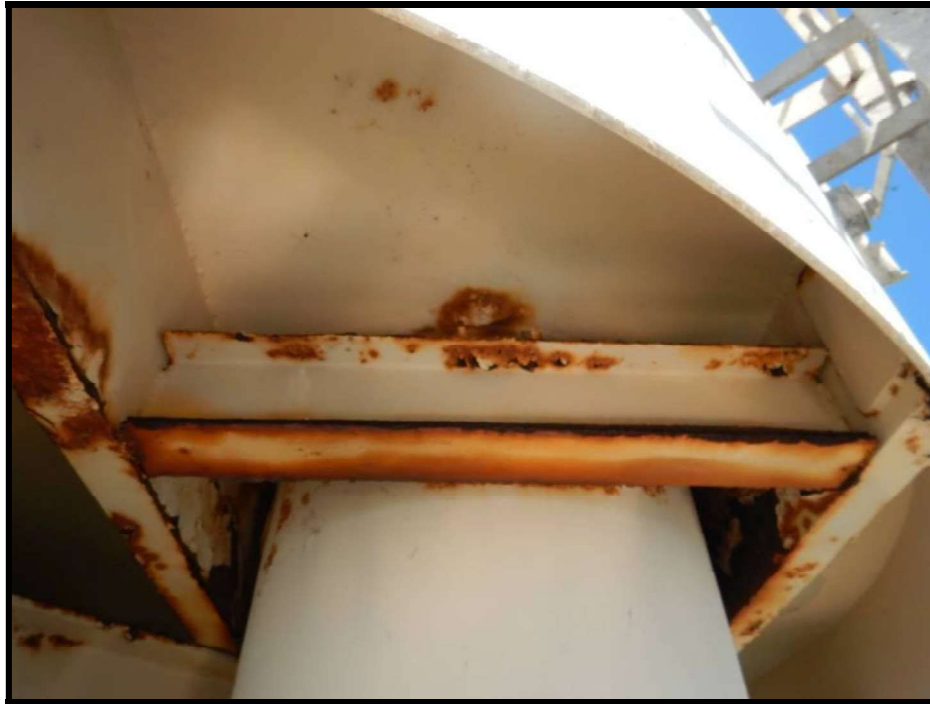
Photo Type: Typical UFII/Asset Type: H102001\_B1

Photo 3.28-7: View of the typical condition of the floor beams.

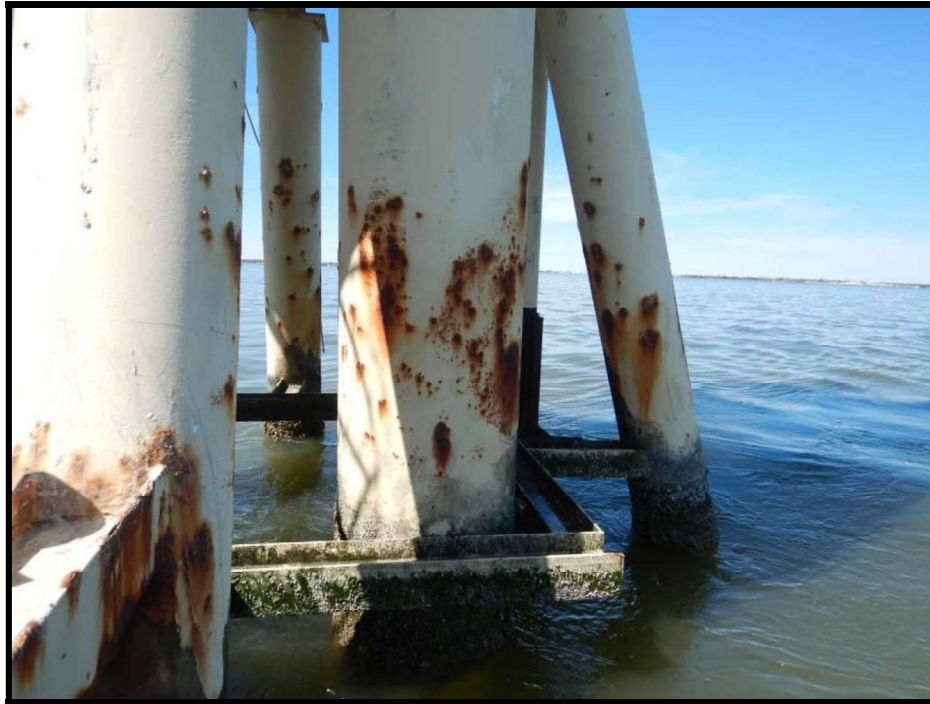
UFII/Asset Type: H102002\_COL

| Findings | The steel pipe columns are in Satisfactory Condition. There are four 30 in. steel columns. The columns have minor coating failure on up to 10% of the surface area with light surface corrosion. There are no other notable defects. | | |

Photo 3.28-9: View of the typical condition of the steel pipe columns used for sensor cables.

| Recommendations | It is recommended that the steel pipe columns be cleaned and recoated above MLW. | | |

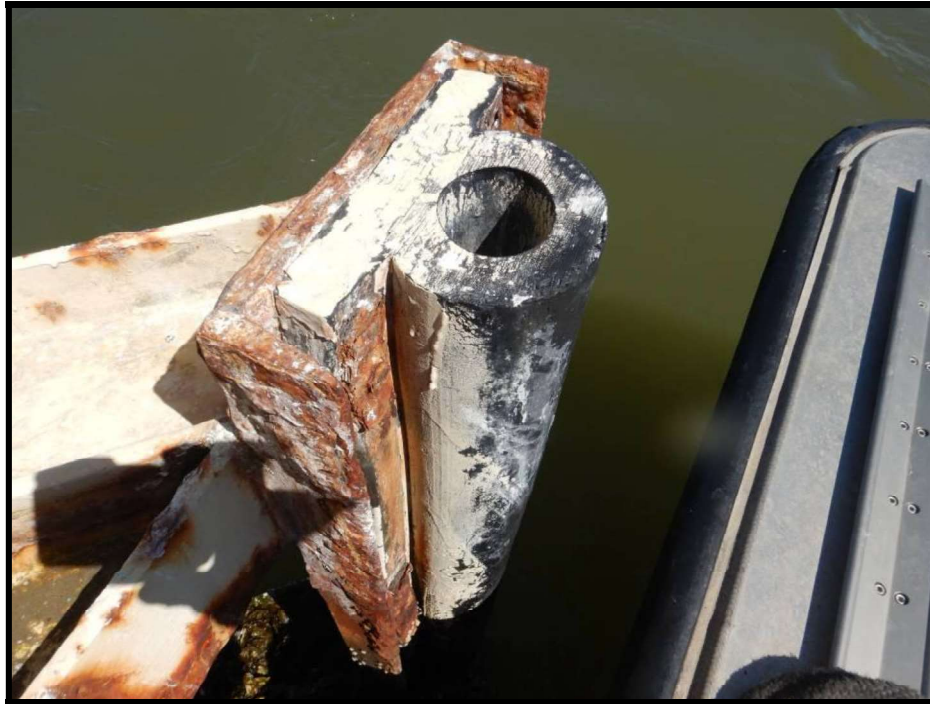
UFII/Asset Type: H10400102\_FF3

| <b>Findings</b> | The fender frame members are in Fair Condition. There are two horizontal steel beams and four vertical steel channels. Each of the vertical steel channels has a rubber rubrail attached. The vertical rubber rubrails have minor abrasion damage. The steel members have moderate to major coating loss with moderate corrosion and delaminations. The rubrail mounting channels have moderate to heavy surface corrosion, with 100% section loss on the steel connection plates for the rubrails. | |

Photo 3.28-11: View the typical coating failure and moderate corrosion on the vertical steel channels and steel connection washers for the rubrails.

| <b>Recommendations</b> | It is recommended that the steel framing members be cleaned and recoated and that the steel connection plates be replaced. | |

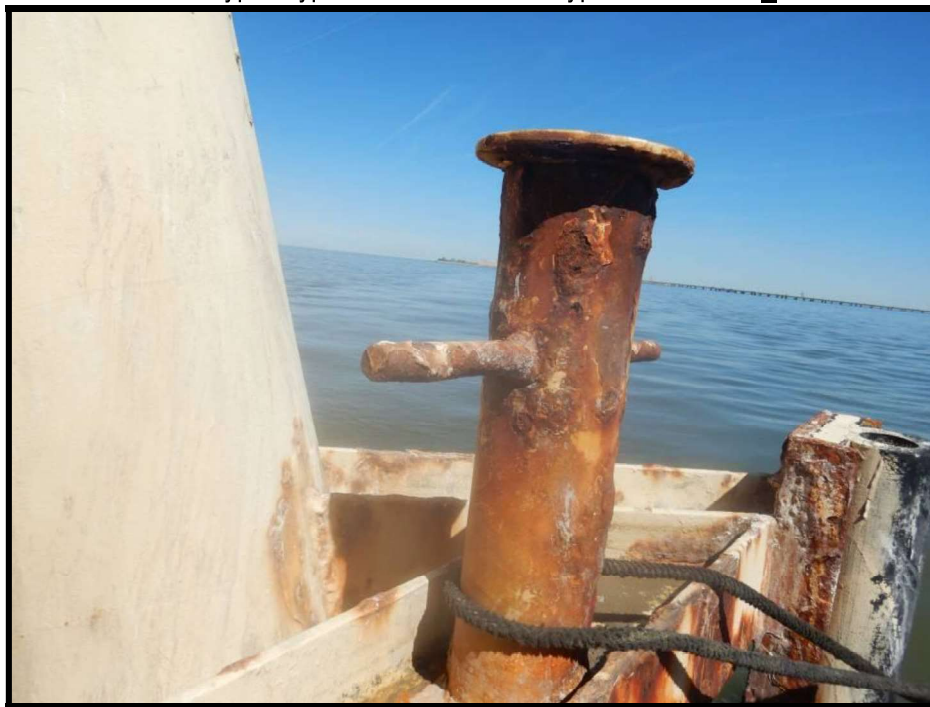
Photo Type: Typical      UFII/Asset Type: H10400501\_MF

| <b>Findings</b> | The steel bollards are in Fair Condition. There are two bollards that have up to 75% coating failure with moderate surface corrosion. | |

Photo 3.28-12: View of the typical coating failure and areas of moderate corrosion on the steel bollards.

| <b>Recommendations</b> | It is recommended that the steel bollards be cleaned and recoated. | |

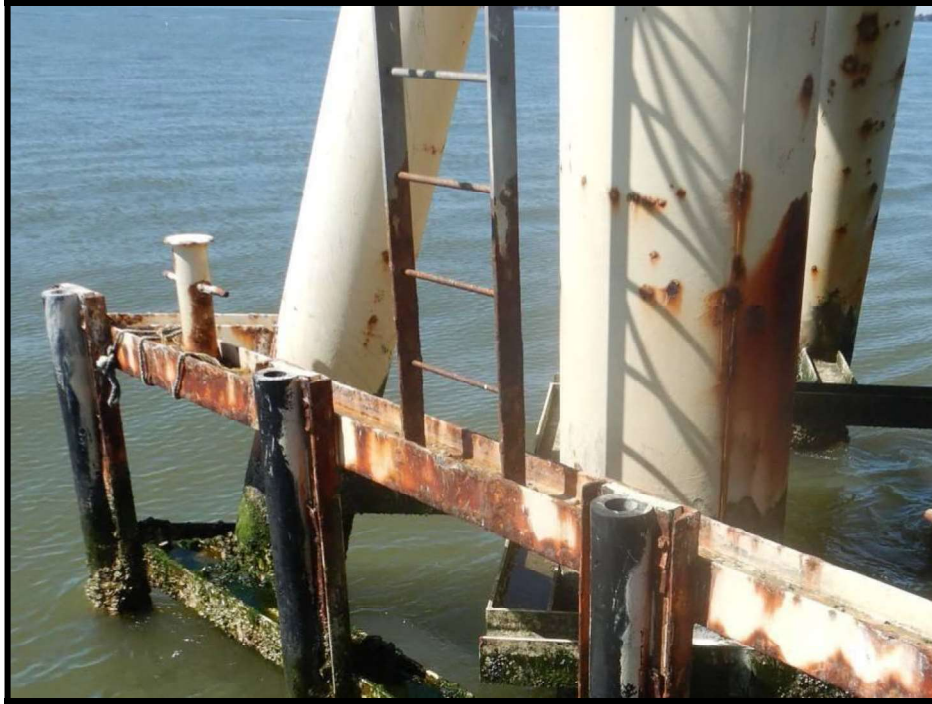
Photo Type: Defect UFII/Asset Type: H105005\_LAD

| Findings | The safety ladder is in Fair Condition. The ladder has coating failure and moderate surface corrosion and delamination on the bottom three rungs and rails. | | |

Photo 3.28-14: View of the coating failure and corrosion on the bottom of the safety ladder.

| Recommendations | It is recommended that the safety ladder be cleaned and recoated. | | |
