**Project:** Repair JBLM Railhead

**Reference Document:** ERDC/GSL APB ARR-20-06, "Railroad Track Inspection and Repair Recommendations, Joint Base Lewis-McChord, Washington" (Dated: March 2021)

**ERDC/GSL APB ARR-20-06**

## **Railroad Track Inspection and Repair Recommendations, Joint Base Lewis- McChord, Washington**

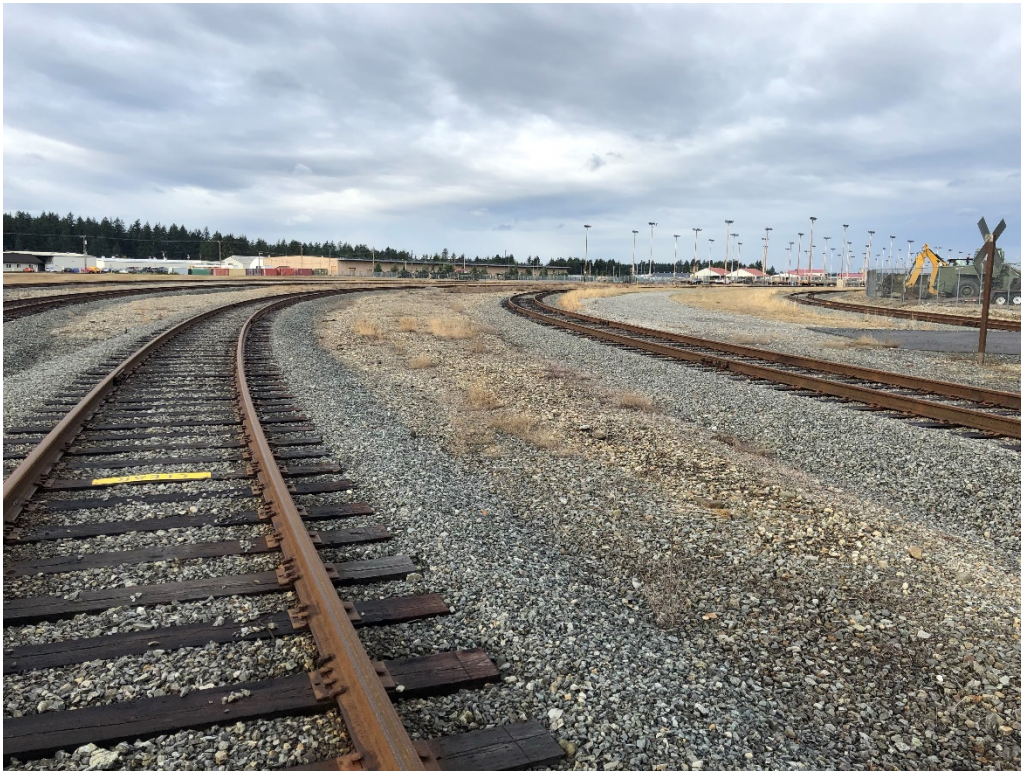
Figure A2. Track 5 Leading into yard tracks.

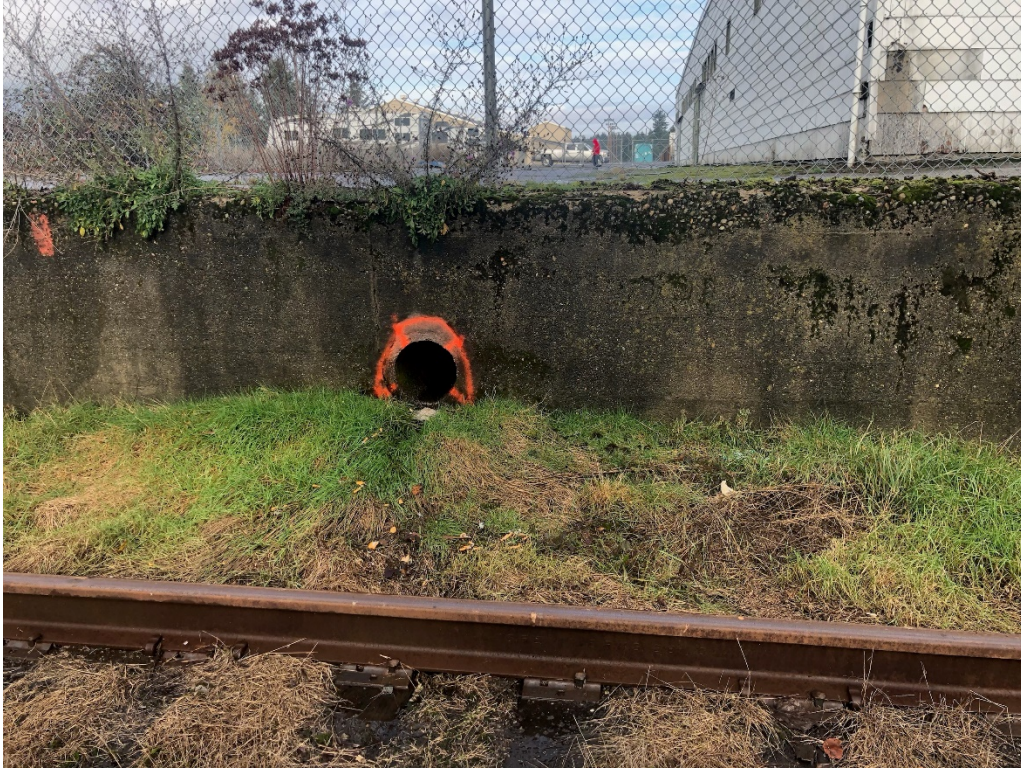
Figure A3. Storm drain along Lead 3 causing heavy vegetation and potentially causing washouts.

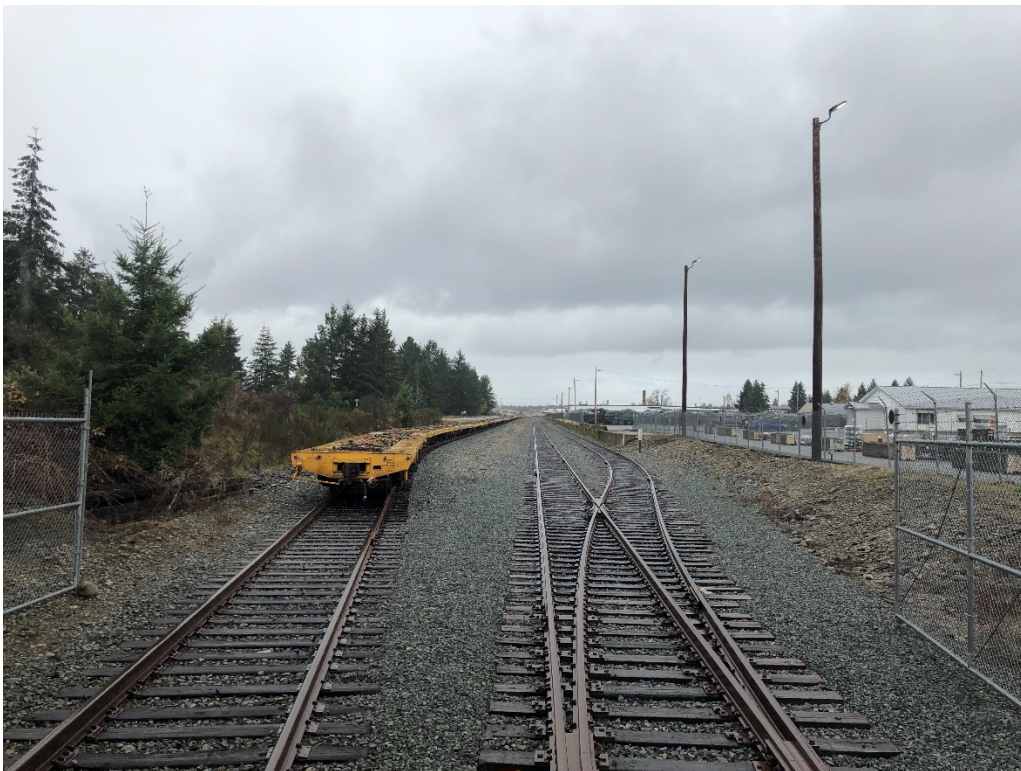
Figure A4. Gate leading to Lead 1, Lead 2 and Lead 3.

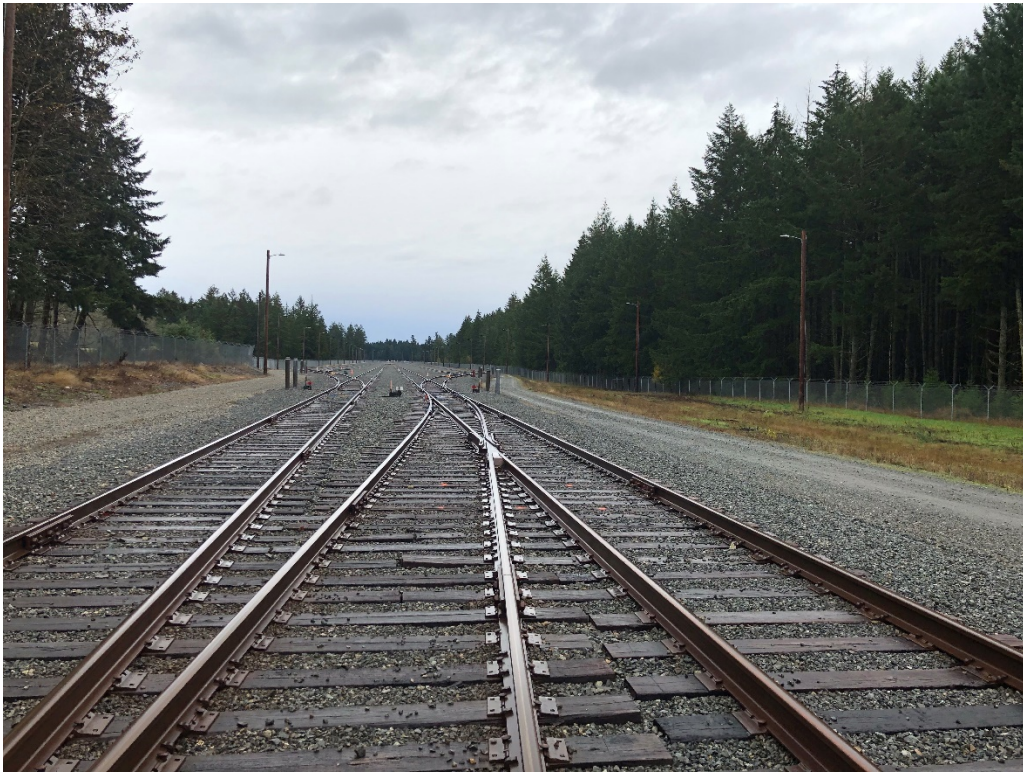
Figure A5. View down Main and LC10 toward the North and South tracks.
