## NORFOLK NAVAL STATION Norfolk, VA

### Section 3.1 - Q47 Fishing Pier

Inspection Date: 07/15/2013

**Contractor:** Collins Engineers, Inc.  
123 N. Wacker Drive, Suite 900  
Chicago, Illinois 60606

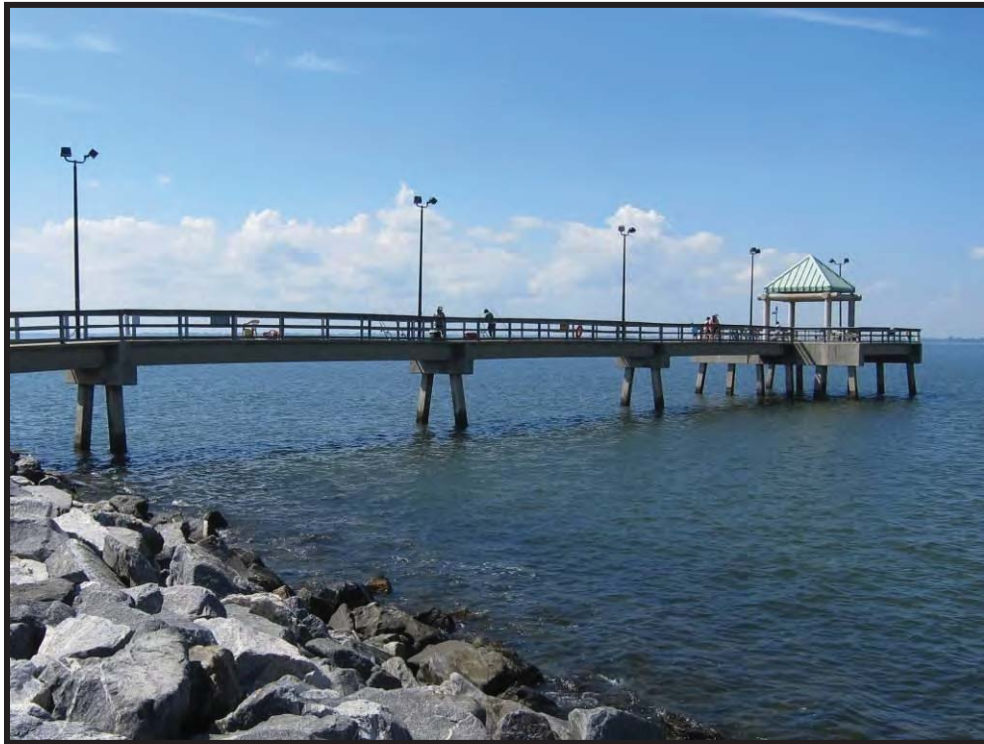
Photo 3.1-1: Overall view of the Q47 Fishing Pier, looking northwest.

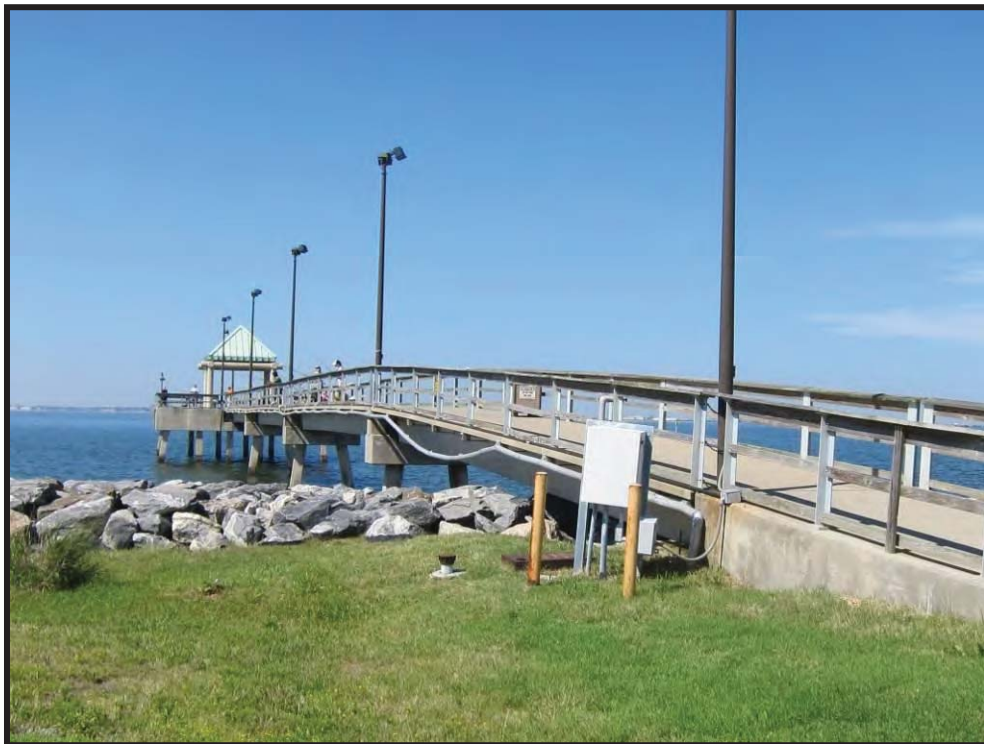
Photo 3.1-2: Overall view of the Q47 Fishing Pier, looking northeast.

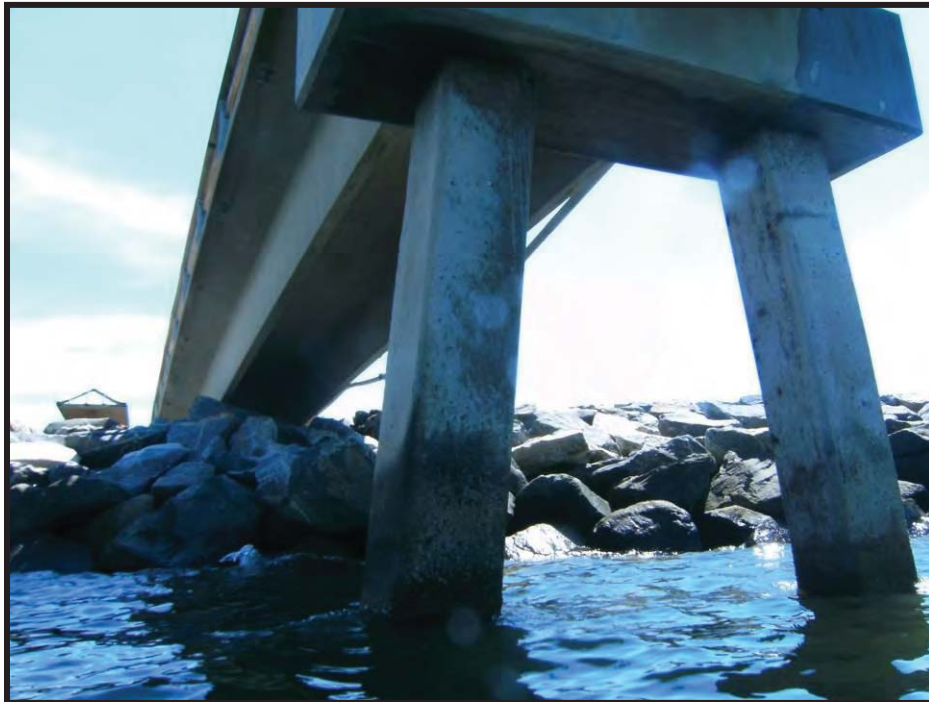
| <b>Findings</b> | The piles are in Good Condition. There are 18 battered piles and no vertical piles supporting the pier. Pile 4F exhibited a small area of section loss that is 8 in. high by 3 in. wide with up to 1 in. of penetration and no exposed reinforcing steel. There are no other notable defects on the concrete piles. | |

Photo 3.1-3: View of the concrete battered piles at Bent 1, looking southwest.

| <b>Recommendations</b> | No repairs are recommended at this time. The area of section loss noted at Pile 4F should be monitored during future inspections for any further deterioration. | |

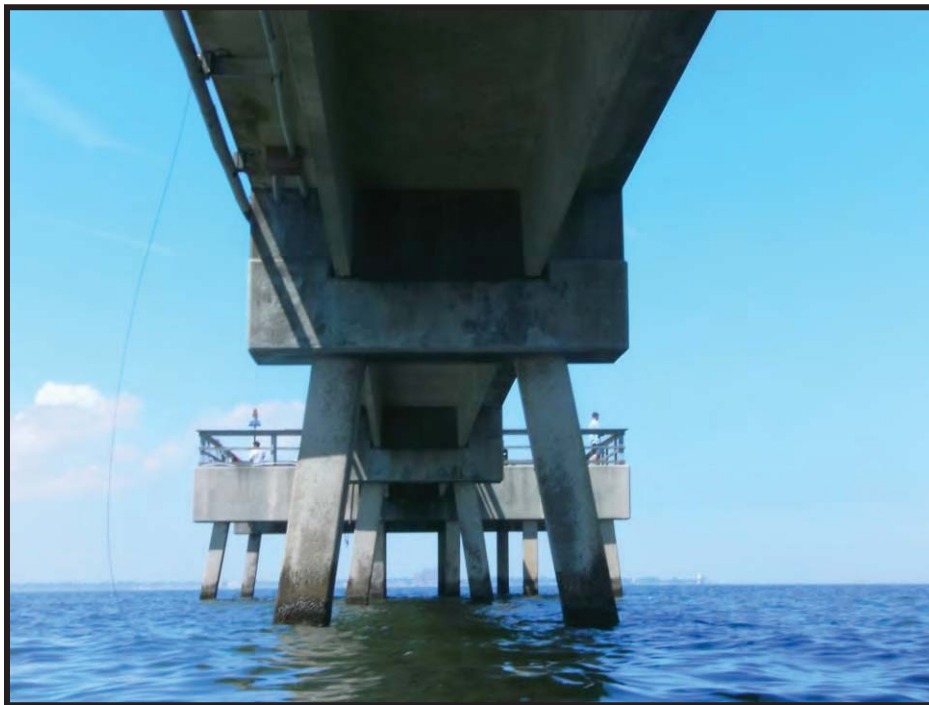
| <b>Findings</b> | The pile caps are in Good Condition. There are five concrete piles caps, three are 9.7 ft long and two are 39.7 ft long. There are no notable defects on the concrete pile caps. | |

Photo 3.1-4: View of the concrete pile cap at Bent 2, looking north.

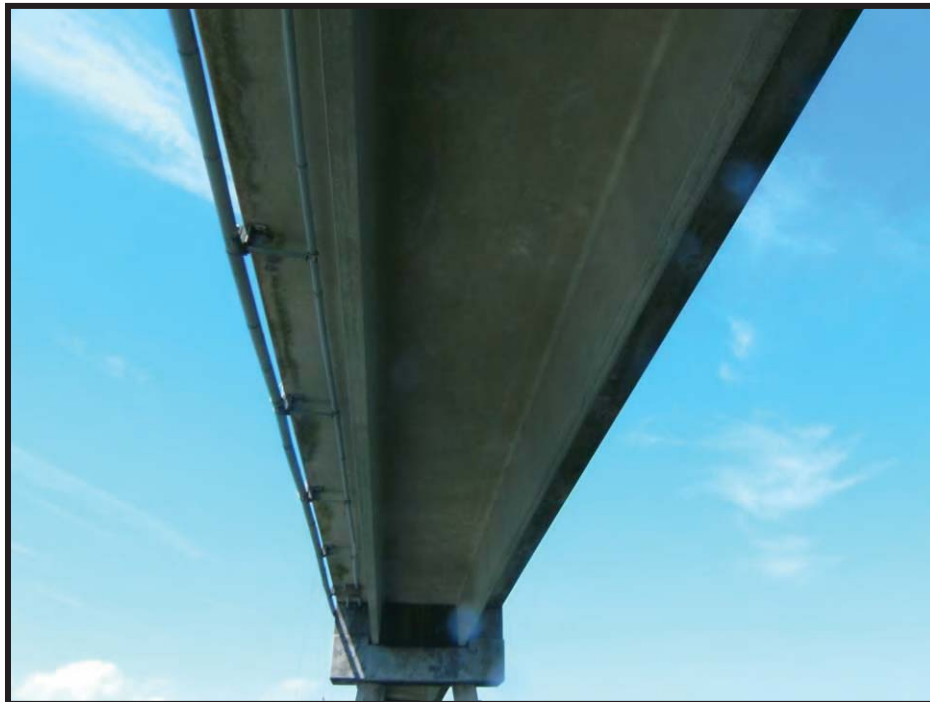
| <b>Findings</b> | The beams are in Satisfactory Condition overall. There are four prestressed double tee concrete beams spanning between Bents 0 and 4 and four prestressed double tee beams spanning between Bents 4 and 5. There are four 18 in. diameter reinforced concrete beams supporting the steel roof. Six of the double tee beams exhibit horizontal cracking along the bottom face of the webs. The cracking ranges from 1/8 in. wide to 1/2 in. wide. There are no notable defects for the beams supporting the steel roof. | |

Photo 3.1-5: View of the concrete double tee beam between Bents 1 and 2, looking north.

| <b>Recommendations</b> | It is recommended that the areas of concrete cracking and associated deterioration noted along the double tee beam webs be repaired. | |

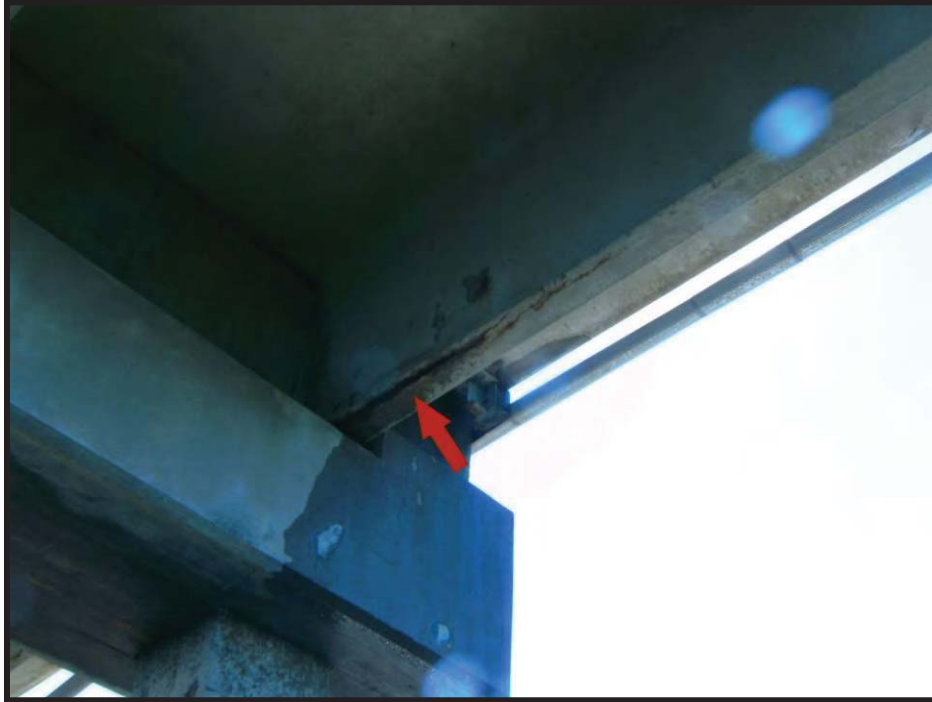
Photo 3.1-6: View of the 1/2 in. wide crack in the double tee beam north of Pile 1C, looking southwest.

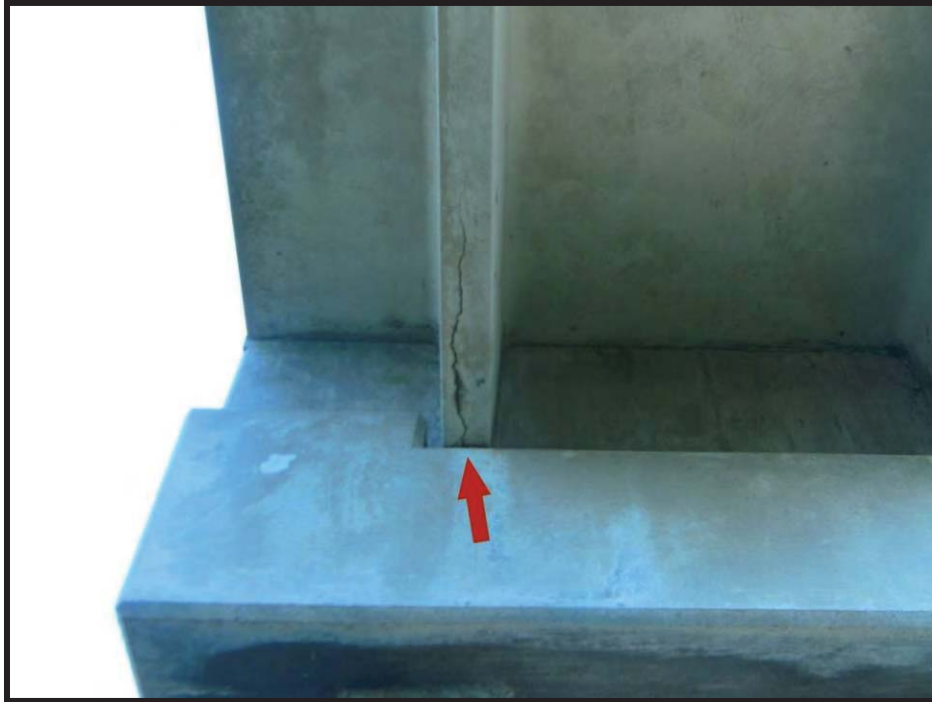
Photo 3.1-7: View of the 1/4 in. wide crack in the bottom of the double tee beam north of Pile 1D, looking south.

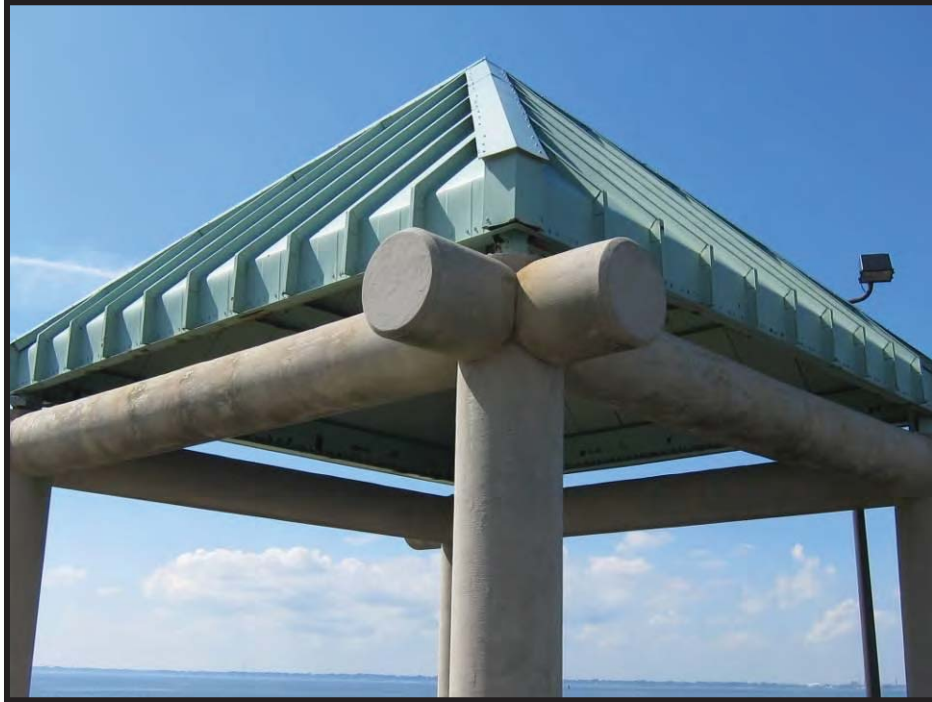
Photo 3.1-8: View of the concrete beams supporting the steel roof, looking northwest.

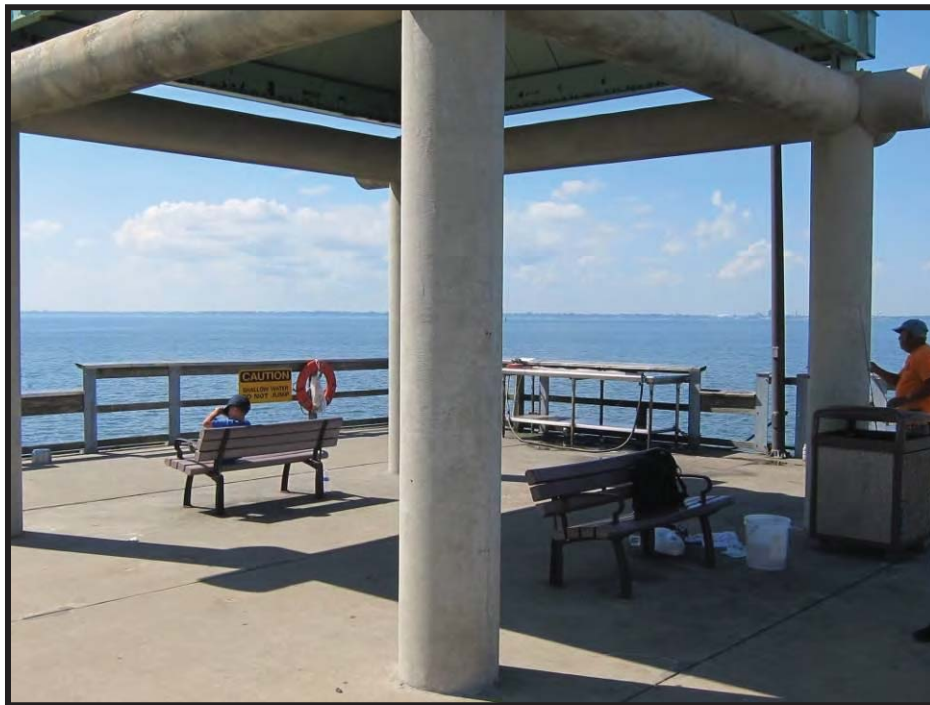
| <b>Findings</b> | The columns are in Good Condition. There are four 18-in.-diameter concrete columns supporting the steel roof. There are no notable defects on the concrete columns. | |

Photo 3.1-9: View of the concrete column condition, looking northwest.

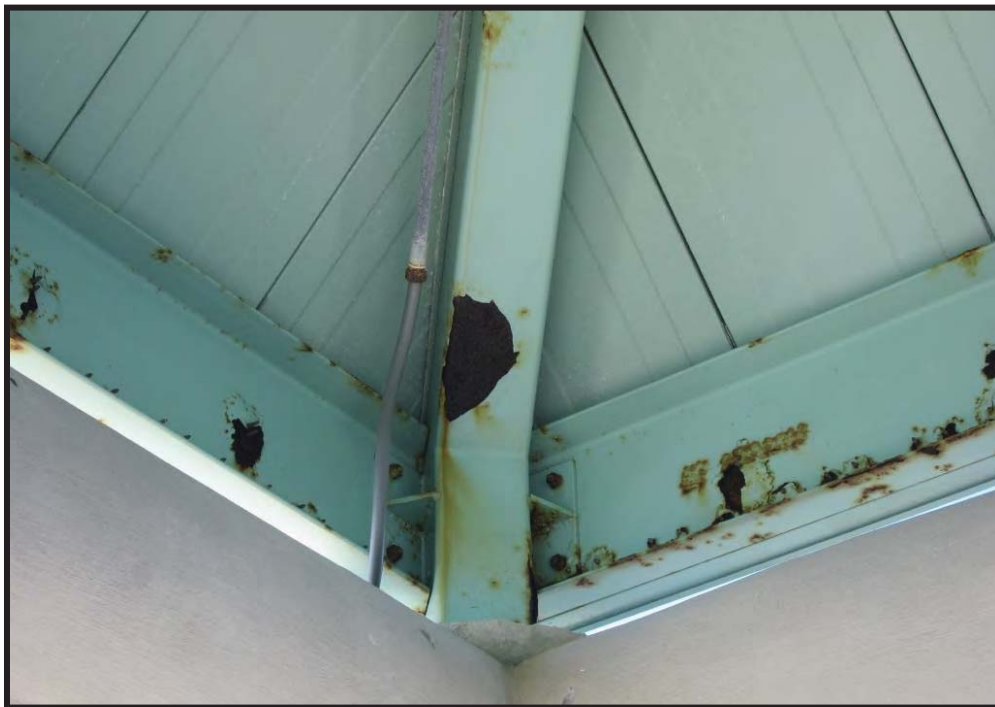
| Findings | The steel roof is in Satisfactory Condition. The steel support members exhibit areas of coating failure with minor corrosion on 5 percent of the surface areas. | | |

Photo 3.1-10: View of an area of coating failure and minor surface corrosion on the steel roof, looking southwest.

| Recommendations | It is recommended that the steel members be cleaned and recoated. | | |

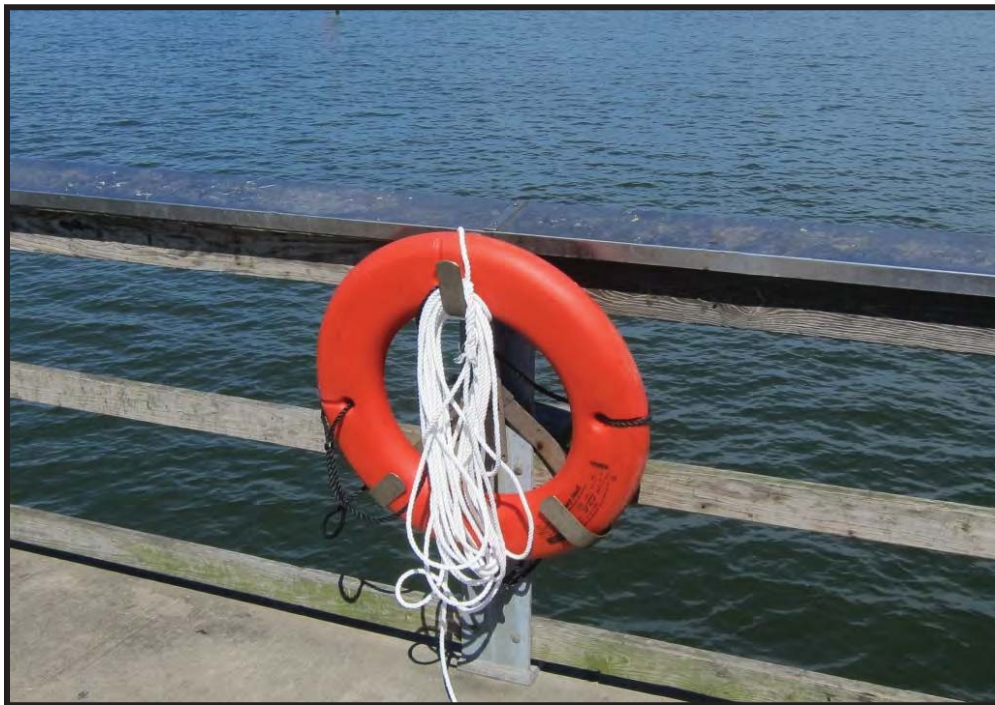
| <b>Findings</b> | The life rings and life ring supports are in Good Condition. There are three life rings and three associated life ring supports, all of which appear to be in proper operational condition. | |

Photo 3.1-12: View of the typical life ring condition, looking northeast.

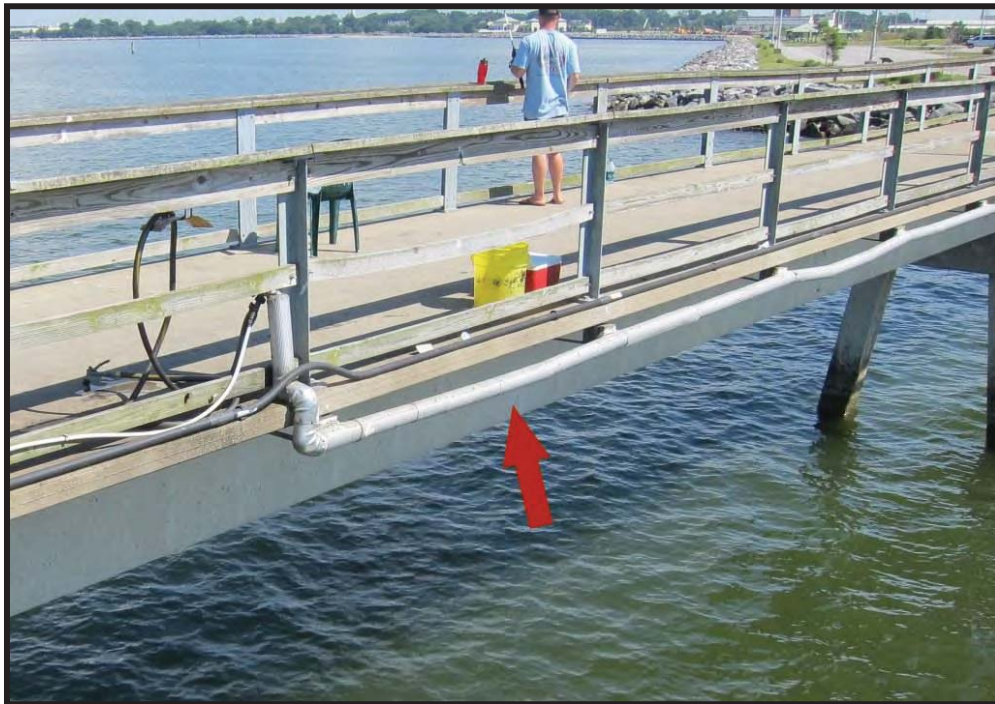
Photo 3.1-13: View of the insulated waterline condition, looking southeast.

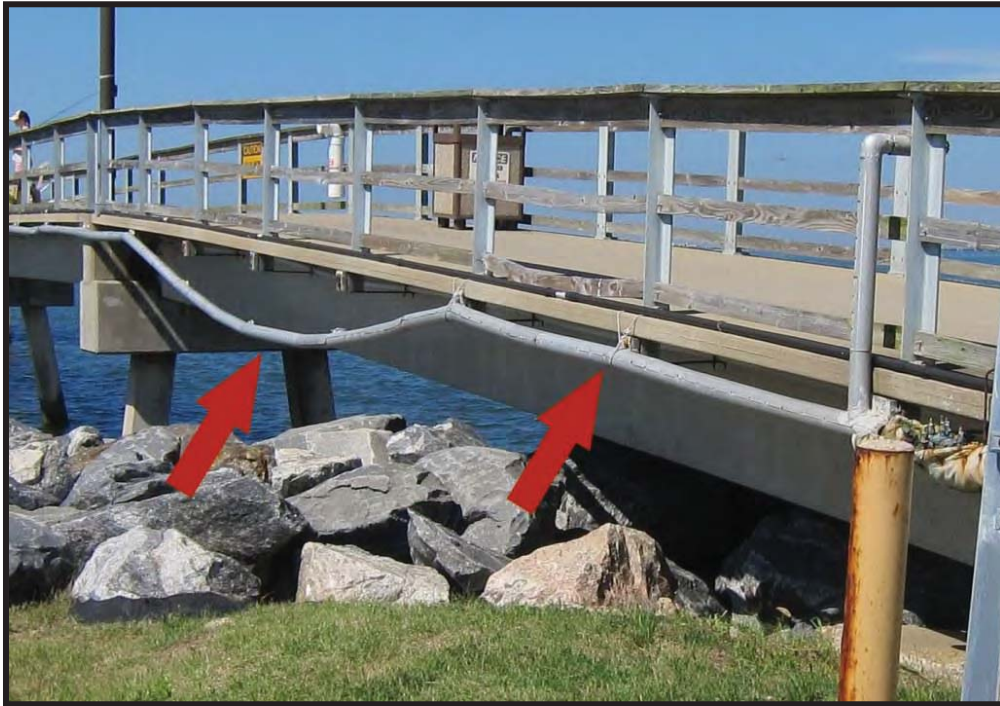
| <b>Findings</b> | The potable waterline is in Satisfactory Condition. There is 220 linear ft of insulated potable waterline along the western side of the pier. The waterline appears to be in operational condition. The supports between Bents 0 and 1, however, are failed with the waterline sagging up to 2 ft and "makeshift" ropes securing the waterline at only two locations. | |

Photo 3.1-14: View of the "makeshift" rope supports and sagging waterline between Bents 0 and 1, looking northeast.

| <b>Recommendations</b> | It is recommended that the five failed supports between Bents 0 and 1 be replaced so that the waterline is properly supported. | |

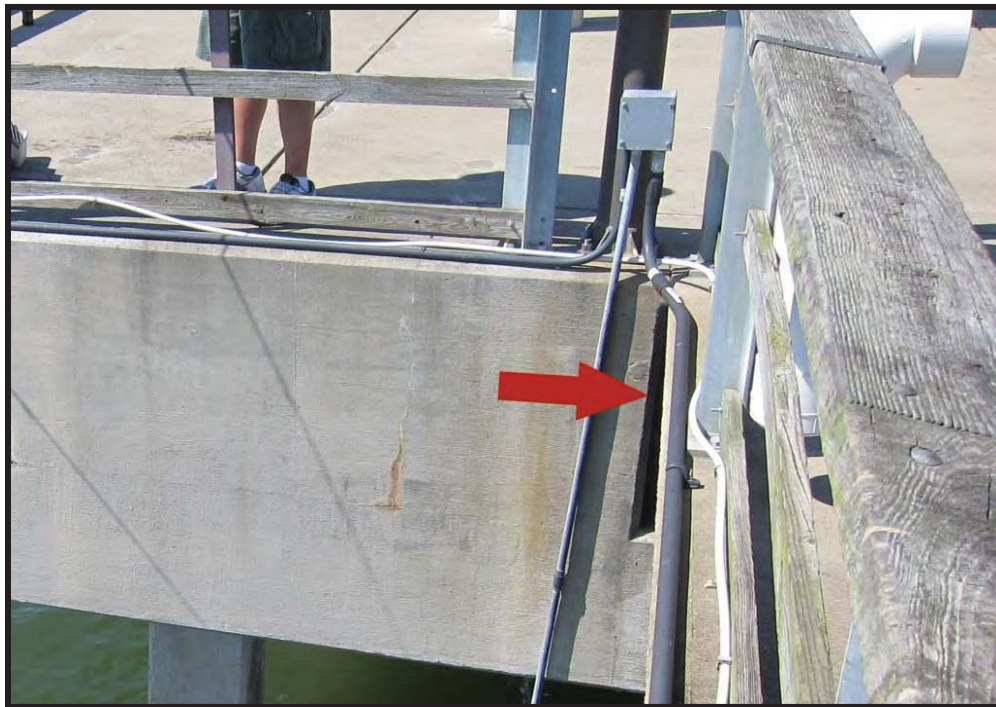
| <b>Findings</b> | The electrical conduits are in Good Condition. There is 334 linear ft of PVC conduit extending along the western side of the pier along the deck topside, and there is 250 linear ft of steel conduit extending along the western side of the pier along the deck underside. The entire conduit is securely attached with no significant deterioration or damage noted. | |

Photo 3.1-15: View of the PVC conduit, looking north.

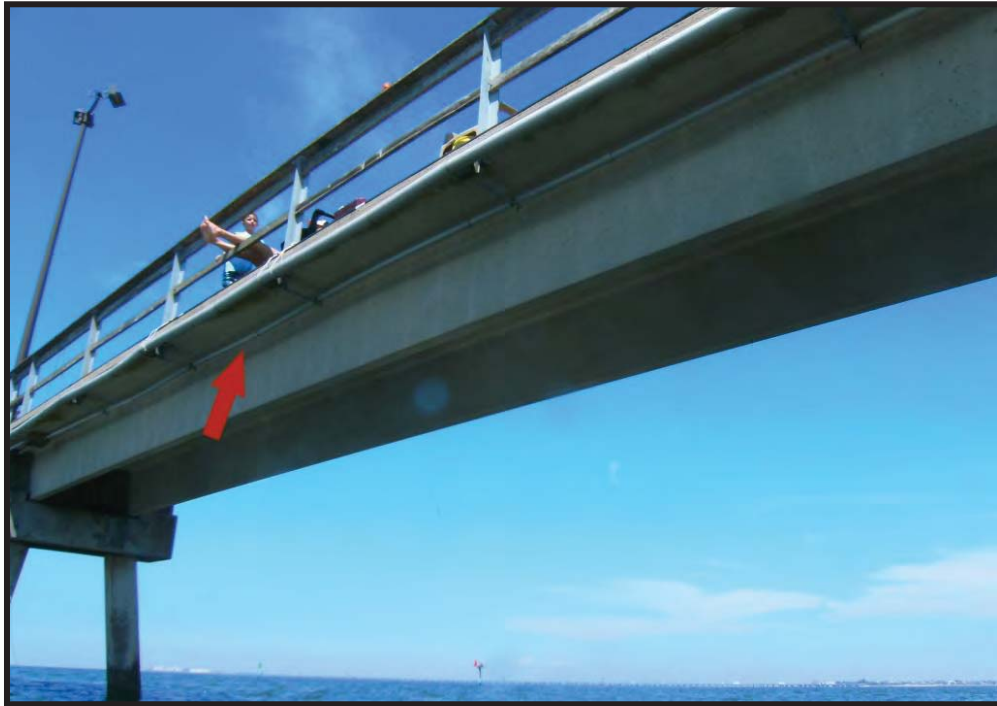
Photo 3.1-16: View of the steel conduit, looking northeast.

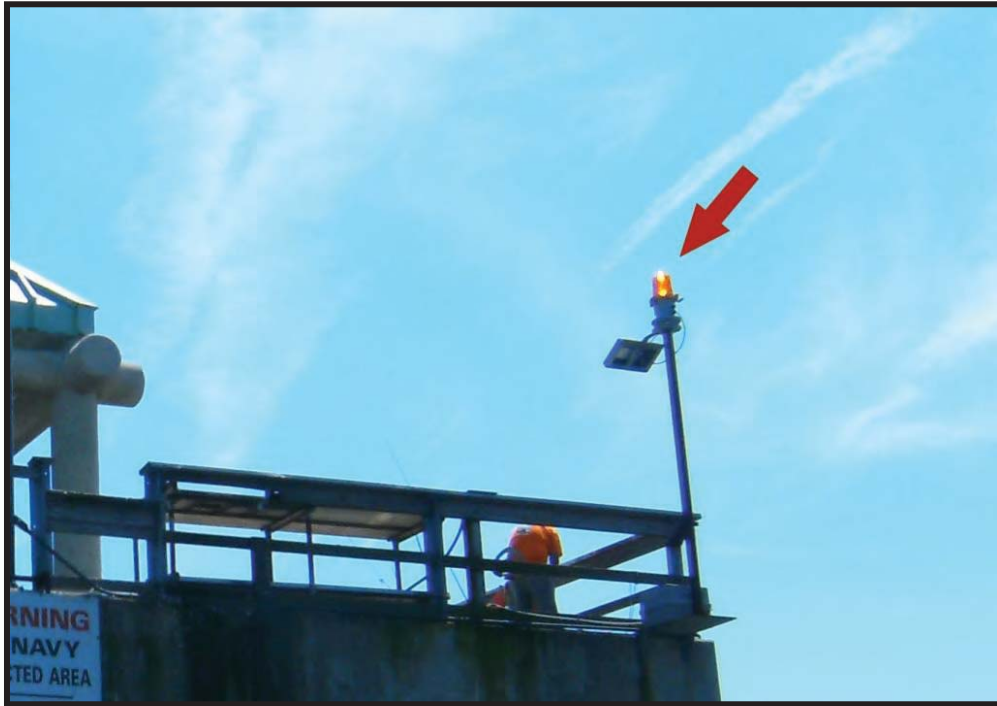
Photo 3.1-18: View of the navigational light at the outboard end of the pier, looking south.

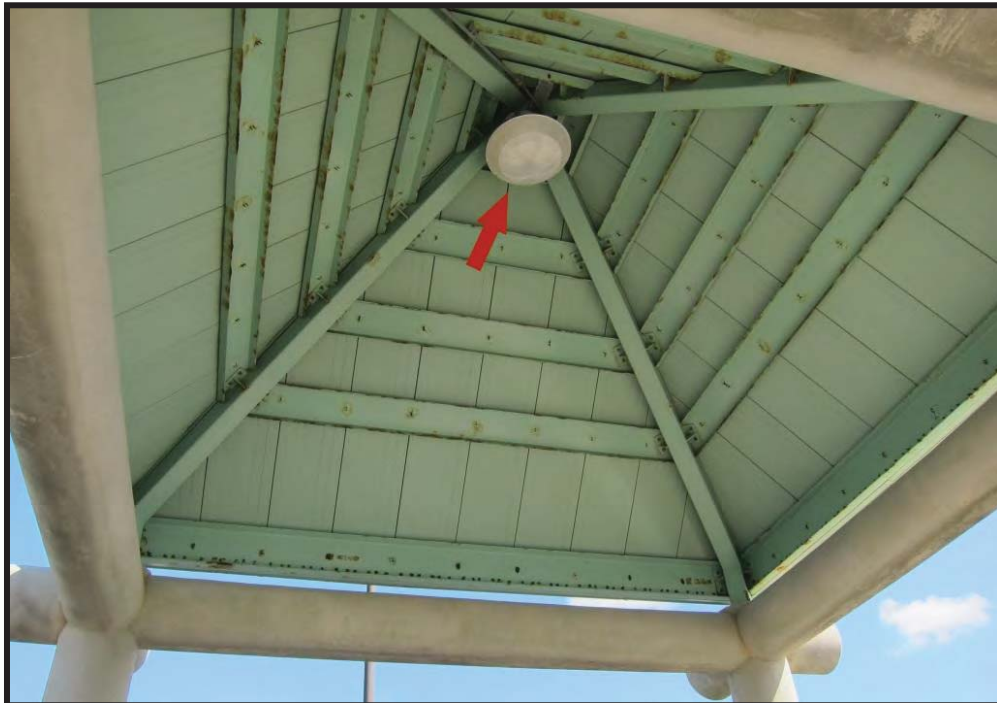
Photo 3.1-19: View of the light attached to the steel canopy.
