# ASBESTOS, LEAD PAINT, AND MOLD ASSESSMENT

TARAWA TERRACE II CHILD DEVELOPMENT CENTER

BLDG. TT-113 IWO JIMA BOULEVARD  
TARAWA TERRACE, NORTH CAROLINA 28547

SEPTEMBER 24, 2024

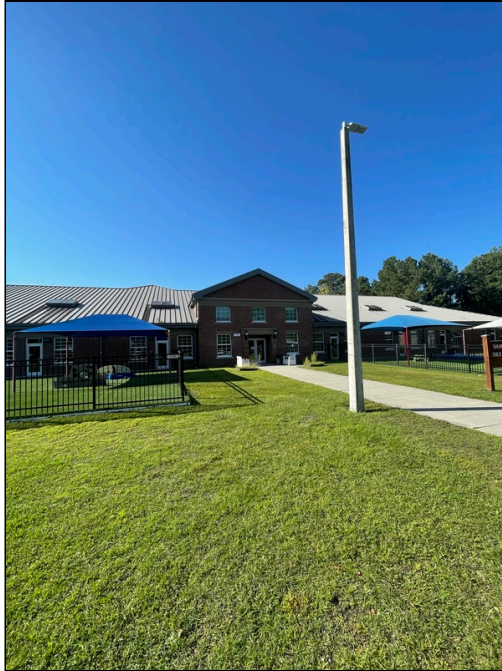
1 - View of front entrance to TT113.

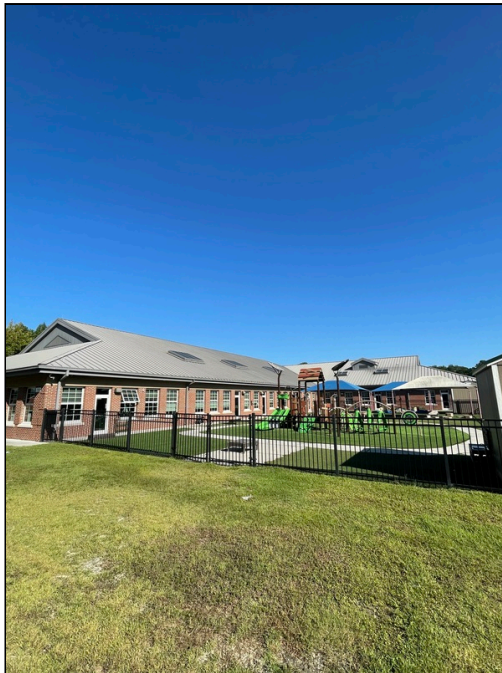
2 - View of the back of the building.

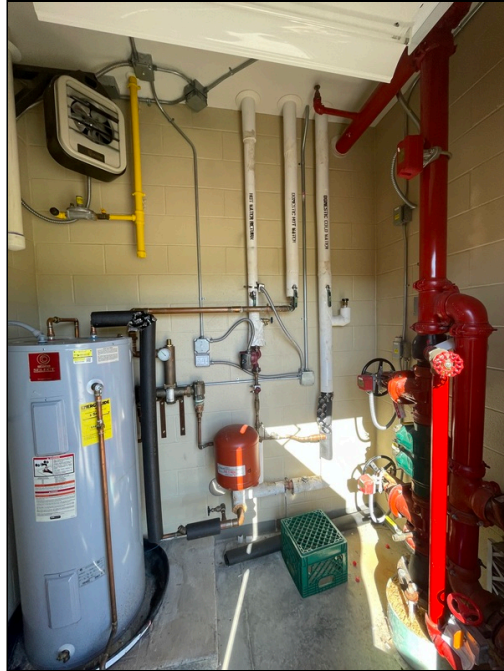
3 - View of the mechanical areas.

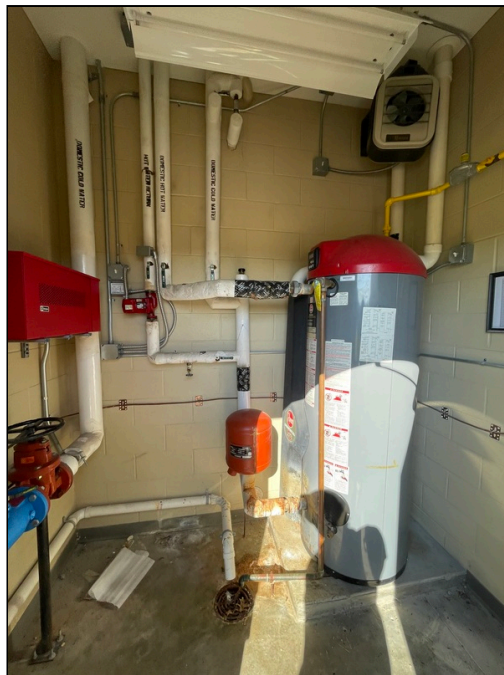
4 - View of the typical mechanical rooms

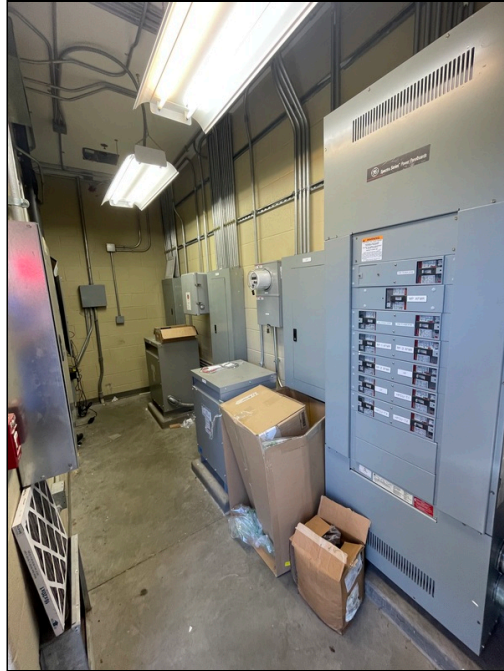
5 - View of the electrical room.

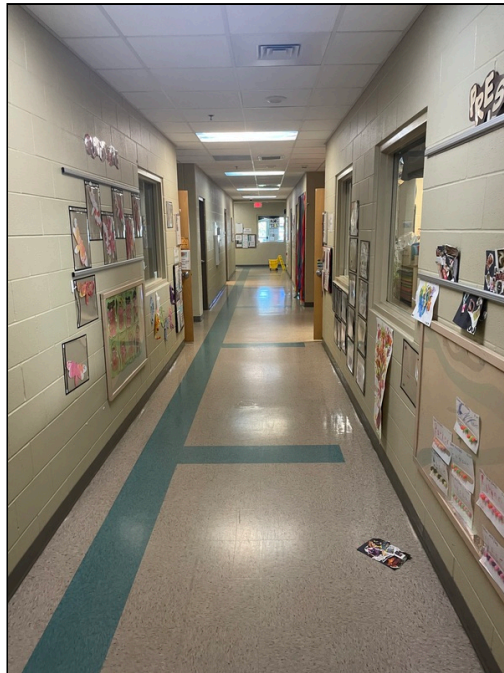
6 - View of the typical hallways.

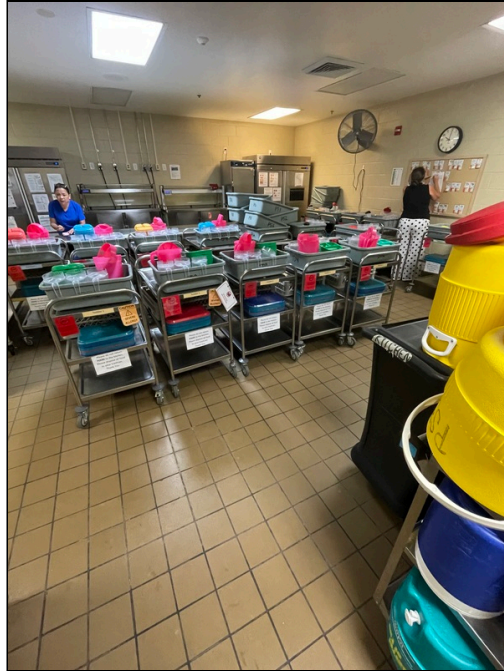
7 - View of the kitchen.

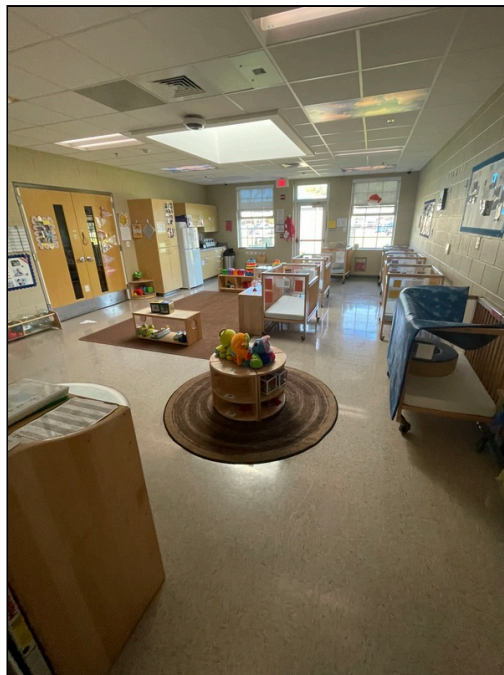
8 - View of the nursery.

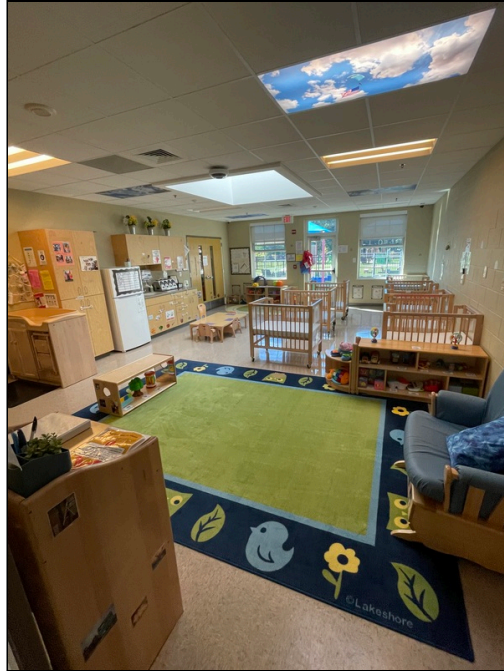
9 - View of the toddlers rooms.

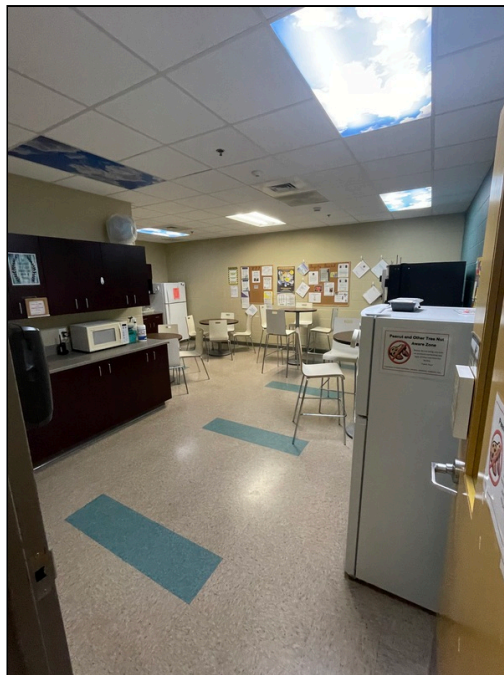
10 - View of the staff lounge.

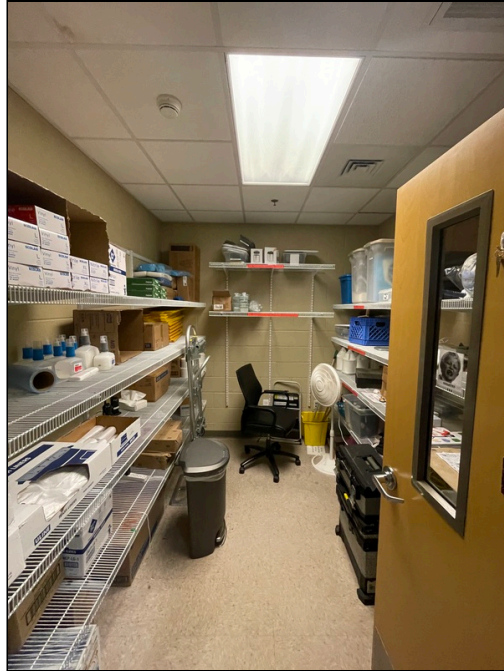
11 - View of storage closet.

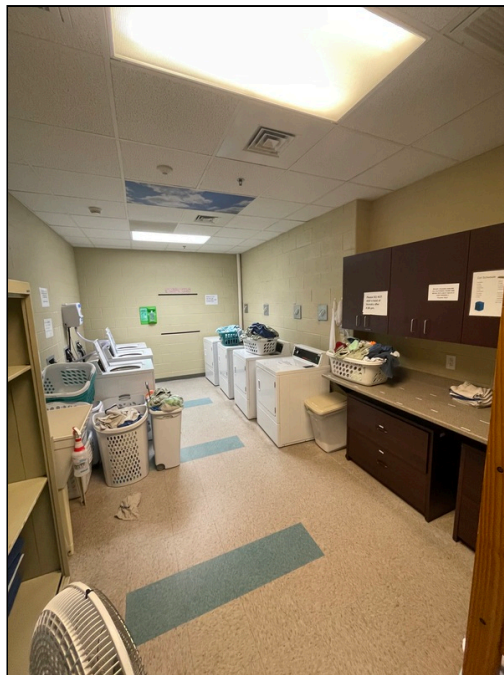
12 - View of the laundry room.

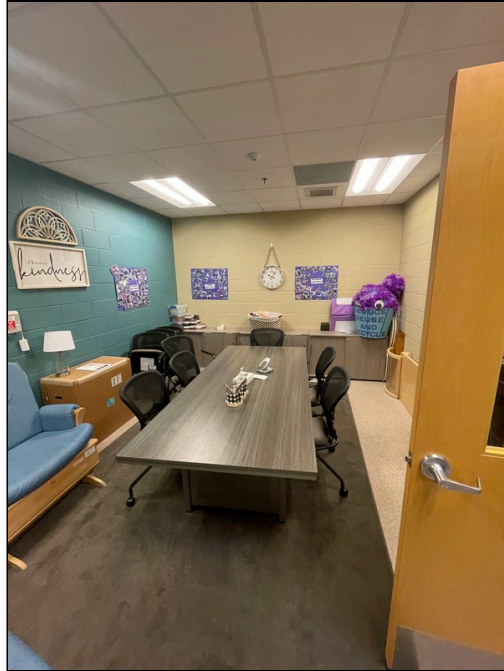
13 - View of the conference room.

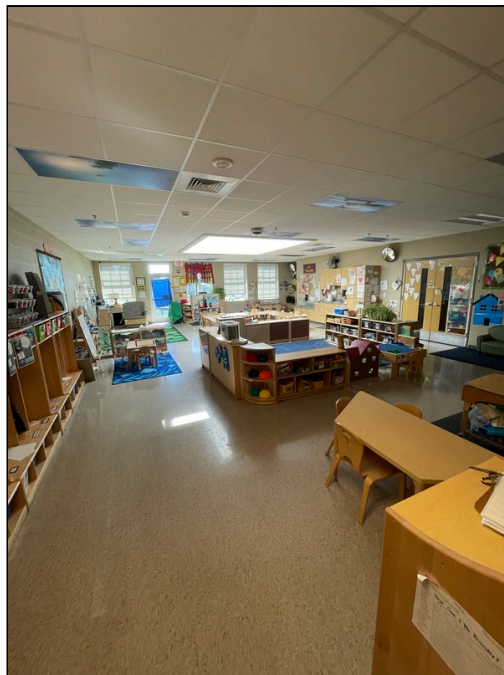
14 - View of the typical classrooms.

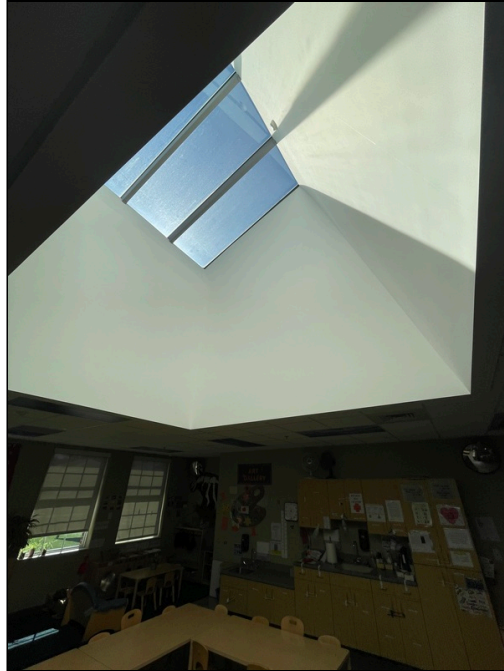
15 - View of the typical skylights.

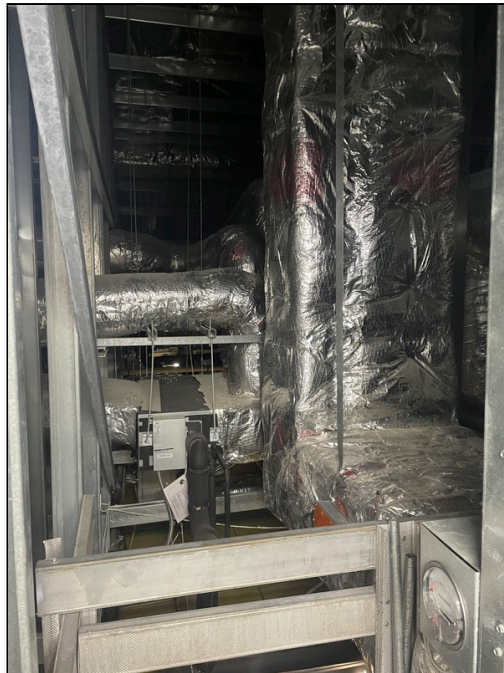
16 - View of the attic space.

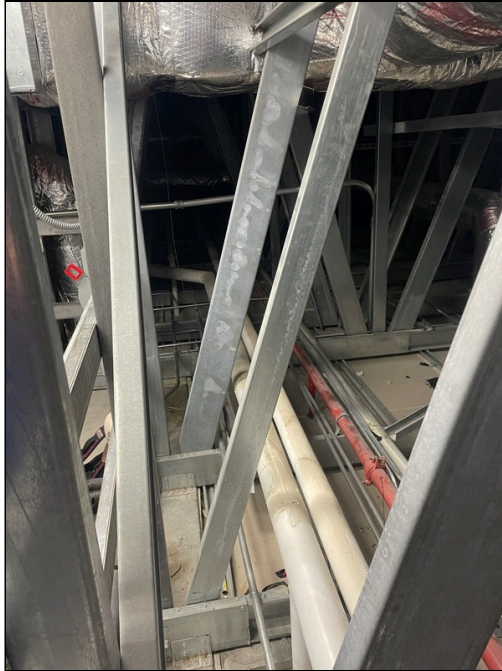
17 - View of the gypsum upper ceilings.

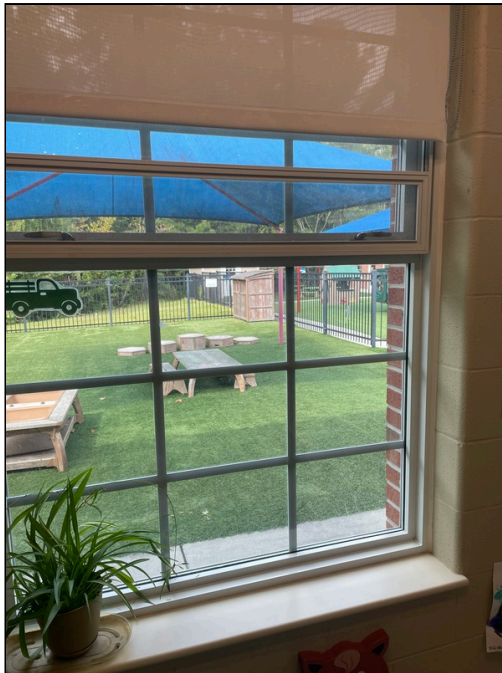
18 - View of the typical windows.

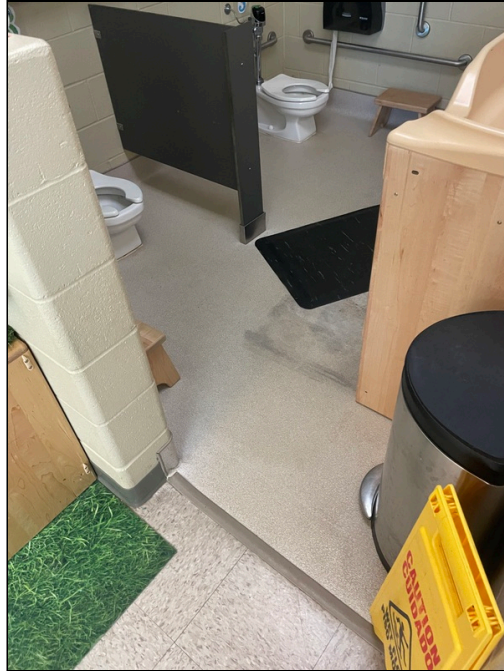
19 - View of the sheet vinyl in individual classrooms.

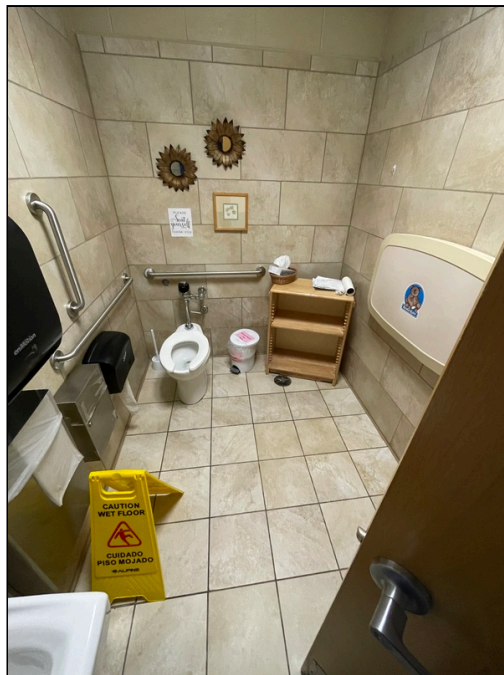
20 - View of the typical staff bathrooms.
