# ROOFING PROJECTS

# Roofing Systems

# Roofing Projects

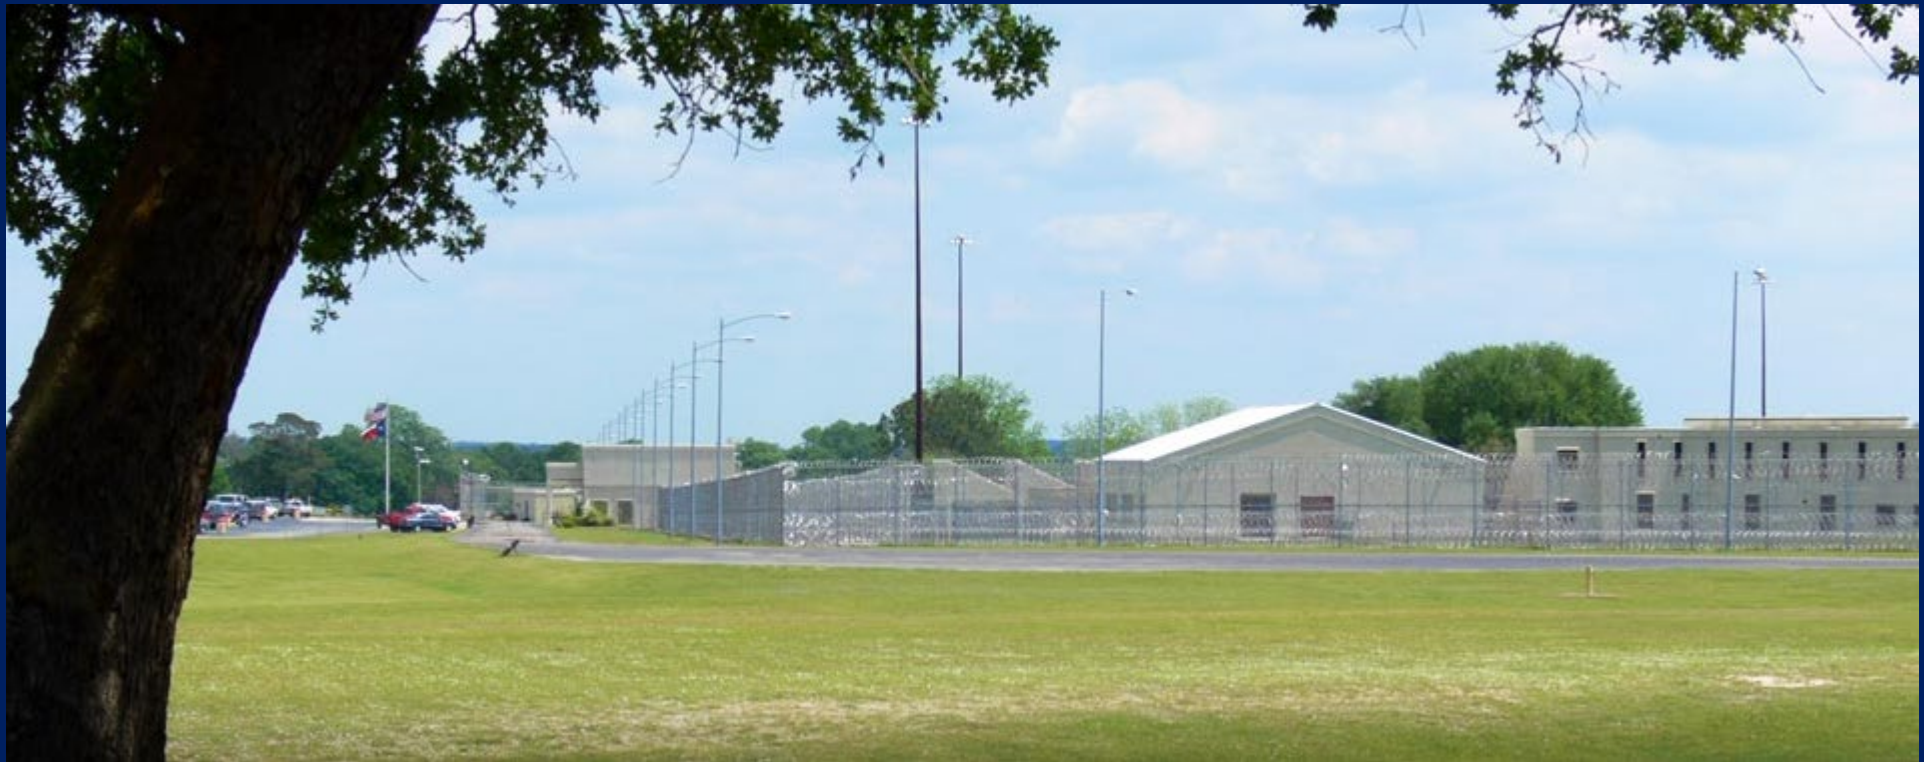
South Central Region  
FCI Bastrop

- FCI Bastrop was constructed in 1979 consists of 393,348 s.f. under roof and occupies 175 acres.
- Existing TPO on Housing Units (4) and asphalt built-up roofs over other areas are past life cycle.
- Housing Units – approx. 40,000 s.f.
  - Remove existing TPO roof system and repair damaged Decking.
  - Install new TPO roof system with insulation, parapet coping/cap and roof drain bodies
- Remaining Roof Area – approx. 58,000 s.f.
  - Thoroughly clean the existing asphalt built-up roof
  - Overlay new TPO roof system over existing
  - Install new drain bodies, parapet coping and caps

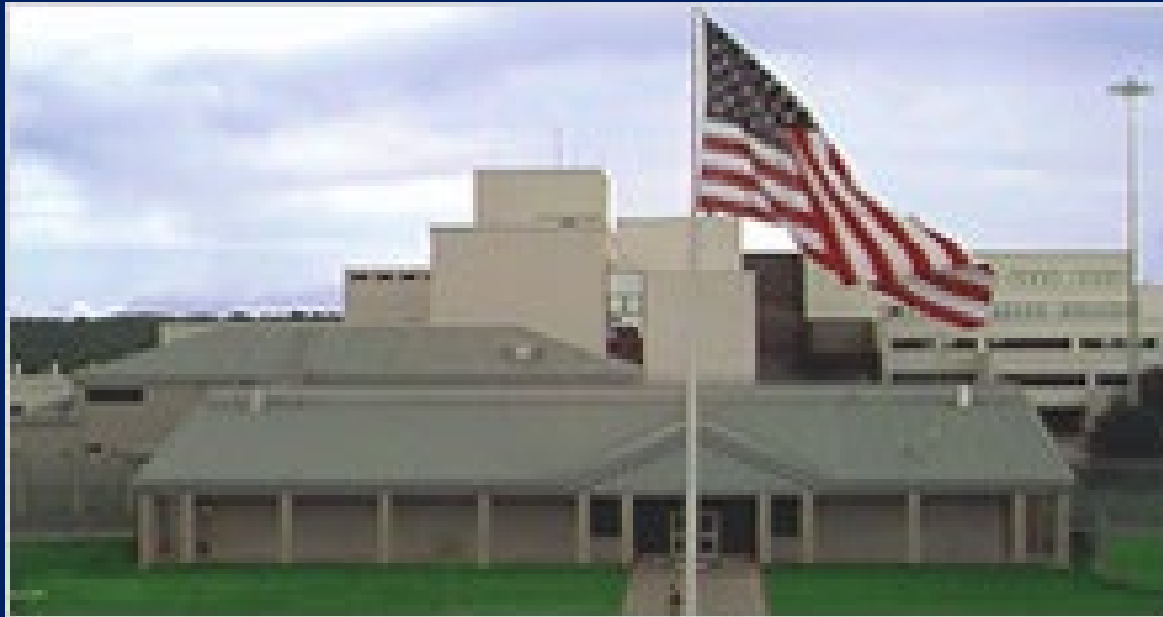
South Central Region  
FMC Carswell

- FMC Carswell was constructed in 1995, comprised of 20 buildings with 171,185 s.f. under roof.
- Existing roofing systems of various types installed and are past life cycle and beyond repair.
- Roof leaks have caused some damage to sections of the metal decking and associated supports.
- Deck types vary from concrete (approx. 63,000 s.f.) to metal (approx. 40,000 s.f.)
- Leaks have caused damage to interior finishes and suspected mold is present.
- New Work will consist of
  - Remove all damaged roof system ( approx. 103,000 s.f.) and repair all damaged decking/supports
  - Install new TPO roof system to include insulation, roof drain bodies, parapet coping/cap and flashing.
  - Perform complete mold remediation in affected areas.
  - Repair damaged interior finishes.

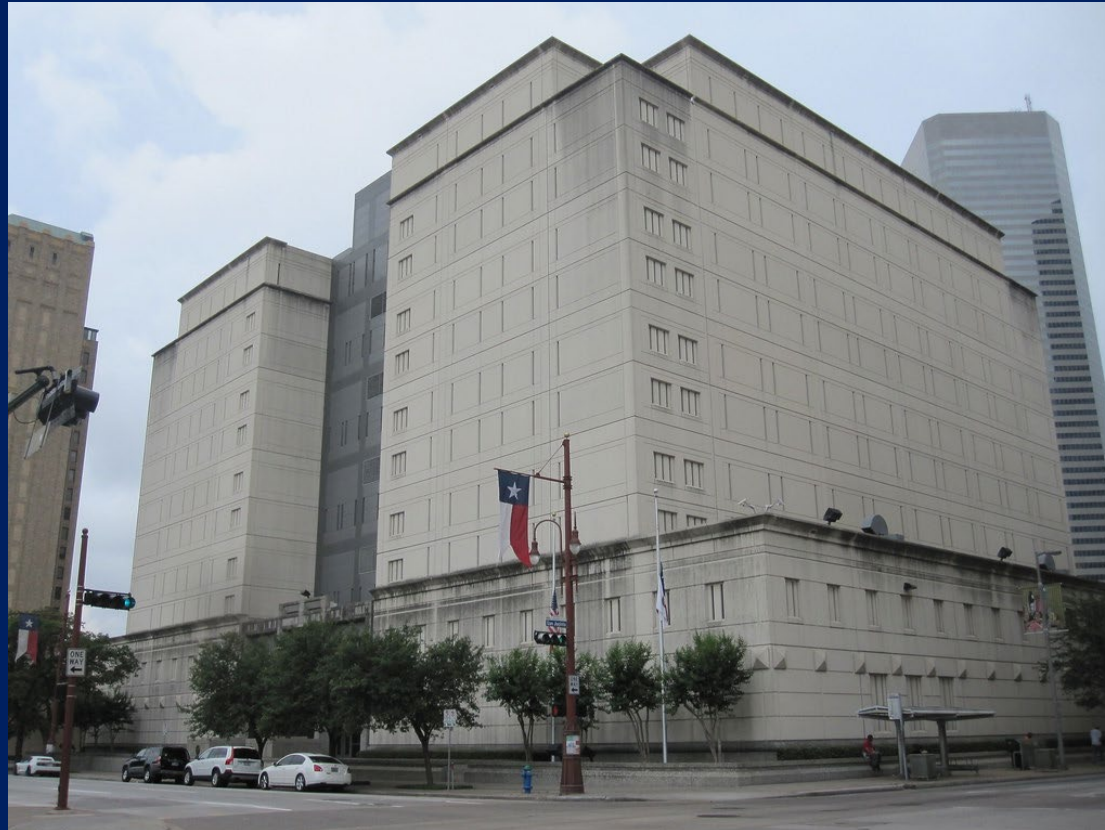
South Central Region  
MDC Houston

- MDC Houston was constructed in 1998 and consist of 300,000 s.f. and 11 floors.
- Existing asphalt built-up roof is past life cycle and despite regular maintenance continues to deteriorate.
- Evaluate existing roof area (approx. 30,000 s.f.) and repair damaged areas.
- Install new TPO roof system overlay with new drain bodies, parapet coping/cap and flashing.
- Possible difficulties:
  - Working in congested street conditions.
  - Roof areas on multiple floors and locations.
  - Handling of material and construction debris.

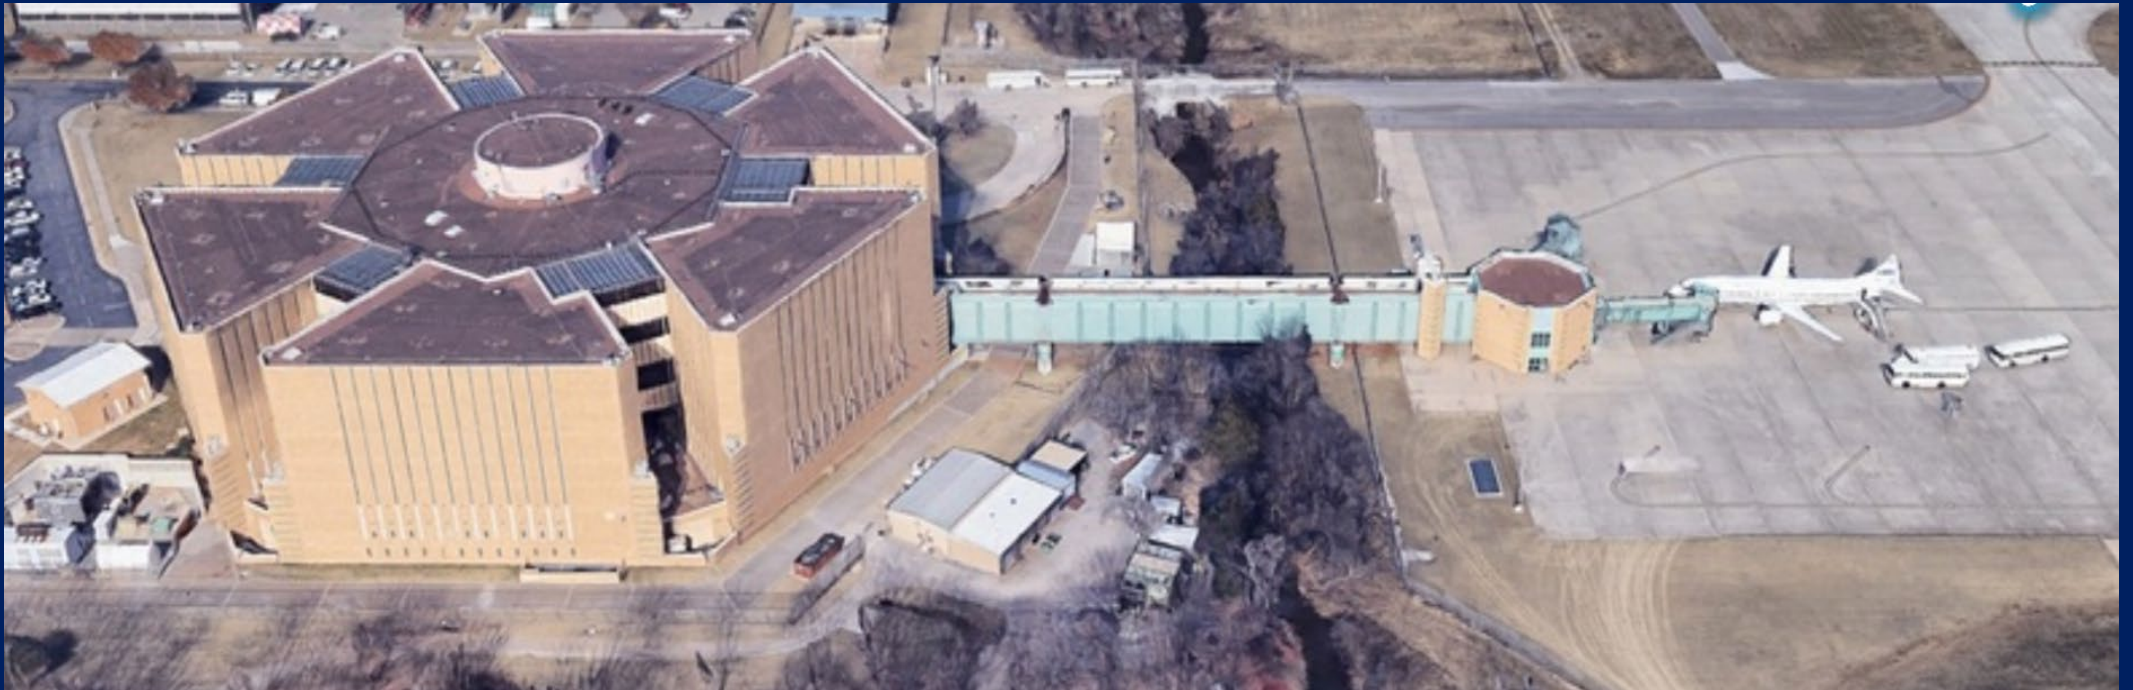
South Central Region  
FTC Oklahoma City

- FTC Oklahoma City was constructed in 1995, consists of 5 buildings with approximately 585,000
- The main FTC building consists of 5 floors and approximately 100,000 s.f. of roof area. This area has a modified bitumen roof system that has exceeded its life cycle and multiple areas are leaking, causing roof deck and interior finish damage.
- Remove existing roof system and repair damaged decking and supports.
- Install new TPO roof with insulation, drain bodies, parapet coping/cap and flashing.
- Possible difficulties:
  - Working in close vicinity to an active airport operation
  - Handling of material and construction debris.

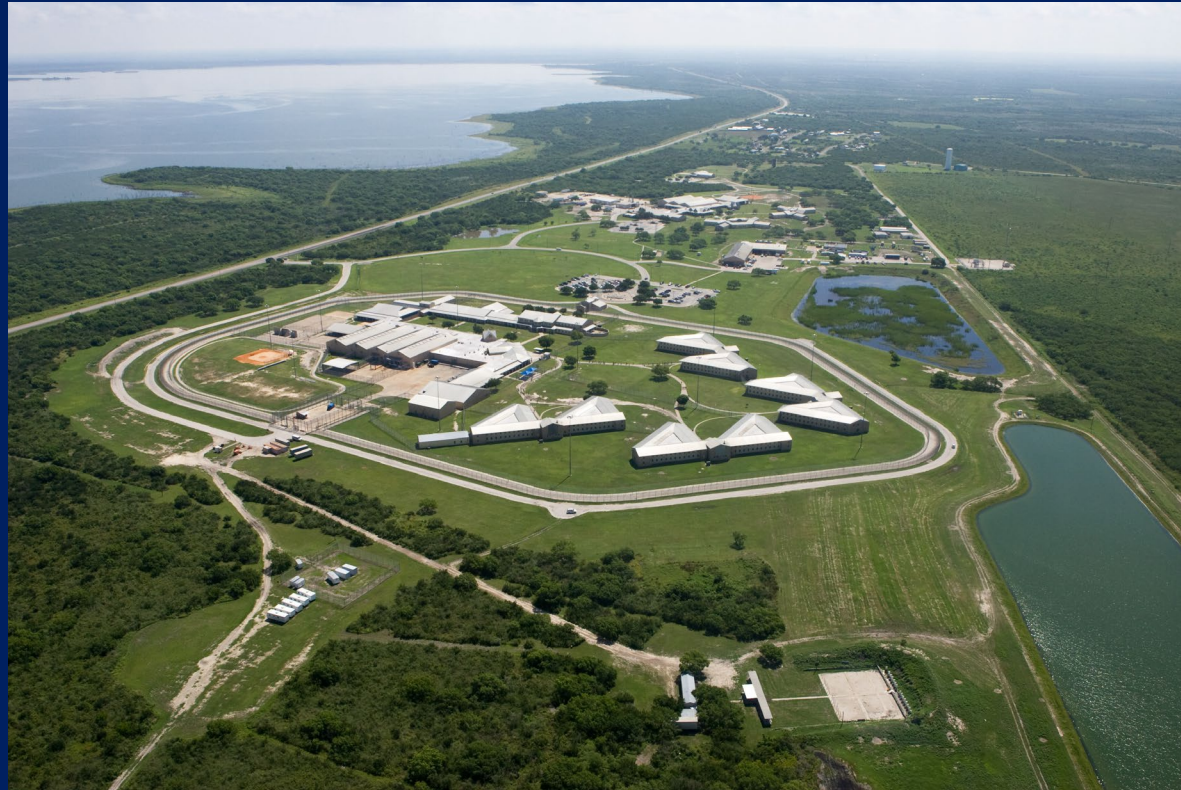
South Central Region  
FCI Three Rivers

- FCI Three Rivers was constructed in 1990 and occupies approximately 300 acres.
- Existing roofs are approx. 110,000 s.f. and constructed of standing seam metal with skylights.
- Metal roofs are leaking throughout and have caused damaged to existing wood structure and decking.
- Replace all roofs with new standing seam metal roofing system to include new decking and insulation.
- Remove skylights and reframe the openings to allow proper tie-in to existing slopes.
- No suspected environmental issues are expected.

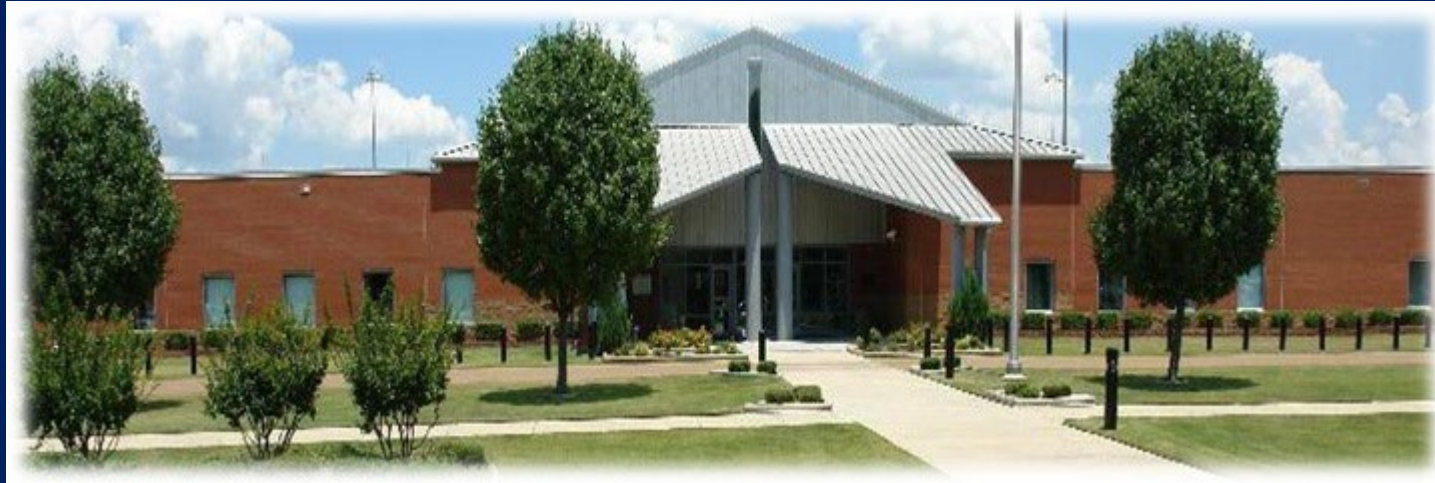
### FCC Yazoo City – FCI 1

- FCC Yazoo was constructed in 1997, consists of 4 facilities and occupies approx. 1000 acres.
- FCI 1 has approximately 43,500 s.f. of asphalt built-up roofing that is past life cycle.
- Areas affected – Special Housing Unit, GP Housing Unit (1), Administrative, Medical, Recreation Buildings
- Remove existing roofing system and repair damaged metal decking
- Install new TPO roofing system with insulation, roof drain bodies, parapet coping/cap and flashing.

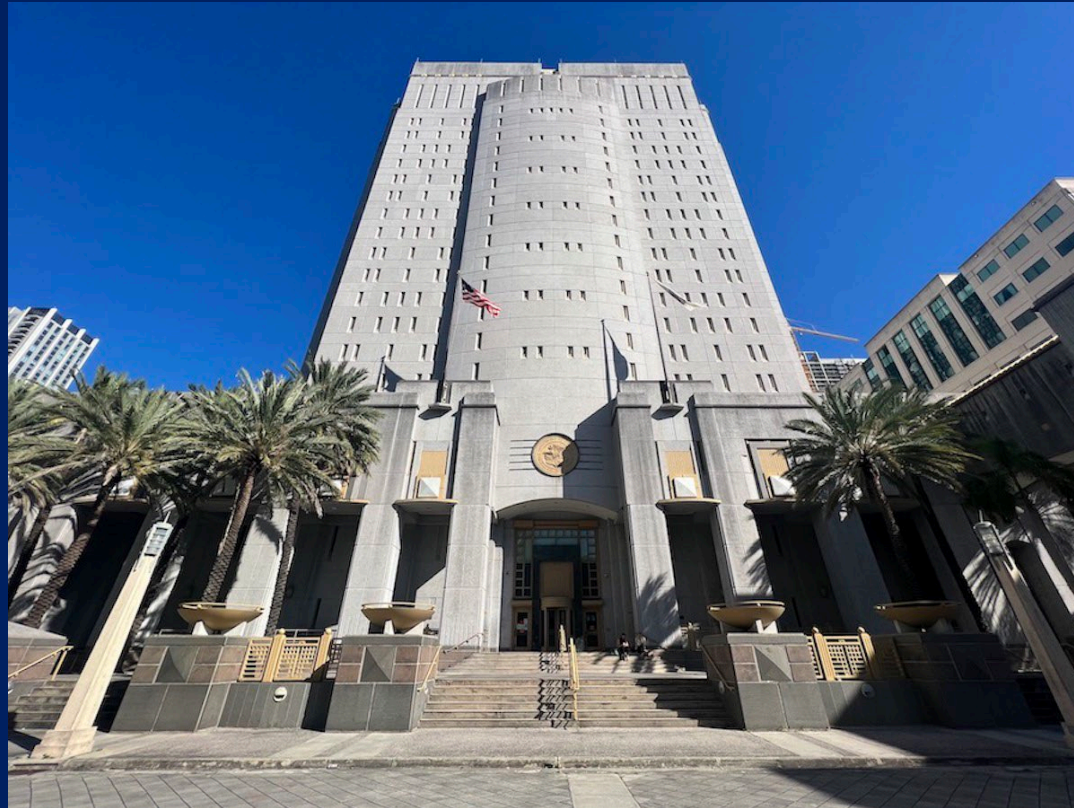
### FDC Miami

- FDC Miami was constructed in 1999 consists of 550,965 s.f. and 13 floor levels
- Existing 44,000 s.f. asphalt built-up roof located on the 4th and 13th floor levels are is past life cycle and leaking.
- Remove existing roof system and repair metal decking and supports.
- Install new TPO roof system with new insulation drain bodies, parapet coping/cap and flashing.
- Possible difficulties:
  - Working in congested street conditions.
  - Roof areas on multiple floors and locations.
  - Handling of material and construction debris.

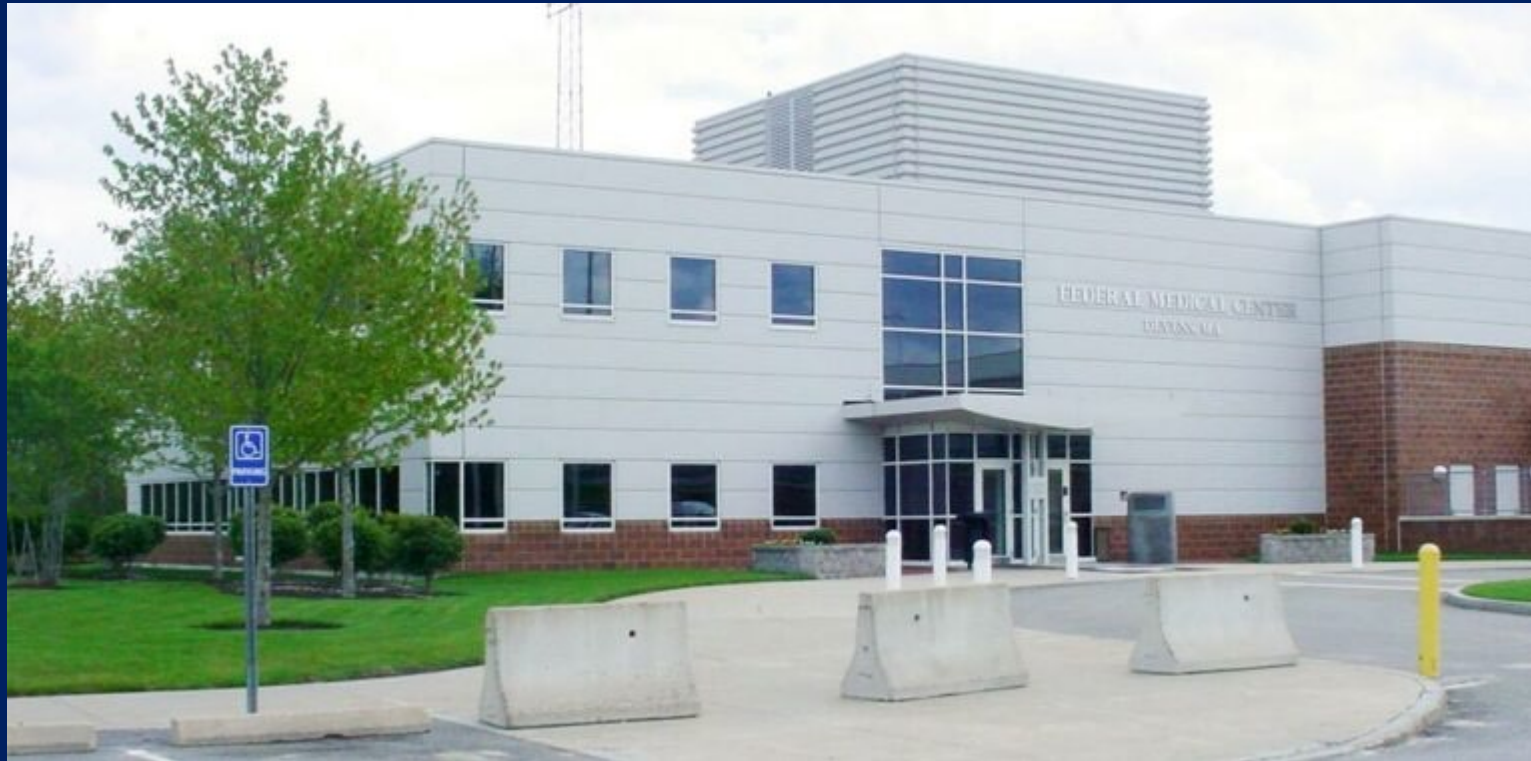
Northeast Region  
FMC Devens

- FMC Devens was originally constructed in 1960 and converted to BOP Facility in 1998
- Consists of 22 buildings and situated on approximately 222 acres
- Existing asphalt built-up roof approximately 120,000 s.f. is severely deteriorated and past life cycle.
- Remove existing roof system and repair existing metal roof deck and supports
- Install new TPO roof system with new insulation drain bodies, parapet coping/cap and flashing.
- No asbestos or environmental concerns are expected.

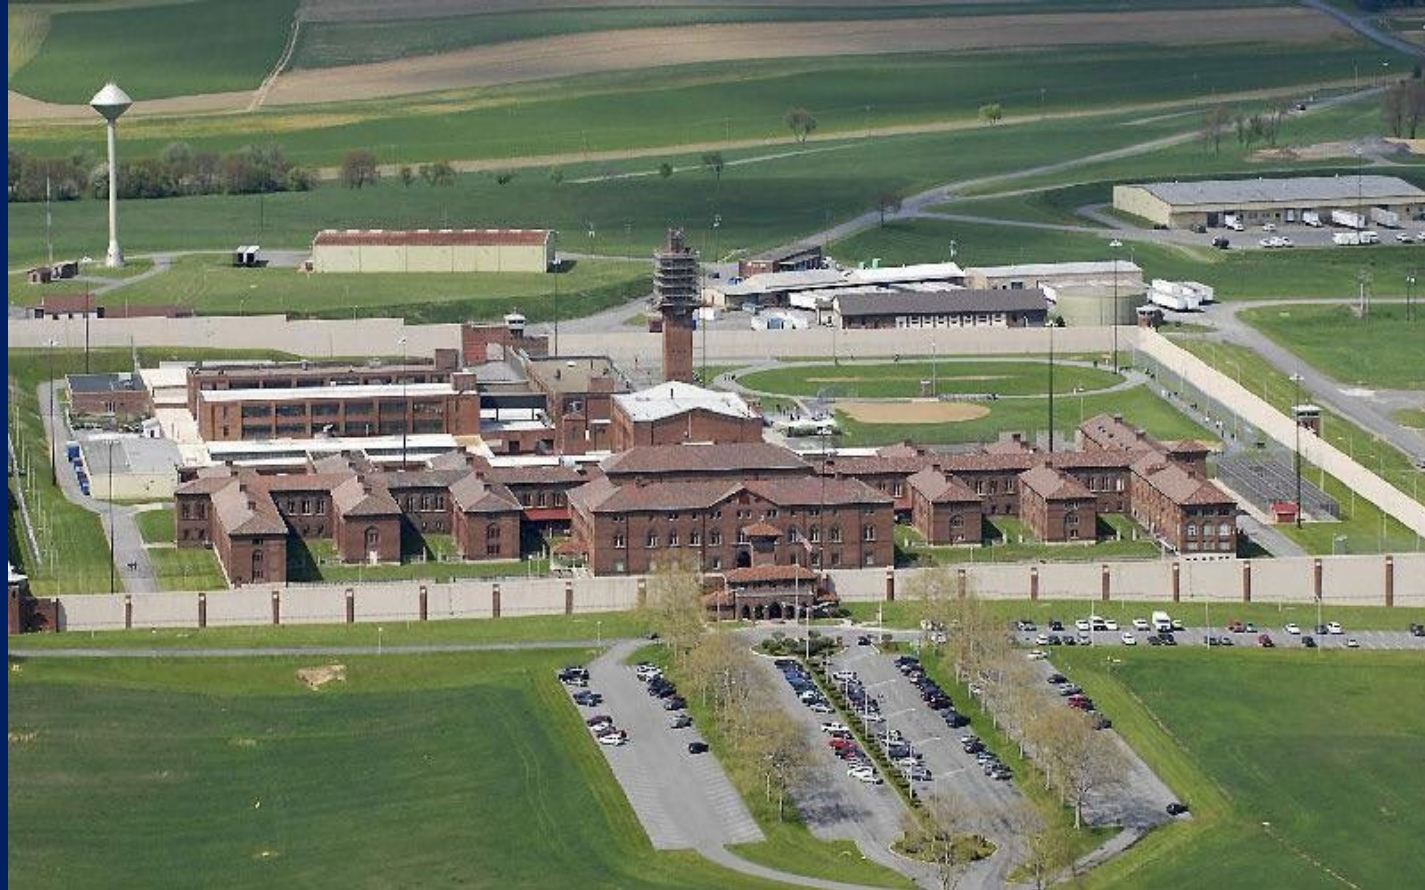
Northeast Region  
FCI Lewisburg

- FCI Lewisburg was constructed in 1932, consists 1,158,514 s.f. and situated on 950 acres.
- Existing asphalt built-up roof on the UNICOR Factory (approximately 105,000) s.f. is severely deteriorated and past life cycle.
- Remove existing roof system and repair existing metal roof deck and supports
- Install new TPO roof system with new insulation drain bodies, parapet coping/cap and flashing.
- No asbestos or environmental concerns are expected.
- Historical Preservation Concerns.

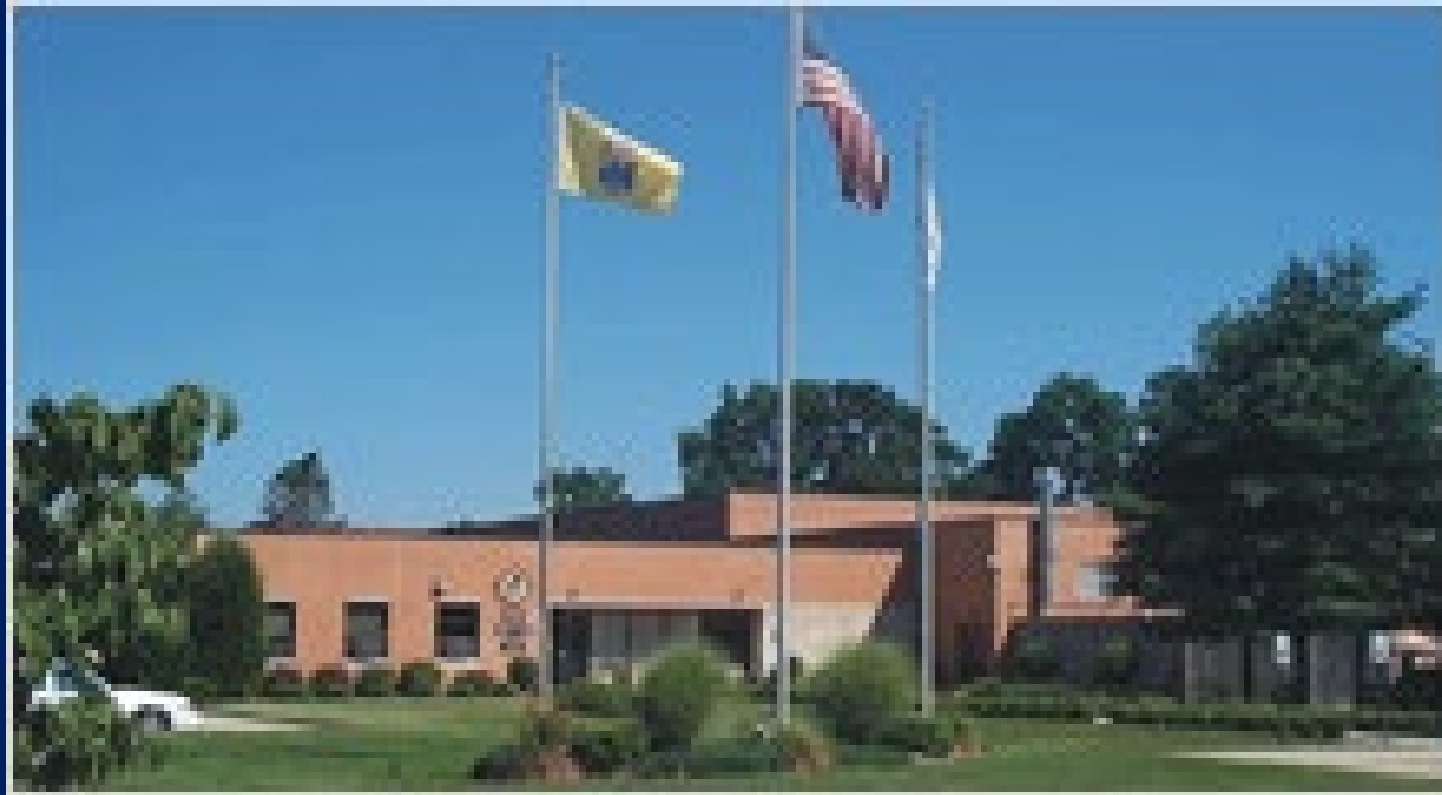
Northeast Region  
FCI Fort Dix

- FCI DIX was constructed in 1992 consists of 1,228,428 s.f. and occupies 210 acres.
- Existing roofing system is EPDM with gravel ballast and is past life cycle.
- Remove existing roof system (approx. 225,000 s.f.) and repair existing metal roof deck and supports
- Install new TPO roof system with new insulation drain bodies, parapet coping/cap and flashing.
- New gutters, scuppers and downspout.
- Mold Remediation Expected
- Repair/Replace damaged interior ceilings and finished.
- Minor brick repair and tuck pointing.

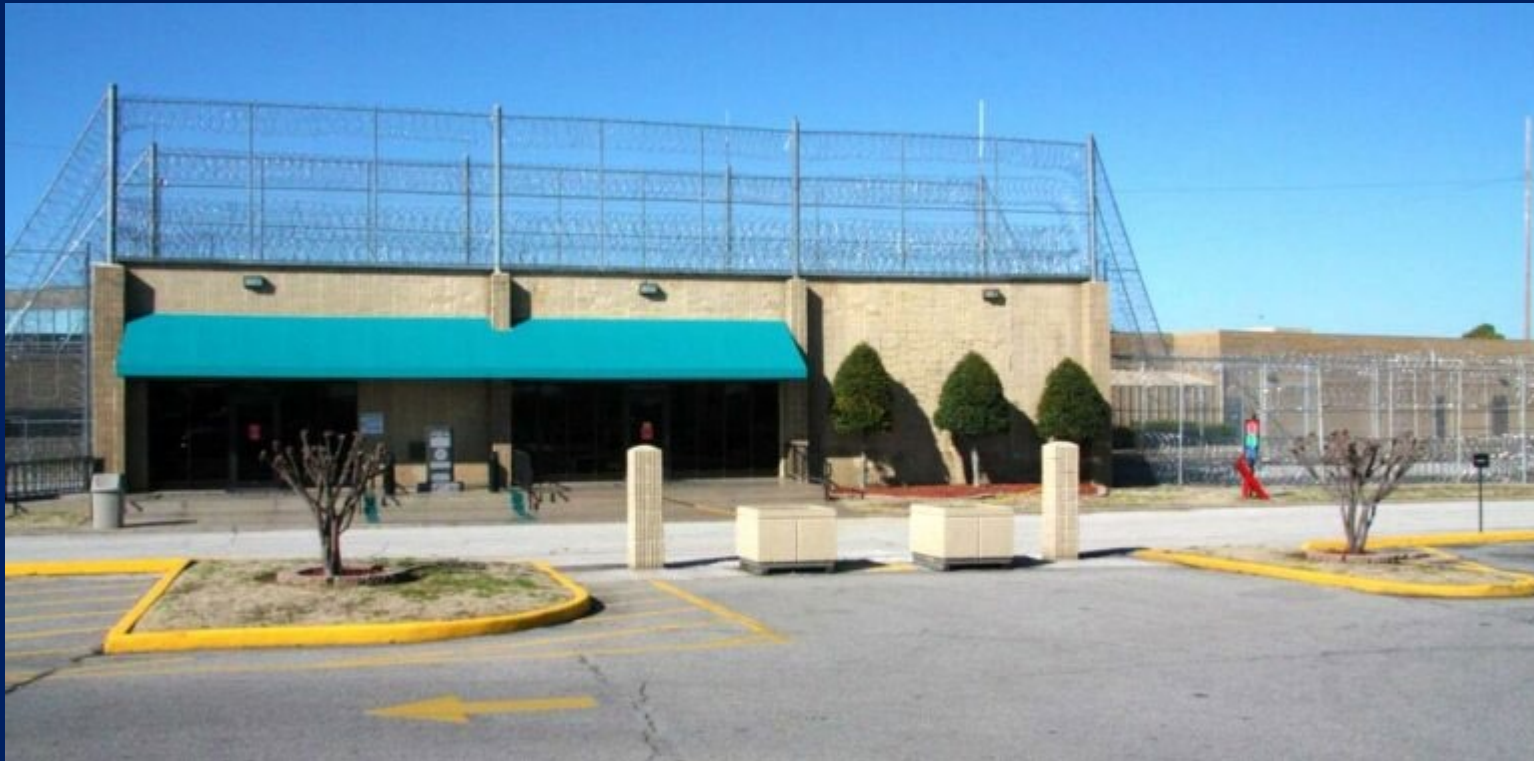
Mid-Atlantic Region  
FCI Memphis

- FCI Memphis was constructed in 1977, consists 24 buildings totaling 304,000 s.f. and occupies 111 acres
- Existing roof is a mixture of TPO and EPDM roofing systems and are severely deteriorated.
- Remove existing roof systems (approx. 245,000 s.f.) and repair existing metal roof deck and supports
- Install new TPO roof system with new insulation, drain bodies, parapet coping/cap and flashing.

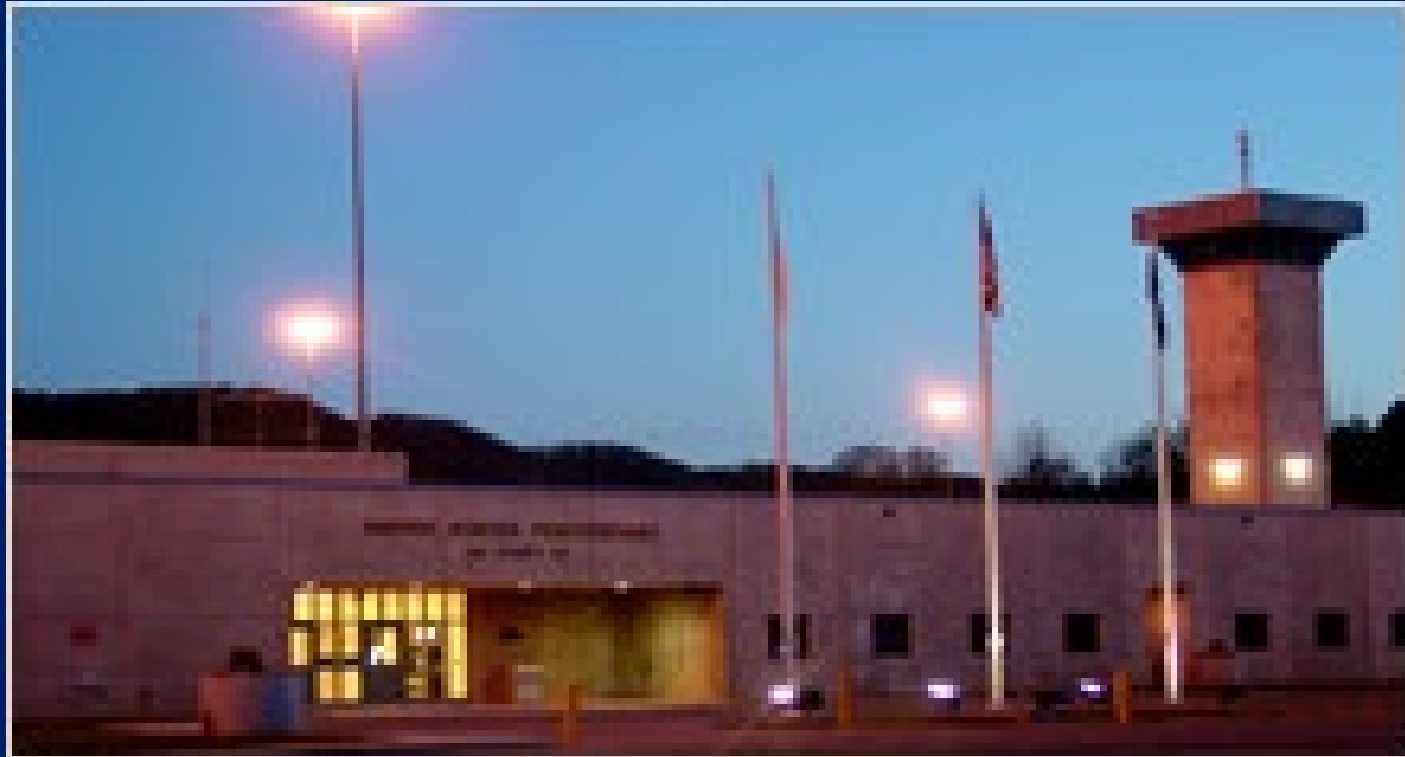
Mid-Atlantic Region  
USP Lee

- USP Lee was constructed in 2001, consists of 675,647 s.f. and occupies 265 acres.
- Existing EPDM roofing systems are past life cycle and severely deteriorated.
- Remove existing roof systems (approx. 128,000 s.f.) and repair existing metal roof deck and supports
- Install new TPO roof system with new insulation, drain bodies, parapet coping/cap and flashing.
- Repair existing lightning protection system to eliminate on-going ground fault issues.

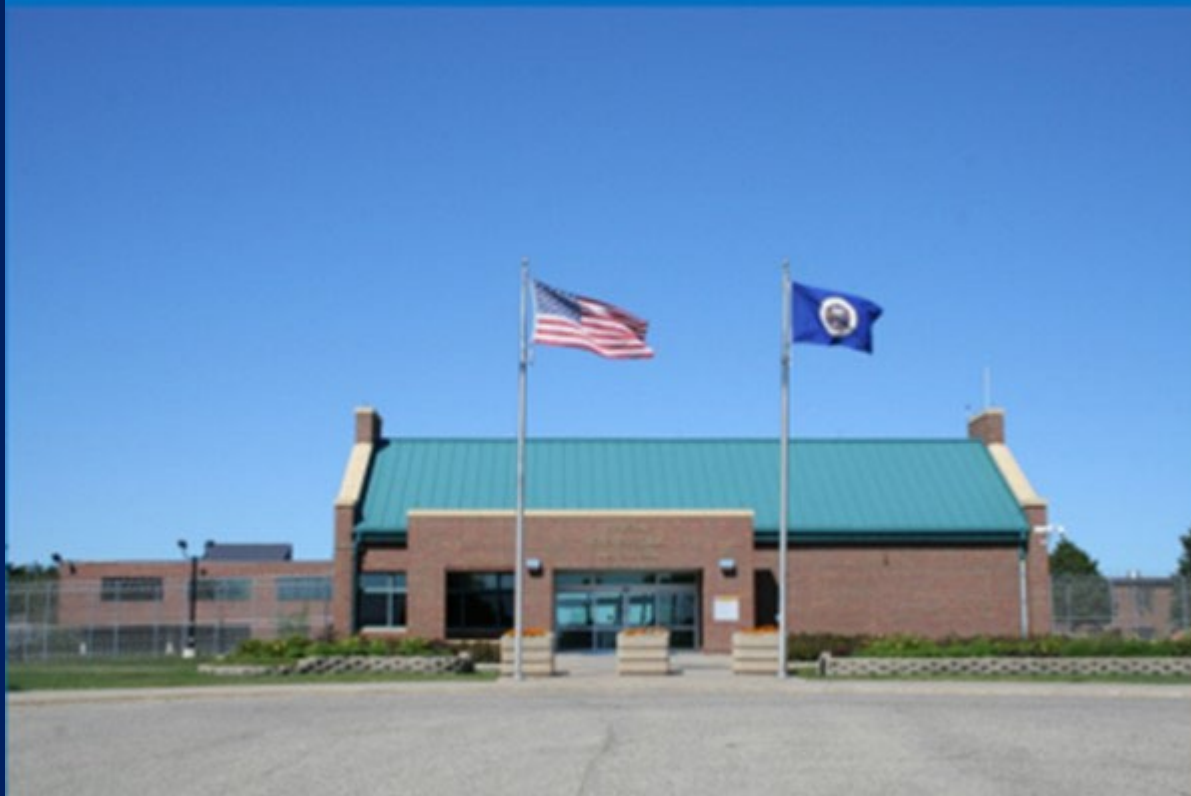
North Central Region  
FCI Waseca

- FCI Waseca was originally an Agricultural College for the University of Minnesota and converted to a BOP Facility in 1996.
- Consists of 675,647 s.f. and occupies 265 acres.
- Existing gravel ballast EPDM roofing systems are past life cycle and severely deteriorated.
- Concrete decking is present however roofs have significant ponding throughout.
- Remove existing roof systems on Special Housing Unit, Medical, Food Service and Recreation Buildings (approx. 250,000 s.f.).
- Install new TPO roof system with new insulation, drain bodies, parapet coping/cap and flashing.
