Roof Asset Management

## Condition Assessment Report

01130-HQ Numbered AF

07/27/2022

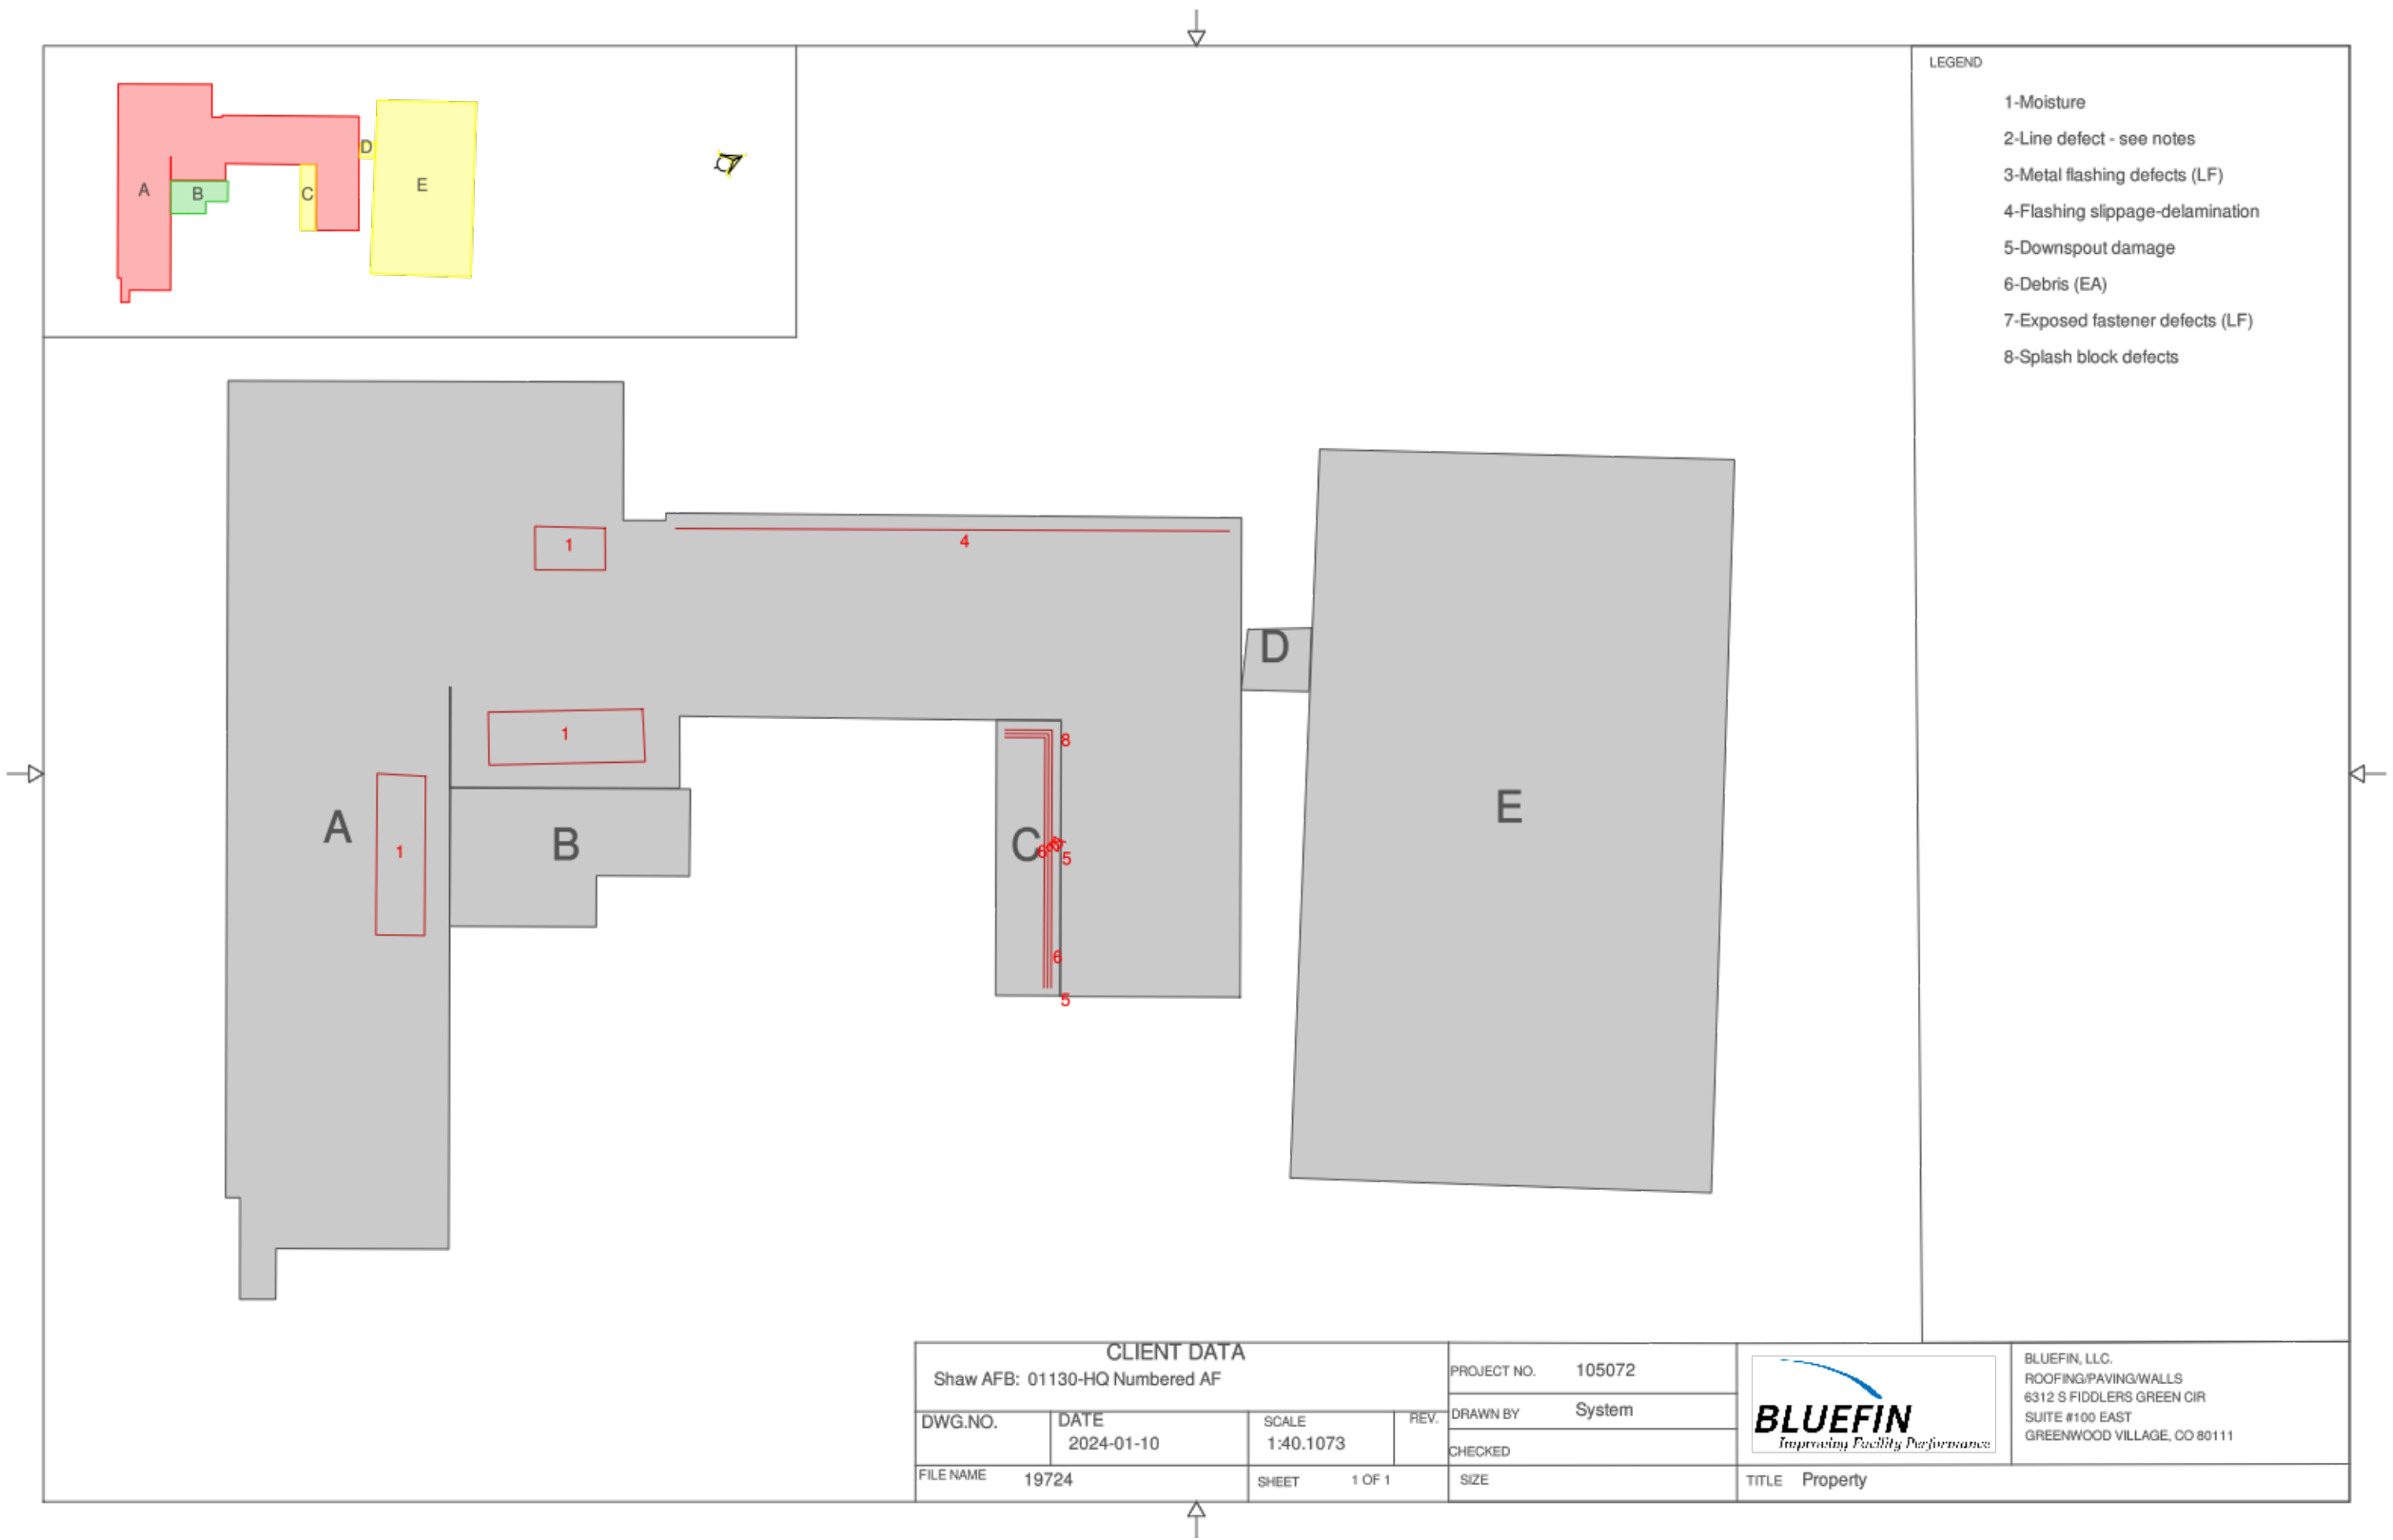
Defect Plan

| Map Link | Defect Group # | Defect | Sec | Recommendation | Defect Count (Qty U/M) | Estimate |
|---|---|---|---|---|---|---|
| <a href="#">Map</a> | 1 | Moisture - Wet insulation | A | Moisture analysis required. | 3<br>(1453 SF) | \$5,400 |
| <a href="#">Map</a> | 2 | Line defect - see notes - Medium severity | C | Employ a qualified Stucco / EIFS contractor to repair damaged area. | 1<br>(80 LF) | \$2,640 |
| <a href="#">Map</a> | 3 | Metal flashing defects (LF) - No water penetration | C | Reposition sheet metal counter flashing to original position, secure and seal. | 1<br>(82 LF) | \$495 |

| <u>Map</u> | 4 | Flashing<br>slippage/delamination -<br>Delamination/slipping; no water<br>penetration | A | Repair open seams<br>with fabric, mastic and<br>granules in a three-<br>course fashion. | 1<br>(154 LF) | \$1,650 |
| <u>Map</u> | 5 | Downspout damage<br>- Loose or missign<br>fasteners | C | Reinstall downspout to<br>original position and<br>properly anchor to wall<br>system. | 2<br>(2 EA) | \$660 |
| <u>Map</u> | 6 | Debris (EA) - Loose<br>or light weight<br>debris | C | Remove materials /<br>equipment / debris<br>and properly dispose /<br>store offsite. | 2<br>(2 EA) | \$330 |
| <u>Map</u> | 7 | Exposed fastener<br>defects (LF) - Loose<br>fasteners (20-50<br>total) | C | Remove and replace<br>loose / missing /<br>corroded fasteners<br>with new proper sized<br>grommets fasteners. | 1<br>(84 LF) | \$245 |
| <u>Map</u> | 8 | Splash block defects<br>- Damaged splash<br>block | C | Supply and install<br>splash block at<br>downspout outlet. | 1<br>(1 EA) | \$185 |

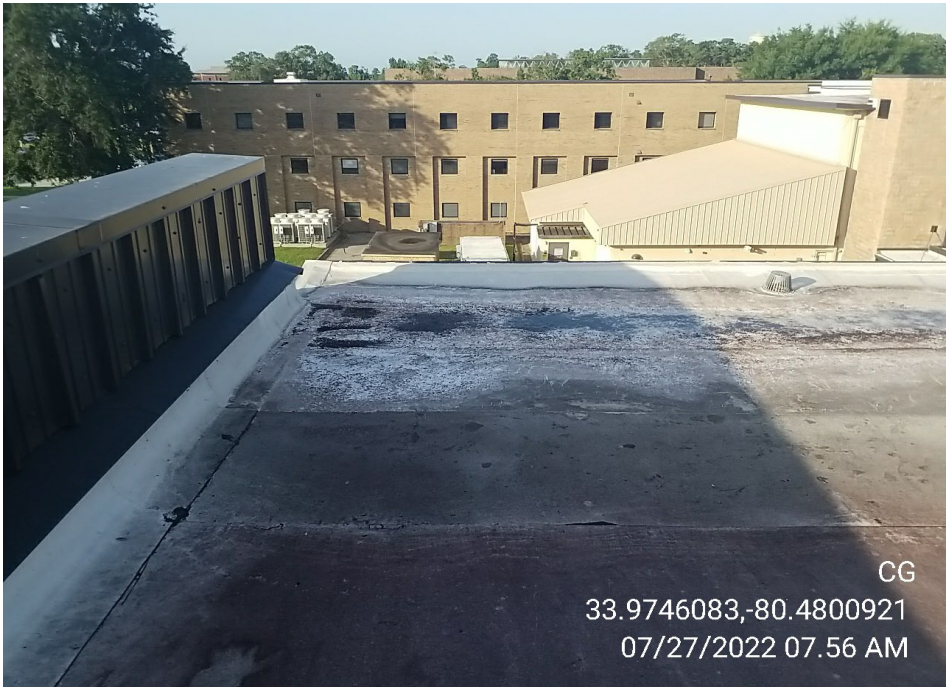
Section Summary - A

| Condition Score: | 50 (Unsatisfactory) | ● Insulation: |
| Notes: Prior RCS=58; prior ERSL React/Proact=6/0. Prior RCS=53; prior ERSL React/Proact=2/0. building scheduled for complete renovation. Did not remove copious debris as per Tsgt Maldonado. Much abandoned equip to remove before re-roof. Few active leaks due to concrete deck | | |

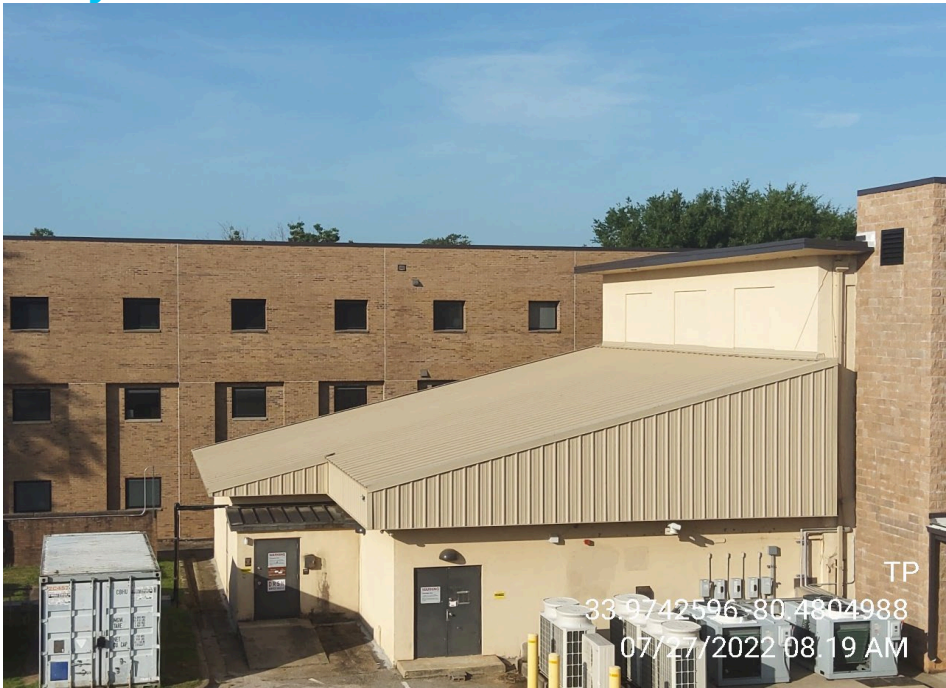
Section Summary - B

| Condition Score: | 90 (Adequate) | |

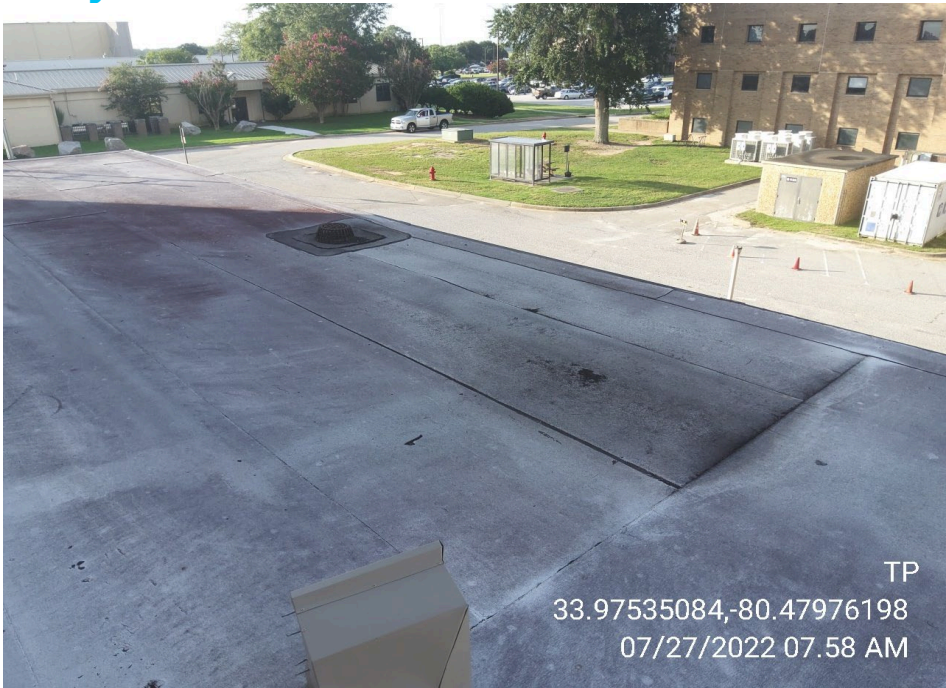
Section Summary - C

| Condition Score: | 69 (Degraded) | |

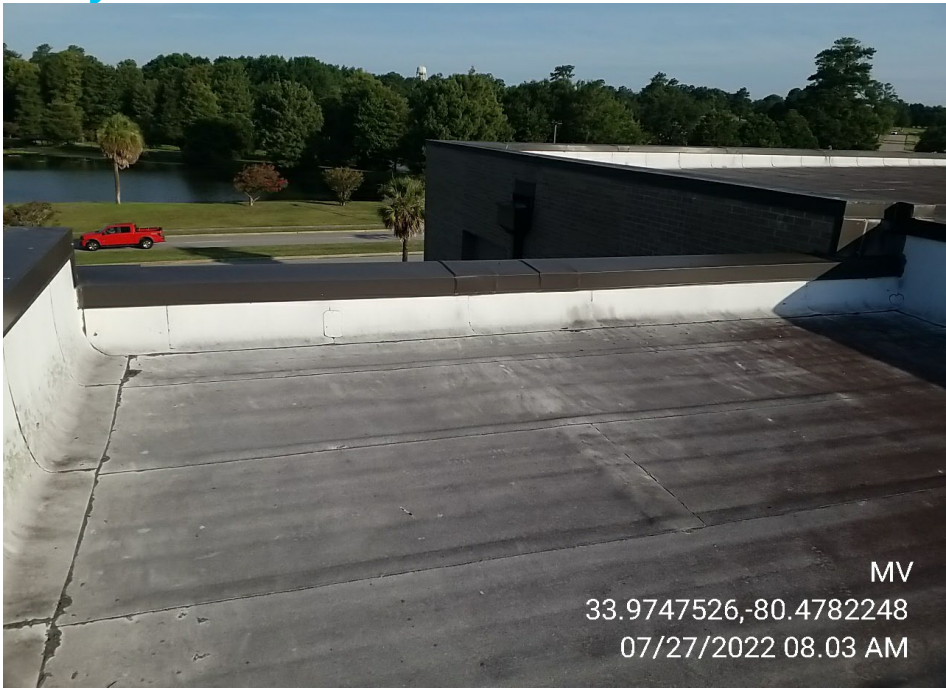
Section Summary - D

| Condition Score: | 75 (Degraded) | |

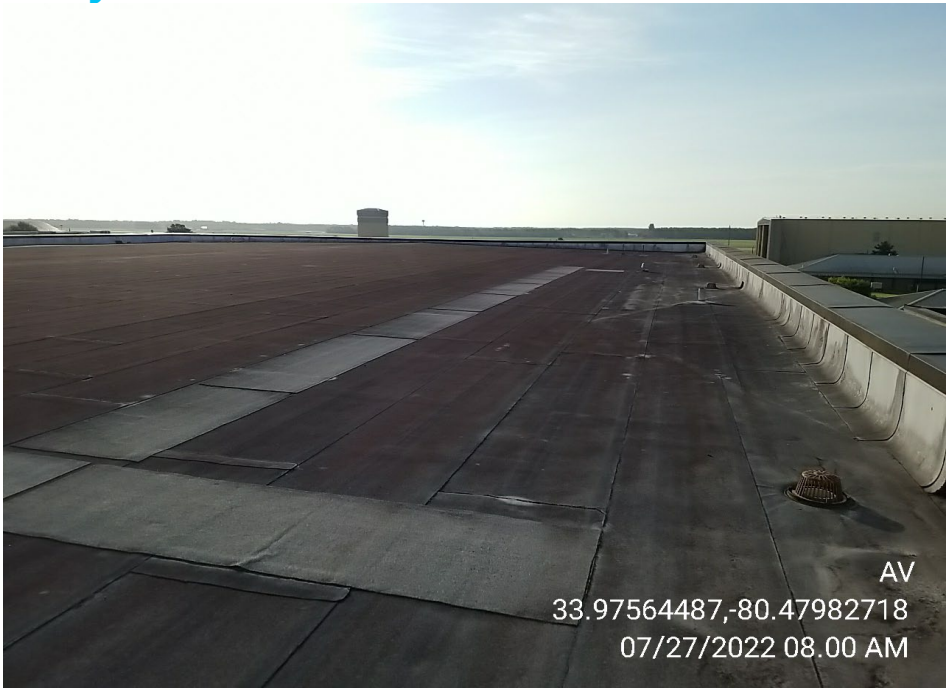
Section Summary - E

| Condition Score: | 70 (Degraded) | |

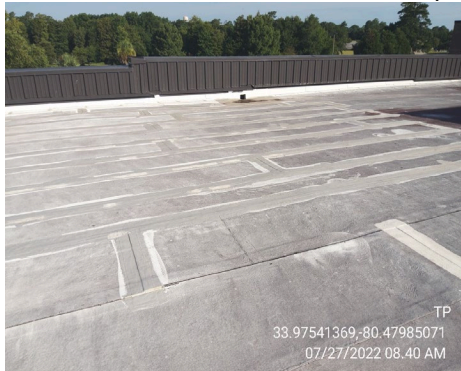
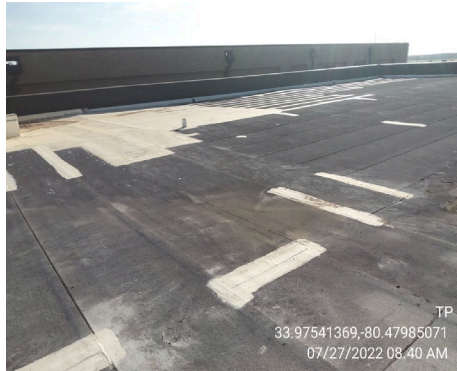
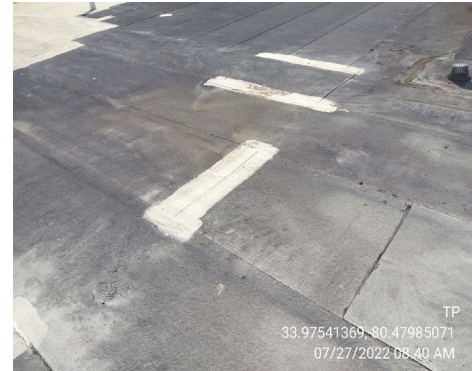
| Map Link | Defect Group # | Defect | Section | Recommendation | Count (Qty U/M) | Estimate Repair Cost |
|---|---|---|---|---|---|---|
| <a href="#">Map</a> | 0 | Patched or repaired areas - Patch exists<br>Status: Recorded | A | No action required at this time. Monitor and maintain. | 1<br>(30773 SF) | \$0 |

**Defect Group #: 0****Defect:** 1 (30773 SF) Patched or repaired areas - Patch exists**Recommendation:** No action required at this time. Monitor and maintain.

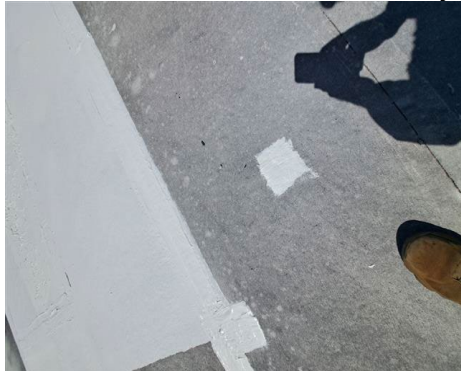
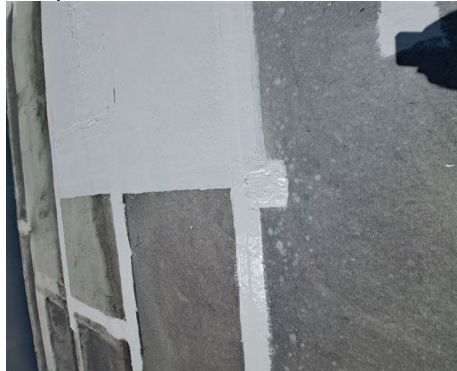
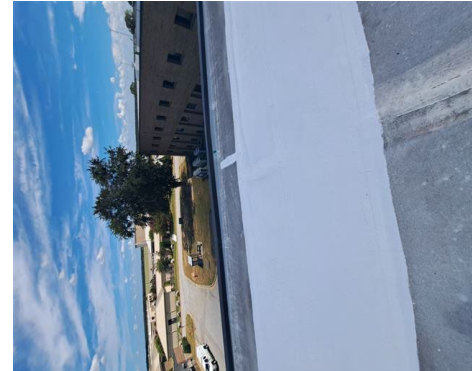
| Map Link | Defect Group # | Defect | Section | Recommendation | Count (Qty U/M) | Estimate Repair Cost |
|---|---|---|---|---|---|---|
| <a href="#">Map</a> | 1 | Moisture - Wet insulation<br>Status: Proposed | A | Moisture analysis required. | 3<br>(1453 SF) | \$5,400 |

**Defect Group #: 1****Defect:** 3 (1453 SF) Moisture - Wet insulation**Recommendation:** Moisture analysis required.

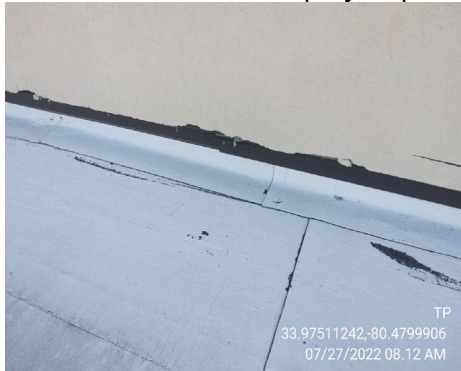
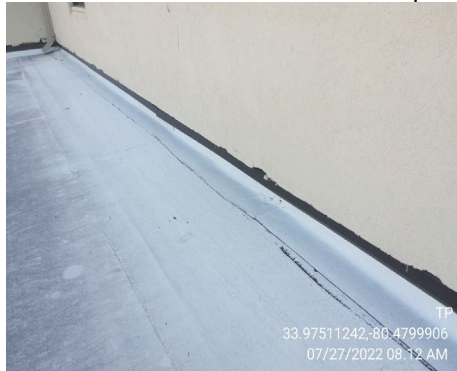
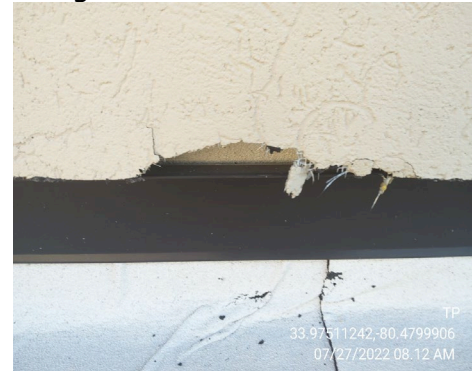
| Map Link | Defect Group # | Defect | Section | Recommendation | Count (Qty U/M) | Estimate Repair Cost |
|---|---|---|---|---|---|---|
| <a href="#">Map</a> | 2 | Line defect - see notes - Medium severity<br>Status: Proposed | C | Employ a qualified Stucco / EIFS contractor to repair damaged area. | 1<br>(80 LF) | \$2,640 |

**Defect Group #: 2****Defect:** 1 (80 LF) Line defect - see notes - Medium severity**Recommendation:** Employ a qualified Stucco / EIFS contractor to repair damaged area.

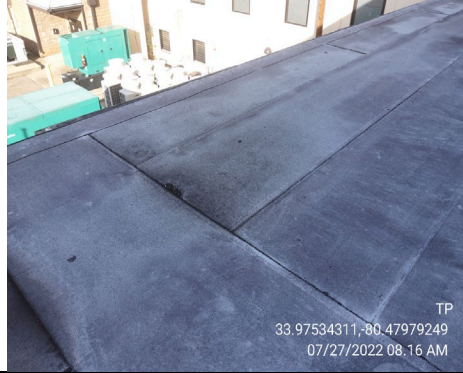
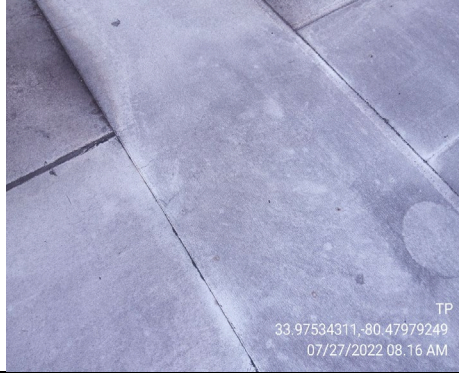
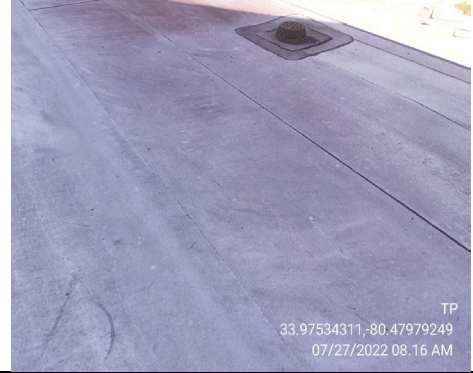
| Map Link | Defect Group # | Defect | Section | Recommendation | Count (Qty U/M) | Estimate Repair Cost |
|---|---|---|---|---|---|---|
| <a href="#">Map</a> | 0 | Membrane aging - Medium severity<br>Status: Recorded | C, E, A, D | No action required at this time. Monitor and maintain. | 4<br>(54323 SF) | \$0 |

**Defect Group #: 0****Defect:** 4 (54323 SF) Membrane aging - Medium severity**Recommendation:** No action required at this time. Monitor and maintain.

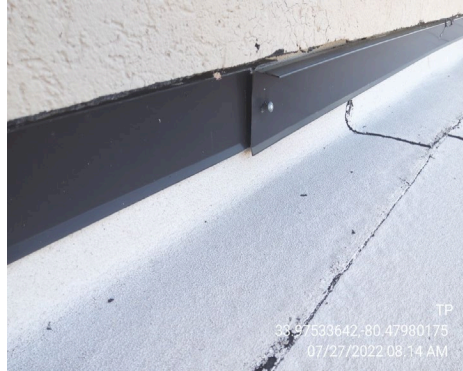
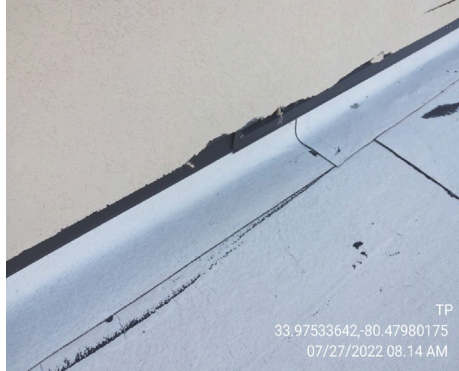
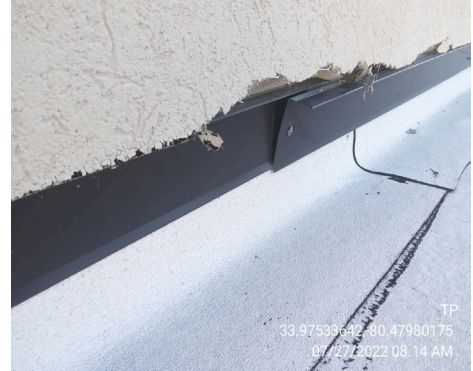
| Map Link | Defect Group # | Defect | Section | Recommendation | Count (Qty U/M) | Estimate Repair Cost |
|---|---|---|---|---|---|---|
| <a href="#">Map</a> | 3 | Metal flashing defects (LF) - No water penetration<br>Status: Proposed | C | Reposition sheet metal counter flashing to original position, secure and seal. | 1<br>(82 LF) | \$495 |

**Defect Group #: 3****Defect:** 1 (82 LF) Metal flashing defects (LF) - No water penetration**Recommendation:** Reposition sheet metal counter flashing to original position, secure and seal.

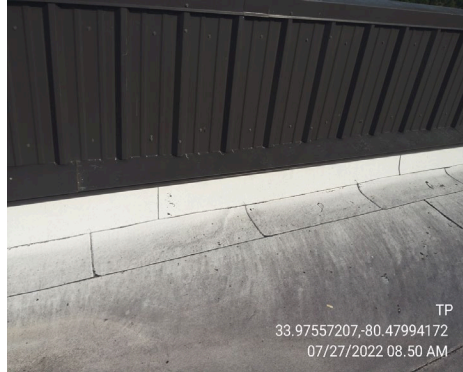
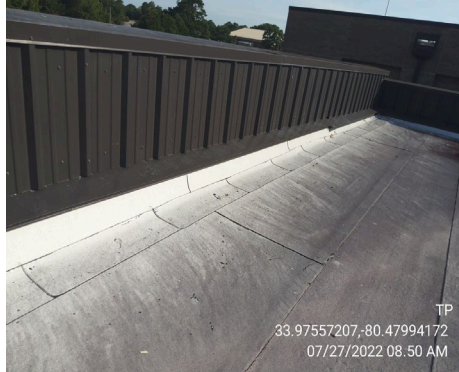
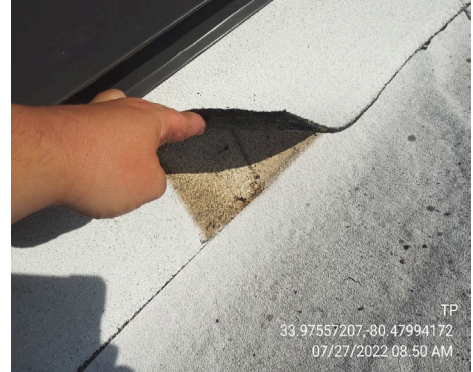
| Map Link | Defect Group # | Defect | Section | Recommendation | Count (Qty U/M) | Estimate Repair Cost |
|---|---|---|---|---|---|---|
| <a href="#">Map</a> | 4 | Flashing slippage/delamination - Delamination/slipping; no water penetration<br>Status: Proposed | A | Repair open seams with fabric, mastic and granules in a three-course fashion. | 1<br>(154 LF) | \$1,650 |

**Defect Group #: 4****Defect:** 1 (154 LF) Flashing slippage/delamination - Delamination/slipping; no water penetration**Recommendation:** Repair open seams with fabric, mastic and granules in a three-course fashion.

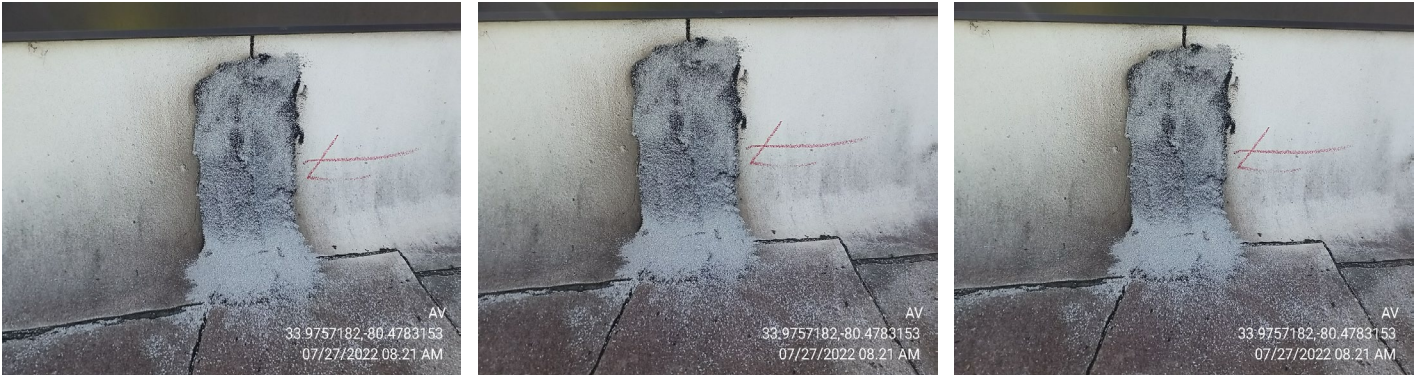
Defect Group #: 0

| Map Link | Defect Group # | Defect | Section | Recommendation | Count (Qty U/M) | Estimate Repair Cost |
|---|---|---|---|---|---|---|
| <a href="#">Map</a> | 0 | Flashing seam or side lap defects (EA) - Missing lap edge sealant<br>Status: Repaired | E | BF REPAIR | 1<br>(1 EA) | \$0 |

Defect: 1 (1 EA) Flashing seam or side lap defects (EA) - Missing lap edge sealant

Recommendation: BF REPAIR

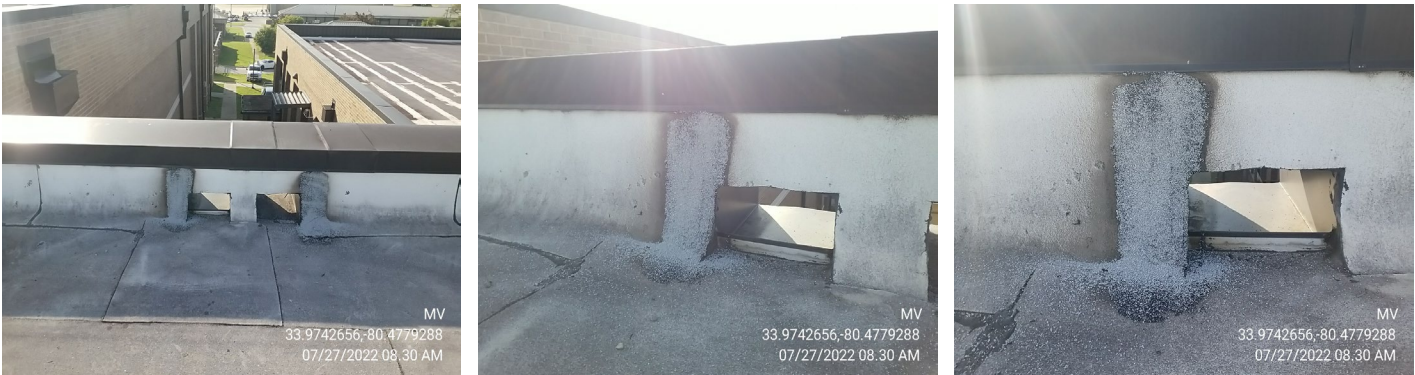
Defect Group #: 0

| Map Link | Defect Group # | Defect | Section | Recommendation | Count (Qty U/M) | Estimate Repair Cost |
|---|---|---|---|---|---|---|
| <a href="#">Map</a> | 0 | Flashing seam or side lap defects (EA) - Open > 1/2" into seam, no water penetration<br>Status: Repaired | D | BF REPAIR | 2<br>(2 EA) | \$0 |

Defect: 2 (2 EA) Flashing seam or side lap defects (EA) - Open > 1/2" into seam, no water penetration

Recommendation: BF REPAIR

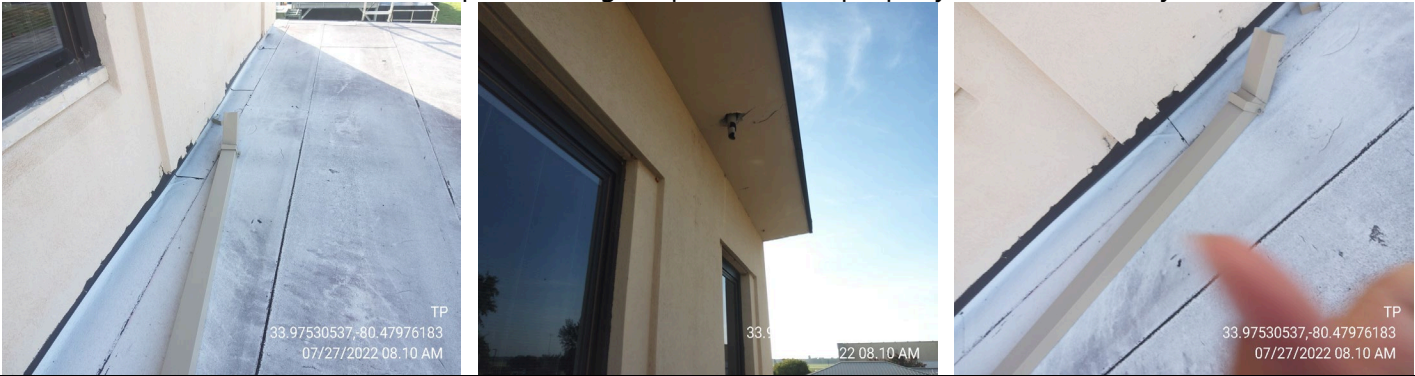
Defect Group #: 5

| Map Link | Defect Group # | Defect | Section | Recommendation | Count (Qty U/M) | Estimate Repair Cost |
|---|---|---|---|---|---|---|
| <a href="#">Map</a> | 5 | Downspout damage - Loose or missign fasteners<br>Status: Proposed | C | Reinstall downspout to original position and properly anchor to wall system. | 2<br>(2 EA) | \$660 |

Defect: 2 (2 EA) Downspout damage - Loose or missign fasteners

Recommendation: Reinstall downspout to original position and properly anchor to wall system.

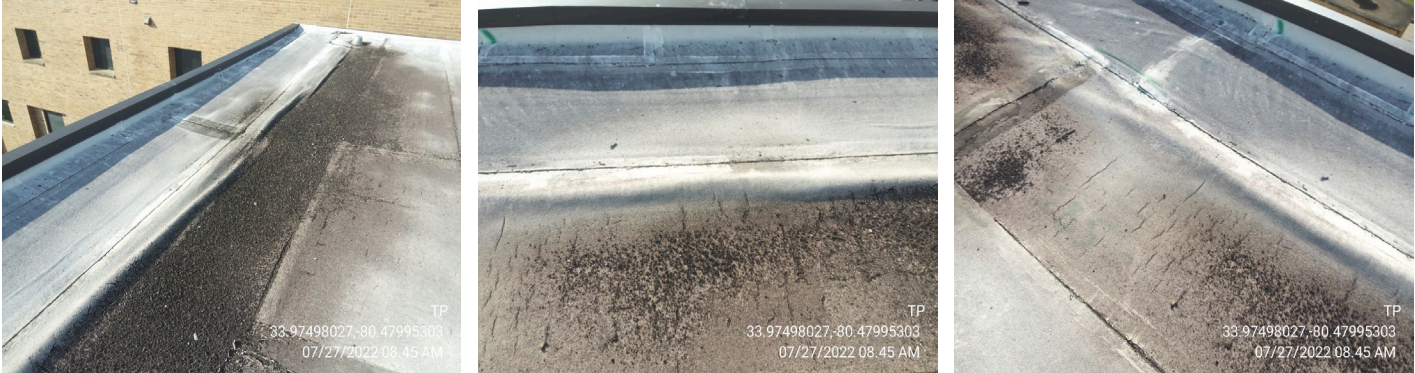
| <u>Map</u> | <b>0</b> | Membrane ridges -<br>Noticeable, felts are not<br>exposed<br>Status: Recorded | <b>A</b> | <b>No action required at<br/>this time. Monitor<br/>and maintain.</b> | <b>1<br/>(53 LF)</b> | <b>\$0</b> |

**Defect Group #: 0**  
**Defect:** 1 (53 LF) Membrane ridges - Noticeable, felts are not exposed  
**Recommendation:** No action required at this time. Monitor and maintain.

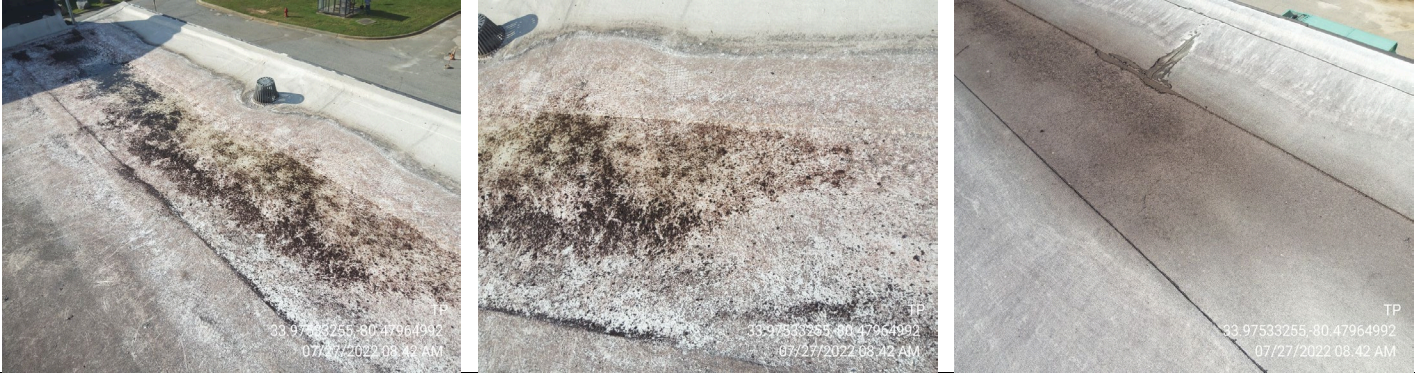
| <u>Map</u> | <b>0</b> | Ponding - Ponding in<br>membrane field<br>Status: Recorded | <b>A</b> | <b>No action required at<br/>this time. Monitor<br/>and maintain.</b> | <b>3<br/>(720 SF)</b> | <b>\$0</b> |

**Defect Group #: 0**  
**Defect:** 3 (720 SF) Ponding - Ponding in membrane field  
**Recommendation:** No action required at this time. Monitor and maintain.

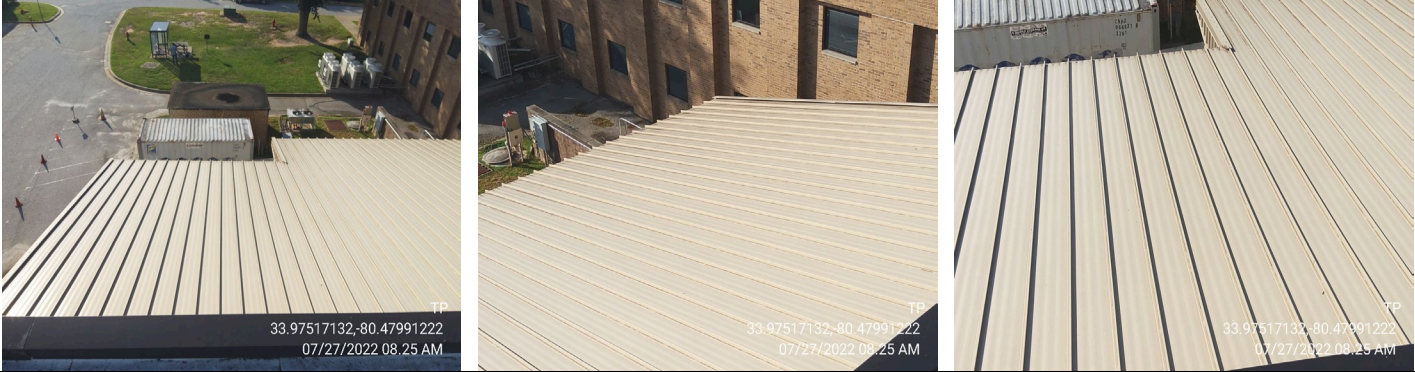
| <u>Map</u> | <b>0</b> | Metal coated surface defect -<br>10% of coating is deteriorated<br>Status: Recorded | <b>B</b> | <b>No action required at<br/>this time. Monitor<br/>and maintain.</b> | <b>1<br/>(1876 SF)</b> | <b>\$0</b> |

**Defect Group #: 0**  
**Defect:** 1 (1876 SF) Metal coated surface defect - 10% of coating is deteriorated  
**Recommendation:** No action required at this time. Monitor and maintain.

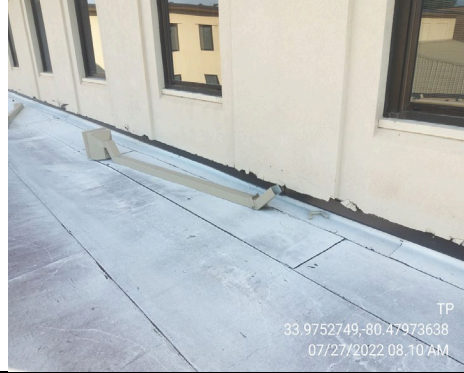
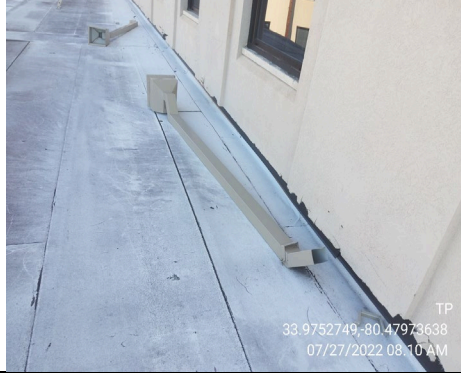
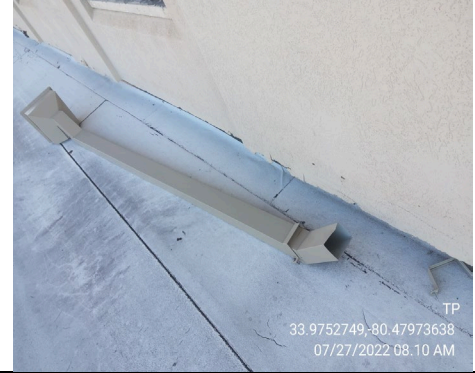
| <u>Map</u> | <b>6</b> | Debris (EA) - Loose or light<br>weight debris<br>Status: Proposed | <b>C</b> | <b>Remove materials /<br/>equipment / debris<br/>and properly dispose<br/>/ store offsite.</b> | <b>2<br/>(2 EA)</b> | <b>\$330</b> |

**Defect Group #: 6****Defect:** 2 (2 EA) Debris (EA) - Loose or light weight debris**Recommendation:** Remove materials / equipment / debris and properly dispose / store offsite.

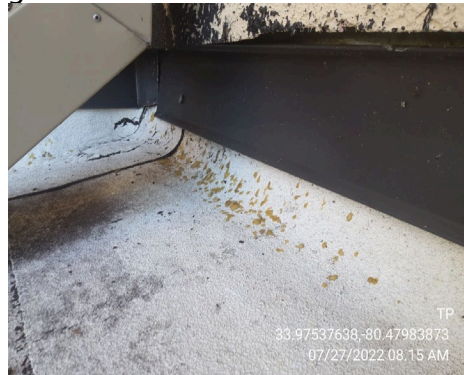
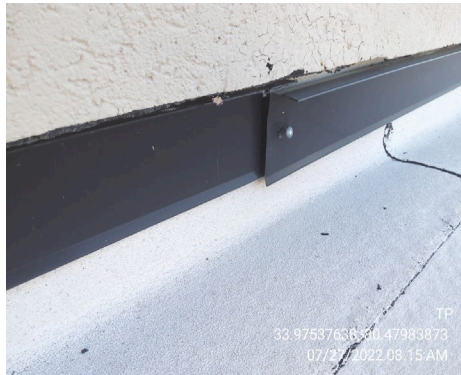
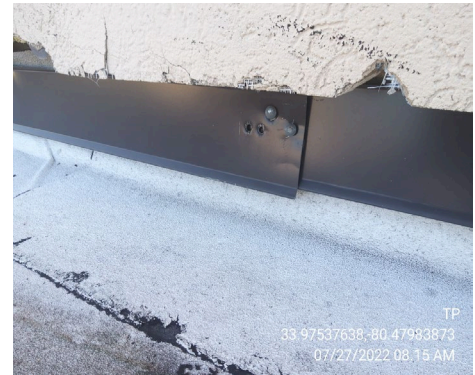
| <u>Map</u> | <b>7</b> | Exposed fastener defects (LF)<br>- Loose fasteners (20-50 total)<br>Status: Proposed | <b>C</b> | <b>Remove and replace<br/>loose / missing /<br/>corroded fasteners<br/>with new proper<br/>sized grommited<br/>fasteners.</b> | <b>1<br/>(84 LF)</b> | <b>\$245</b> |

**Defect Group #: 7****Defect:** 1 (84 LF) Exposed fastener defects (LF) - Loose fasteners (20-50 total)**Recommendation:** Remove and replace loose / missing / corroded fasteners with new proper sized grommets fasteners.

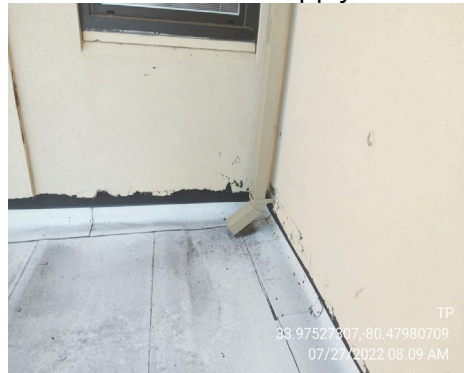
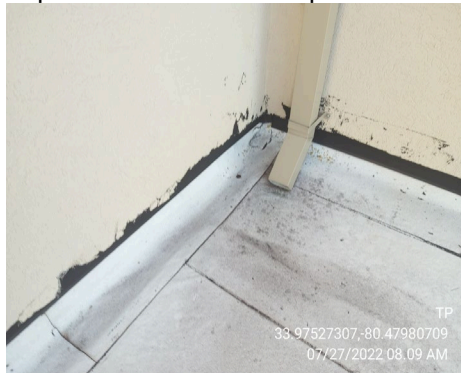
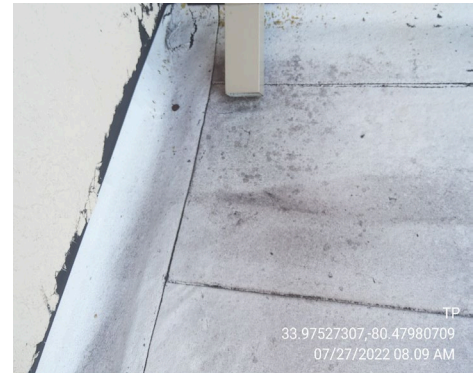
| <u>Map</u> | <b>8</b> | Splash block defects -<br>Damaged splash block<br>Status: Proposed | <b>C</b> | <b>Supply and install<br/>splash block at<br/>downspout outlet.</b> | <b>1<br/>(1 EA)</b> | <b>\$185</b> |

**Defect Group #: 8****Defect:** 1 (1 EA) Splash block defects - Damaged splash block**Recommendation:** Supply and install splash block at downspout outlet.

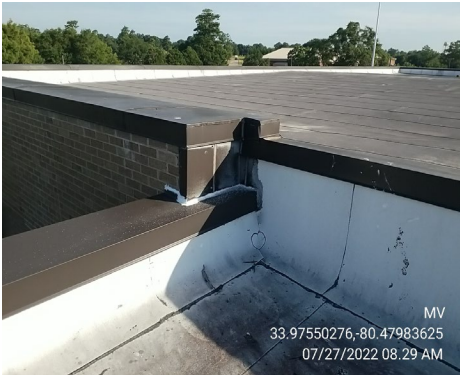
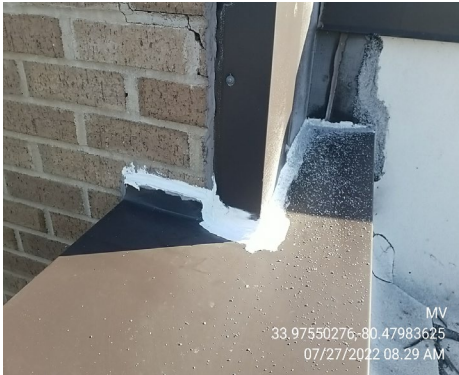
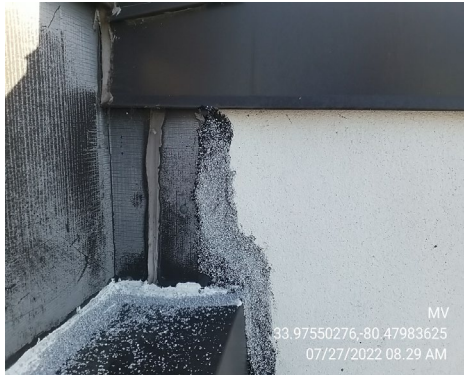
| <u>Map</u> | <b>0</b> | Deteriorated sealant - Highly<br>deteriorated<br>Status: Repaired | <b>D</b> | <b>BF REPAIR</b> | <b>1<br/>(6 LF)</b> | <b>\$0</b> |

**Defect Group #:** 0  
**Defect:** 1 (6 LF) Deteriorated sealant - Highly deteriorated  
**Recommendation:** BF REPAIR
