**Fire Hydrant and PIV Locations for 630A4-26-406 [12-18-2025]**

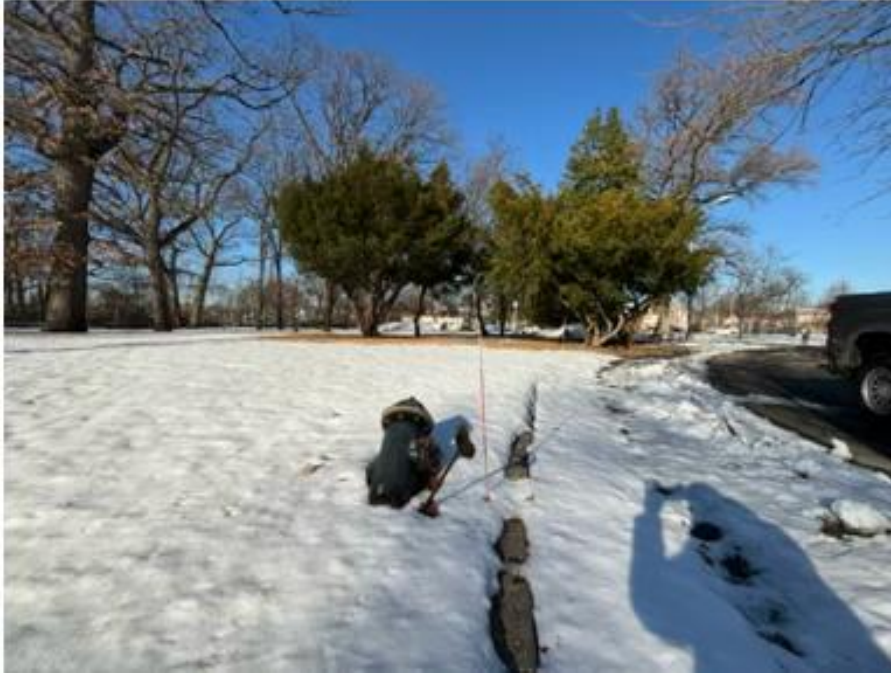
Pump House: knocked over hydrant

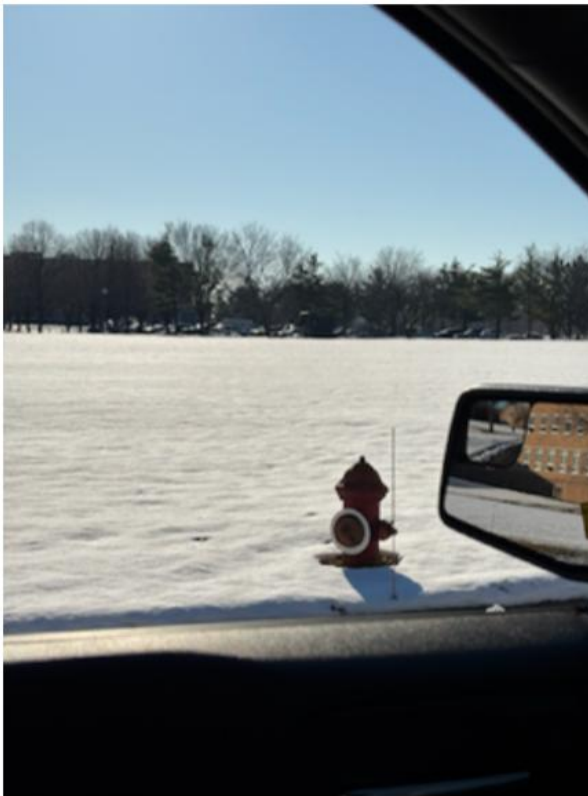
Empty Field Near Pump House: Hydrant, not functional

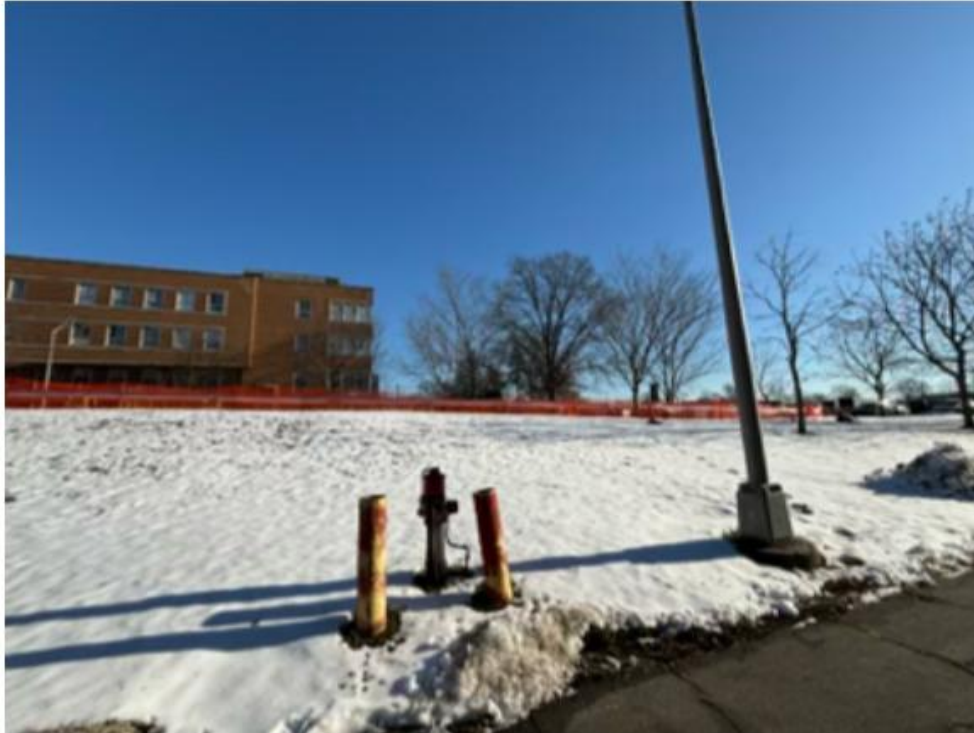
Building 89 Loading Dock: PIV, not functional

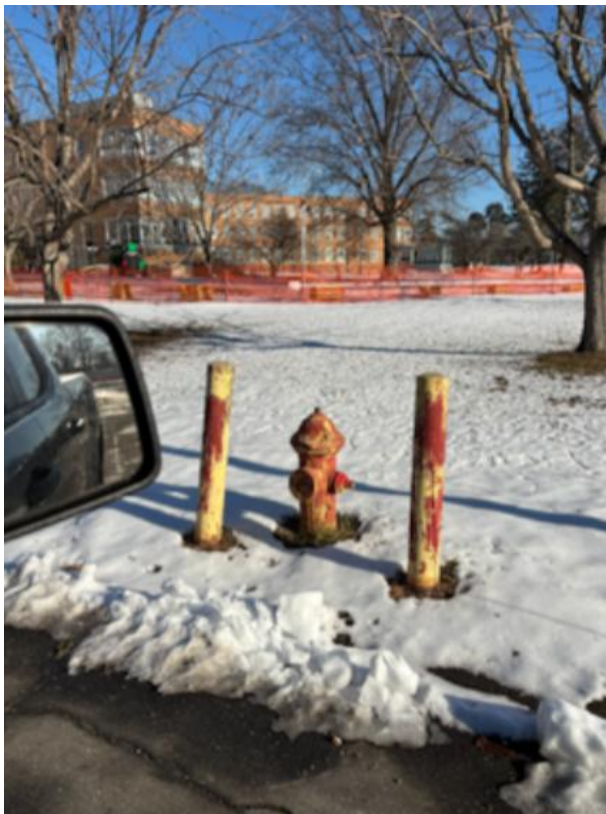
Building 89 Loading Dock: Fire Hydrant 1, not functional

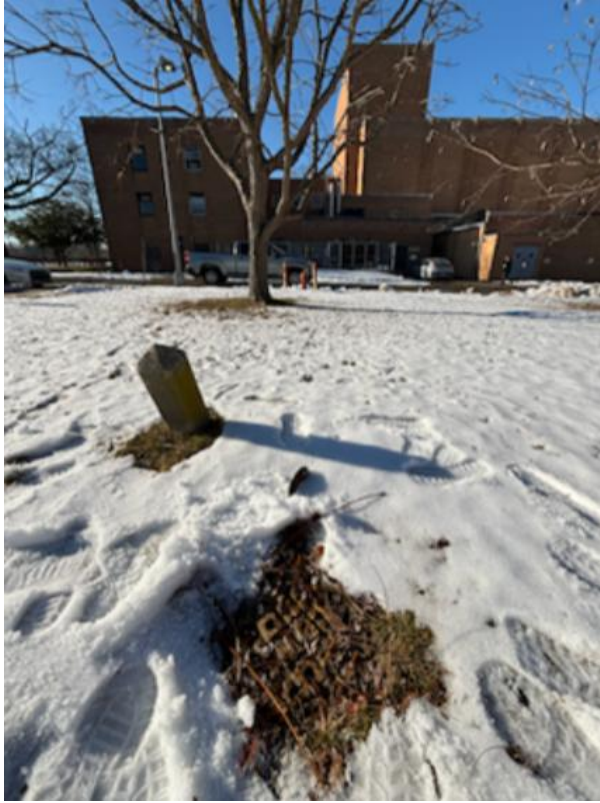
Building 89 Loading Dock: Fire Hydrant 1 Isolation Valve, to be replaced

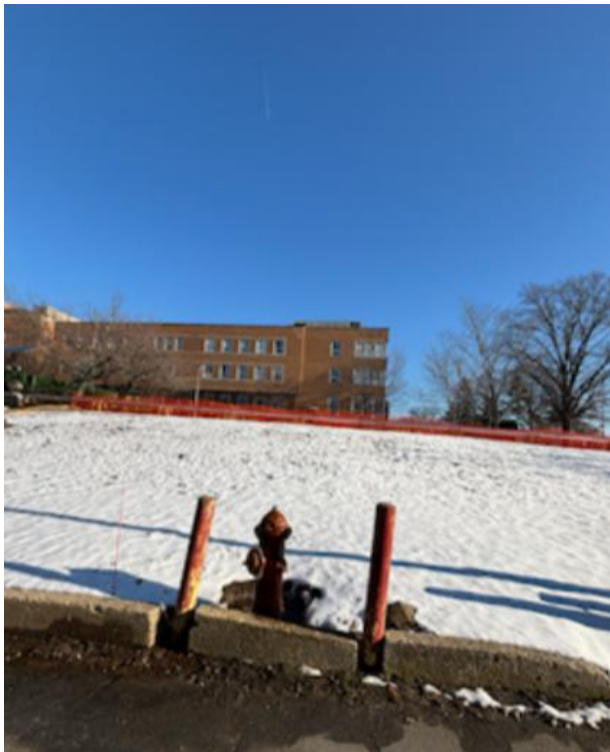
Building 89 Loading Dock: Fire Hydrant 2, not functional

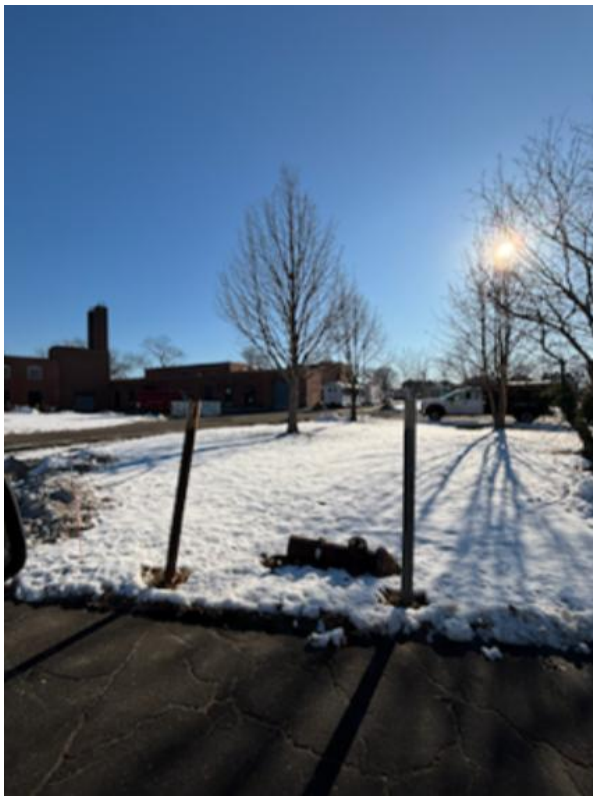
Building 64 Boiler Plant: Fire Hydrant, knocked over

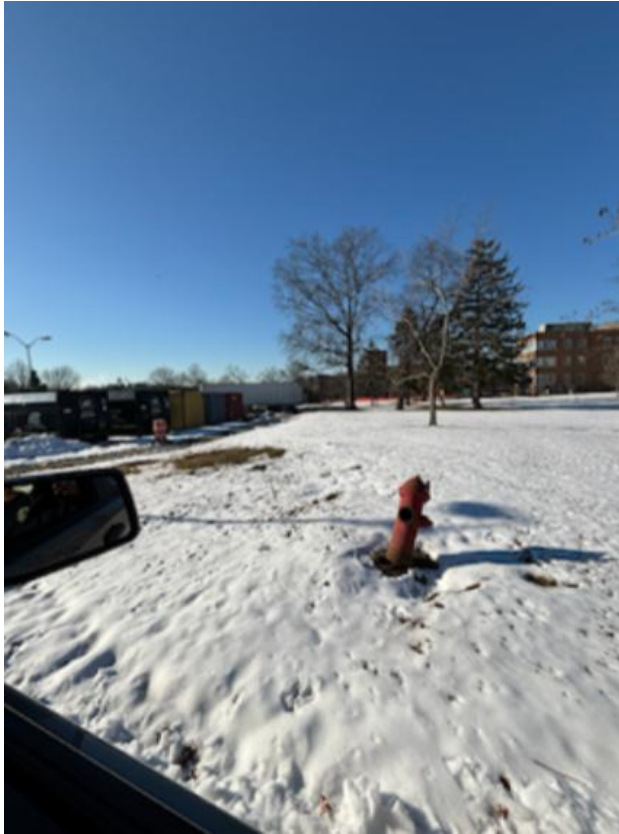
Building 85: Damaged Fire Hydrant

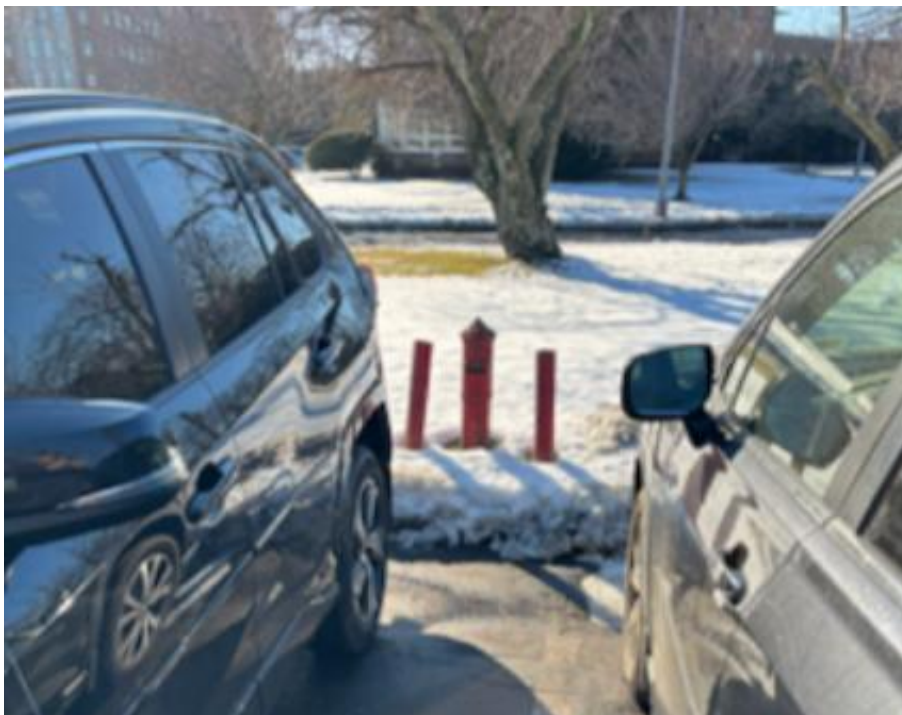
Building 89 West-side Parking Lot: PIV, not functional
