## **CR-NAVFAC EXWC-CIOFP-2129**

**2021 WATER TANK INSPECTION AND ASSESSMENT AT  
NAVAL WEAPONS STATION EARLE COLTS NECK, NEW  
JERSEY**

By  
TANK INDUSTRY CONSULTANTS  
June 2021

## **TANK 558**

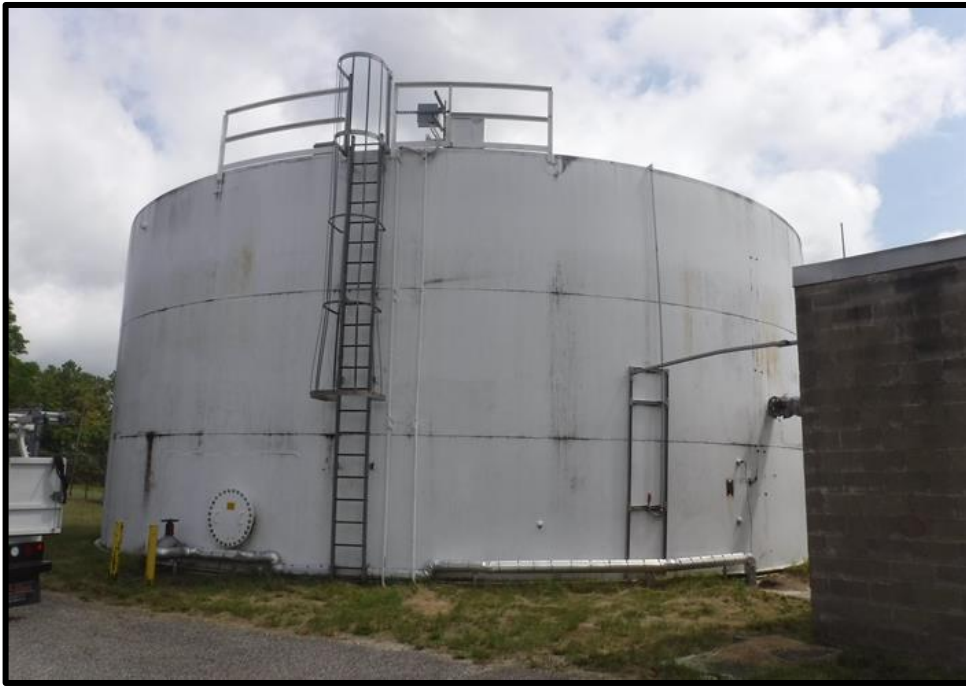
PHOTO 3.1-1 Tank 558 and site.

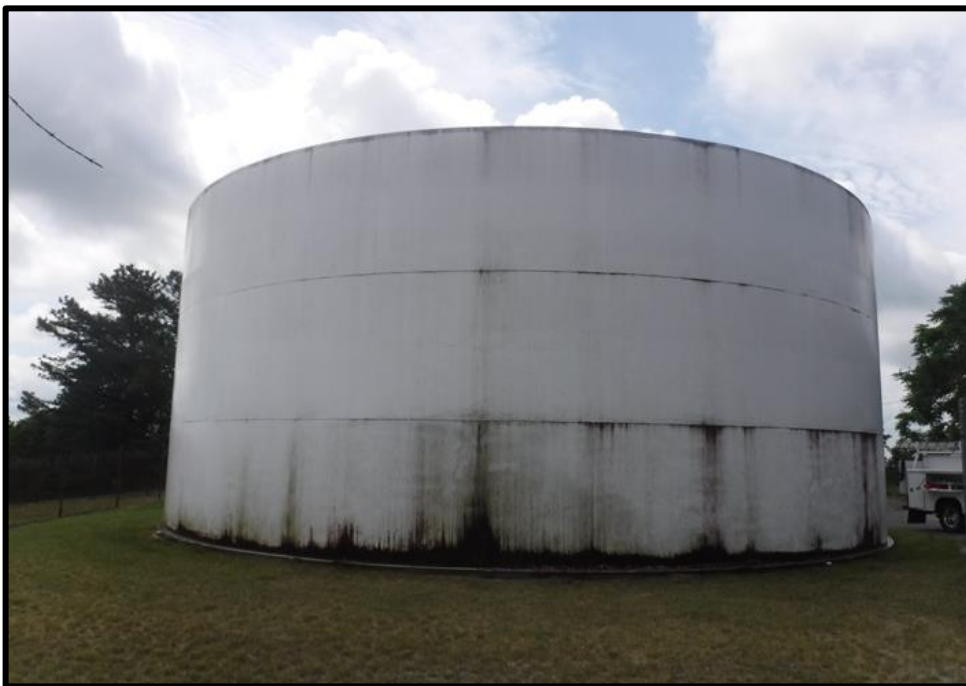
PHOTO 3.1-2 Tank 558 and site.

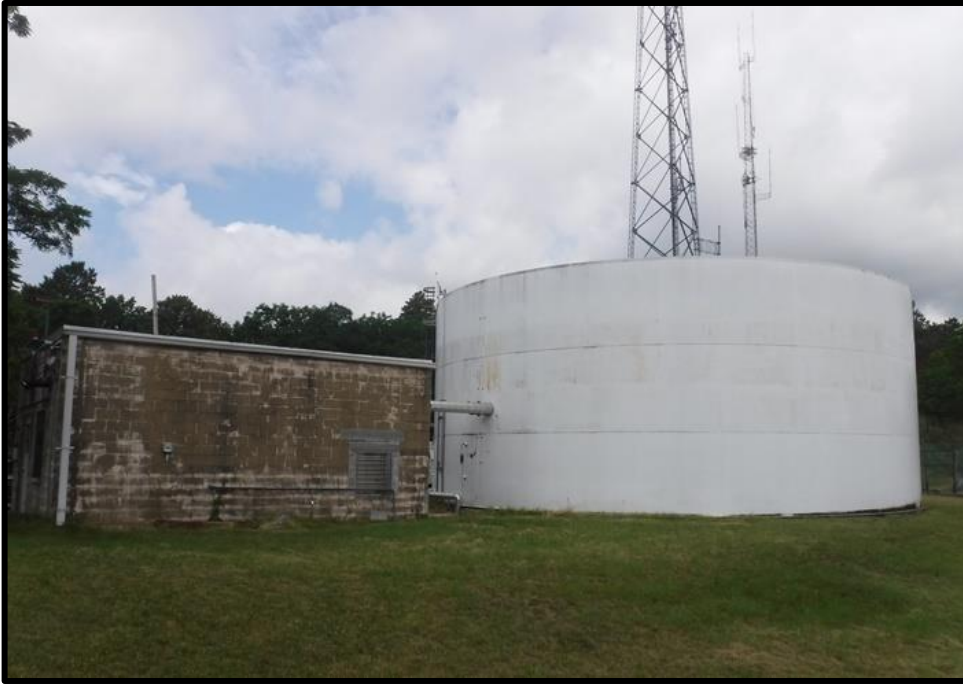
PHOTO 3.1-3 Building adjacent to the tank.

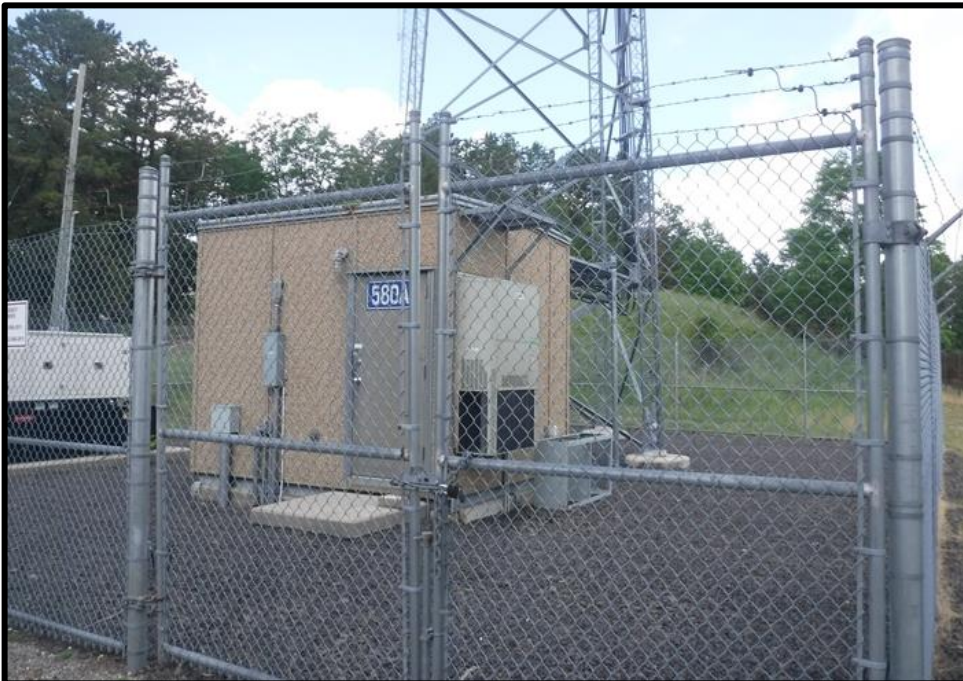
PHOTO 3.1-4 Fenced building and antenna tower on site.

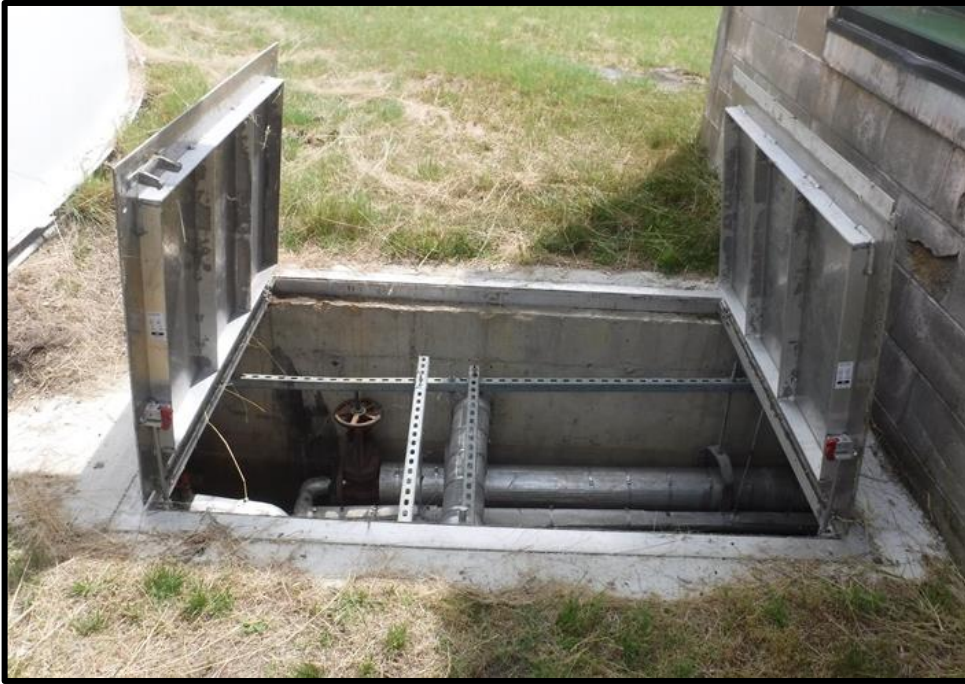
A valve vault is located south of the tank on the site (See photos 3.1-5 to 3.1-7). Areas of the valve vault extend below the tank and Building 559. The access into the valve vault was not locked prior to or after the field evaluation. Several pipes inside the valve vault are covered with jacketed insulation which restricted their evaluation. Widespread corrosion is present on the uncovered piping inside the valve vault (See photos 3.1-6 and 3.1-7). The vault is not equipped with a sump or pump, and water is present on the vault floor. The valve vault was not locked prior to or after the field evaluation which is a safety-related deficiency.

PHOTO 3.1-5 Valve vault access.

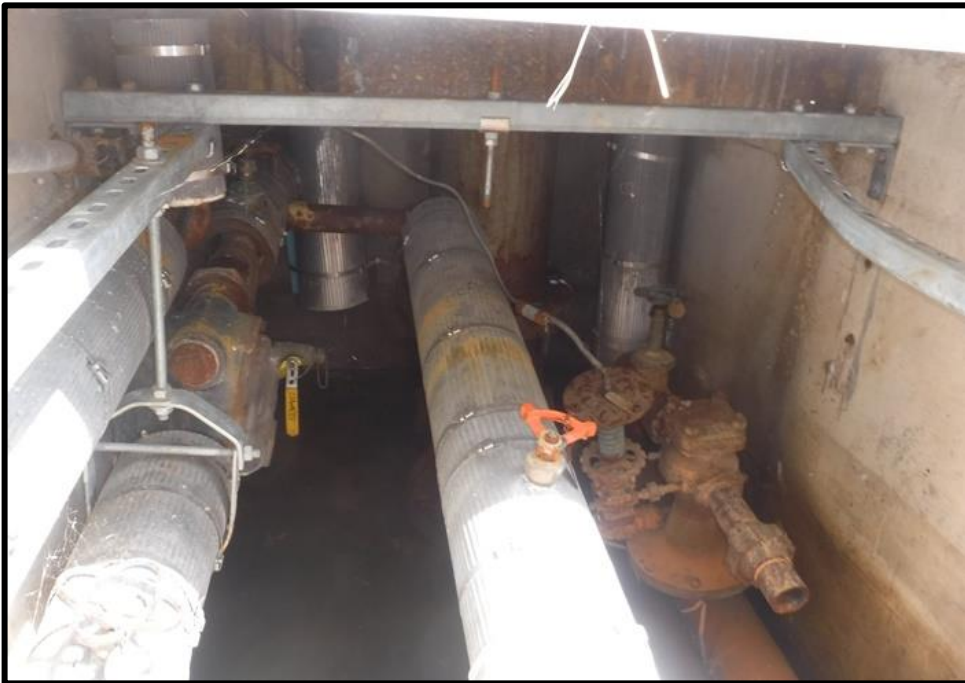
PHOTO 3.1-6 Valve vault piping covered with jacketed insulation and corrosion on uncovered piping.

**Valve Vault:** A sump with pump should be installed inside the valve vault to eliminate the water on the vault floor. The jacketed insulation on the piping should be removed, and the piping inspected to determine its condition. The piping and valves located in the valve vault should be cleaned and painted in accordance with the interior coating recommendations at the time of the tank cleaning and coating. The exterior concrete surfaces should be cleaned to the equivalent of a brush-off blast cleaning and painted with a concrete sealer. The valve vault access should be locked at all times in order to limit liability to the Owner and to protect water system security. Freeze protection should be provided on all control piping and static water lines.

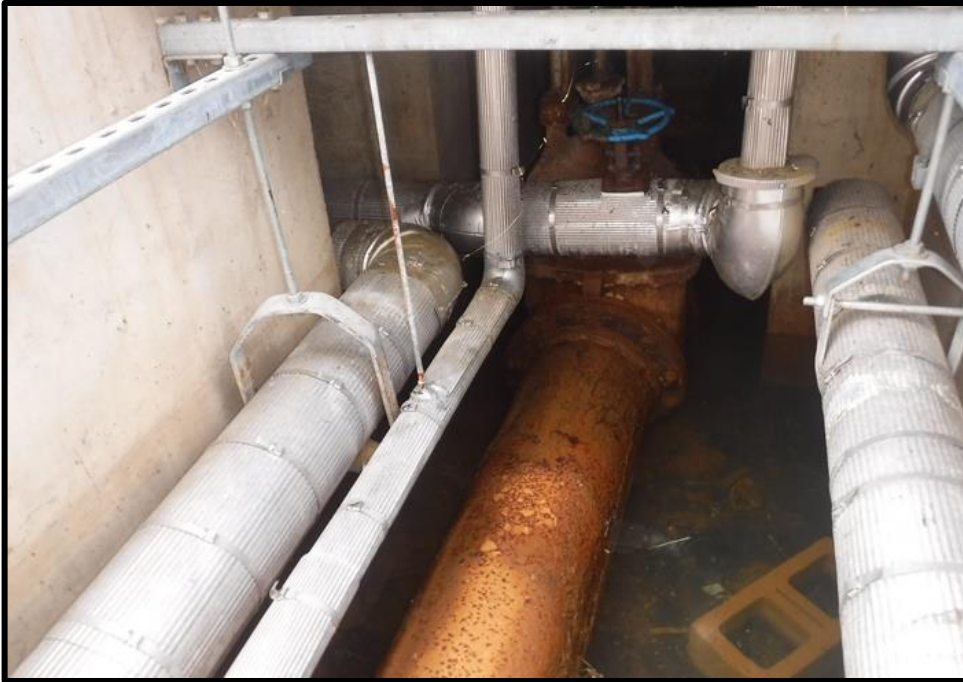
PHOTO 3.1-7 Valve vault piping covered with jacketed insulation, corrosion on uncovered piping, and water on the vault floor.

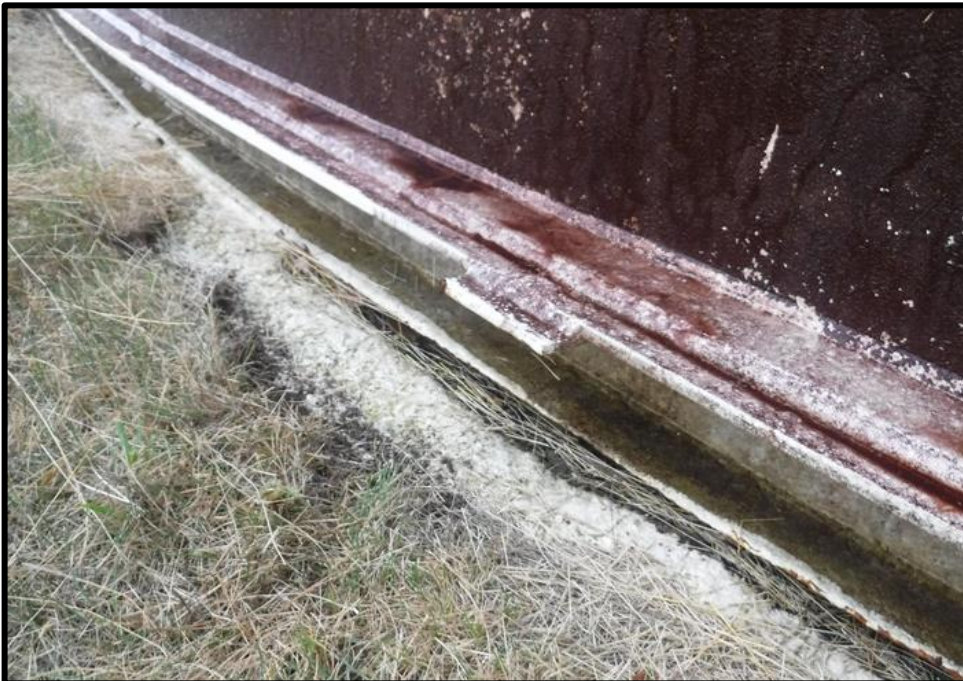
The tank rests on a concrete foundation (See photo 3.1-8). The foundation does not meet the AWWA recommended minimum projection of 6 in. (152 mm) and is mostly buried. The visible areas of the foundation appear to be in adequate condition. A white colored coating is visible on the foundation. **No grout or sealant is present between the foundation and bottom plate, and gaps are located between the foundation and bottom plate (See photo 3.1-9).**

PHOTO 3.1-8 Partially buried foundation, and corrosion on bottom plates and stiffener.

**Site Maintenance:** The Navy should consider installing a chain link fence topped with barbed wire around the immediate tank site for improved tank and site security. The site should be regraded so that the top of the foundation projects a minimum of 6 in. (152 mm) above grade and so that proper drainage away from the foundation continues. Site maintenance should be performed with the mower discharge directed away from the base of the tank to prevent rock chips in the coating and the accumulation of grass and leaves on the bottom plates.

**Foundation:** When the next exterior recoating is performed, any unsound concrete should be chipped to sound material and the concrete should be brush-off blasted. Any deteriorated areas or voids found should have a bonding agent and a vinyl emollient modified concrete patching mortar applied to build up the surface to its original contour. The concrete should then be painted with a concrete sealer.

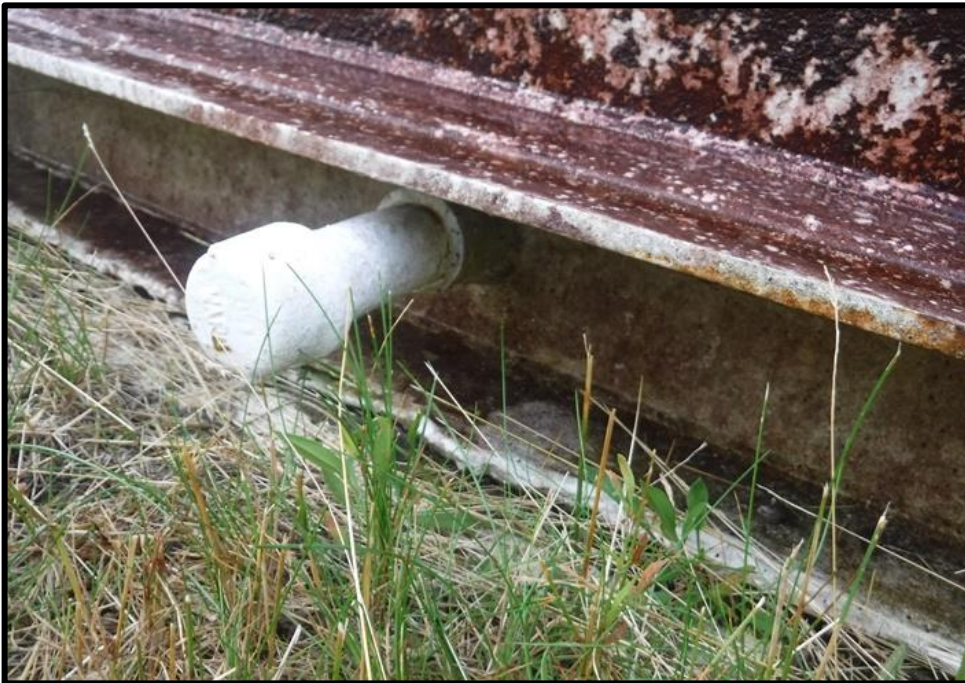
PHOTO 3.1-10 Capped pipe projecting from the shell between the two bottom plates.

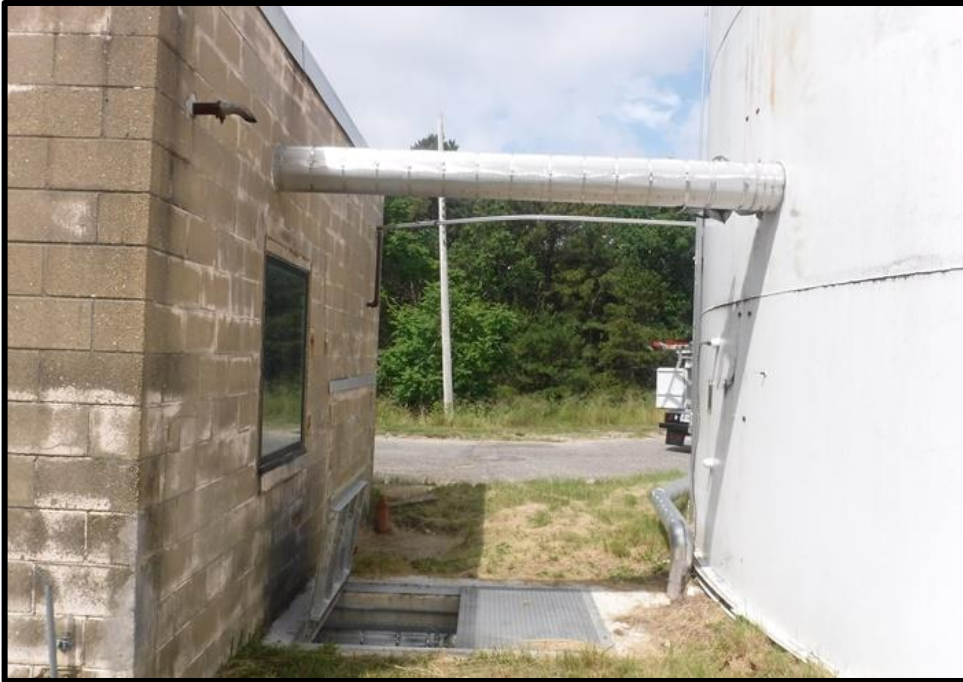
PHOTO 3.1-11 Pipe covered with jacketed insulation extending from building and penetrating the tank shell.

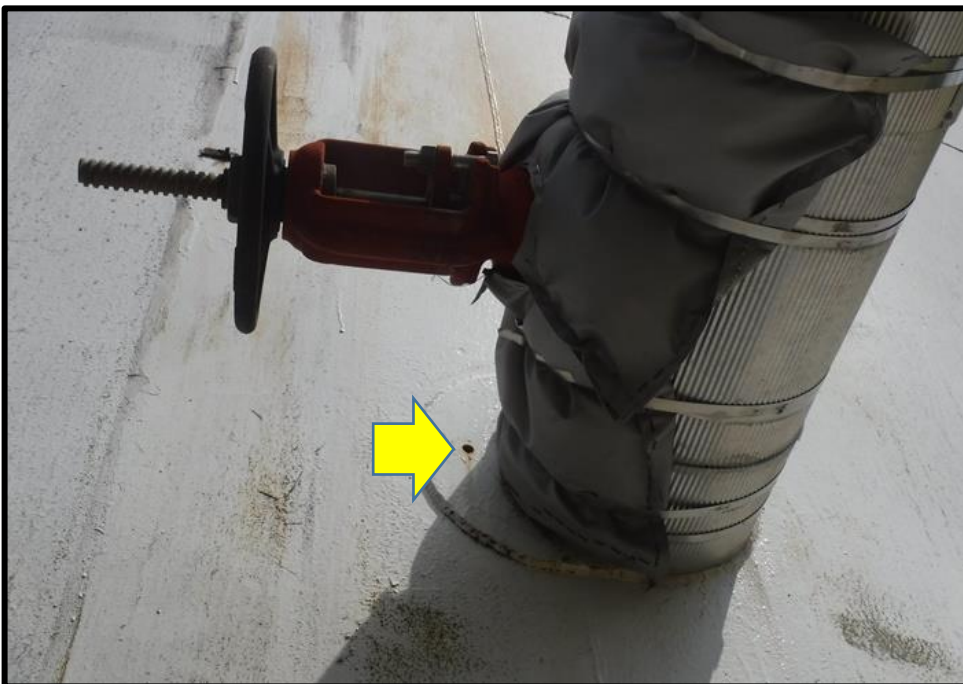
PHOTO 3.1-12 Pipe equipped with a valve and covered with jacketed insulation penetrating the tank shell. Note unplugged weep hole in the reinforcing plate.

**Exterior Piping:** The jacketed insulation on the exterior piping penetrating the tank should be removed, and the piping inspected to determine its condition. The unplugged weep hole in the reinforcing plate around the pipe penetration on the west side of the shell should be tapped and plugged.

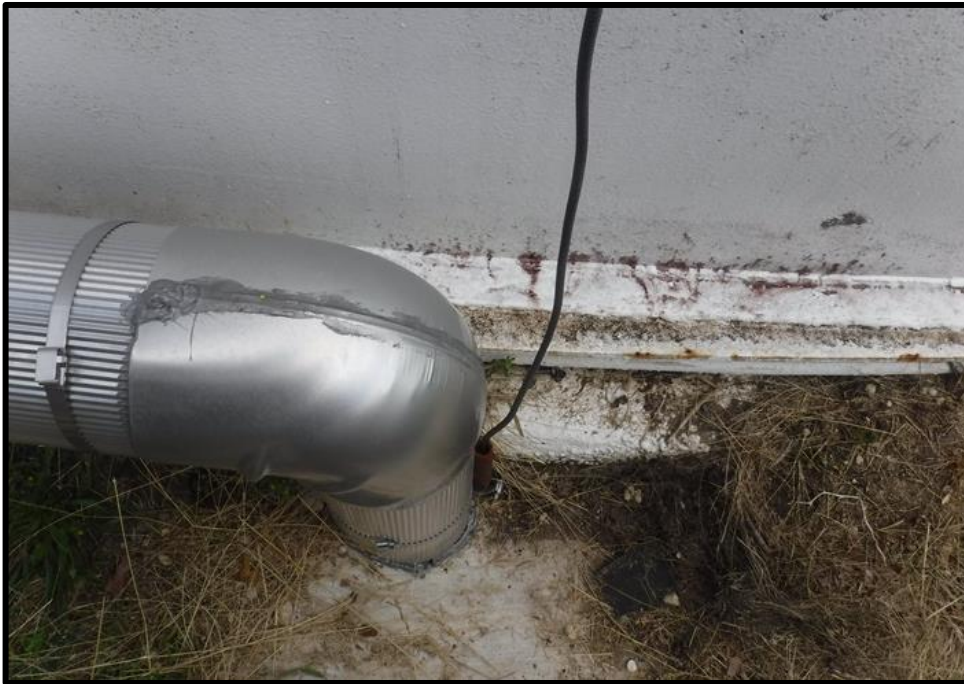
PHOTO 3.1-13 Pipe covered with jacketed insulation and wiring extending from the valve vault.

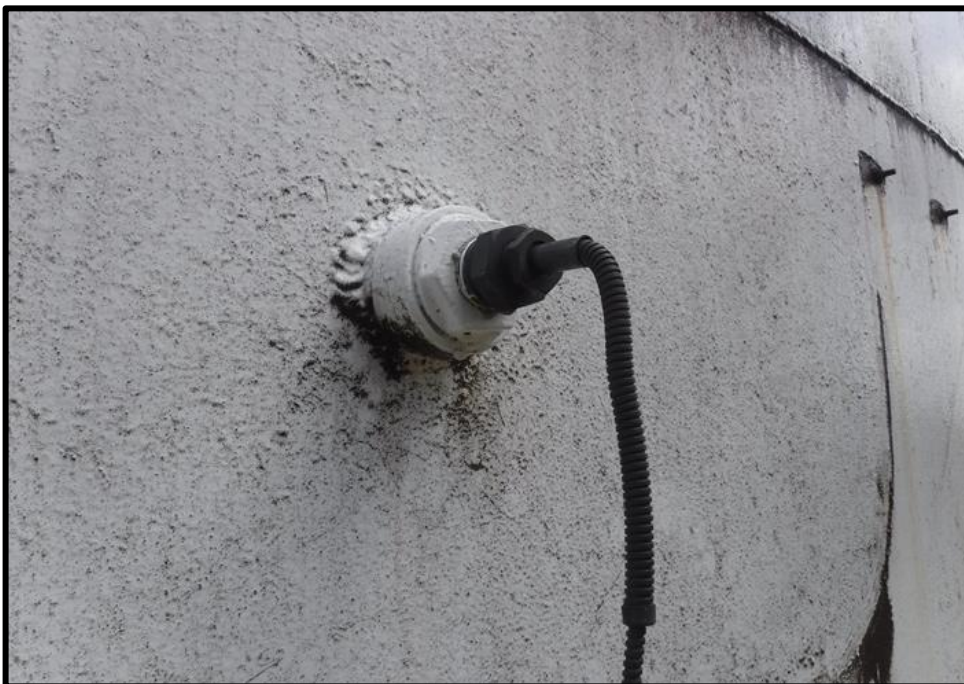
PHOTO 3.1-14 Wiring extending from the valve vault connected to a threaded and plugged coupling in the tank shell.

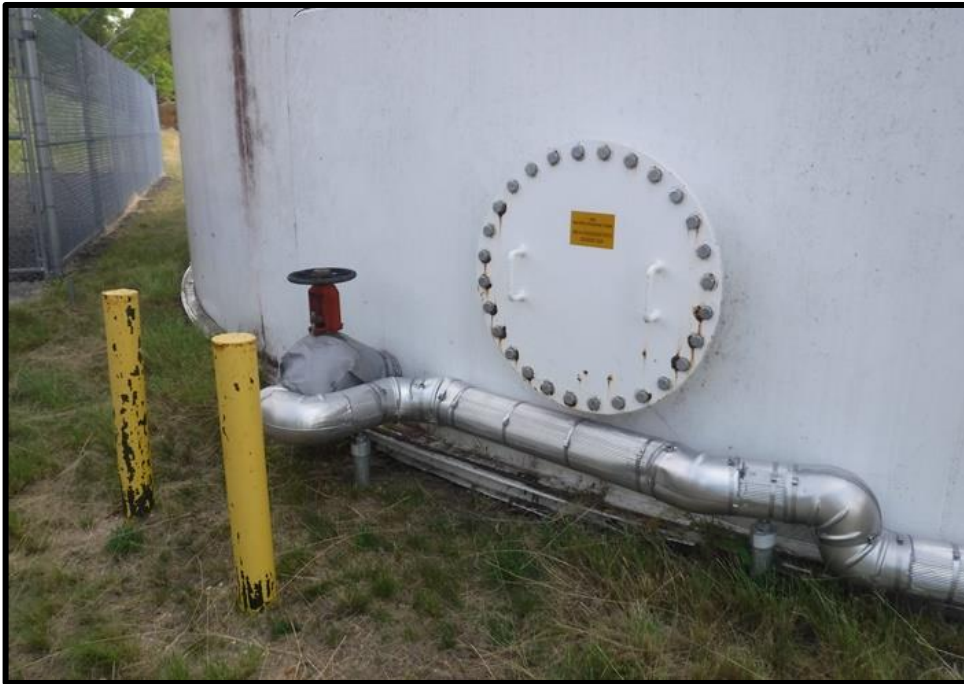
PHOTO 3.1-15 Pipe equipped with a valve and covered with jacketed insulation penetrating near the bottom of the shell, shell manhole, and pipe bollards.

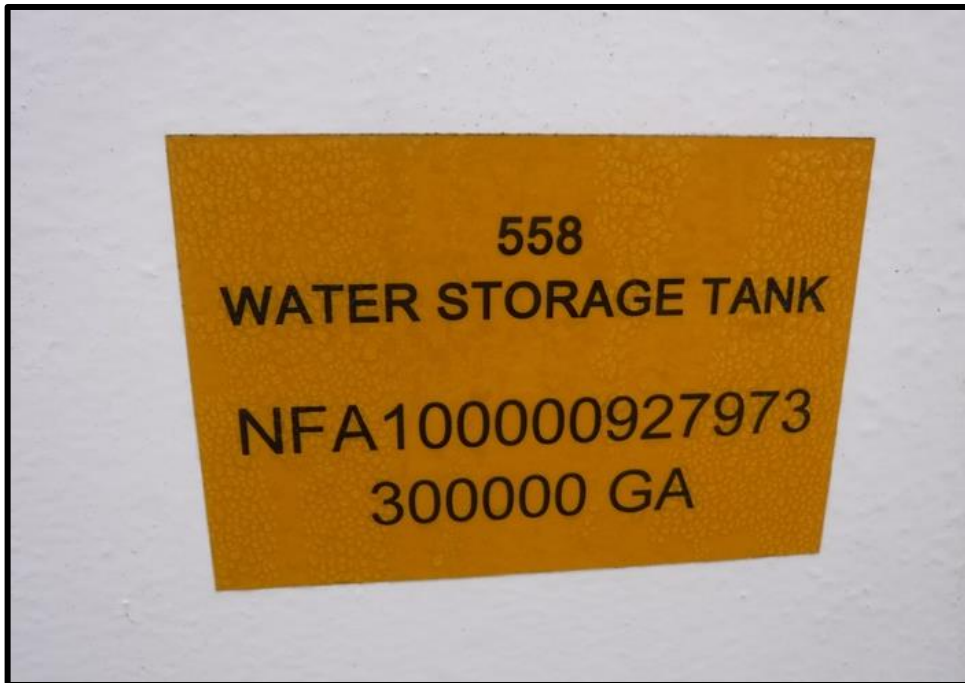
PHOTO 3.1-17 Tank information decal on the shell manhole cover.

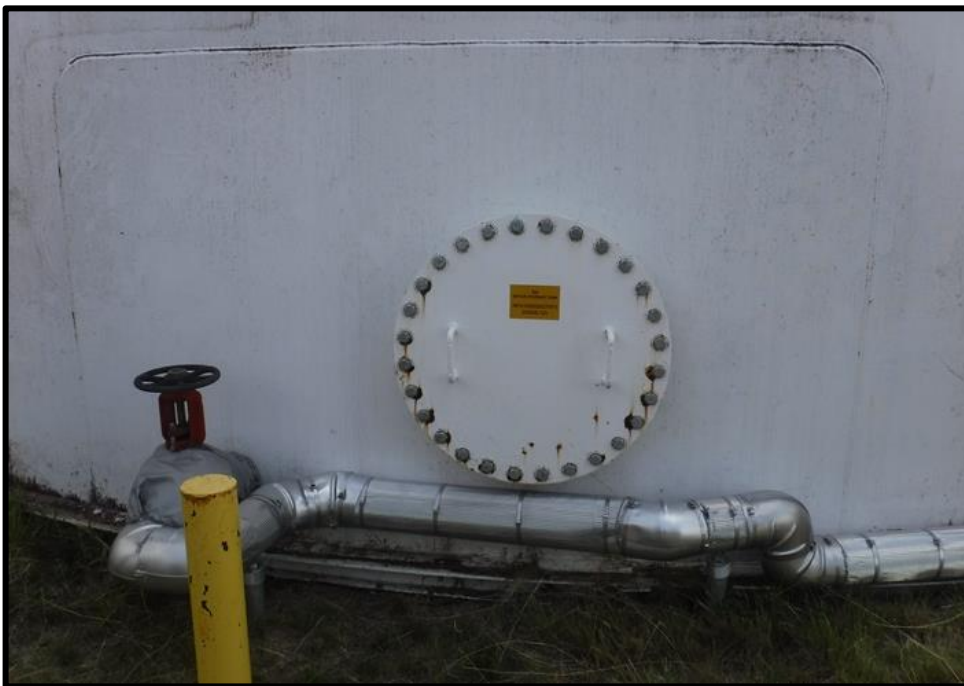
PHOTO 3.1-18 Welded steel insert plate in the shell around the shell manhole and pipe penetrating near the bottom of the shell.

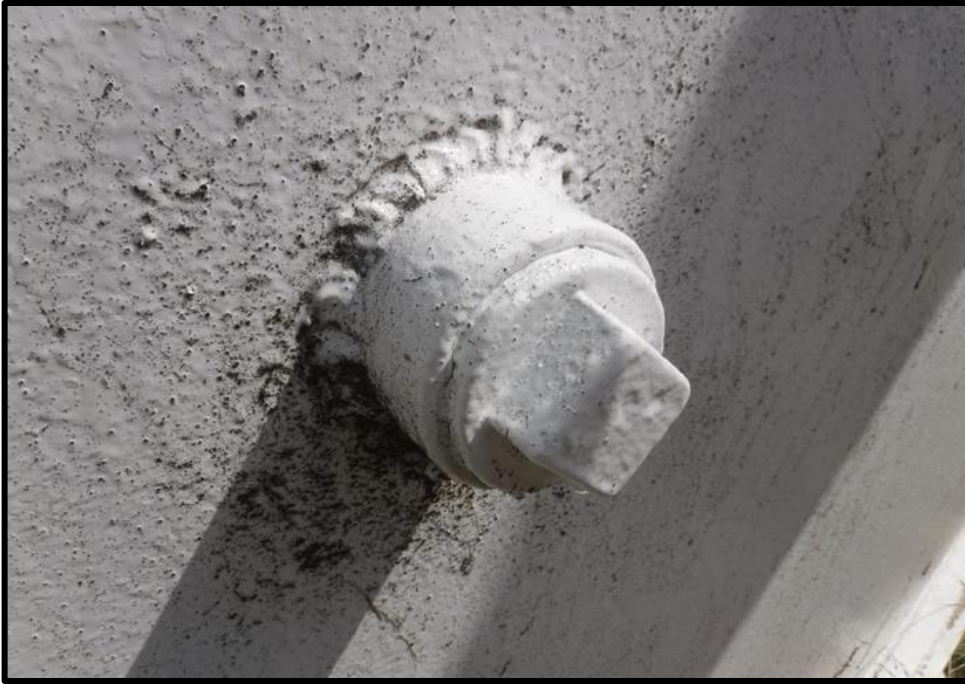
PHOTO 3.1-19 Threaded and plugged coupling in the shell.

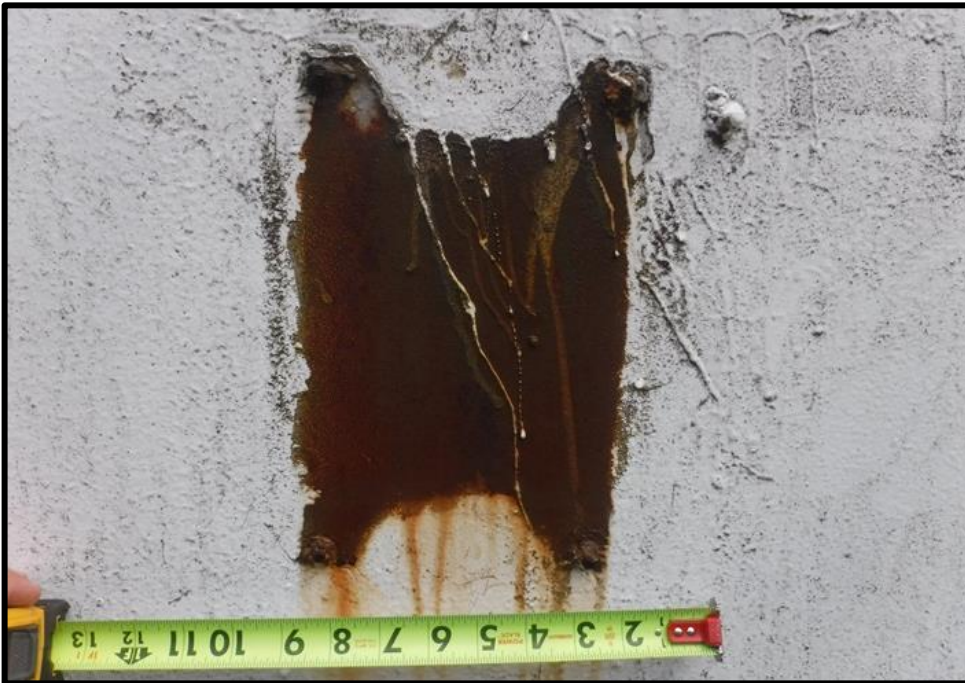
The shell's contour appears to be in adequate condition. The coating on the exterior shell is in fair overall condition as corrosion is present on areas of the shell (See photos 3.1-20 and 3.1-22). The coating has chalked, and drips, sags, and debris are present in the coating. Mildew is located on areas of the shell. The exterior shell coating has fair adhesion to the underlying coating. Several unused stud remains are located on the south side of the shell, and coating failure, corrosion, and rust staining are present on the areas where cabinets were previously located (See photos 3.1-20 to 3.1-22). An approximately 5 ft 6 in. (1.7 m) x 9 ft 1 in. (2.7 m) welded steel insert plate with rounded corners is located in the shell around the shell manhole and pipe penetrating near the bottom of the shell (See photo 3.1-18). Two threaded and plugged couplings are located on the south side of the shell (See photo 3.1-19). Another threaded and plugged coupling is located on the south side of the shell, and a wire extends from the valve vault and connects to this coupling (See photos 3.1-13 and 3.1-14). Two electrical conduits extend along the shell between the two bottom plates on the south side. Three electrical conduits extend up the shell on the southwest side adjacent to the exterior shell ladder, and corrosion is present on the conduit brackets (See photos 3.1-25 and 3.1-26). Another conduit extends up the shell on the south side (See photos 3.1-23 and 3.1-24).

PHOTO 3.1-20 Unused studs and coating failure, corrosion, and rust staining on area of previous cabinet on the shell exterior.

**Electrical Apparatus:** All unused electrical conduit, fixtures, and electrical metering equipment should be removed from the tank and tank site. All required equipment should be repaired and maintained in accordance with the National Electric Code (NEC).

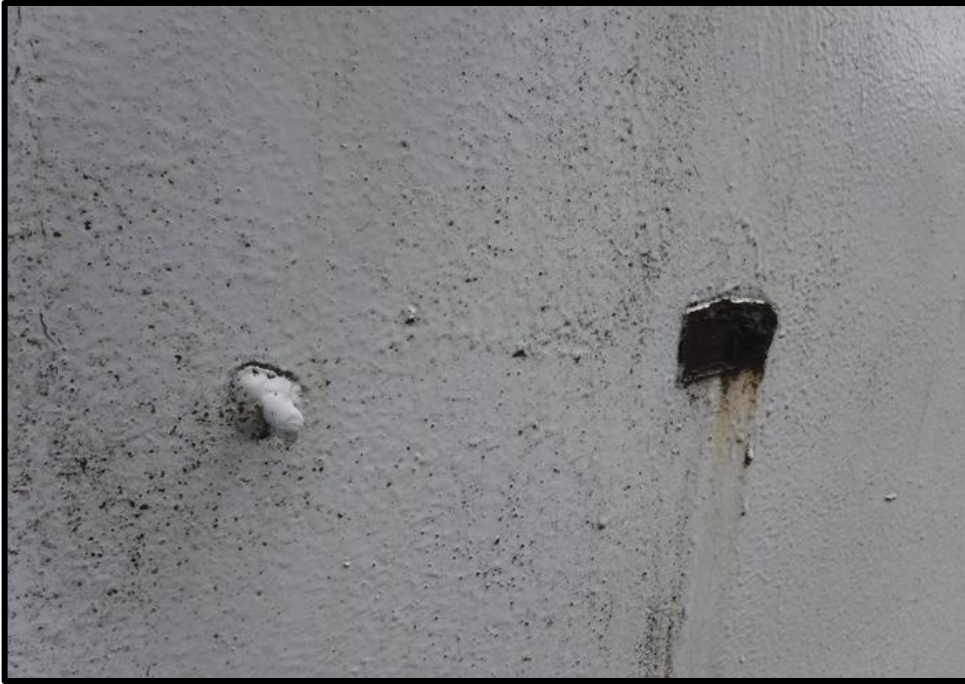
PHOTO 3.1-21 Unused stud remains and coating failure, corrosion, and rust staining on area of previous cabinet bracket on the shell exterior.

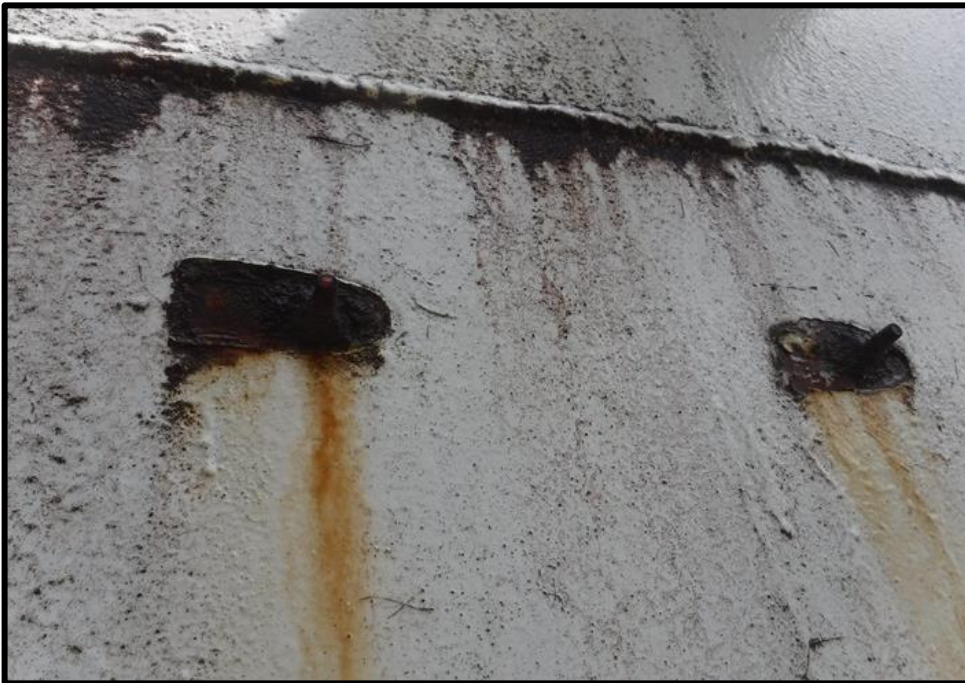
PHOTO 3.1-22 Unused stud remains and coating failure, corrosion, and rust staining on areas of previous cabinet brackets on the shell exterior.

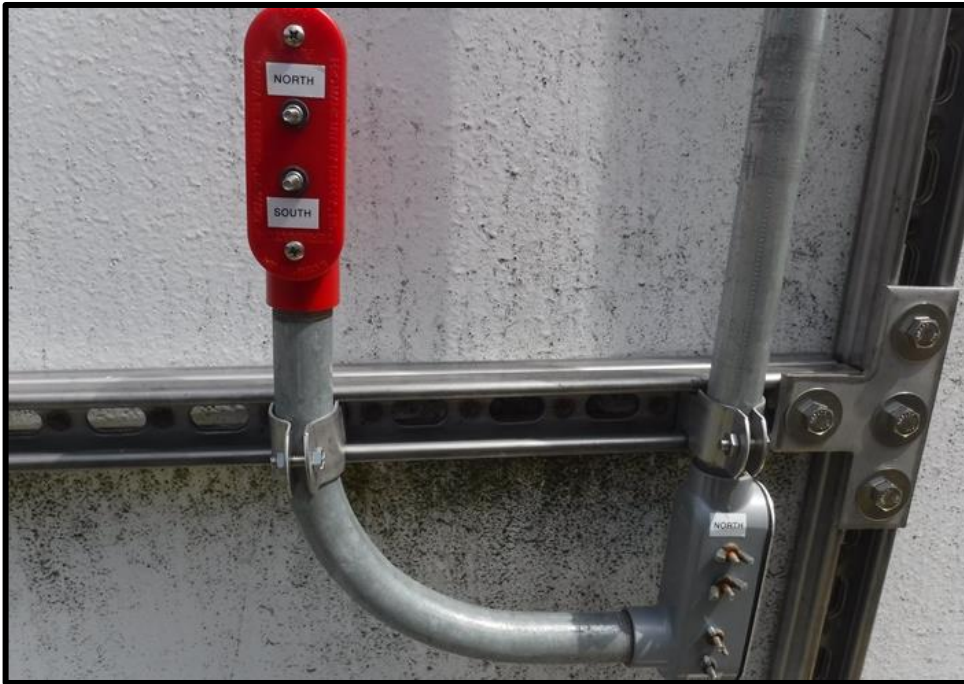
PHOTO 3.1-23 Conduit and brackets on the shell exterior.

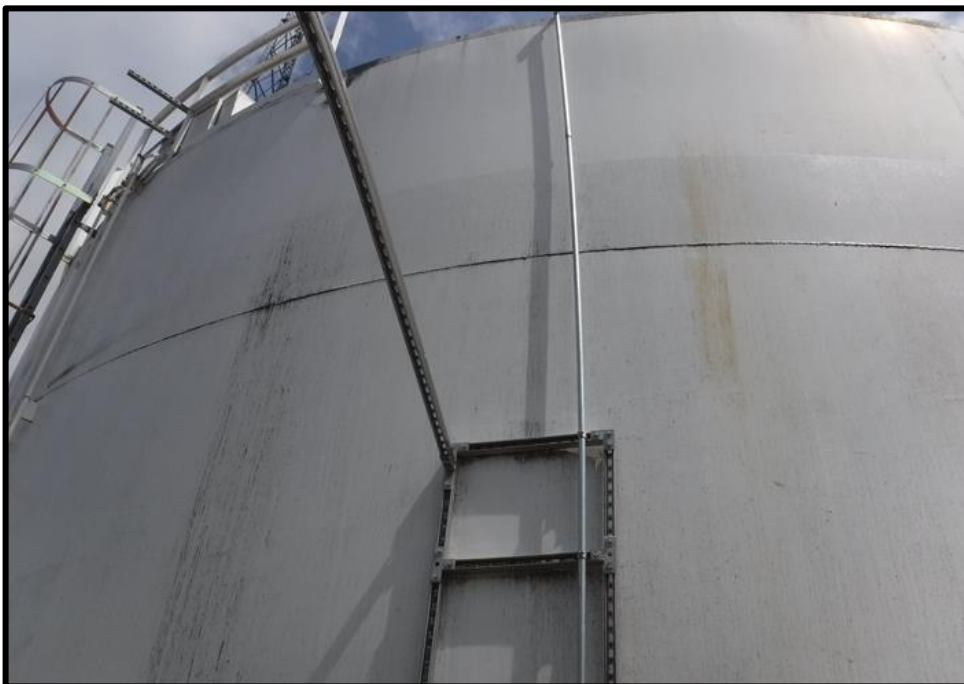
PHOTO 3.1-24 Conduit extending up the shell and brackets on the shell exterior.

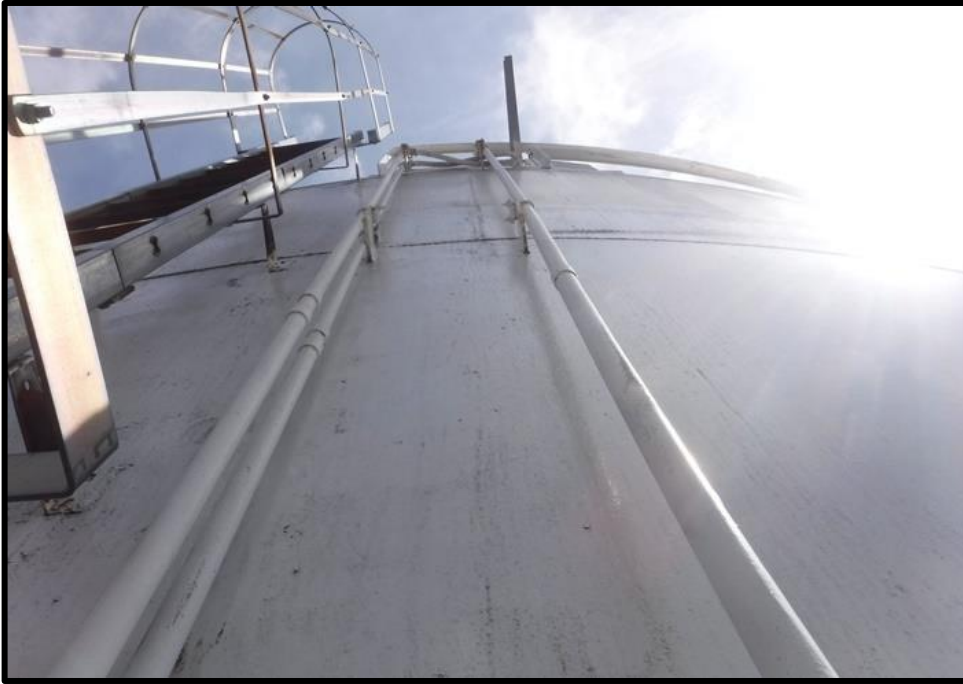
PHOTO 3.1-25 Conduits extending up the shell adjacent to the exterior shell ladder.

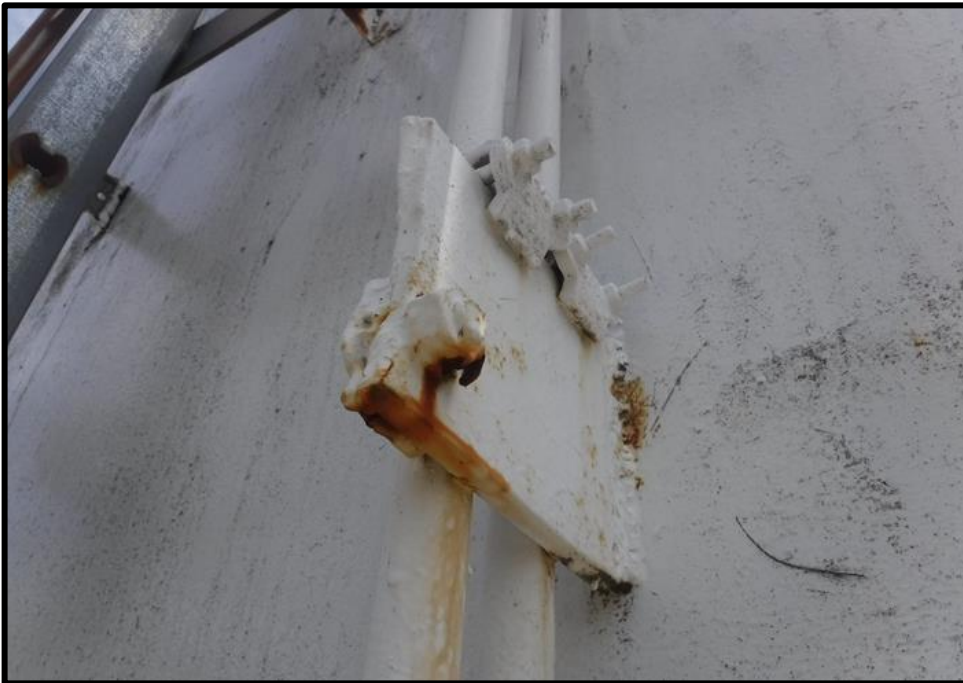
PHOTO 3.1-26 Corrosion on conduit bracket.

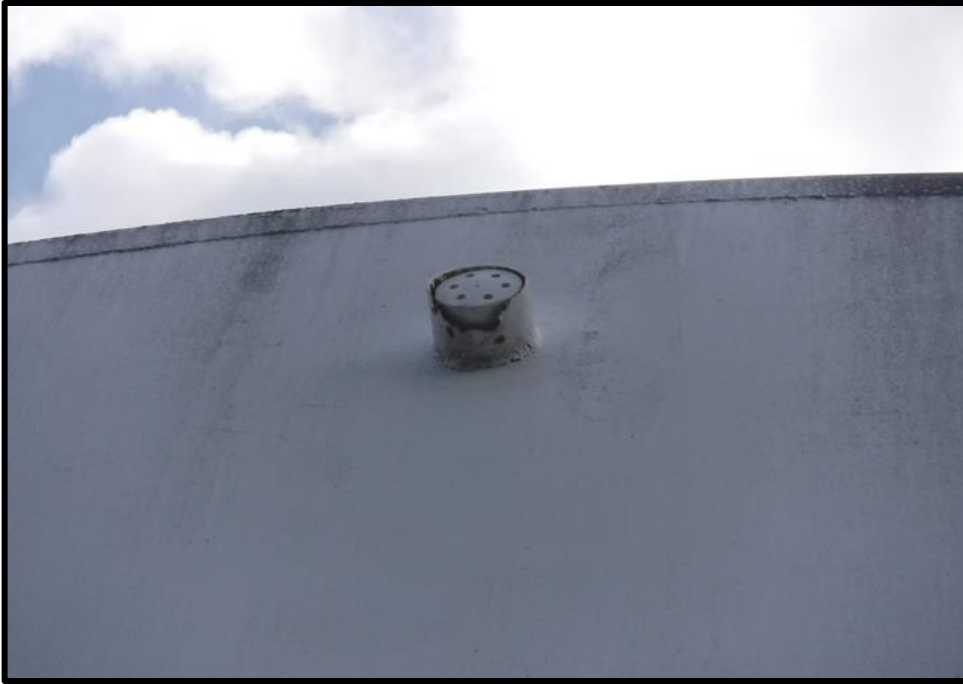
The stub overflow pipe exits near the top of the shell and immediately discharges (See photo 3.1-27). The discharge end of the overflow pipe is equipped with a perforated plate screening. No significant coating failure or corrosion are present on the overflow pipe. AWWA and operational deficiencies include: (1) the overflow pipe discharges near the top of the shell which allows the potential of ice-formation of the effluent on the shell during freezing weather, and (2) the 3 in. (76 mm) projection of the overflow pipe from the shell does not meet the minimum required 12 in. (305 mm) projection (AWWA D100-11 Sec. 7.3).

PHOTO 3.1-27 Stub overflow pipe equipped with perforated plate screening.

**Overflow Pipe:** Stub overflow pipes result in the potential for ice formation on the exterior of a tank as well as erosion of the soil due to effluent discharge. Such icing conditions can cause damage and accelerated corrosion and metal loss rates. Therefore, Tank Industry Consultants and the 10 State Standards recommend extending the pipe to near grade. The overflow pipe should exit the top shell ring and extend to approximately 24 in. above grade attached to the shell by welded steel brackets. The overflow pipe discharge could be equipped with a screened, counter-weighted flap gate or elastomeric check valve if desired by the Navy. The air break should be adequately sized to allow the proper functioning of the new flap gate. The overflow effluent should be directed away from the foundation using a concrete splash block and rip rap.

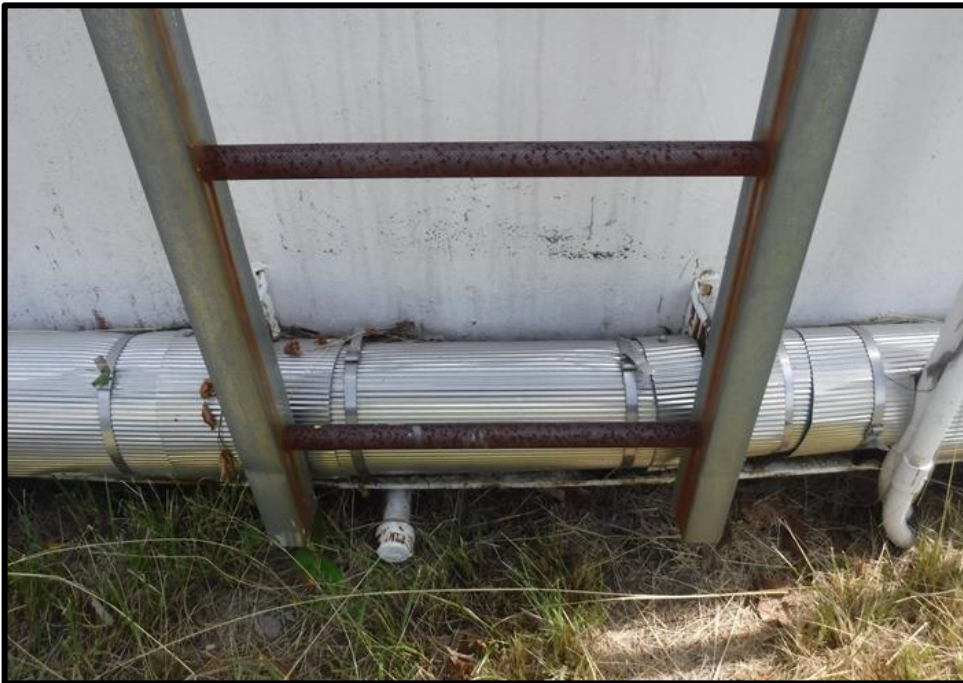
An exterior ladder provides access from the ground to the tank roof (See photos 3.1-28 to 3.1-32). The ladder is not equipped with a safe-climbing device; however, OSHA does not require safe-climbing devices on ladders less than 24 ft (610 mm) high. The ladder is equipped with a safety cage constructed of welded and bolted flat bar members. The base of each safety cage section is flared. The ladder is bolted to brackets which are welded to the shell. Widespread corrosion is present on the ladder rungs, rust staining is present on the ladder side rails, and corrosion is present on the brackets (See photos 3.1-29 and 3.1-30). The exterior shell ladder is not equipped with a vandal deterrent which is a safety-related deficiency.

PHOTO 3.1-28 Corrosion and rust staining on the exterior shell ladder.

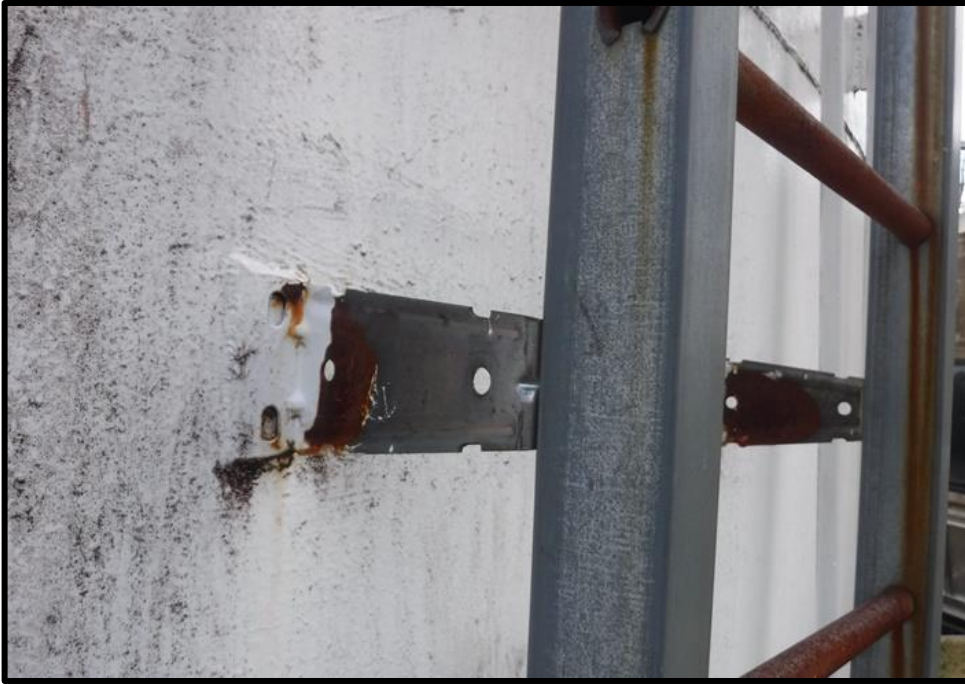
PHOTO 3.1-29 Corrosion on exterior shell ladder rungs and brackets.

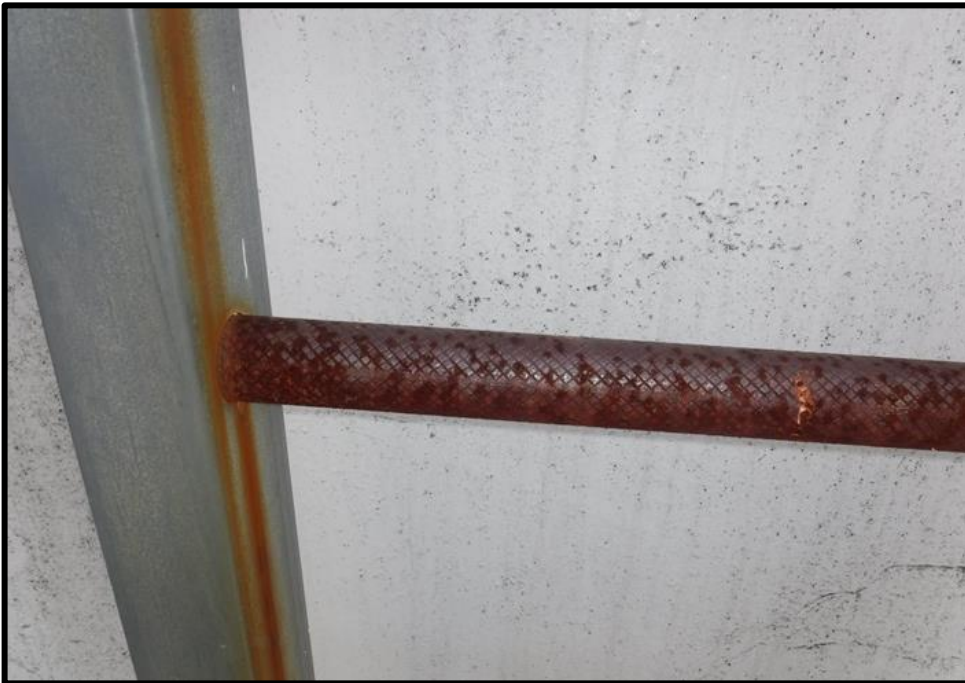
PHOTO 3.1-30 Corrosion and rust staining on the exterior shell ladder.

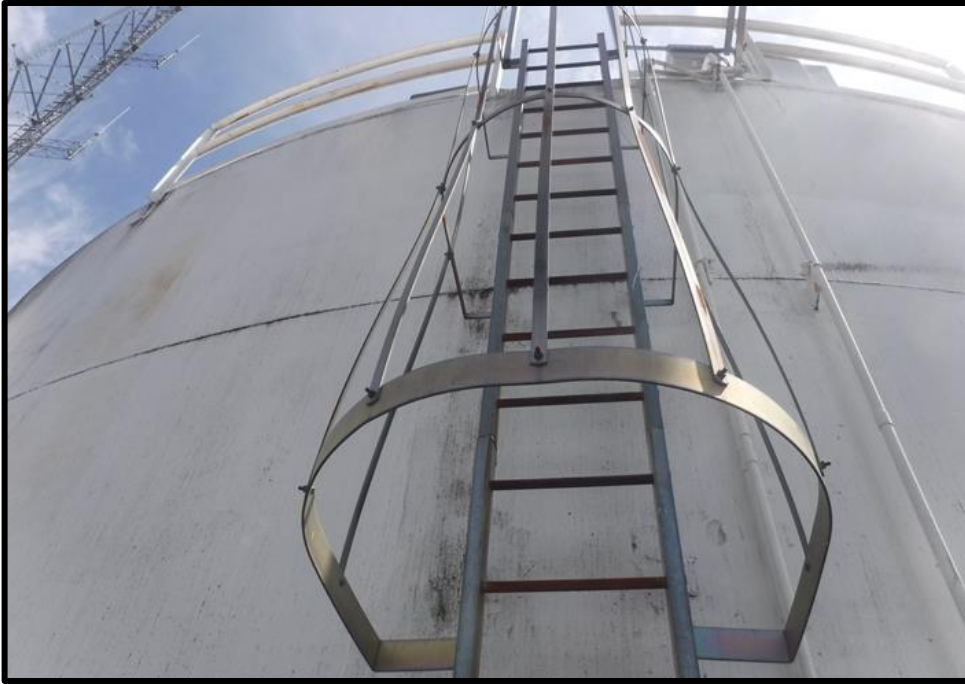
PHOTO 3.1-31 Exterior shell ladder and safety cage.

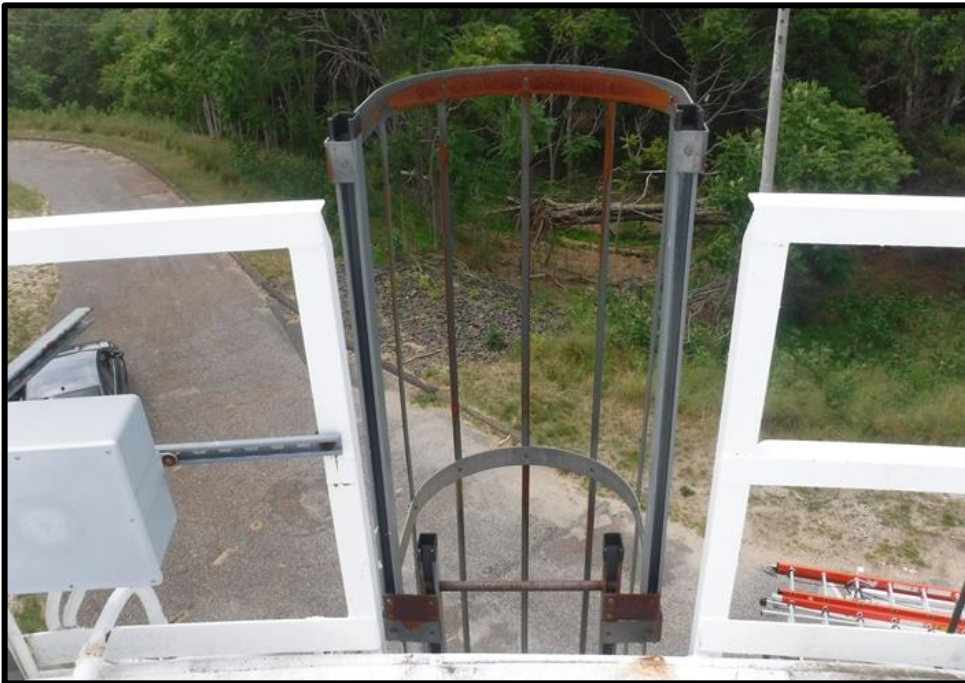
PHOTO 3.1-32 Roof access and safety railing.
