## **CR-NAVFAC EXWC-CIOFP-2129**

**2021 WATER TANK INSPECTION AND ASSESSMENT AT  
NAVAL WEAPONS STATION EARLE COLTS NECK, NEW  
JERSEY**

By  
TANK INDUSTRY CONSULTANTS  
June 2021

## **TANK 558**

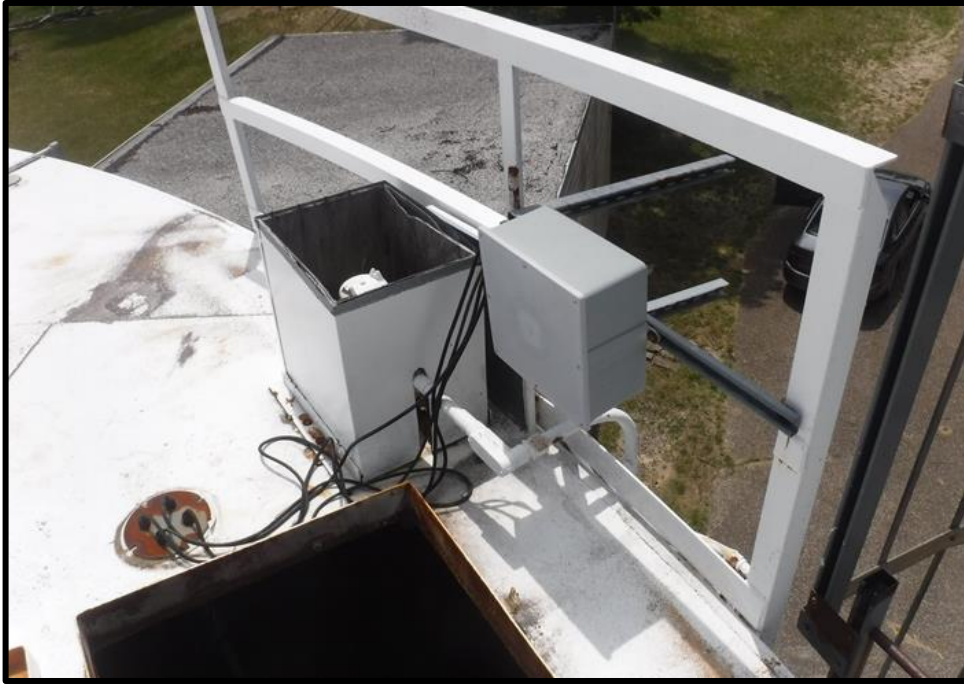
PHOTO 3.1-33 Electrical cabinet attached to the roof safety railing and water level indicating device within uncovered enclosure on the roof.

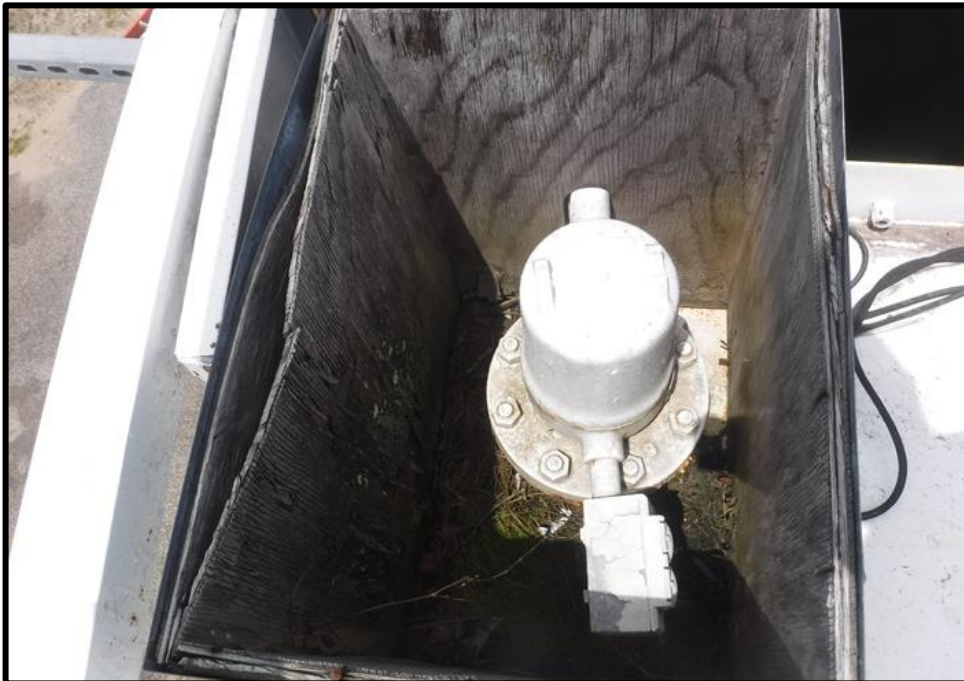
PHOTO 3.1-34 Capped water level indicating device equipment equipped with electrical outlets within uncovered enclosure on the roof.

**Level Indicating Device:** The electrical outlets at the level indicating device equipment on the roof should be equipped with ground fault interrupt circuits. The proper operation of the level indicating device should be verified. If the Owner does not wish to operate or replace the level indicating device floats and wires, all associated couplings, brackets, and components should be removed from the tank. Patch plates should be welded over the openings created by the indicating device removal. The patch plates should be completely seal welded on both the interior and exterior surfaces.

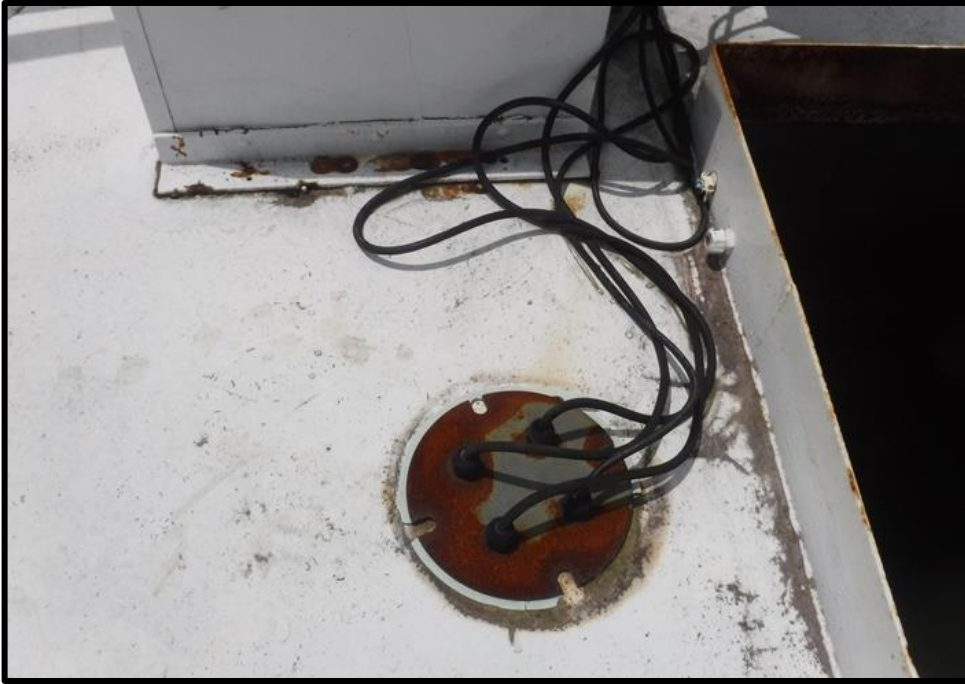
PHOTO 3.1-35 Wiring penetrating circular hand hole cover plate on the roof.

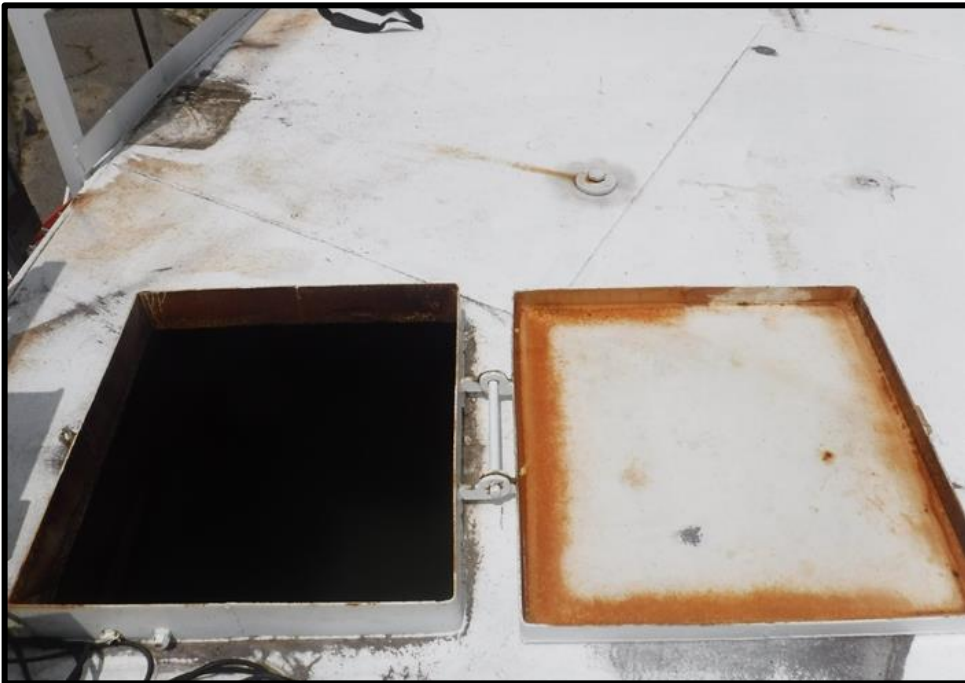
The roof is equipped with one hinged-cover manhole which is welded on the exterior and interior (See photos 3.1-36 and 3.1-37). Significant corrosion is present on the interior of the roof manhole cover and along the curb. Wires penetrate the roof manhole curb. The roof manhole was not locked prior to or after the field evaluation which is a safety-related and AWWA deficiency (AWWA D100-11 Sec. 7.4.3).

PHOTO 3.1-36 Corrosion on the interior of the roof manhole cover and curb.

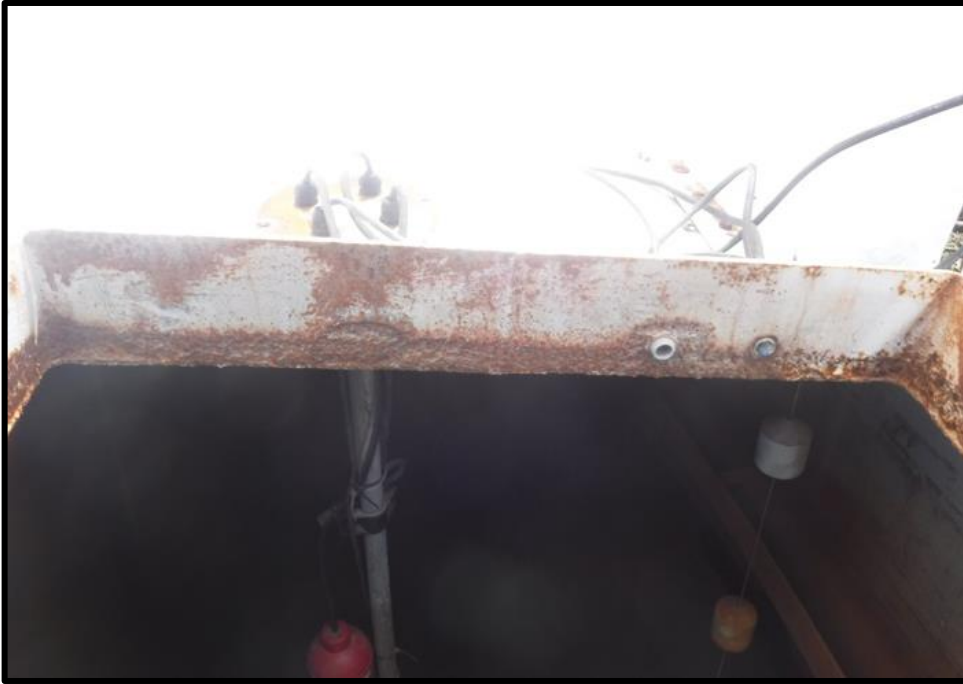
PHOTO 3.1-37 Corrosion on the roof manhole curb and wiring penetrating the curb.

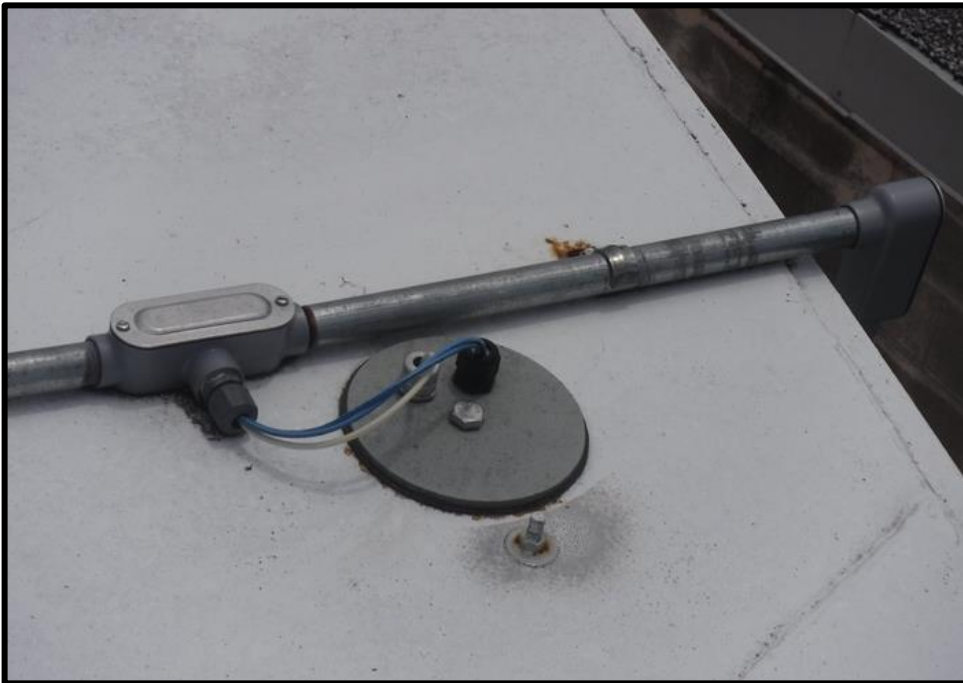
PHOTO 3.1-38 Wiring extending from conduit junction box penetrating circular hand hole cover plate on the roof.

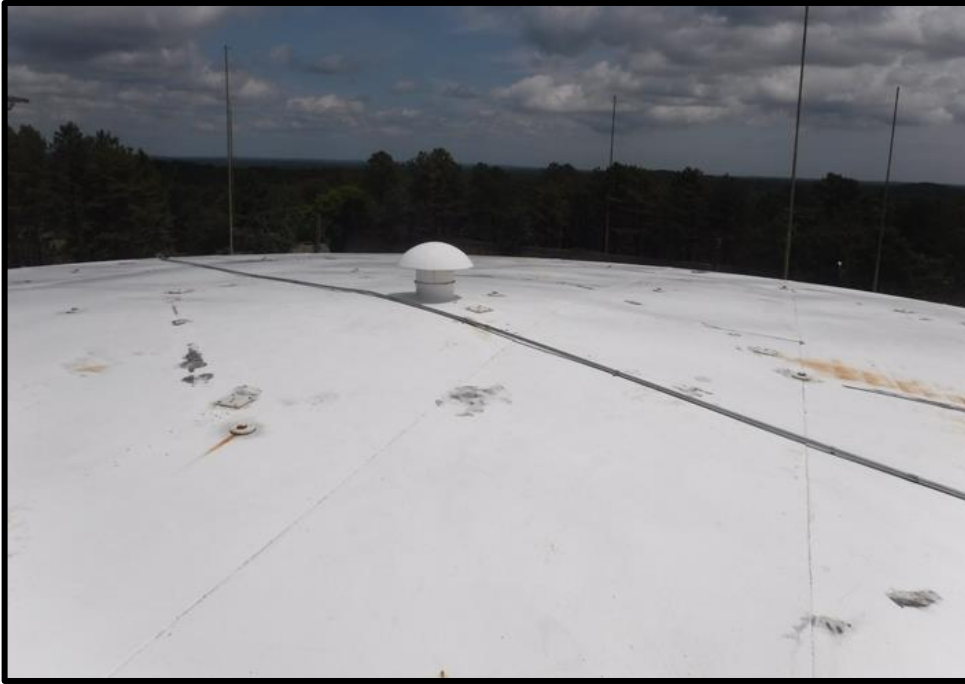
PHOTO 3.1-39 Conduit extending across the roof exterior.

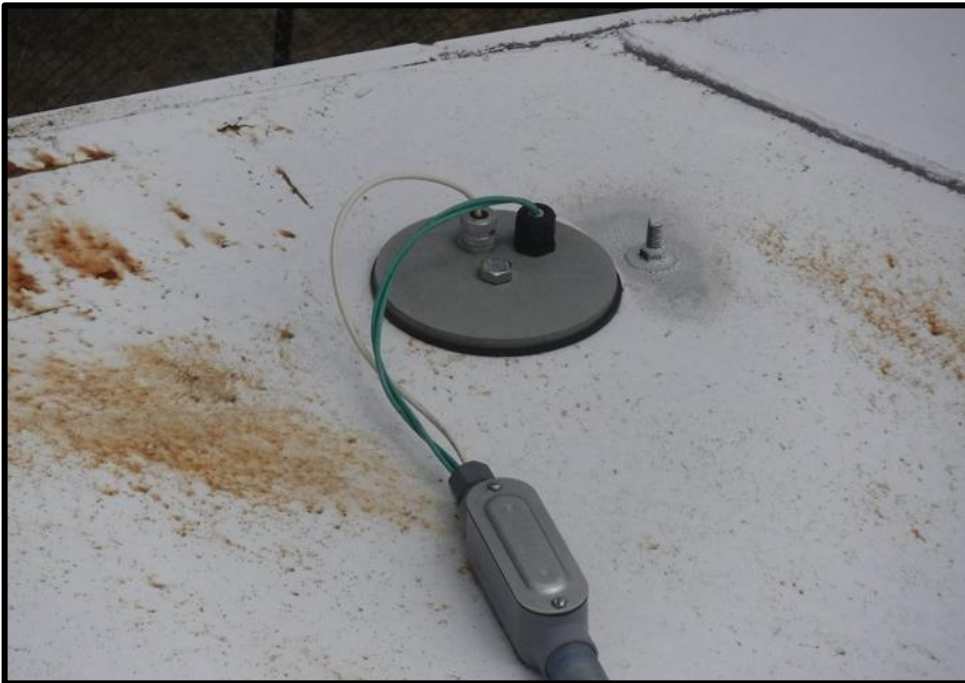
PHOTO 3.1-40 Wiring extending from conduit junction box penetrating circular hand hole cover plate on the roof.

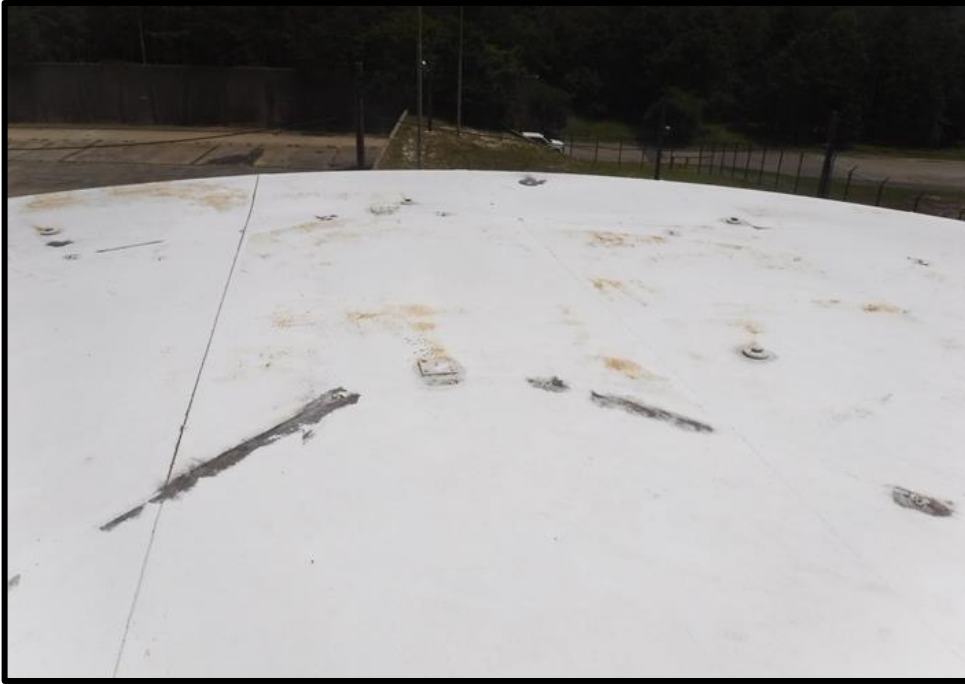
The contour of the roof is adequate. The exterior roof coating appears to be in fair to poor condition as corrosion is located on several areas of the roof (See photos 3.1-41 to 3.1-43). The roof coating has chalked, and debris is present in the coating. The roof coating has good adhesion to the underlying coating. Twenty circular hand holes and cover plates are located on the roof (See photos 3.1-38 to 3.1-40). A conduit extends across the roof, and wiring from the conduit junction boxes penetrates hand hole cover plates on the roof (See photos 3.1-38 to 3.1-40). Several unused conduit brackets are bolted to the roof. Seventeen rectangular cover plates are bolted to the roof, and corrosion is present on the plates (See photo 3.1-46). These plates are equipped with gaskets, but the gaskets have deteriorated. Several bolts are missing from these plates. Threaded and plugged couplings are located on the roof, and corrosion is present on the couplings (See photo 3.1-47). Nine studs are located in the roof, and sealant is located around the bolts (See photos 3.1-44 and 3.1-45).

PHOTO 3.1-41 Corrosion on areas of the roof exterior.

**Life of the Exterior Coating:** The coating on the exterior of the tank appears to be in fair to poor overall condition as corrosion is located on several areas of the roof and shell. Tank Industry Consultants recommends the exterior should be recoated within the next 2 to 3 years.

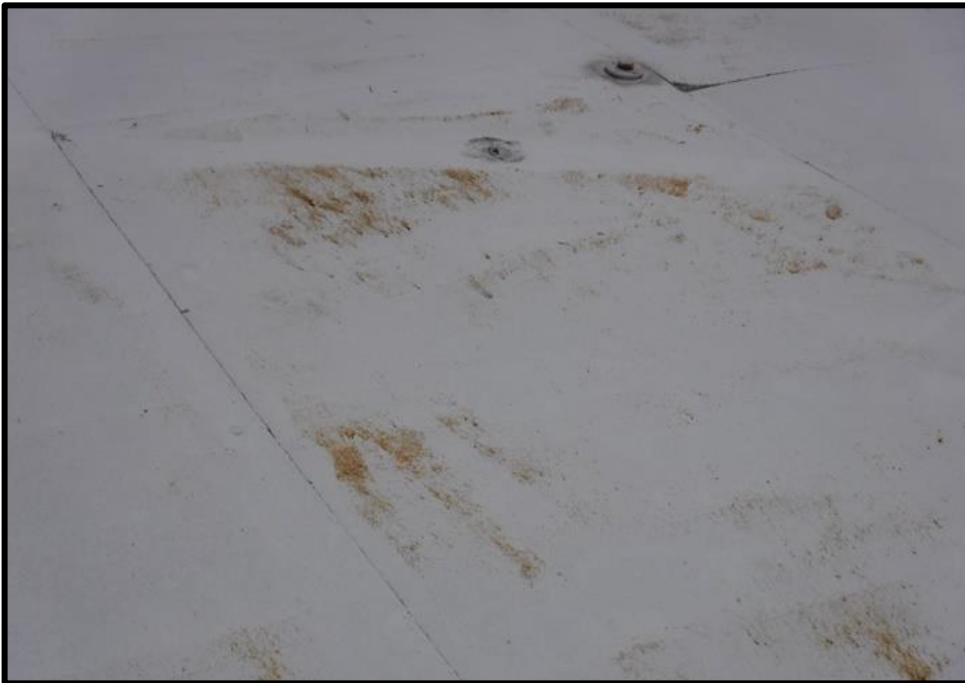
PHOTO 3.1-42 Corrosion on areas of the roof exterior.

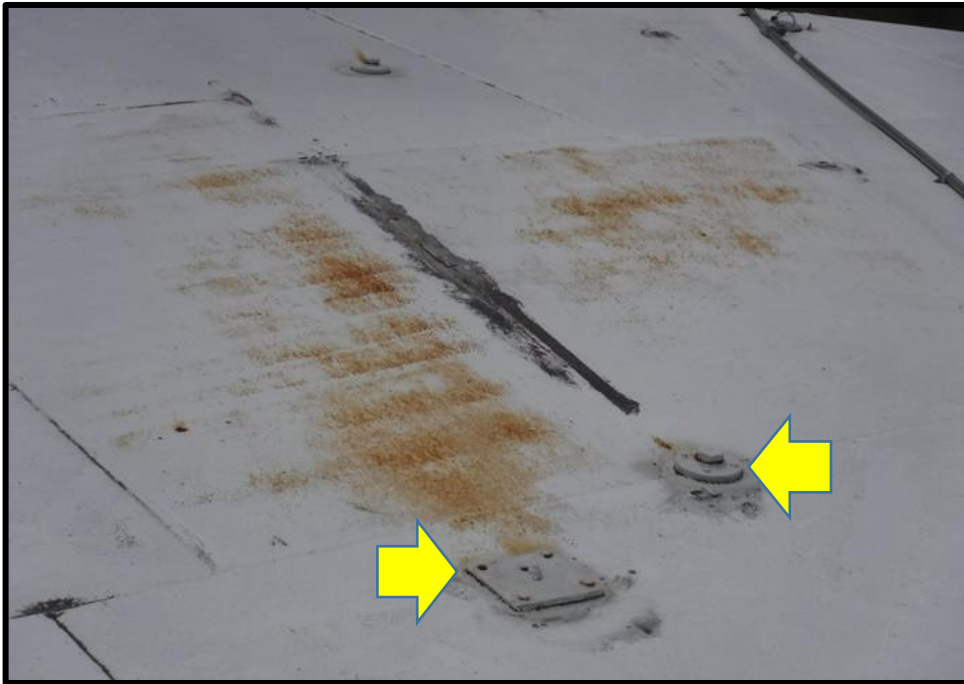
PHOTO 3.1-43 Corrosion on areas of the roof exterior. Note threaded and plugged coupling and bolted rectangular plate on the roof exterior.

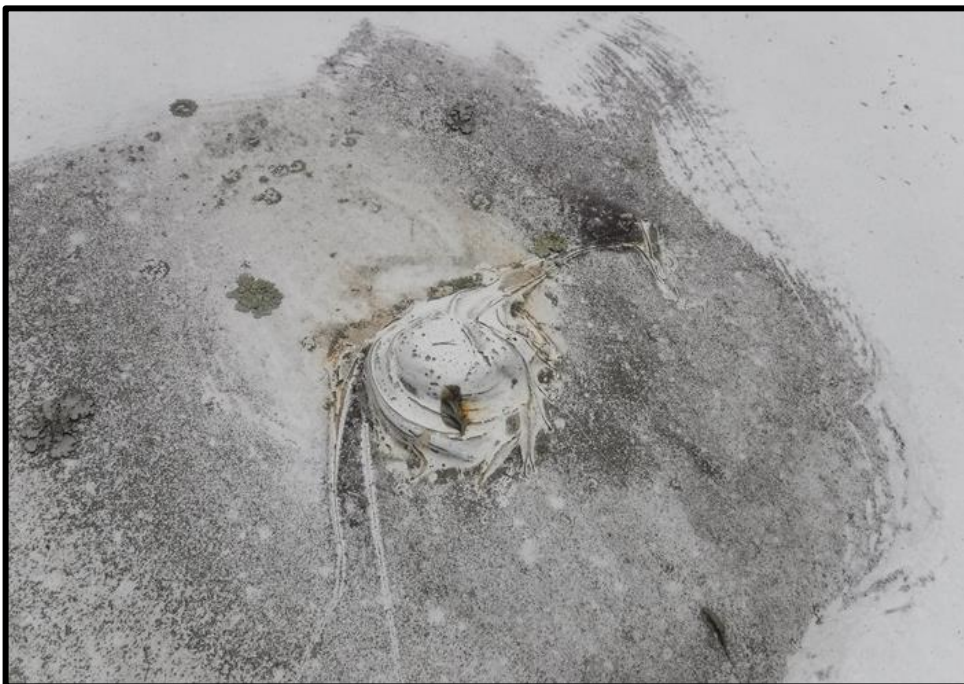
PHOTO 3.1-44 Sealant around bolt in the roof.

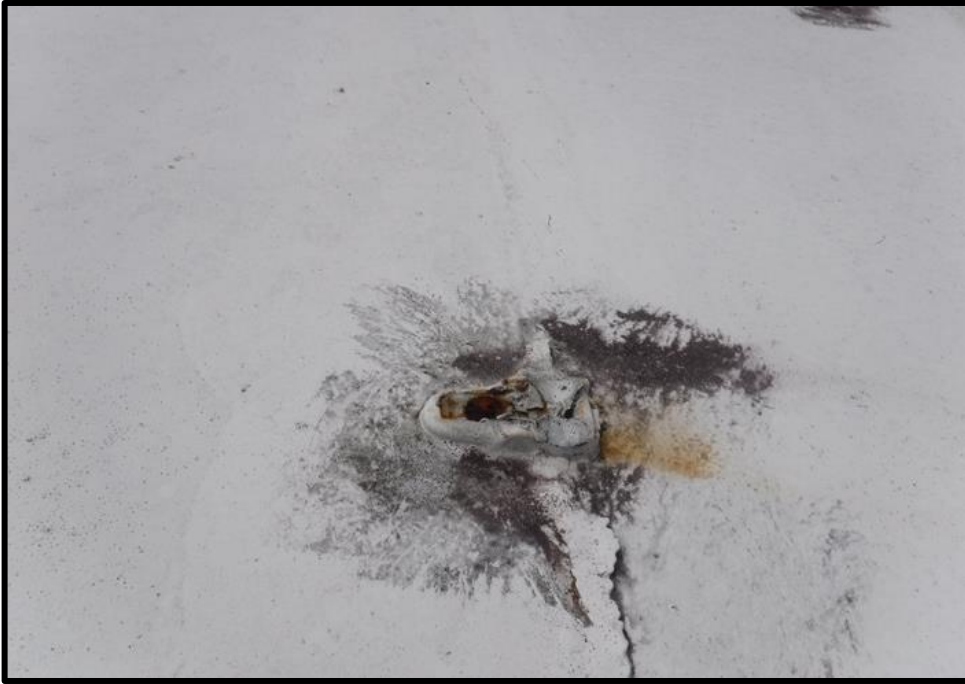
PHOTO 3.1-45 Sealant around rusty stud in the roof.

**Cover Plates on Roof:** The missing or rusty bolts on the bolted cover plates on the roof should be replaced. The existing gaskets at the cover plates should be replaced with new ones.

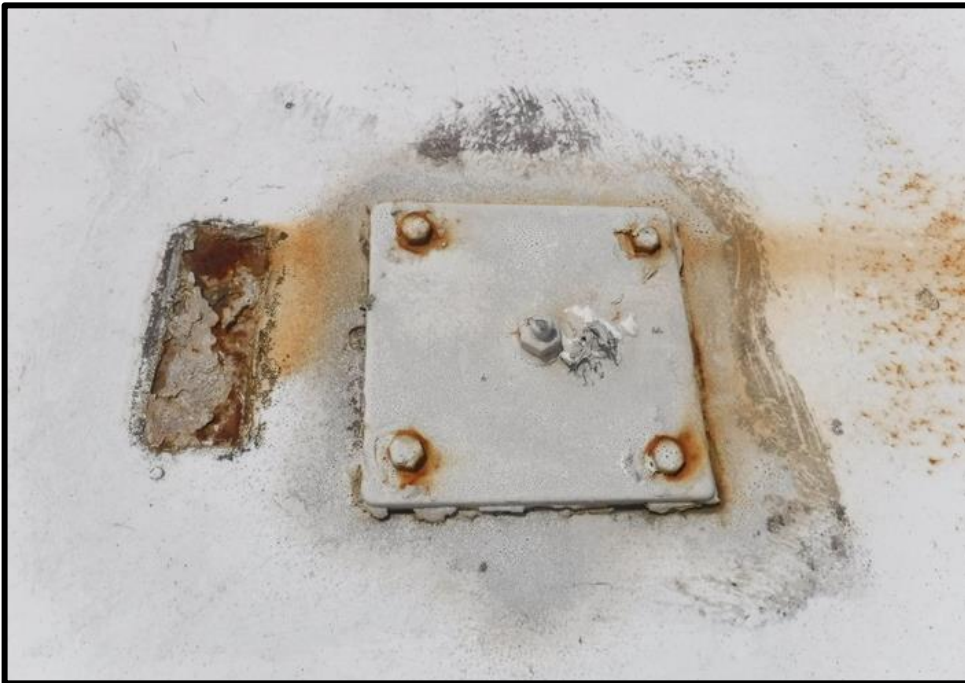
PHOTO 3.1-46 Corrosion on bolted rectangular plate on the roof exterior. Note deteriorated gasket.

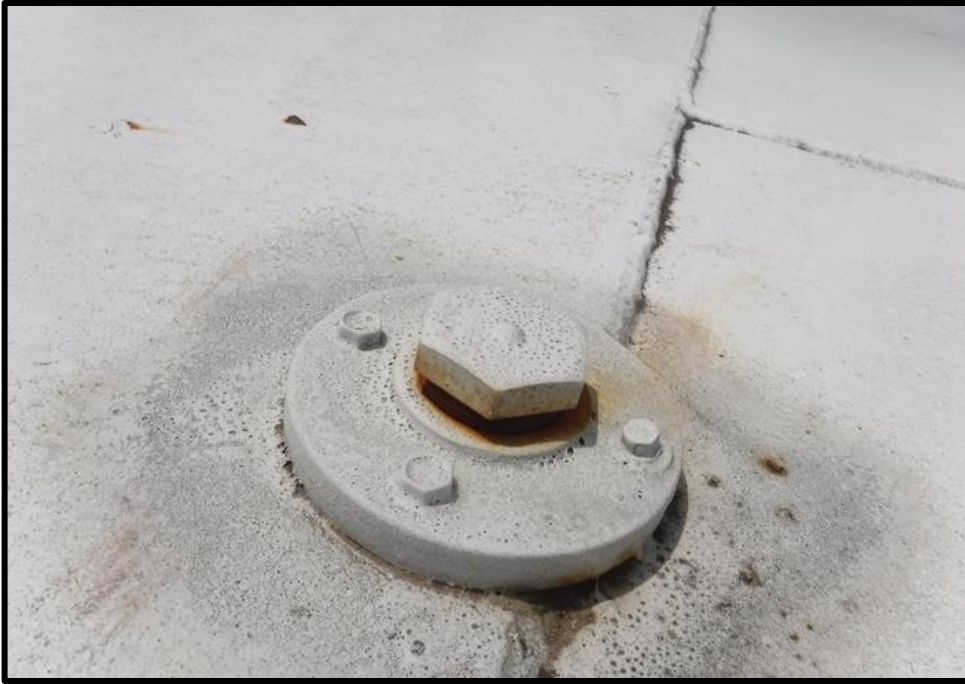
PHOTO 3.1-47 Corrosion on threaded and plugged coupling on the roof.

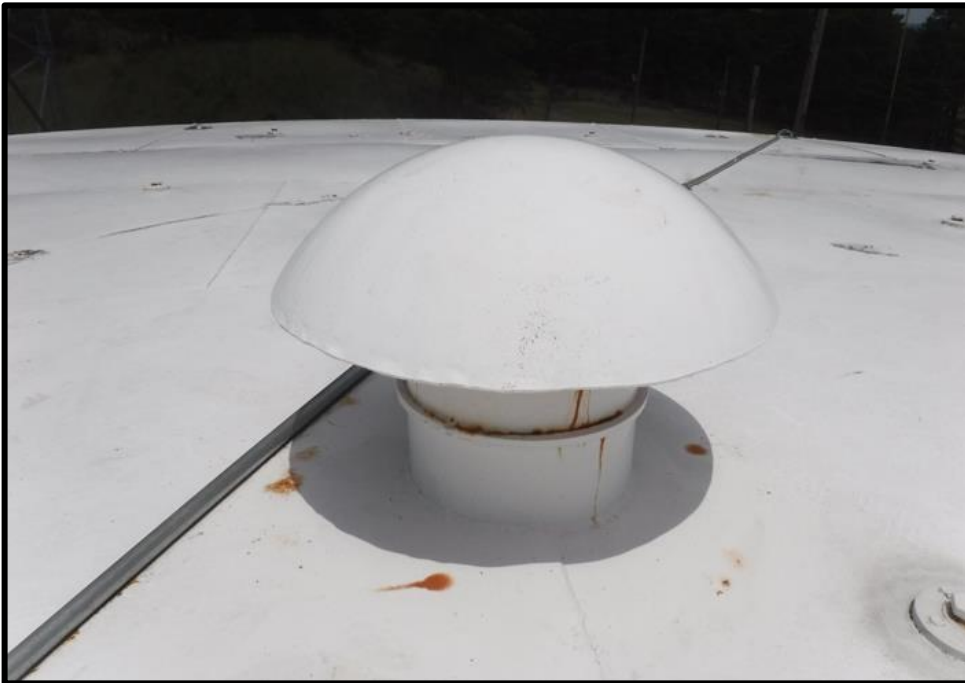
PHOTO 3.1-48 Roof vent.

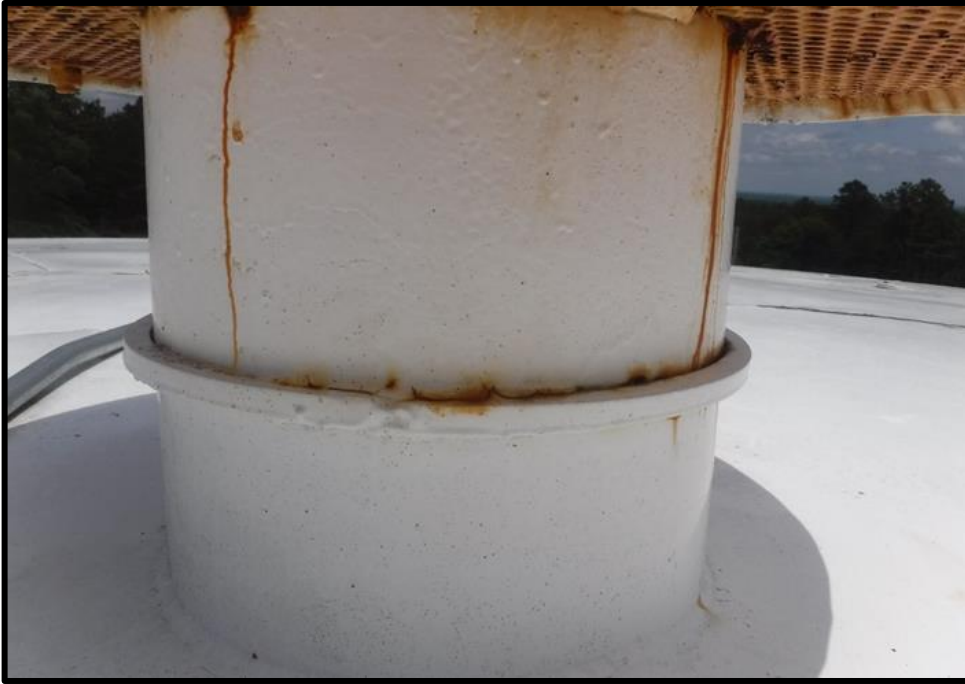
PHOTO 3.1-49 Rust staining on the roof vent neck and corrosion along stiffener.

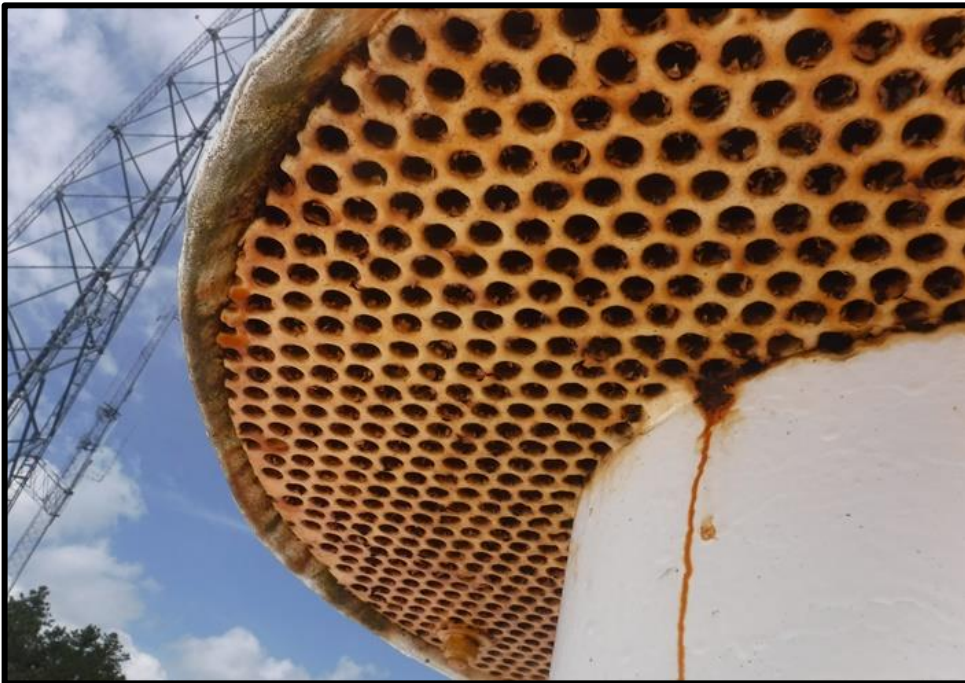
A mushroom-cover vent is located near the center of the roof (See photos 3.1-48 to 3.1-50). The roof vent neck is equipped with a flat bar stiffener (See photo 3.1-49). The roof vent is equipped with horizontally-oriented perforated plate screening, and widespread corrosion and rust staining are present on the perforated plate (See photo 3.1-50). The roof vent is not clog-resistant which is an AWWA and operational deficiency (AWWA D100-11 Sec. 7.5).

PHOTO 3.1-50 Widespread corrosion on roof vent perforated plated screening.

**Clog-Resistant Vent:** The tank is not equipped with a clog-resistant vent. AWWA Standards recommend that all vents with screening against insects be designed to ensure "fail-safe" operation if the insect screens become occluded. Inadequate ventilation could cause a tank collapse if the tank is rapidly drained while the screen is occluded or frosted over. Therefore, a clog-resistant vent should be installed near the center of the roof. The existing vent opening should be equipped with a large flanged opening for evaluating, cleaning, repairing, and painting the interior roof structure ends and the center hub. The flanged opening will then be used to mount a clog-resistant vent at the center of the roof. The vent should be designed so that it is removable in order to access the ends of the roof rafter and center hub.

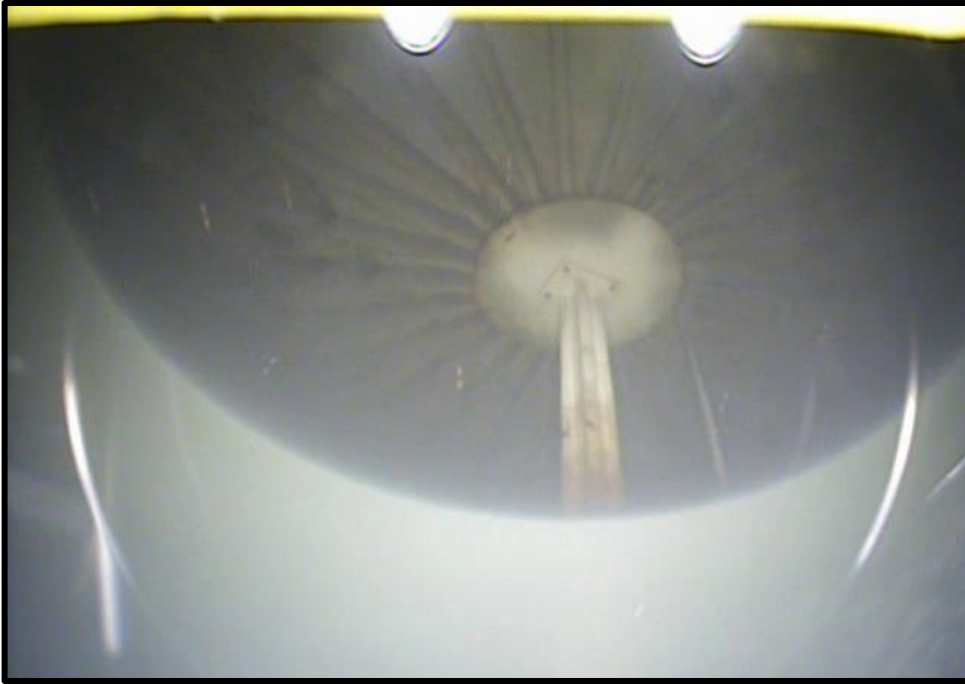
PHOTO 3.1-51 Roof interior and support structure.

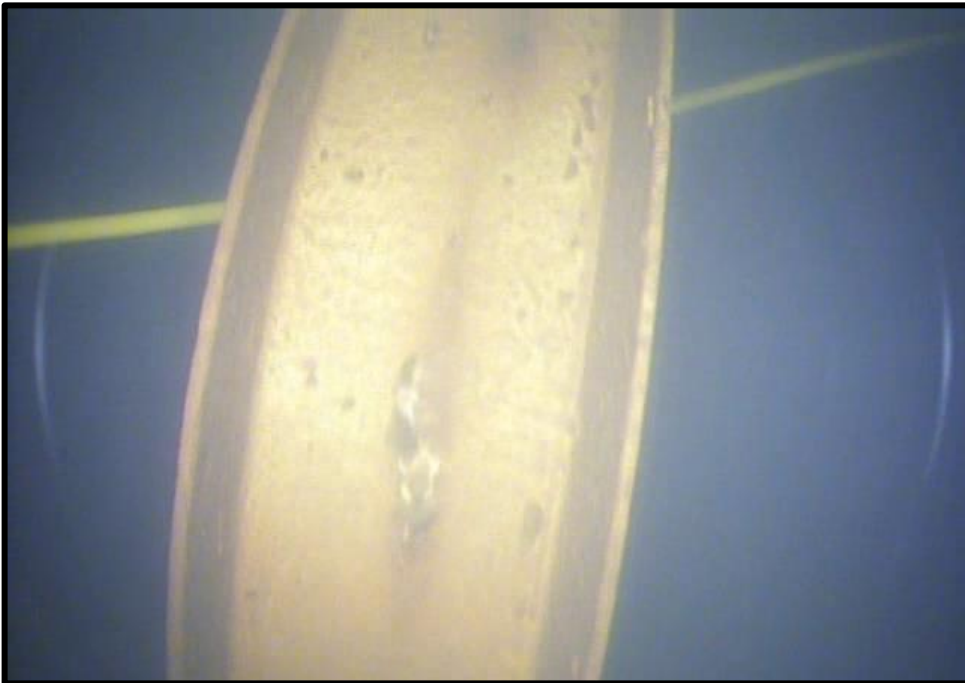
PHOTO 3.1-52 Spots of corrosion on the center column.

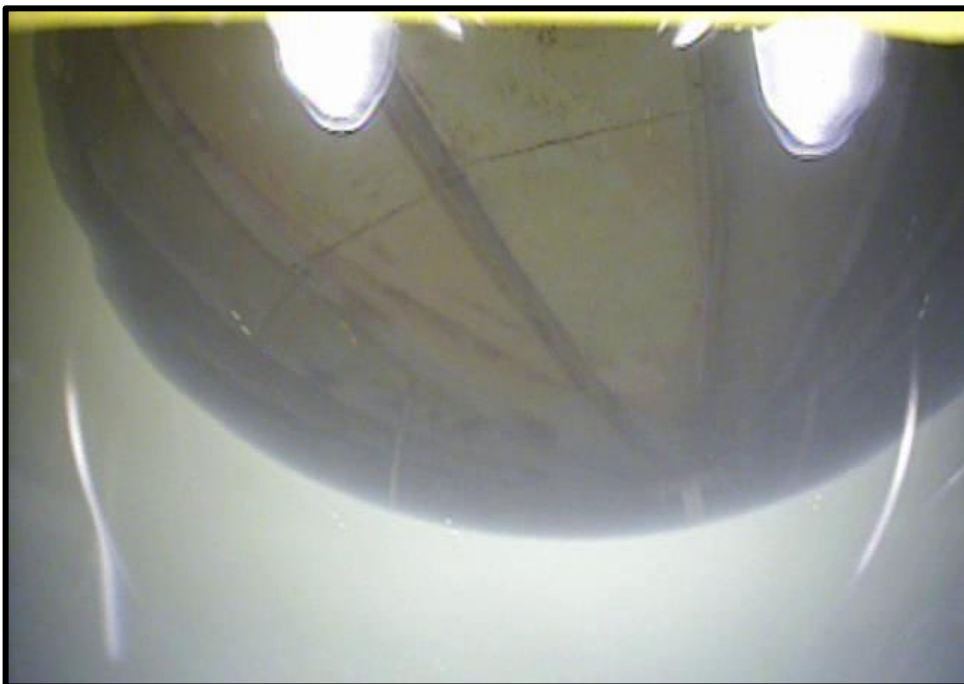
PHOTO 3.1-54 Roof interior and support structure.

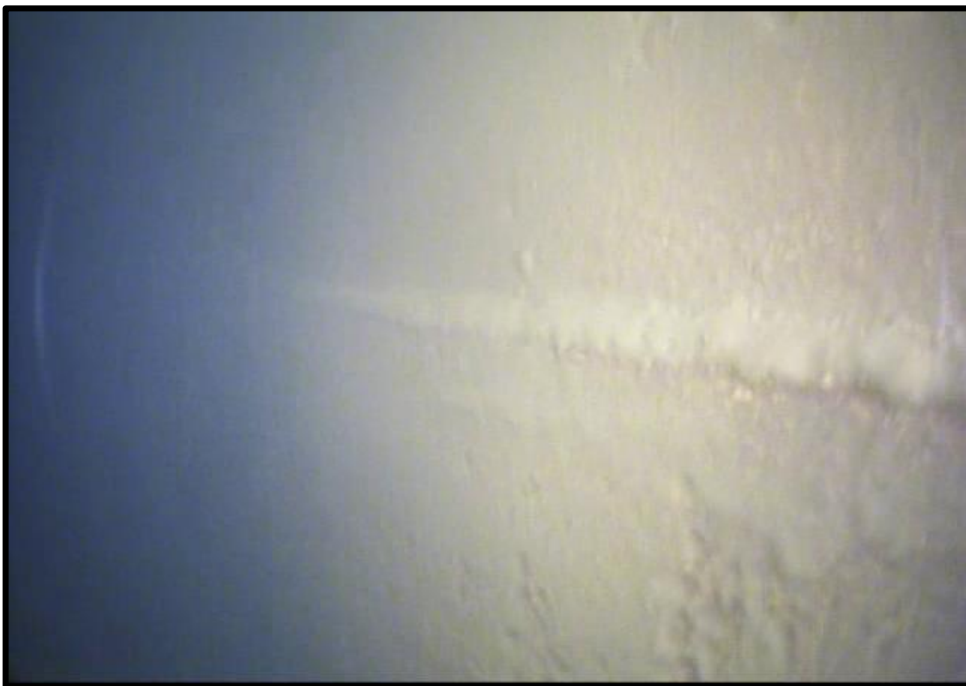
From the limited area observed during the ROV evaluation, the coating on the interior shell appears to be in fair to poor condition as corrosion and pitting which had occurred prior to the previous repainting are located on areas of the shell (See photos 3.1-56 and 3.1-57). Dirt is present on the shell.

PHOTO 3.1-56 Pitting in shell interior.

**Life of the Interior Coating:** The interior surfaces should be drained and inspected before the rehabilitation of the tank. The interior coating appears to be in fair to poor overall condition as corrosion is located on areas of the roof, support structure, and shell. Tank Industry Consultants recommends the interior should be recoated within the next 2 to 3 years. When the interior is repainted, an epoxy coating system should be used.
