## MEMORANDUM

**Subject:** Asbestos Survey / Building A, 4<sup>th</sup> Floor

**Date:** February 9, 2023

**Subject:** NARA 4<sup>th</sup> Floor Archive Storage Lead Survey

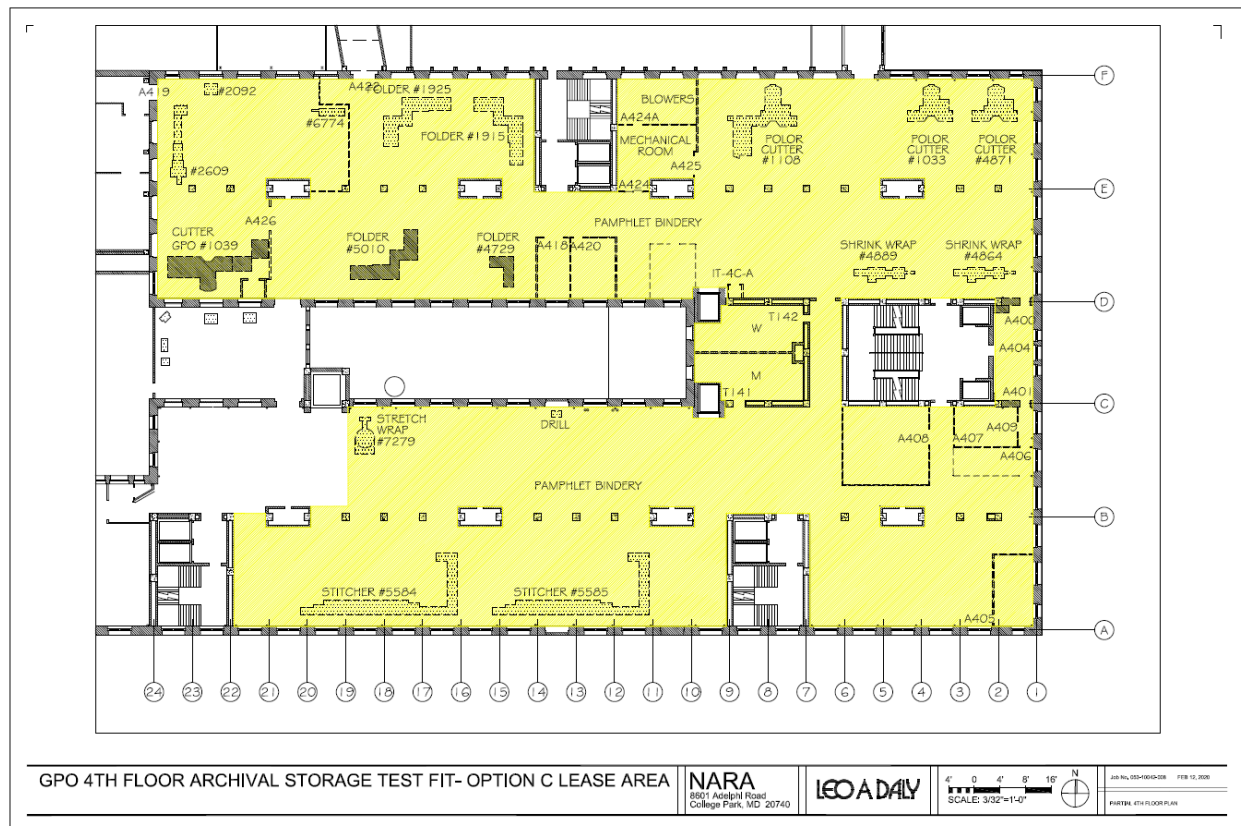
The GPO Safety Branch evaluated the spaces highlighted in the drawing seen below for the presence of asbestos containing materials (ACM) that may interfere with the construction / demolition tasks of converting this area of the building into Archival Storage for a tenant, the National Archives and Records Administration.

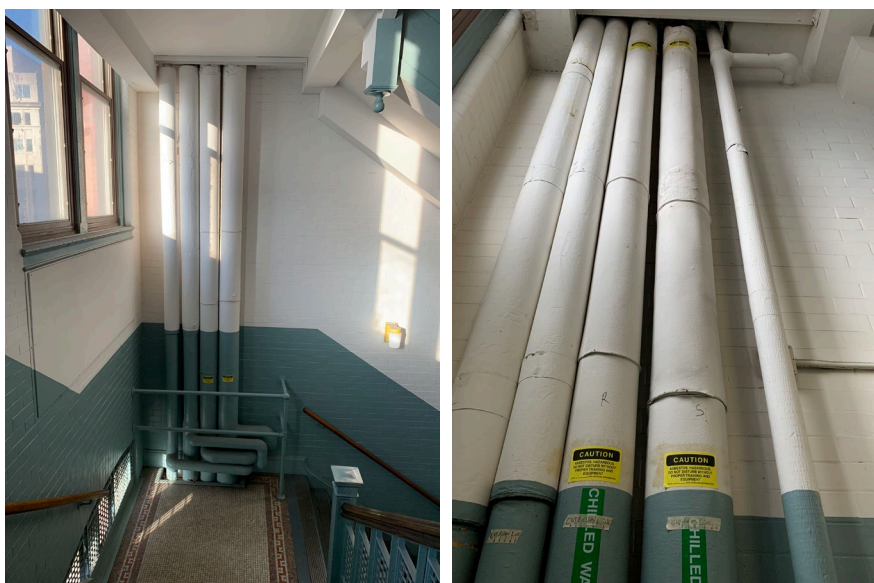
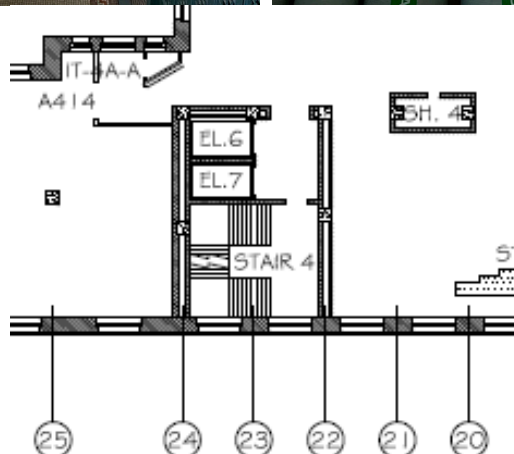
- 1) Stairway 4: Vertical chilled water pipes wrapped in TSI containing ACM, with branch pipes feeding the 4<sup>th</sup> Floor that are also wrapped in TSI with ACM.

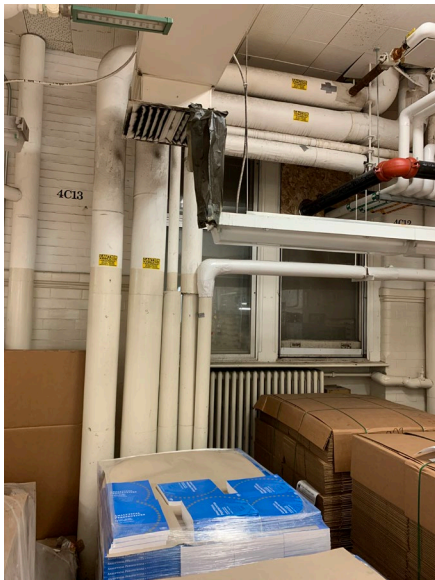
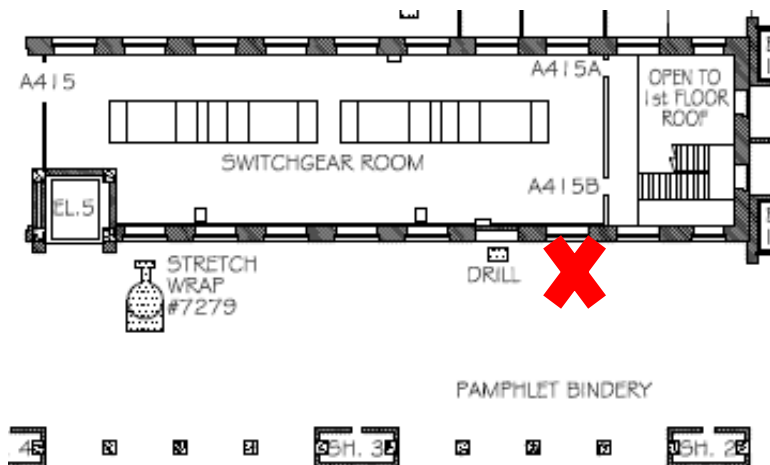
- 2) Column 4C13: Chilled water pipes wrapped in TSI with ACM.

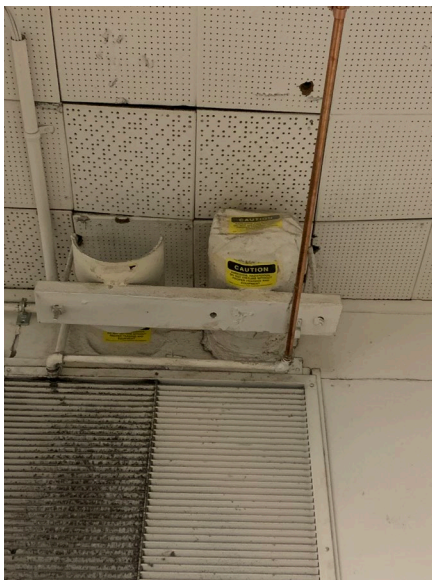
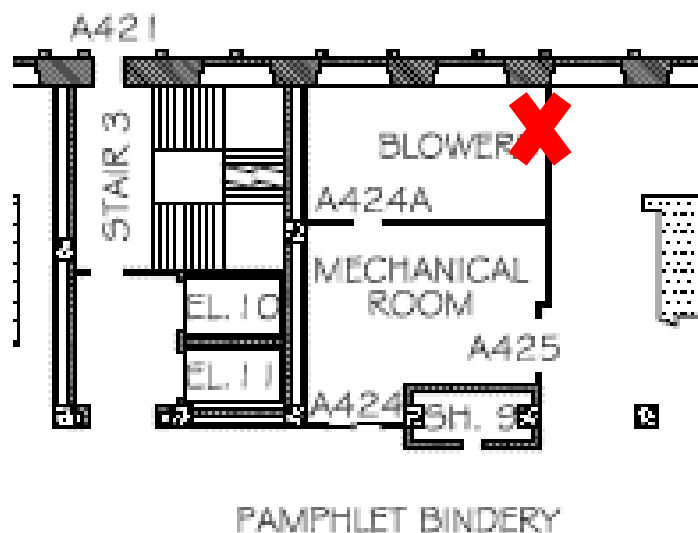
- 3) A424A, East wall: Chilled water pipes wrapped in TSI with ACM.

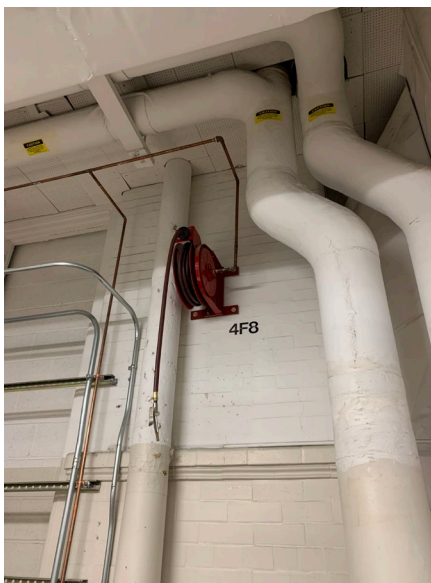
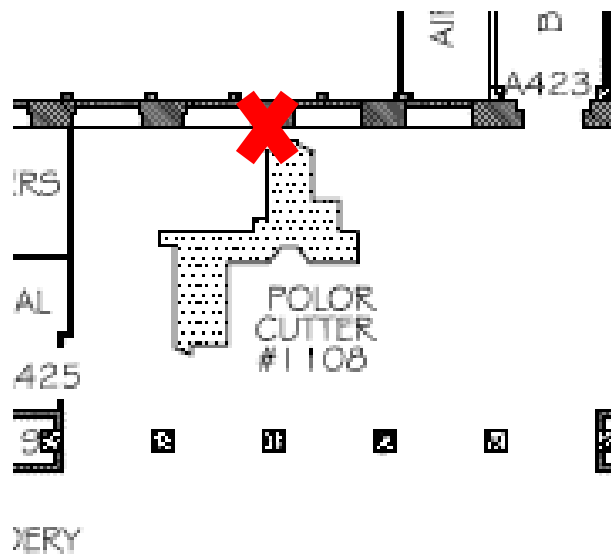
- 4) Column 4F8: Chilled water pipes wrapped in TSI with ACM.

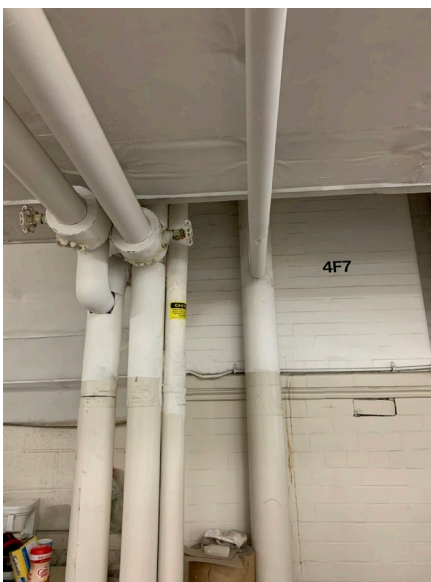
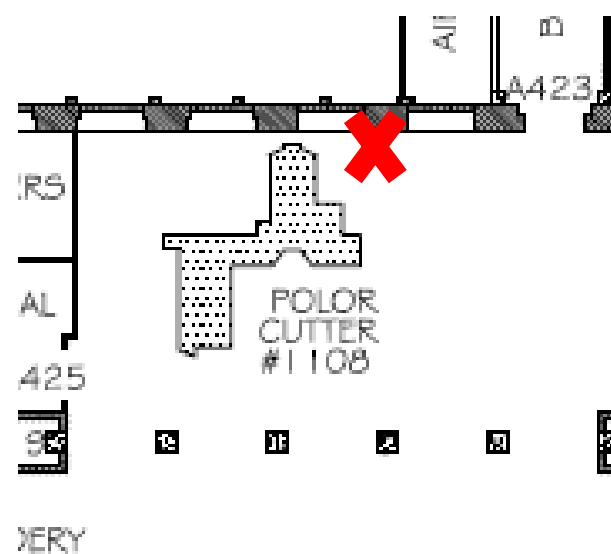
- 5) Column 4F7: Hot water pipes wrapped in TSI with ACM.

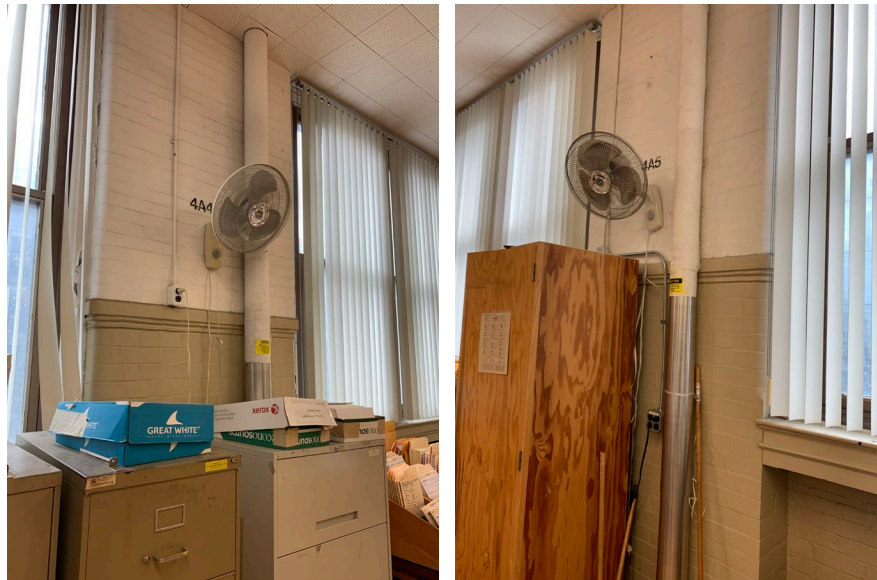
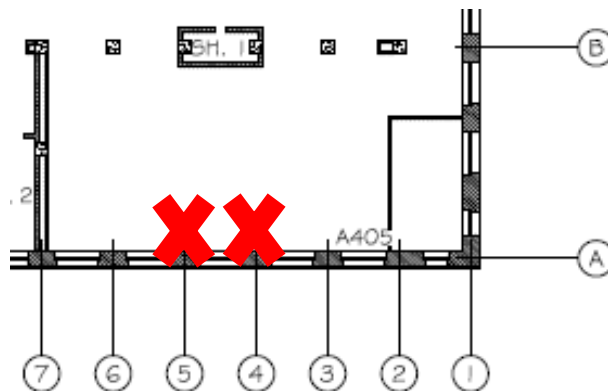
- 6) Columns 4A4 / 4A5: Rain leader pipes wrapped in insulation with ACM.

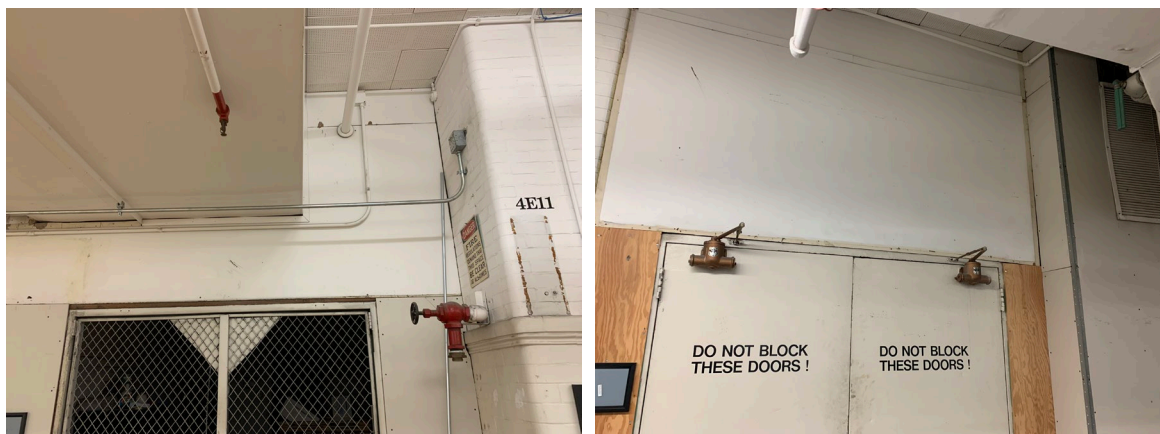
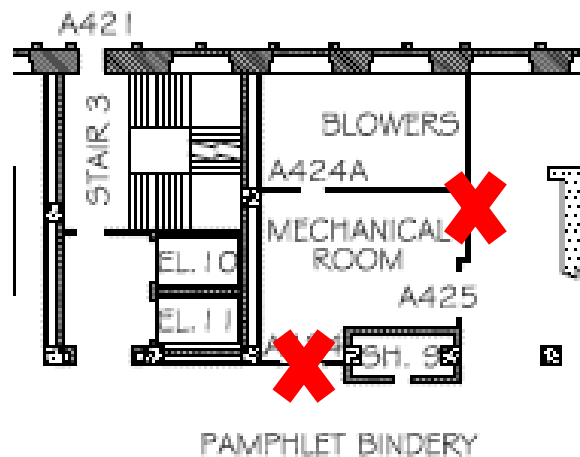
- 7) A424 / A424A / A425: Asbestos-containing, cement-board material (Transite) secured to the metal cage and used as wall boards:

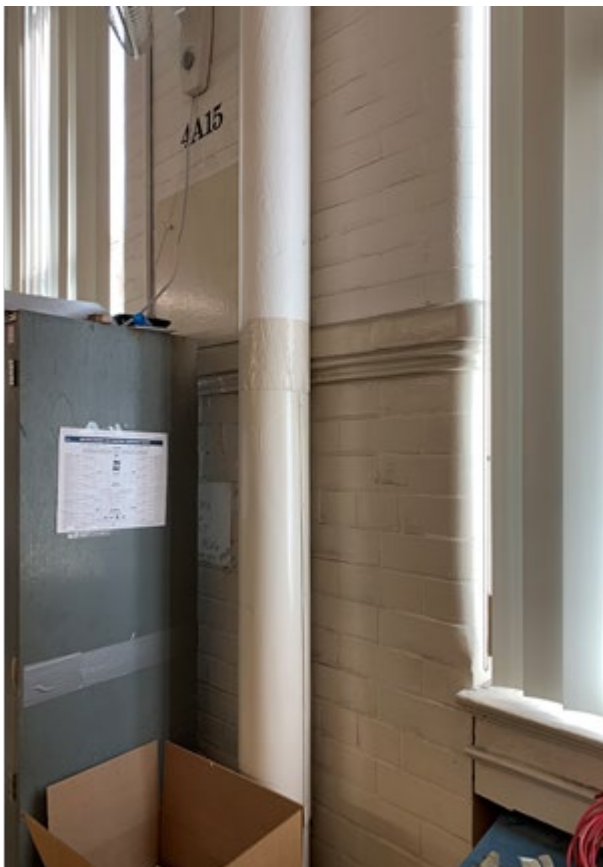
- a) The IH was not able to access the ceiling of the 4<sup>th</sup> floor, Bldg. A. Kindly notify the IH if the ceiling will be impacted so that XRF testing can be done.
- b) The pipes have typically 2 surfaces. The lower half has a metal guard while the upper part has a pipe wrap surface. Both surfaces tested negative for lead based paint.

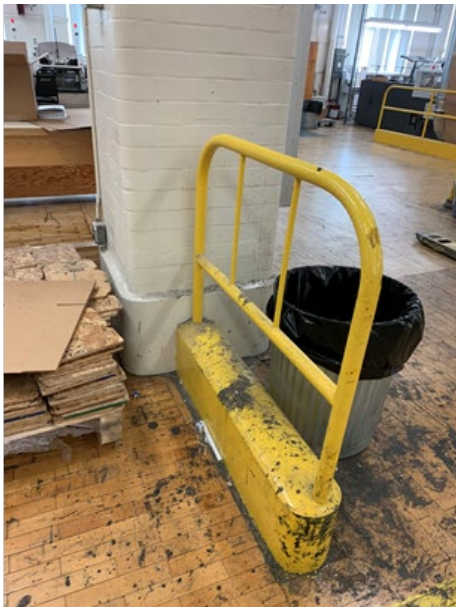
- d) Footer refers to the architectural component found at the base of safety railings, walls and columns
