## TASK GROUP INSTRUCTION

| <b>DDG-115</b> | <b>USS RAFAEL PERALTA</b> | | <b>K61</b> | | |
| CU PHASE TITLE:<br><b>F/O - ACCOMPLISH REPLT OF WTRTT DOOR 01-240-1 &amp; REPAIR OF DEFECT IN 01-240-1-A</b> | | | | | |

1.1 Title: Replacement of Watertight Door 01-240-1 and Repair of Defect on Collar Plate, Stuffing Tube, and 02 Level Deck Plating in 01-240-1-A; accomplish

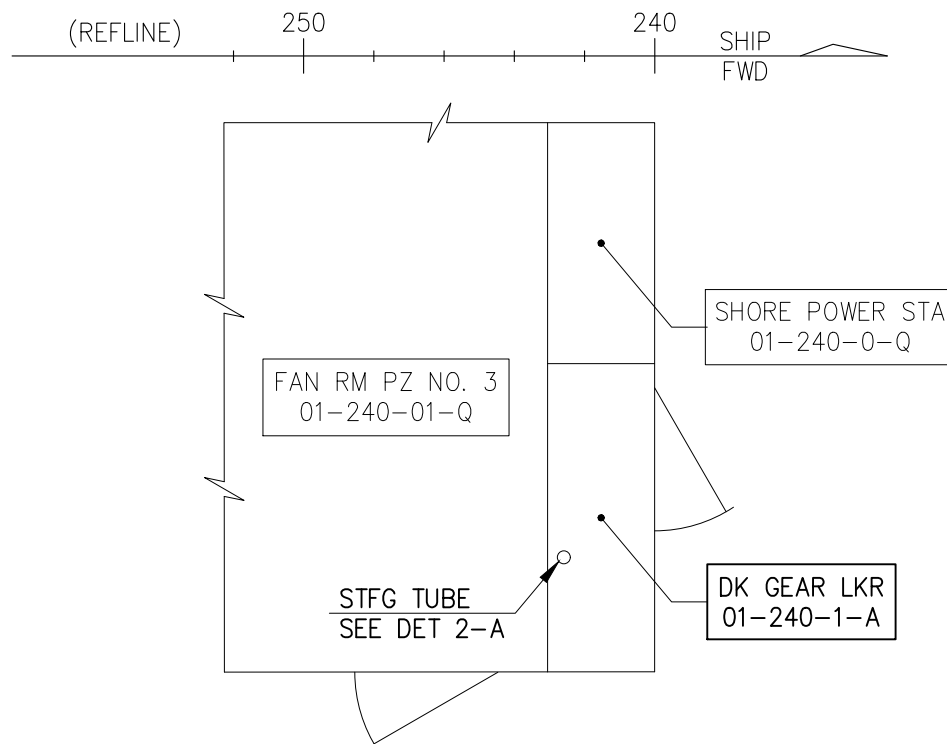
KEY PLAN

# LOCATION OF DEFICIENT WELD & MECH DAMAGE IN 01-240-1-A

**DET 1-B**  
DEFICIENT WELD ON  
COLLAR PLATE

**DET 1-D**  
MECH DAMAGE ON  
02 LVL DK PLTG

5.8 Accomplish weld repair of deficient weld of each existing collar plate and stuffing tube listed in 1.3.4 and 1.3.5 in accordance with Enclosure-01, using 2.7 and 2.9 for guidance.

5.9 Accomplish build up weld of mechanical damage on each existing deck plating listed in 1.3.6, using 2.7 for guidance.

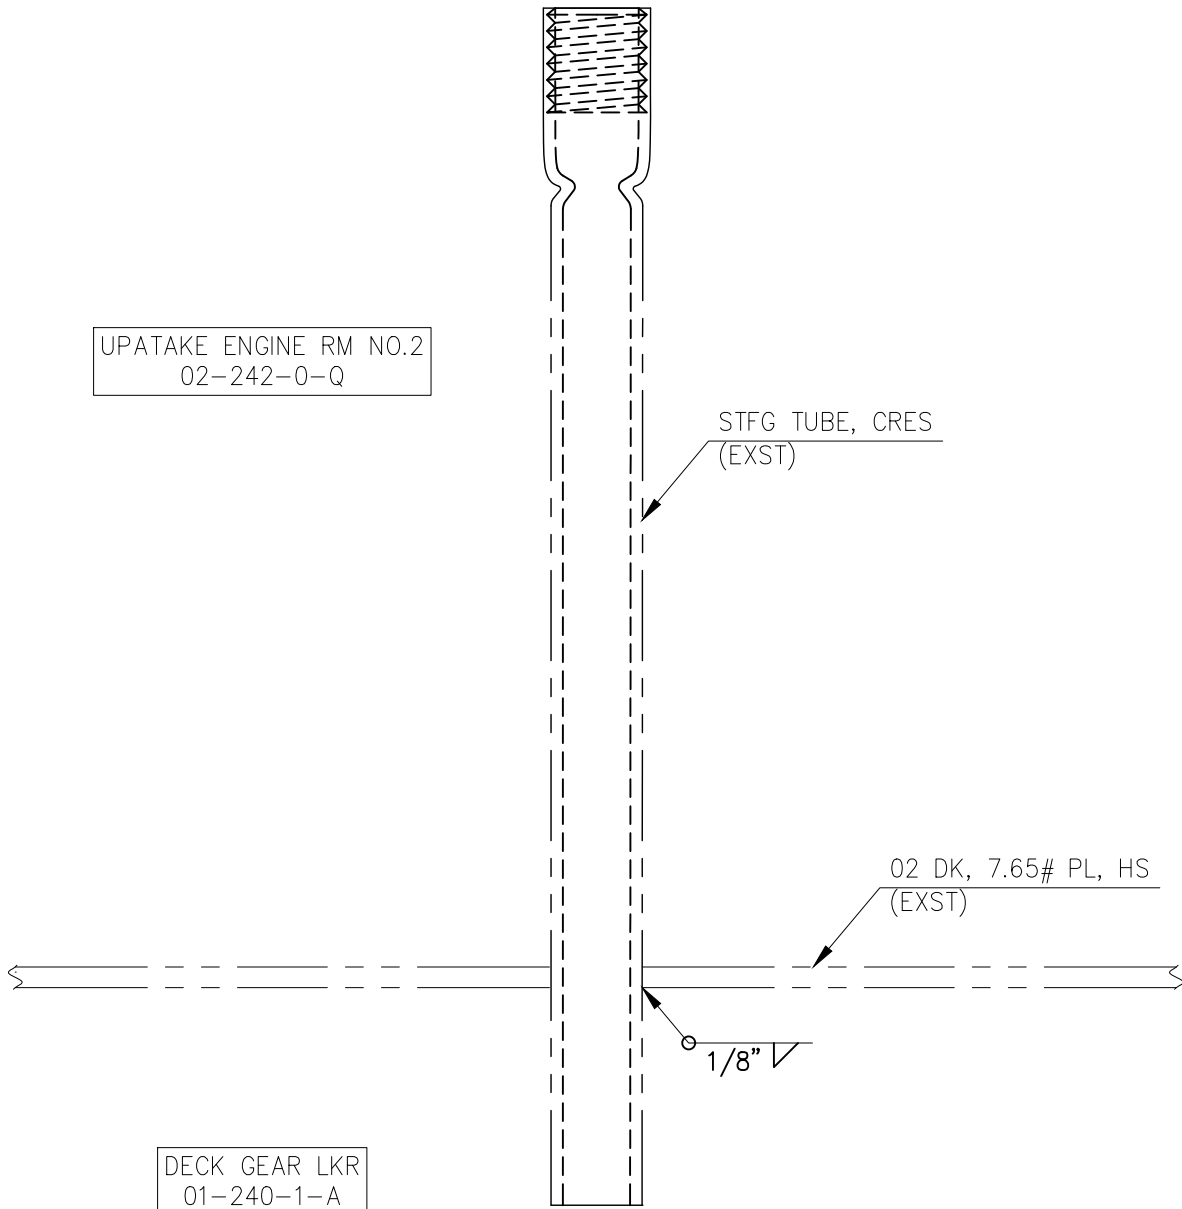
DET 2-A

STFG TUBE

01 LVL, FR 243, OVHD, STBD

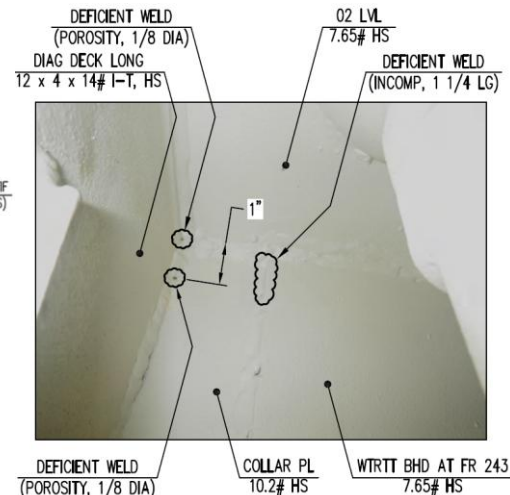
### 1.3.4 Quantity (One Lot), Collar Plate, Watertight in 01-240-1-A, Frame 243

5.8.1 Gouge out deficient welds.

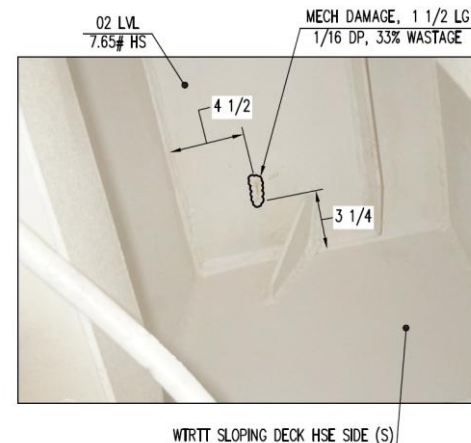
### 1.3.6 Quantity (One Lot), Deck Plating, 02 Level Deck Plating in 01-240-1-A, between Frames 241 and 242, and Longitudinal No. 6S and House Side Bulkhead Plating
