# Limited Hazardous Materials Survey

## Building 2652

2652 Harney Path  
JBSA – Fort Sam Houston, Texas 78234

Project No. 26-09-00191.00

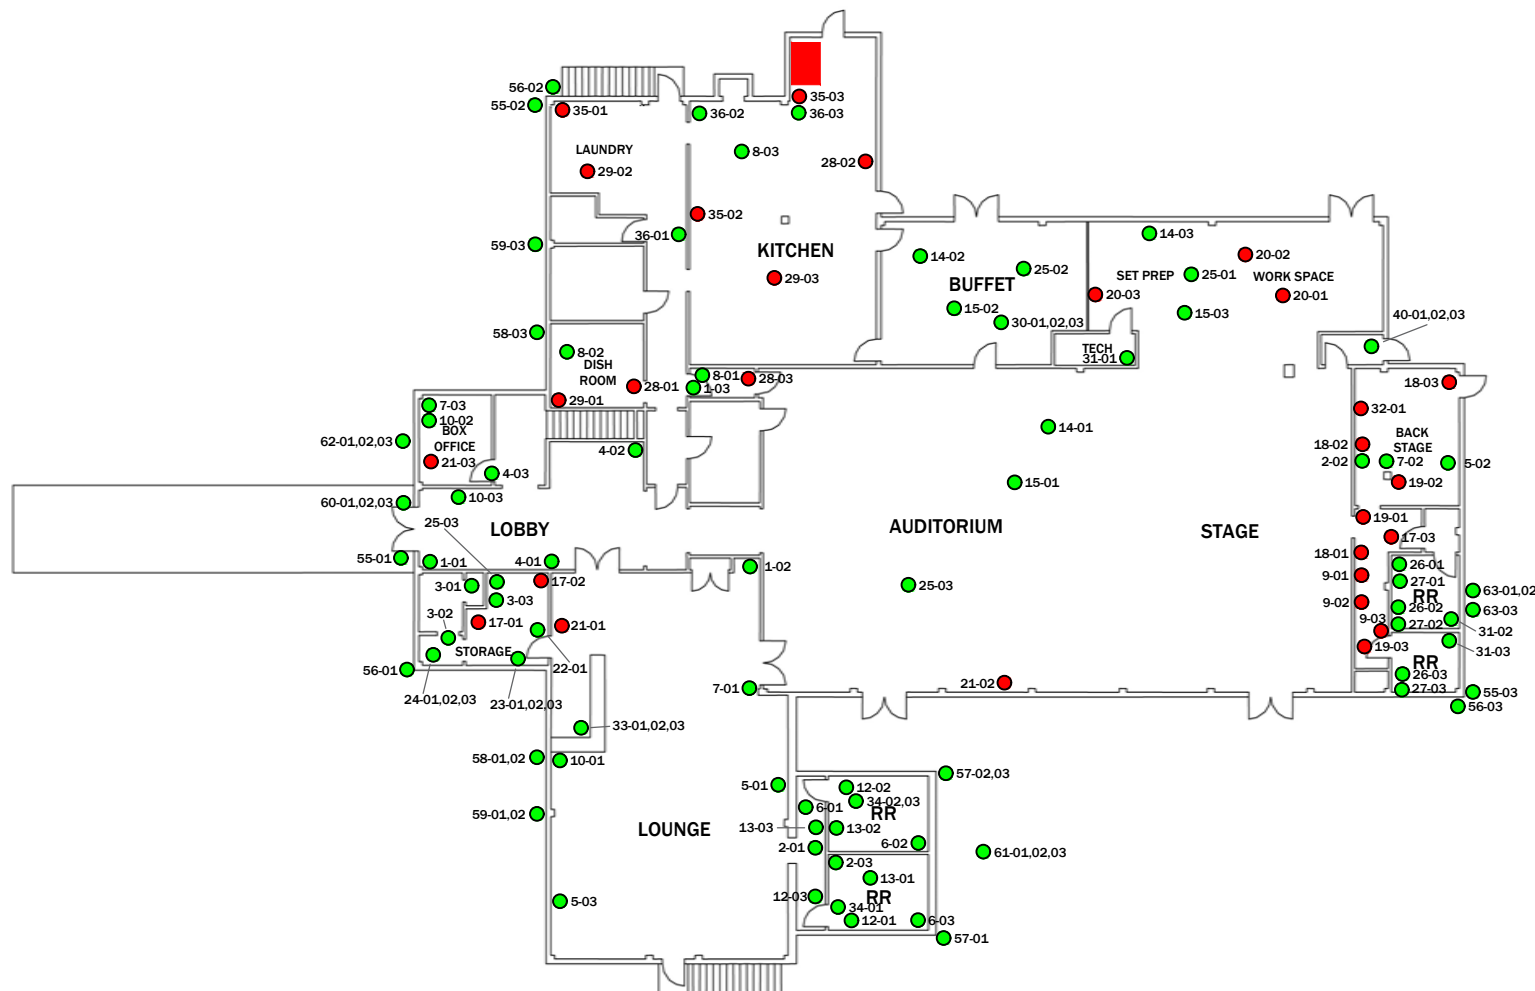
JBSF - 2652 / Floor: 1

**ASBESTOS CONTAINING MATERIALS  
SAMPLE LOCATIONS**

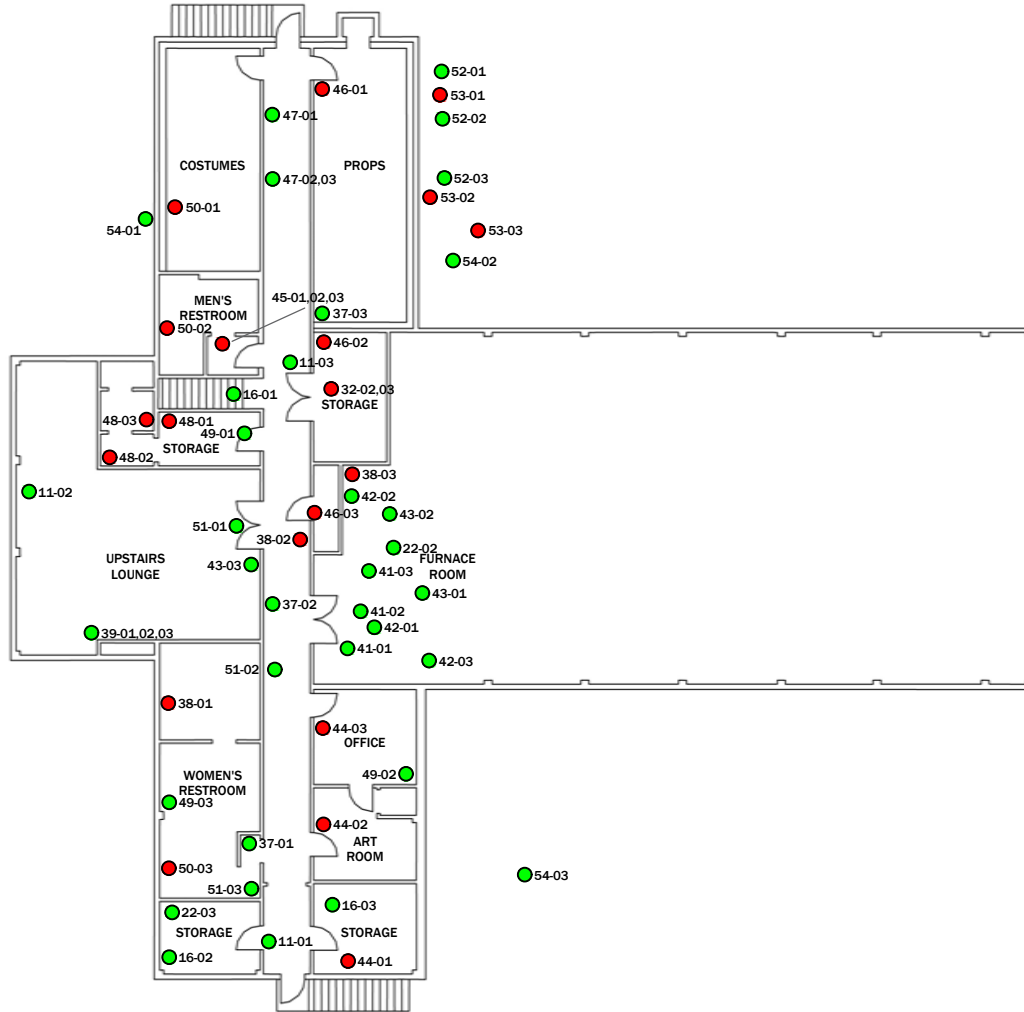
JBSF - 2652 / Floor: 2

**ASBESTOS CONTAINING MATERIALS  
SAMPLE LOCATIONS**

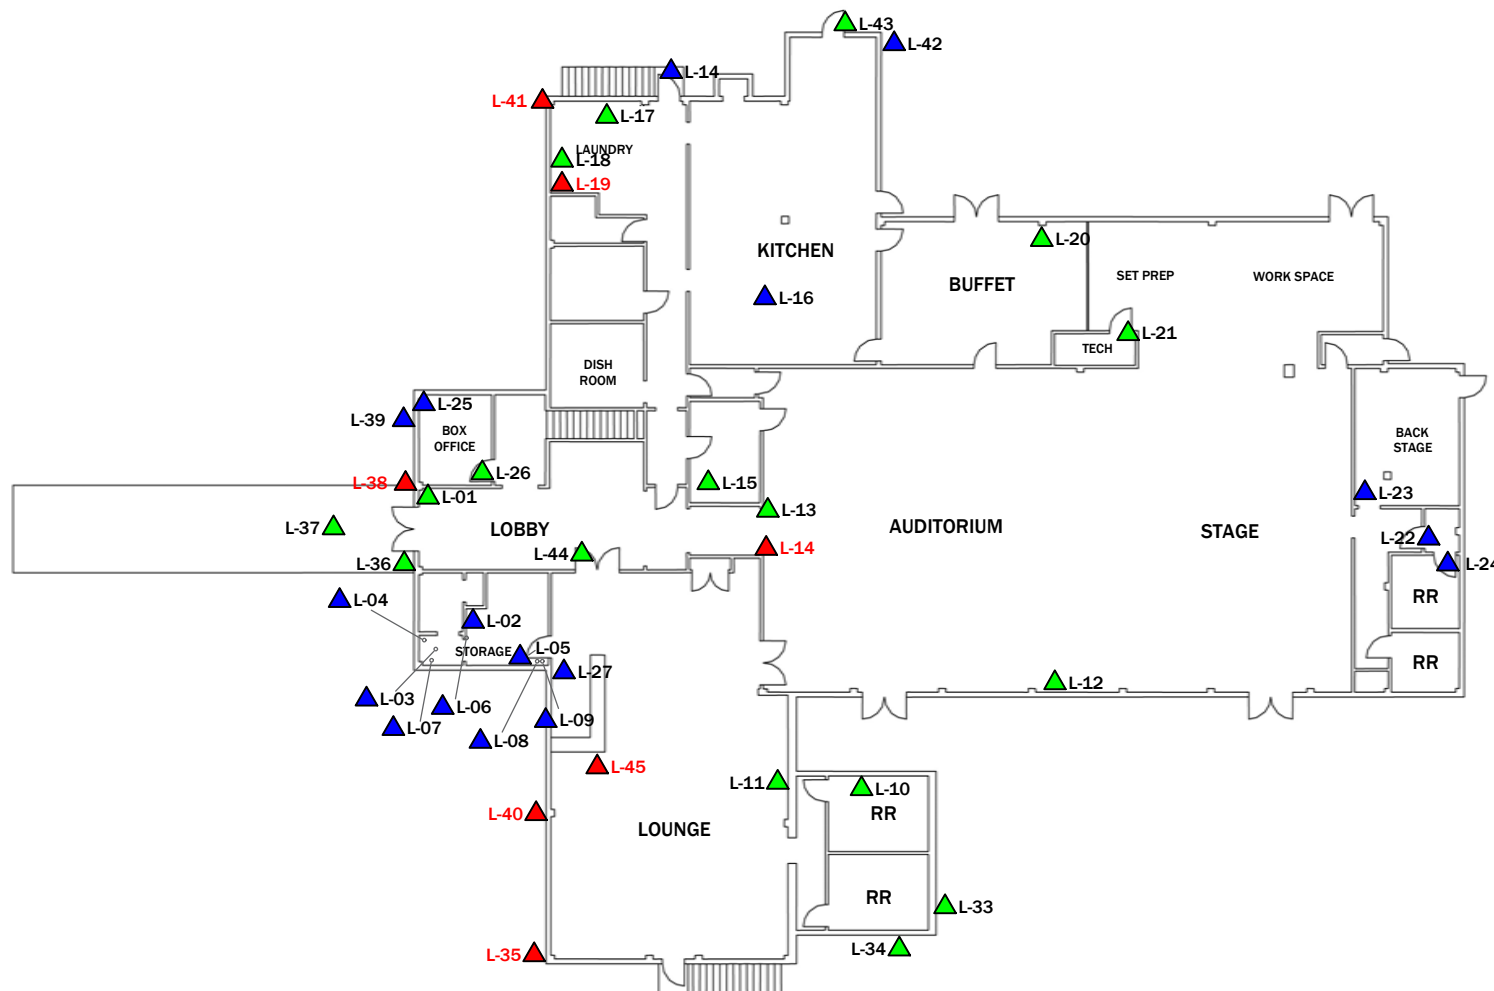
JBSF - 2652 / Floor: 1

**LEAD BASED PAINT SURVEY  
SAMPLE LOCATIONS**

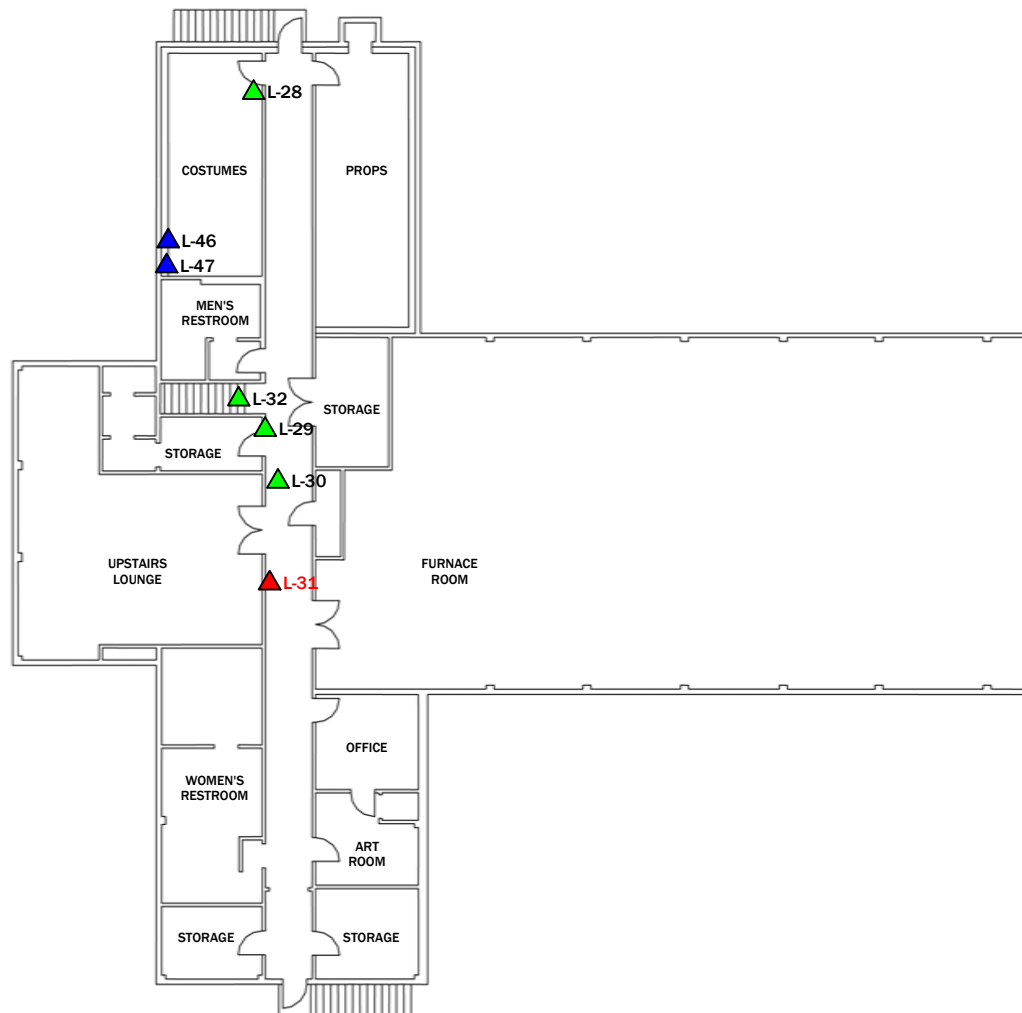
JBSF - 2652 / Floor: 2

**LEAD BASED PAINT SURVEY  
SAMPLE LOCATIONS**

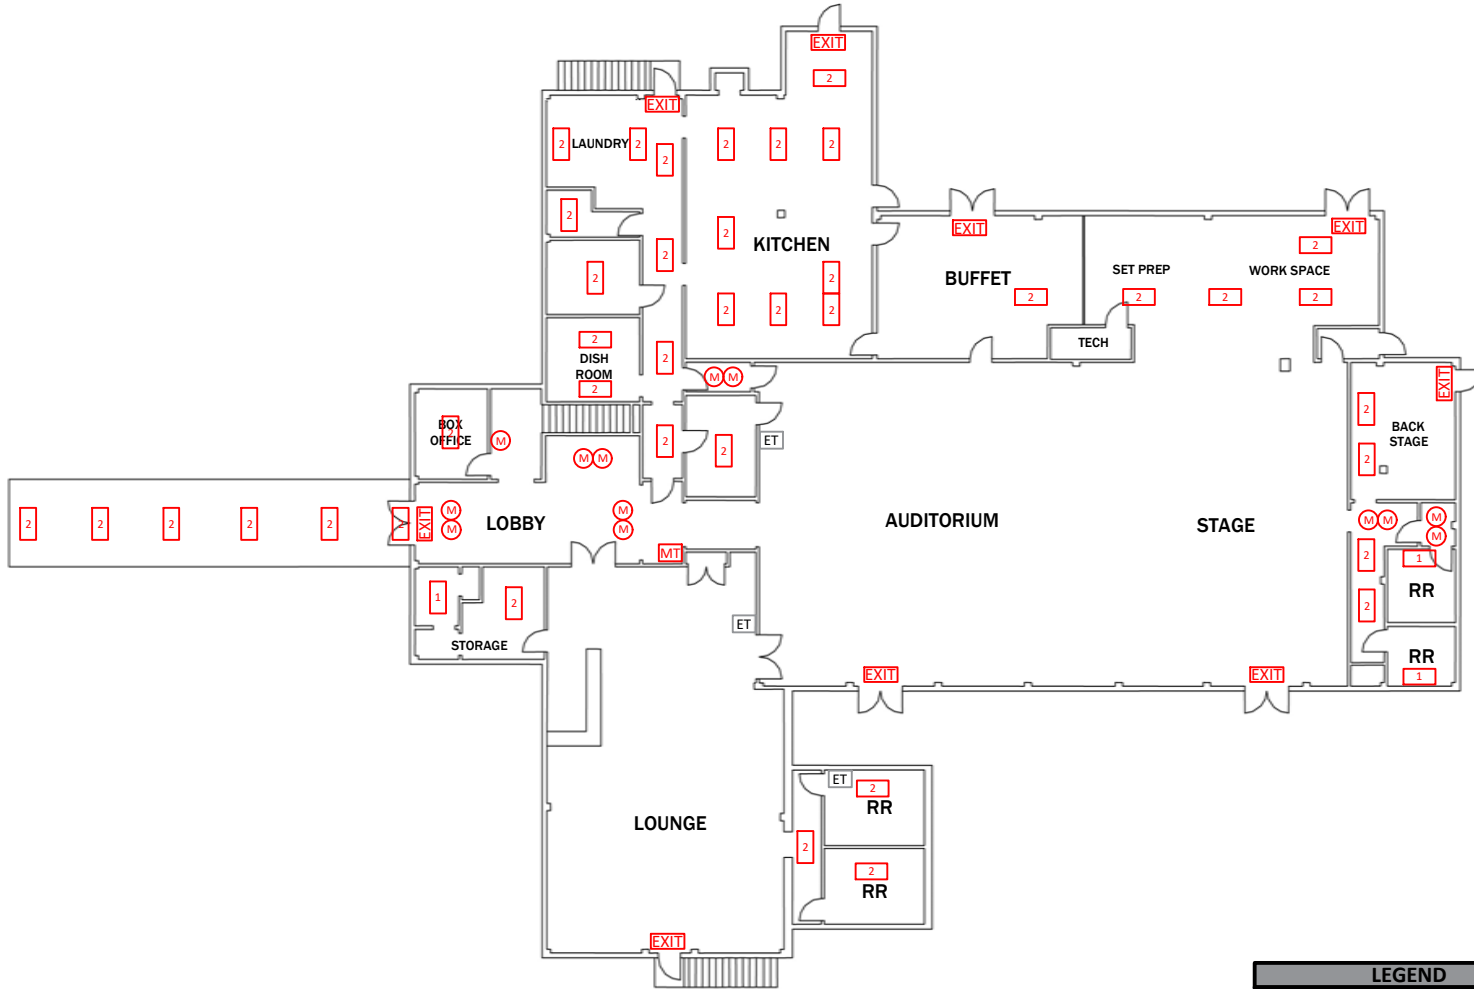
JBSF - 2652 / Floor: 1

**HAZARDOUS COMPONENTS SURVEY**

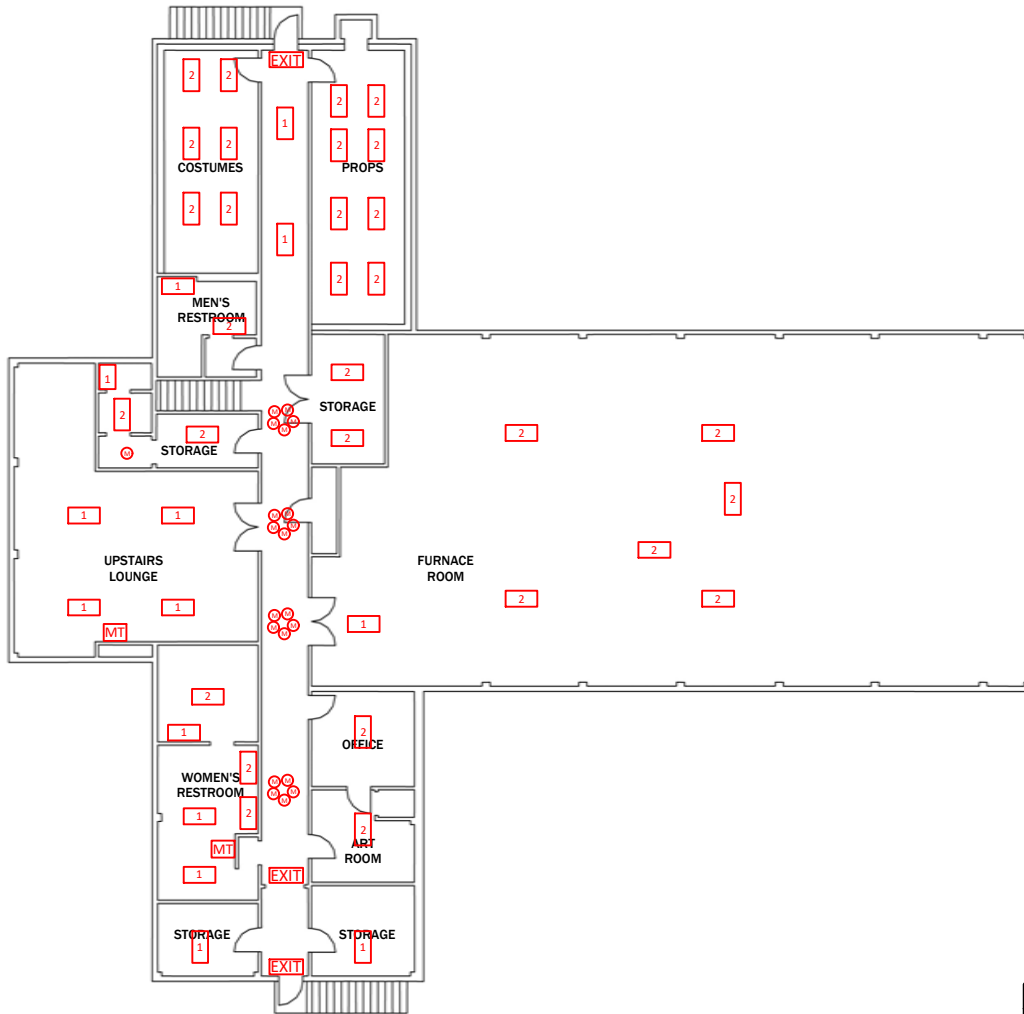
JBSF - 2652 / Floor: 2

**HAZARDOUS COMPONENTS SURVEY**

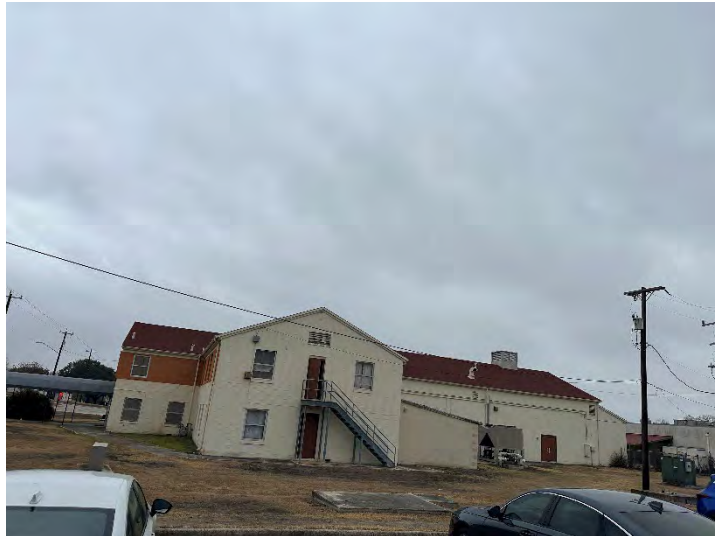
**PHOTO 1:** View is of the building exterior.

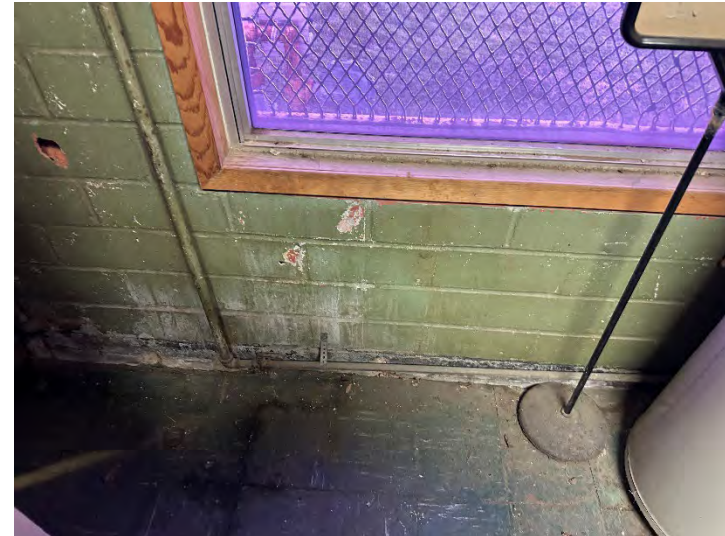
- Joint compound and texture associated with drywall ceiling system found back stage on the 1<sup>st</sup> floor.
- 9" x 9" dark green floor tile and black mastic found on 1<sup>st</sup> floor.

**PHOTO 2:** View is of the asbestos containing 9" x 9" dark green floor tile with black mastic.

ACMs identified at the building that will be impacted by renovation or demolition should be removed and disposed of in accordance with federal, state, and local regulation, prior to disturbance. It is recommended that the asbestos abatement must be performed by a TDSHS licensed asbestos abatement contractor in accordance with a project design prepared by a TDSHS licensed asbestos consultant. In addition, third party air monitoring should be performed during the abatement. Prior to initiating an asbestos abatement project, written notification must be provided no later than 10 calendar days prior to starting abatement.

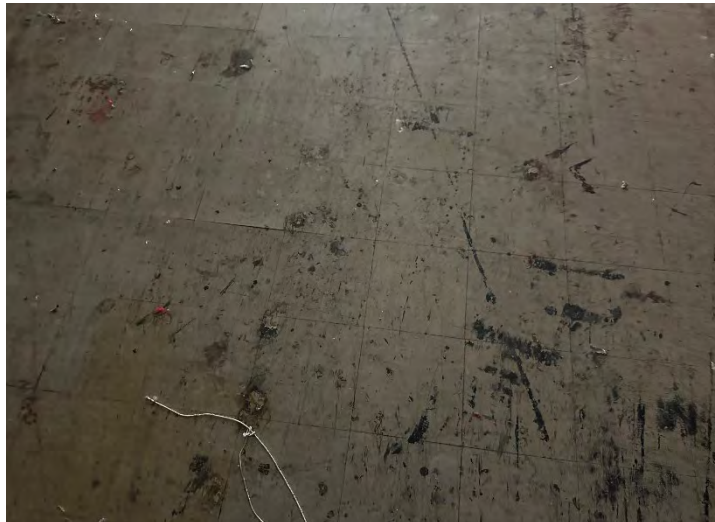
- 9" x 9" tan floor tile and black mastic found on 1<sup>st</sup> floor.
- Black mastic associated with carpet found on 1<sup>st</sup> floor.
- Brown mastic associated with black cove base on the 1<sup>st</sup> floor. It should be noted that a layer of joint compound was detected by the laboratory, therefore the perlite textured drywall system on the 1<sup>st</sup> floor is also considered ACM.

**PHOTO 3:** View is of the asbestos containing 9" x 9" tan floor tile with black mastic.

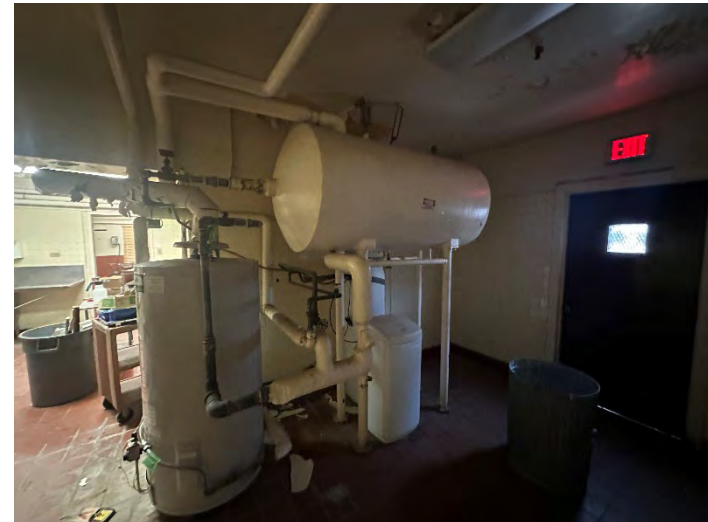
- Pipe wrap / insulation associated with Boiler found in kitchen and laundry.
- Joint compound associated with orange peel textured drywall system found on 2<sup>nd</sup> floor.

A wrapped boiler was observed in the kitchen with a danger asbestos warning sign; therefore, the wrap is assumed to be ACM. The location of this boiler wrap was noted and included in the Site sample location map is provided in Appendix A. The laboratory report and chain of custody are provided in Appendix B.

**PHOTO 4:** View is of the asbestos containing insulation on boiler and associated pipe lines.

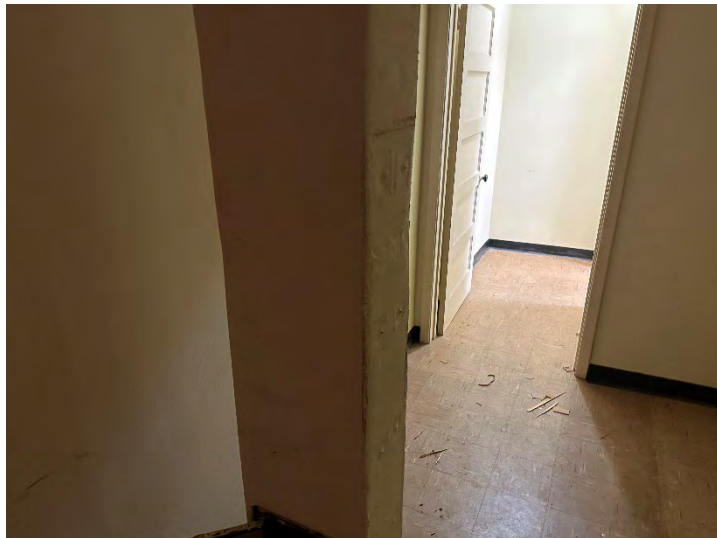
**PHOTO 5:** View is of the asbestos-containing 9" x 9" tan floor tile with black mastic.

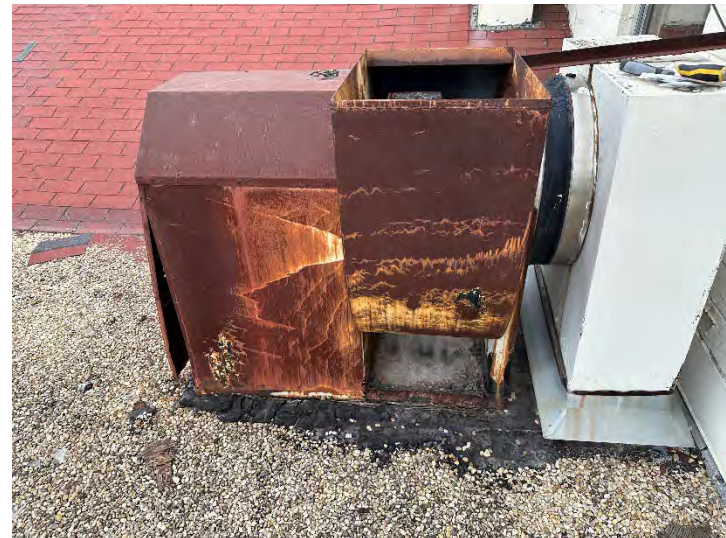
- Gray/black roofing mastic found on roof

**PHOTO 6:** View is of the asbestos-containing gray/black roofing mastic.

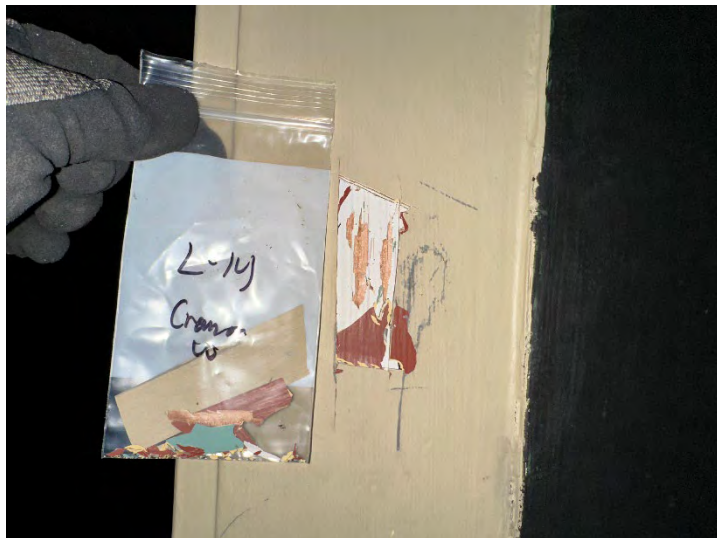
**PHOTO 7:** View is of cream Lead-Based Paint (LBP) on wood door frame.

If any renovation, repair or demolition activity will disturb the LBP, engineering controls such as barriers and water should be used to minimize dust levels. The public should be prevented from unauthorized access to the work area. Ambient air monitoring is recommended to document engineering controls are adequate and that the ambient airborne concentrations do not exceed the permissible exposure levels.

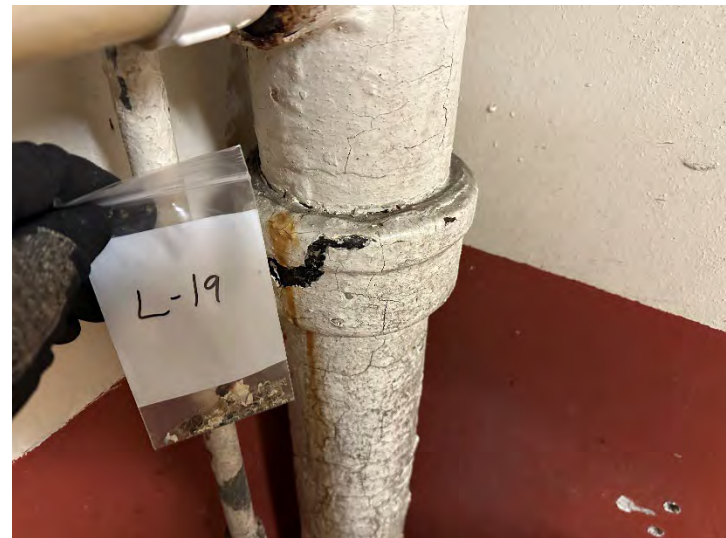
**PHOTO 8:** View is of cream LBP on metal drainpipe.

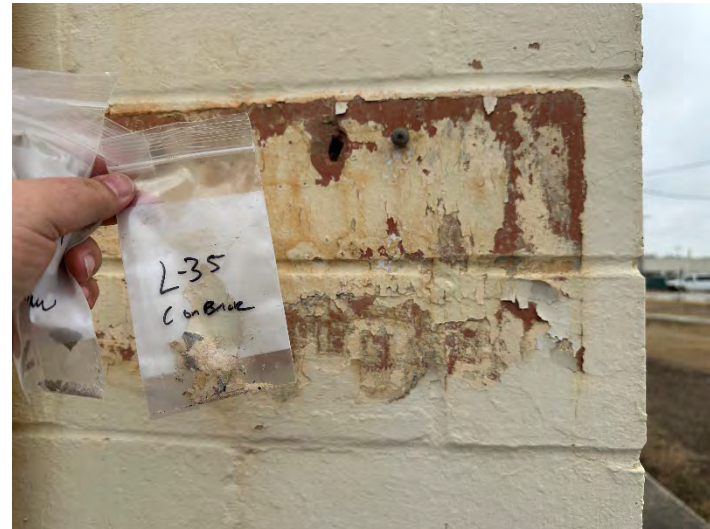
PHOTO 10: View is of cream LBP on brick wall.

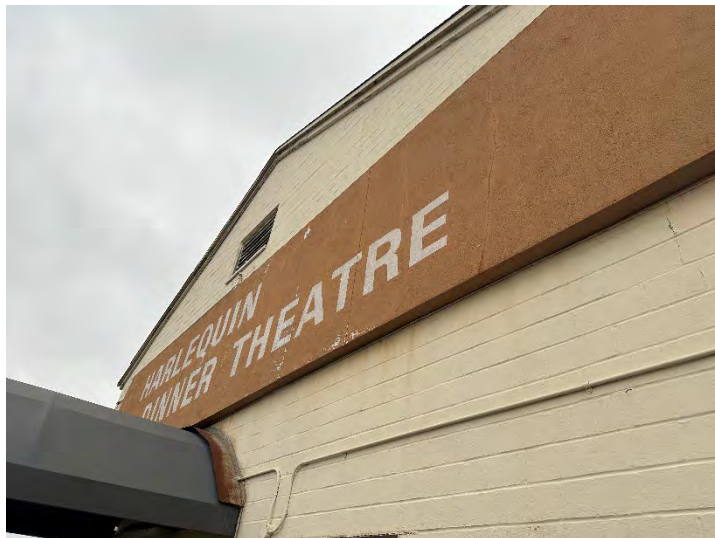
PHOTO 11: View is of orange LBP on stucco wall.

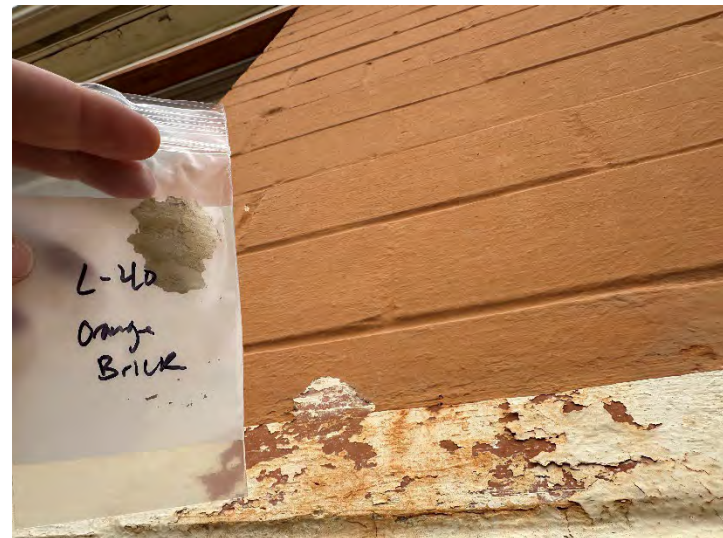
PHOTO 12: View is of orange LBP on brick wall.

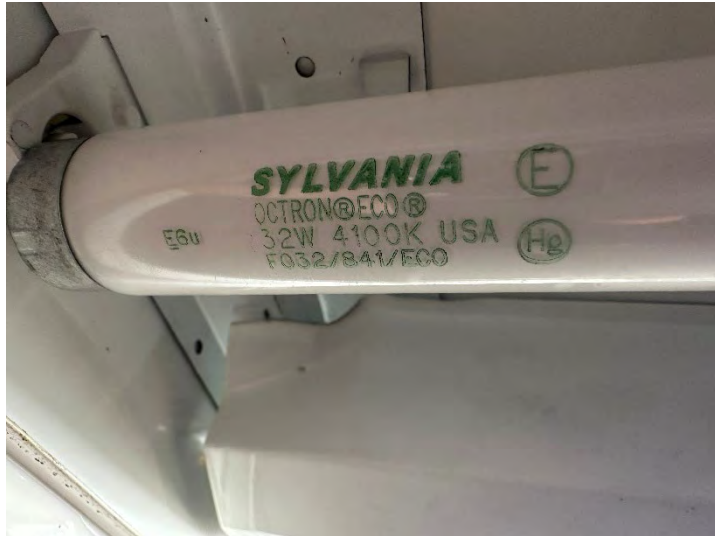
Approximately 87 of the ballasts at the Site were equipped with mercury containing fluorescent tube bulbs. Of the 87 ballasts observed, 70 of these lighting fixtures contained two (2) tube bulbs per ballast and 17 contained one (1) tube bulb per ballast. A total of 34 CFLs were observed throughout the interior of the building. They should be disposed of in accordance with applicable rules and regulations. All fluorescent bulbs must be disposed of as a Universal Waste at an EPA approved recycling facility prior to any renovation / demolition activities.

PHOTO 13: View is of mercury containing fluorescent lamp

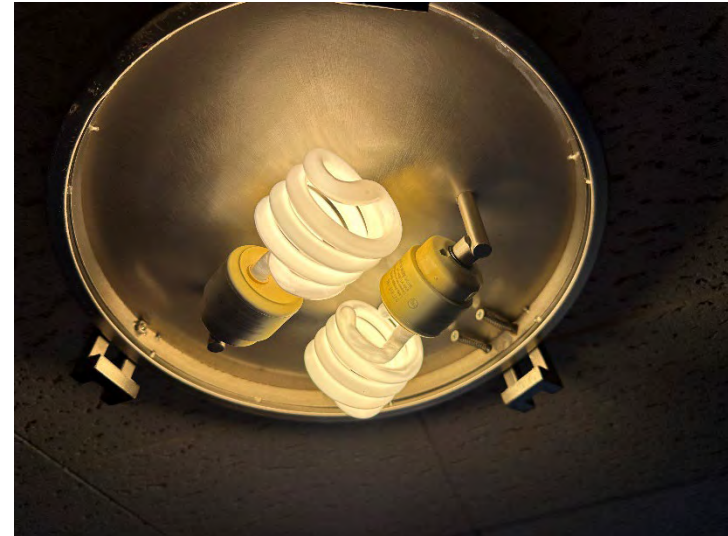
PHOTO 14: View is of CFL bulbs.

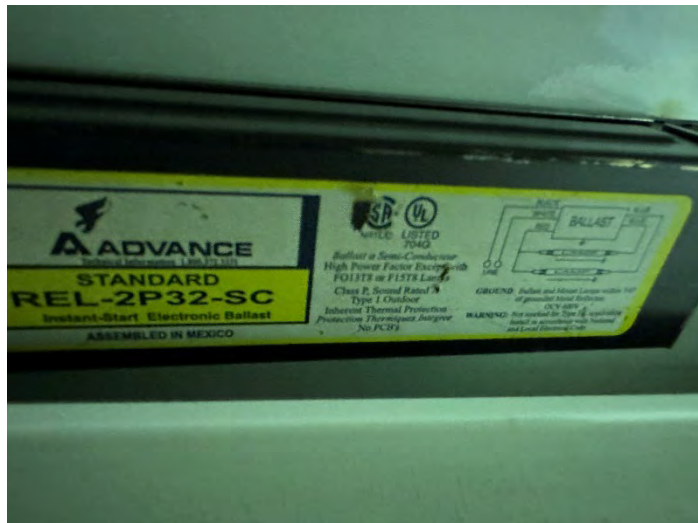
PHOTO 15: View is of the “No PCB” lamp ballast.

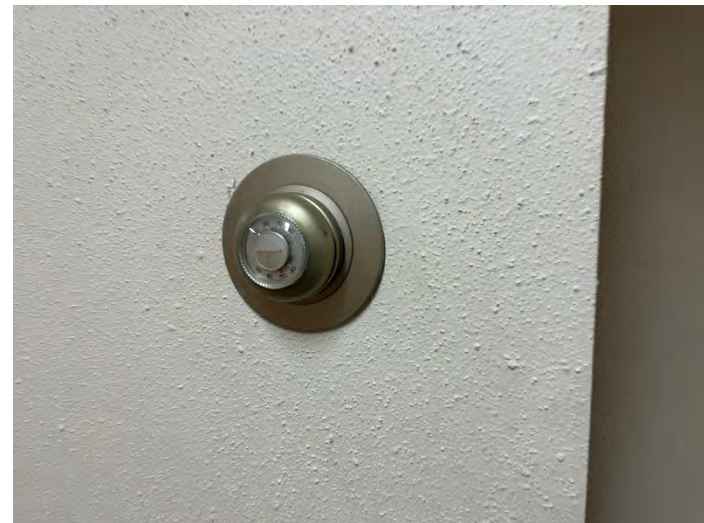
Three (3) mercury containing thermostats and three (3) electric thermostats were observed throughout the building. All thermostats must be disposed of as Universal Waste at an EPA approved recycling facility prior to any renovation / demolition activities.

PHOTO 16: View is of the mercury containing thermostats.

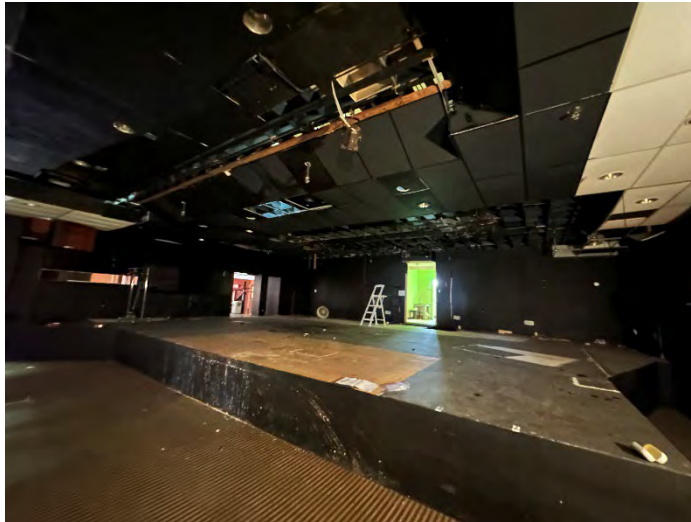
Water damage and mold growth are likely due to roof leaks and a potential water intrusion event.

**PHOTO 17:** View is of water damage in auditorium.

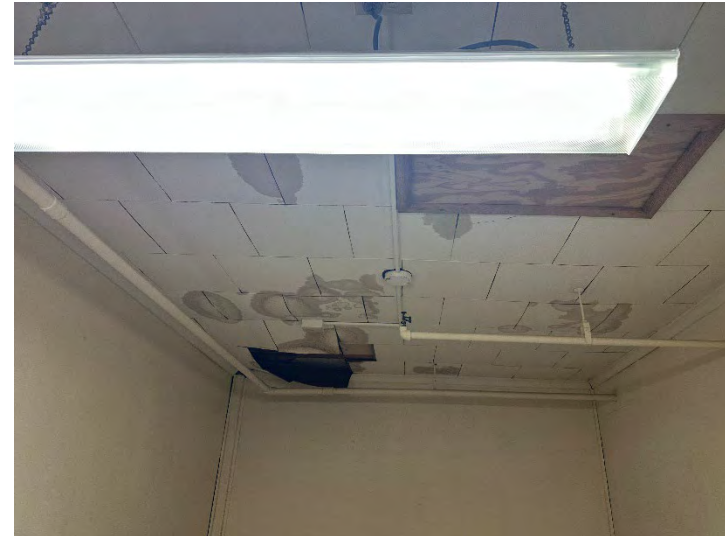
**PHOTO 18:** View is of water damage on ceiling tile in prop room.

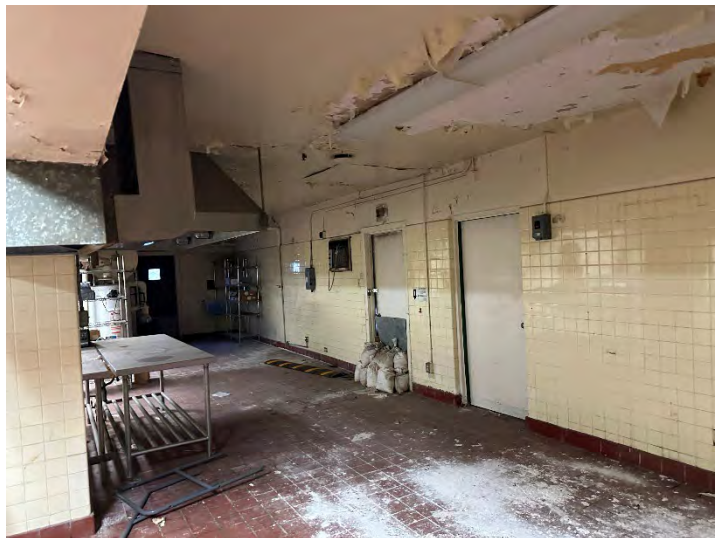
**PHOTO 19:** View is of water intrusion event in kitchen.

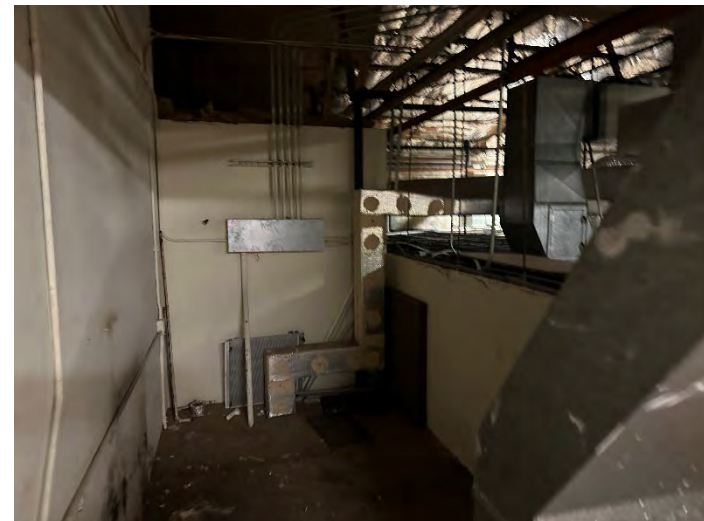
Areas of suspect water damage were observed in the 1<sup>st</sup> Floor lounge, auditorium, storage area, buffet room, kitchen, laundry room, dish room, and box office. As well as the 2<sup>nd</sup> floor lounge, storage area, office, men’s restroom, costume room, prop room, and furnace room. Visible mold growth was observed on the north wall of the furnace room.

**PHOTO 20:** View is of visible mold growth on wall in furnace room.
