# HAZARDOUS BUILDING MATERIALS SURVEY REPORT

B300 Roof and HVAC Repair  
Pre-Renovation Services

B300, Portsmouth Naval Shipyard  
Kittery, ME 03904

September 11, 2024\_Rev 1

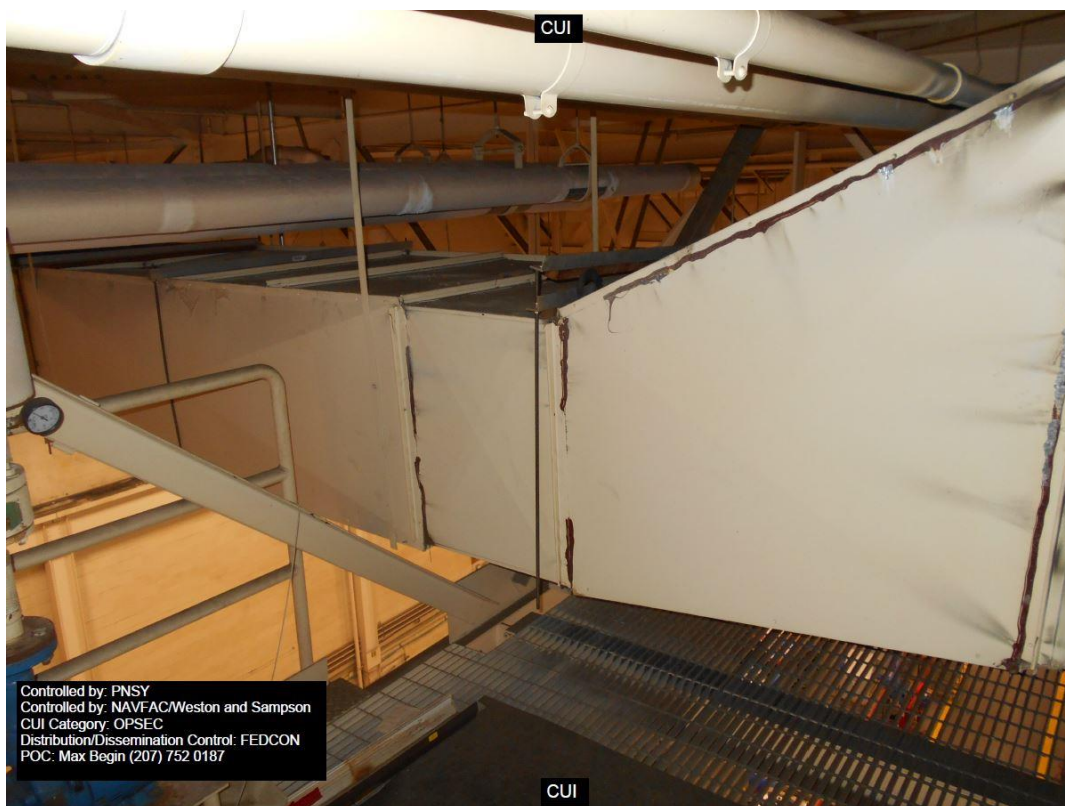
**Image 1**  
**Red Duct Seam Sealant**

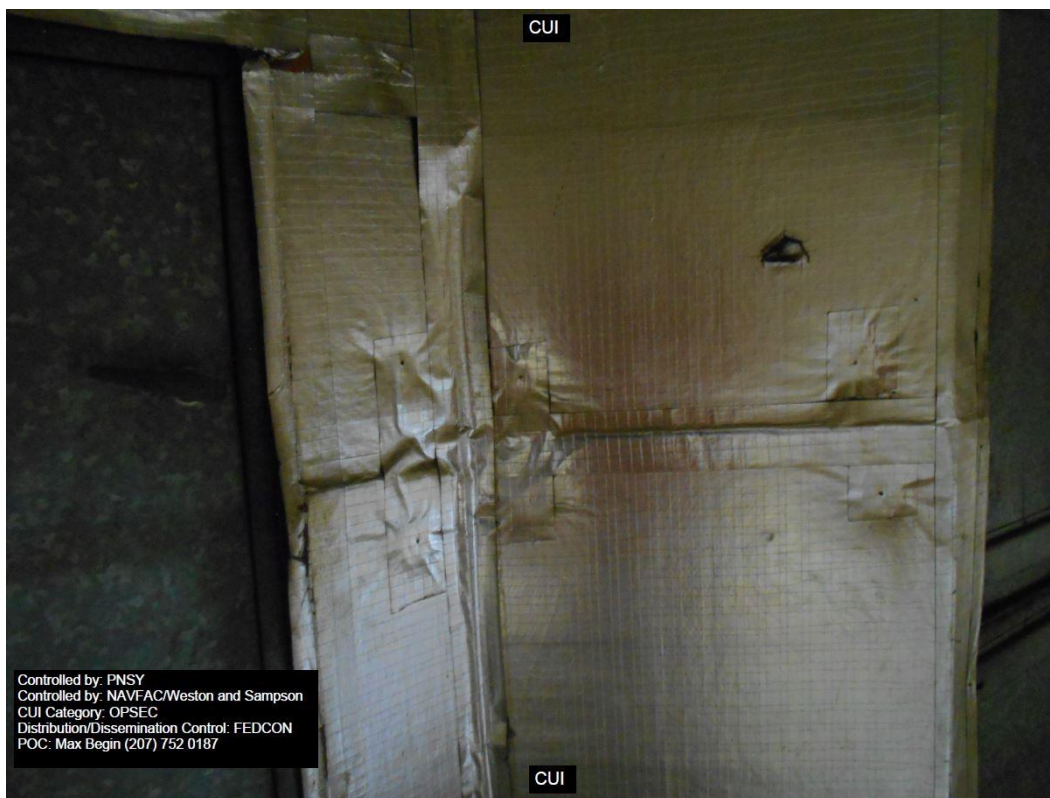
**Image 2**  
**Stick Pin Adhesive**

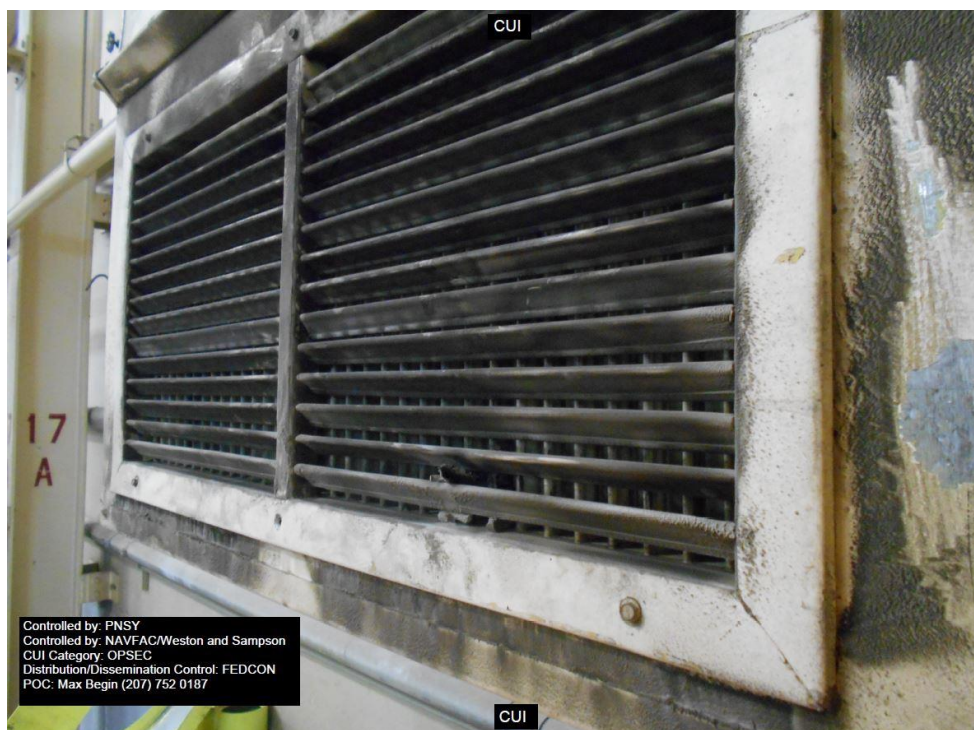
**Image 3**  
**Typical Dust Outside Grille**

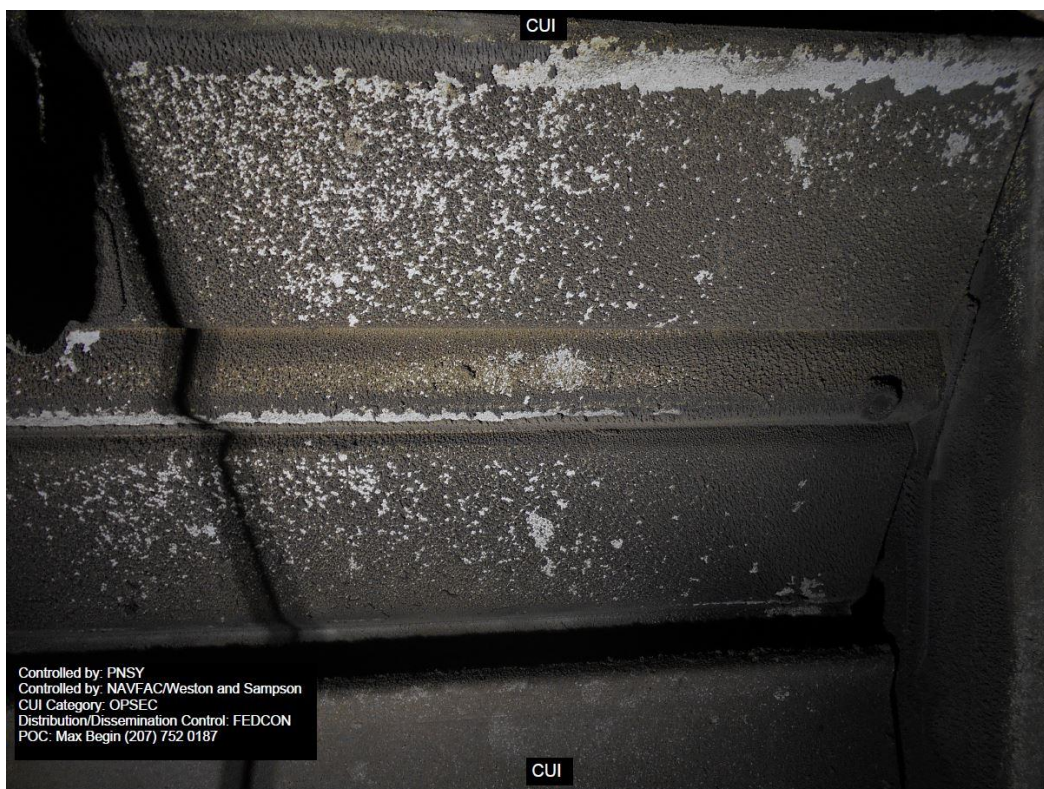
**Image 4**  
**Typical Dust Inside Air Handler**
