ANALYSIS OF SPUN CRANK HUB FAILURES IN BMW F8X MODELS: FAILURE PATTERNS OF THE S55 ENGINE

Date: 08/24/2024

Prepared by: Andreas Kefalas X Driver Spec Garage Socials:

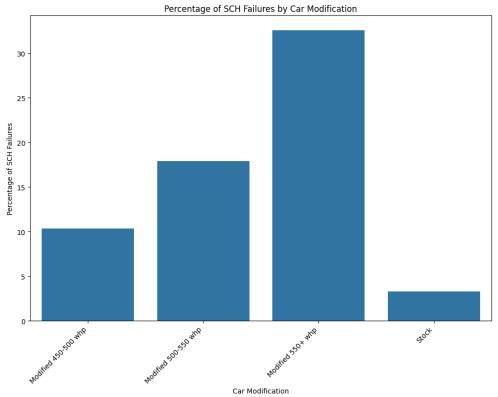
SCH Failure Rates by Modification Type and Power Output (Whp)

- 1. **Higher SCH Failure Rates in Modified Vehicles:** Vehicles with modifications, particularly those classified as "Modified 550+ whp," exhibit significantly higher SCH failure rates compared to stock vehicles. For example, "Modified 550+ whp" has an SCH failure percentage of 32.59%, much higher than the stock's 3.29%.
- 2. **Impact of Modification Intensity:** More intensive modifications are associated with increased SCH failure rates. This is evident from the data where "Modified 550+ whp" shows the highest SCH failure percentage, followed by "Modified 500-550 whp" and "Modified 450-500 whp."

- 1. **Pinning the Crank Hub:** Recommended for modified vehicles to reduce failure risks. Many experts endorse this technique, particularly for high-powered builds, as it significantly decreases the likelihood of hub spinning (Klein, 2022).
- 2. **Moderate Modifications:** Vehicle owners should balance performance enhancements with reliability considerations. According to Stouffer and Richards (2021), maintaining a level of moderation in modifications can prevent detrimental impacts on engine reliability.
- 3. **Regular Maintenance:** A rigorous maintenance schedule is crucial for early detection of potential issues. Regular inspections can identify risks before they
