CUNY QUEENS COLLEGE

ANALYSIS OF SPUN CRANK HUB FAILURES IN BMW F8X MODELS: FAILURE PATTERNS OF THE S55 ENGINE

A QUANTITATIVE STUDY

ANDREAS KEFALAS

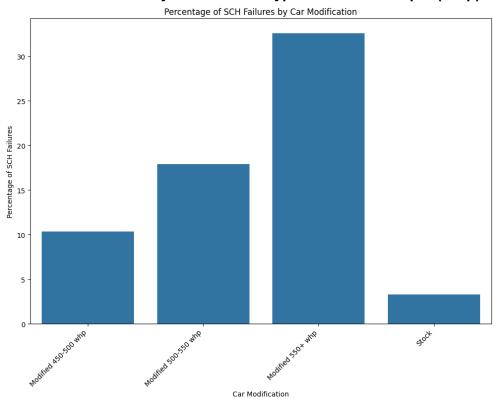
SCH Failure Rates by Modification Type and Power Output (Whp)

- 1. **Higher SCH Failure Rates in Modified Vehicles:** Vehicles with modifications, particularly those classified as "Modified 550+ whp," exhibit significantly higher SCH failure rates compared to stock vehicles. For example, "Modified 550+ whp" has an SCH failure percentage of 32.59%, much higher than the stock's 3.29%.
- 2. **Impact of Modification Intensity:** More intensive modifications are associated with increased SCH failure rates. This is evident from the data where "Modified 550+ whp" shows the highest SCH failure percentage, followed by "Modified 500-550 whp" and "Modified 450-500 whp."

- 1. **Pinning the Crank Hub:** Recommended for modified vehicles to reduce failure risks. Many experts endorse this technique, particularly for high-powered builds, as it significantly decreases the likelihood of hub spinning (Klein, 2022).
