First Step Inspections LLC

Home Inspection Report

**1528 E WAGONWHEEL
Sandy, UT 84093**

Inspected on Fri, Dec 27 2019 at 12:00 AM

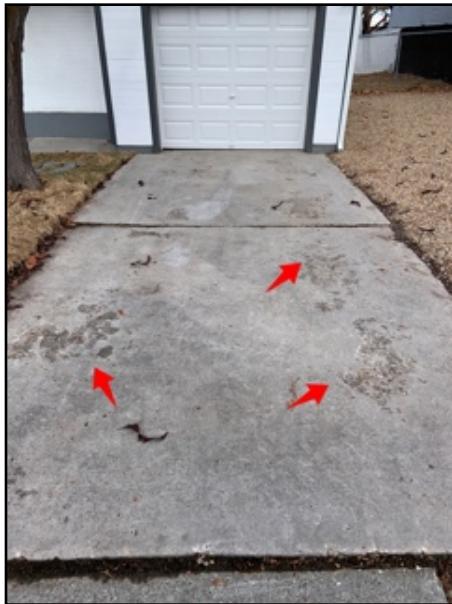
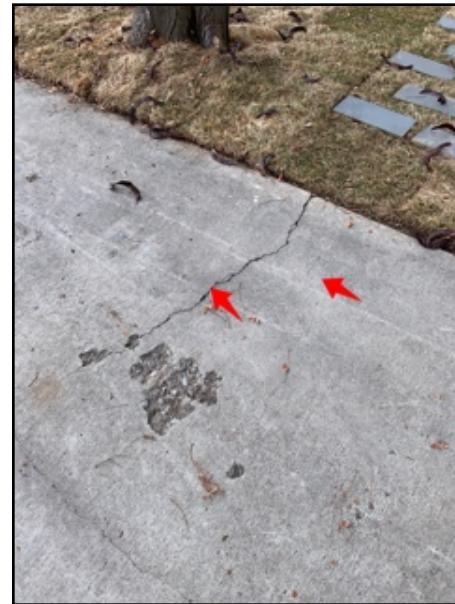
Minor cracking and chipping on driveway recommend resealing to avoid further cracking.

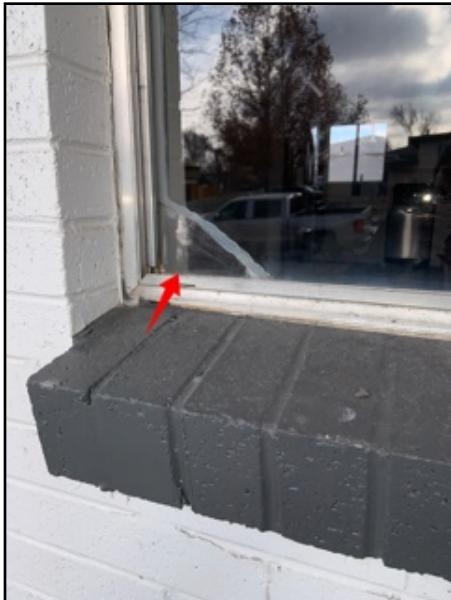
Figure 2-1

Multiple windows with cracked glass recommend repair or replacement .

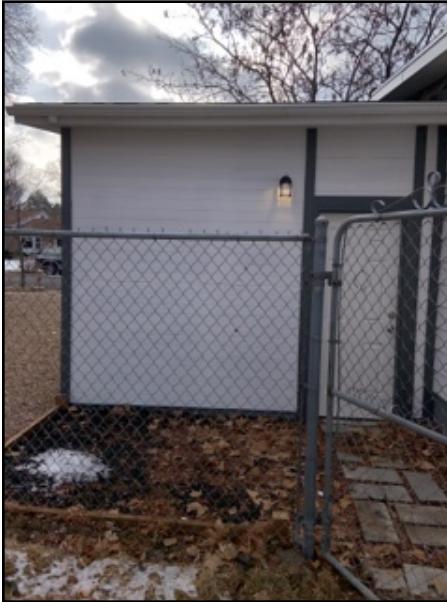
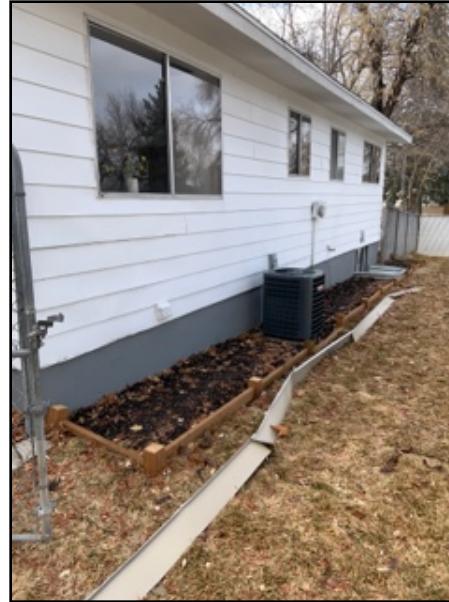
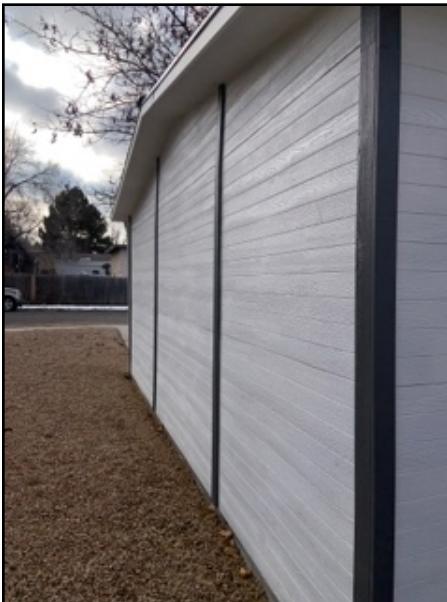
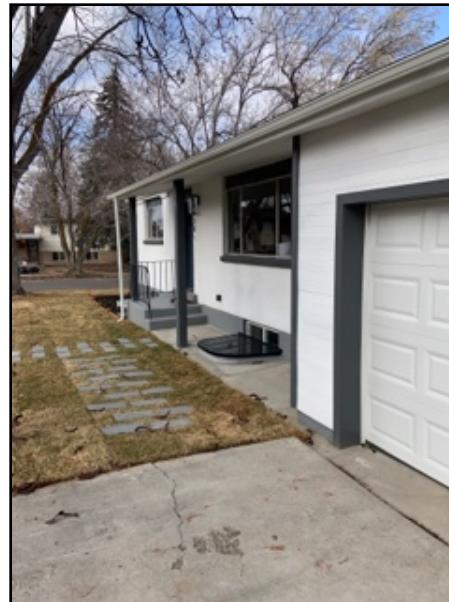
Comment 3:
General, good condition.

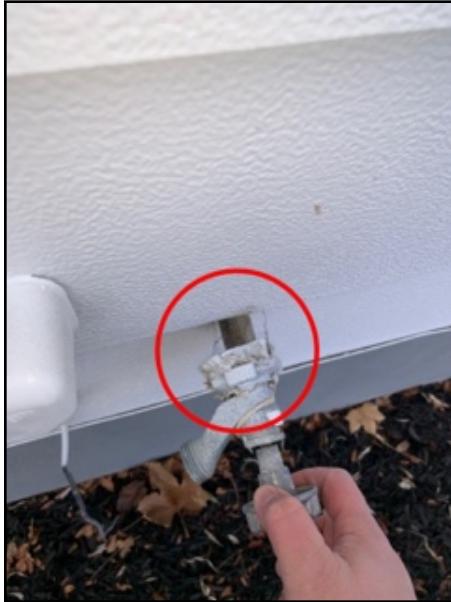
Figure 4-1

Comment 4:
Exterior spout is loose recommend repair or replacement.

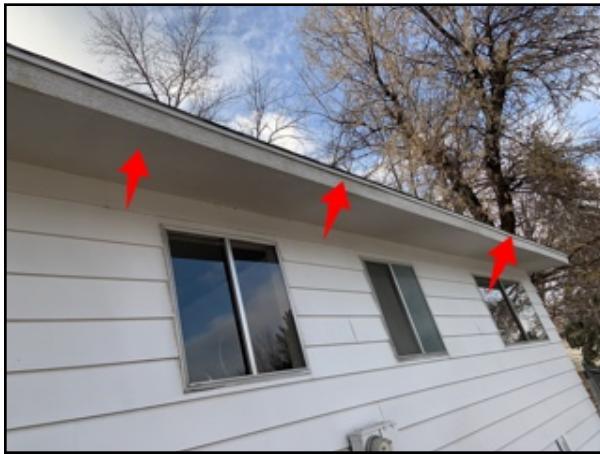
Figure 5-1

Comment 5:
Missing flashing on north side of house recommend repair or replacement.

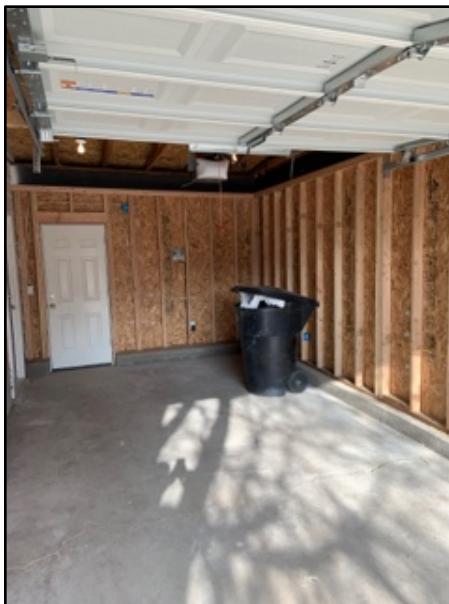
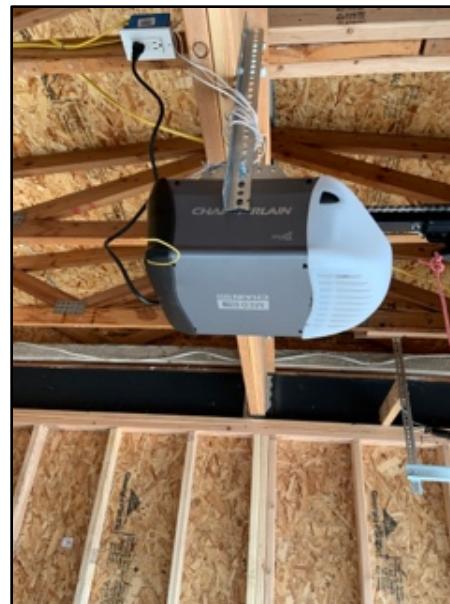
Comment 6:
General, good condition.

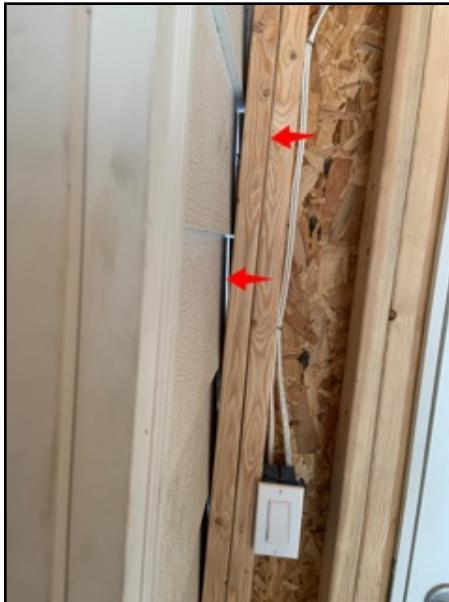
Multiple areas observed with gaps in the wall. Recommend sealing.

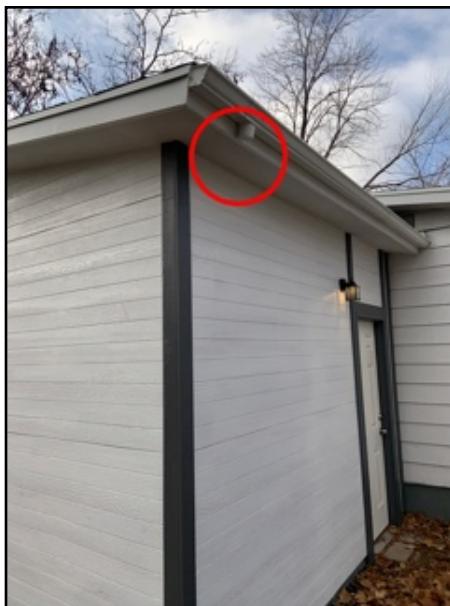
Figure 9-1

Comment 9:
Missing downspout recommend replacement.

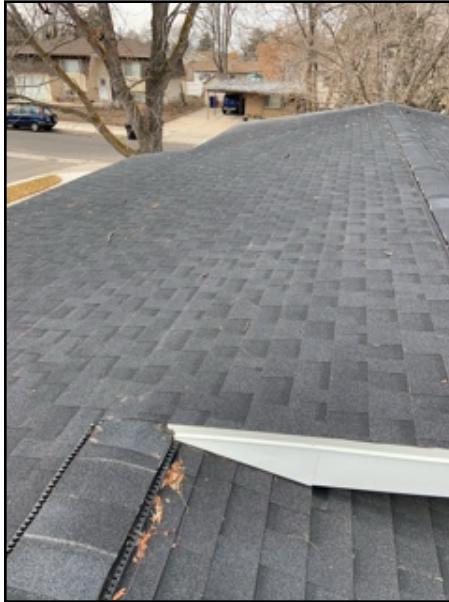
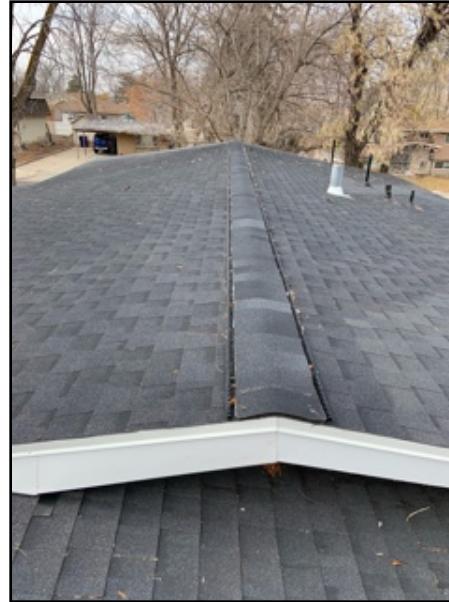
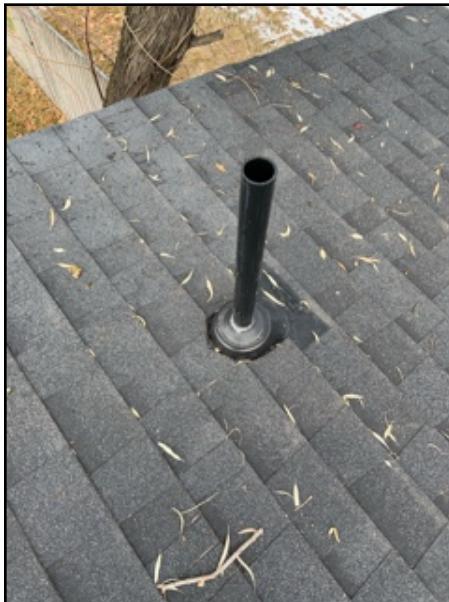
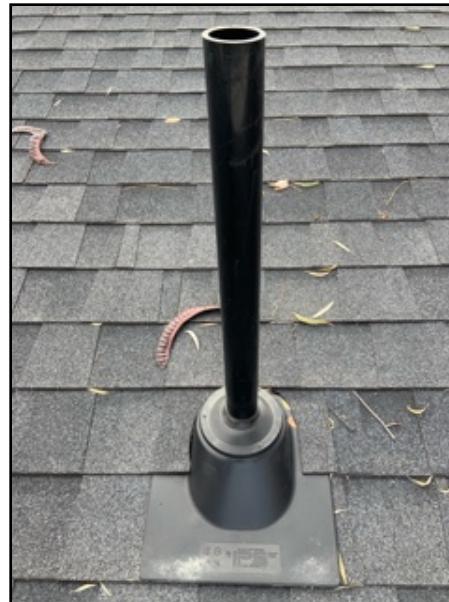
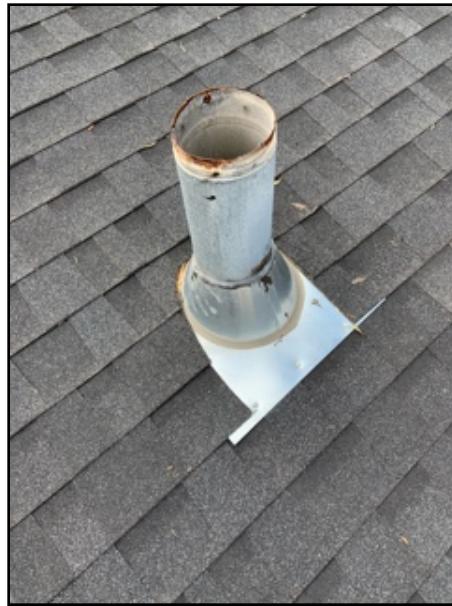
Comment 10:
General, good condition.

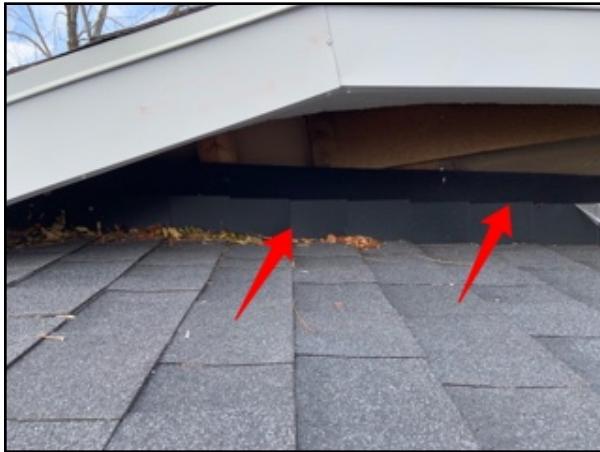
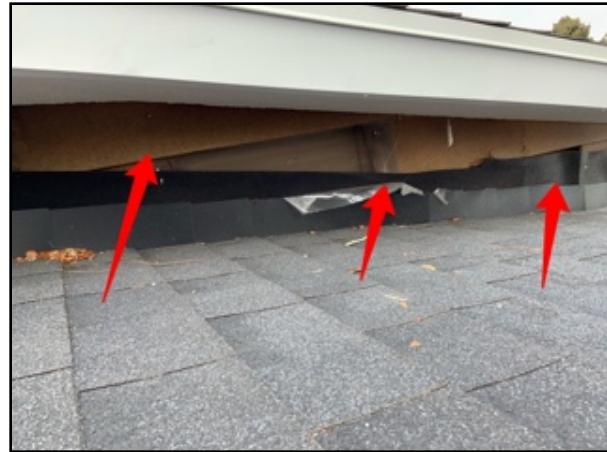
Area near the garage attachment observed missing fascia and flashings.
Recommend repair and replacement.

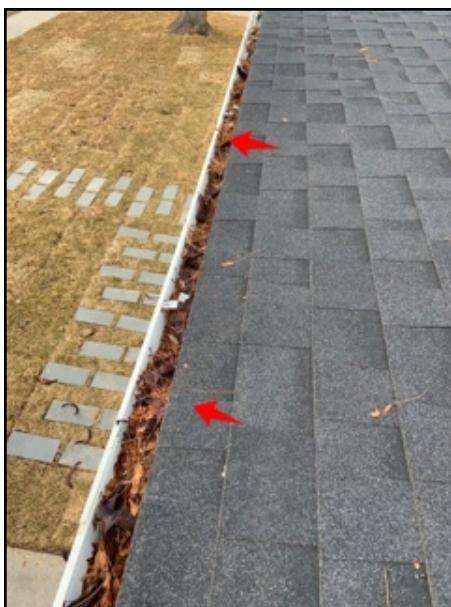
Gutters near trees on front and rear have build up/blockage observed. Recommend cleaning out. As well as keeping up on tree care.

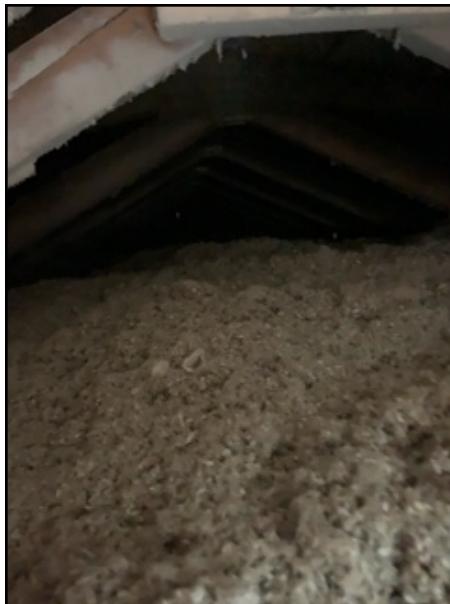
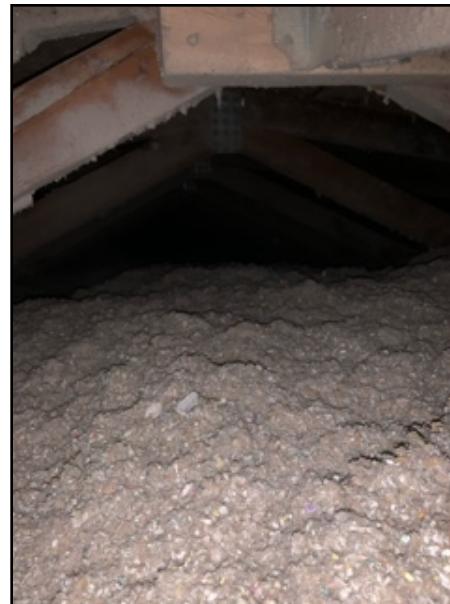
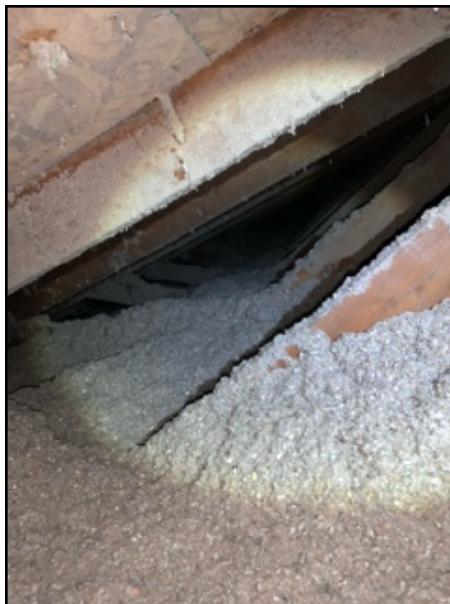
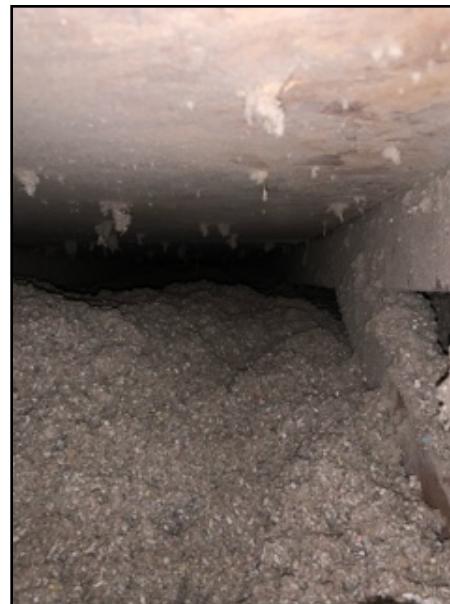
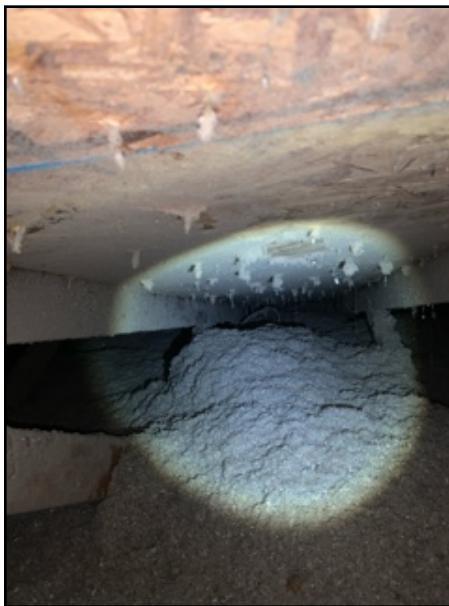
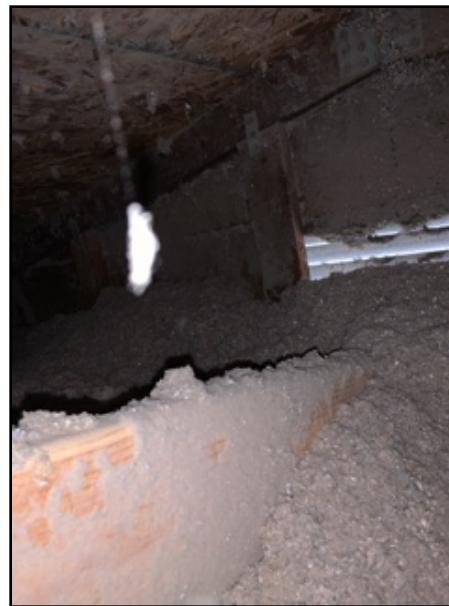
Comment 13:
General, good condition.

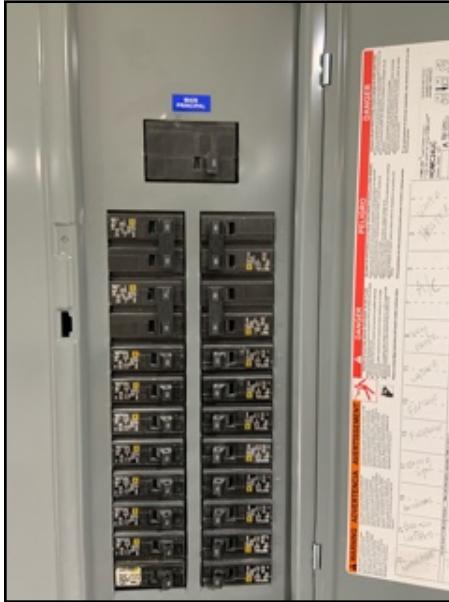
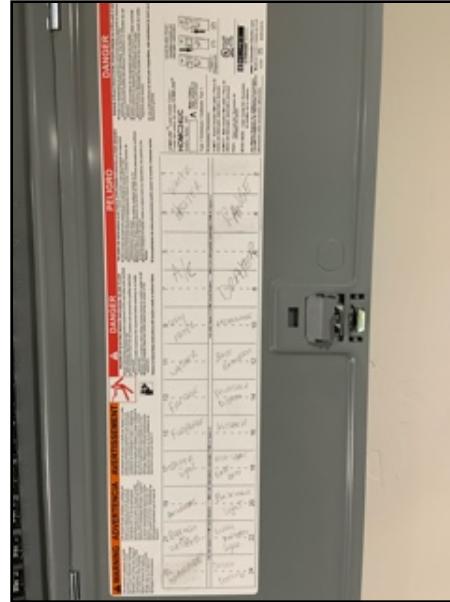
Comment 14:
General, good condition.

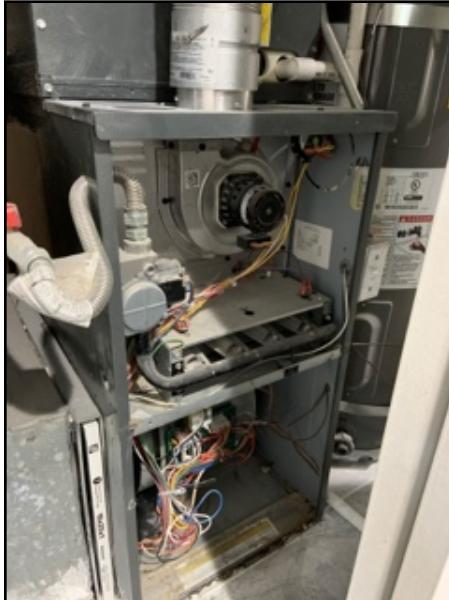
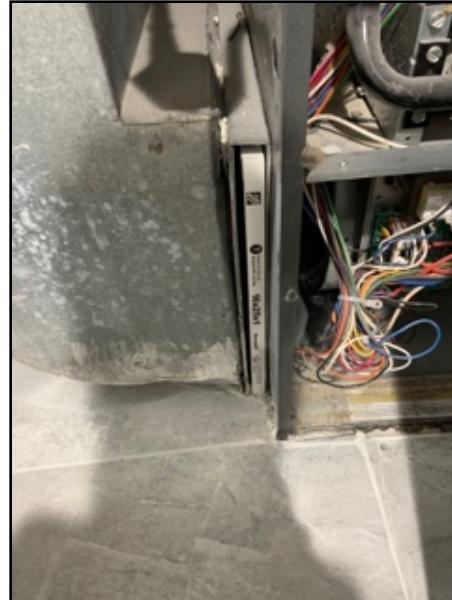
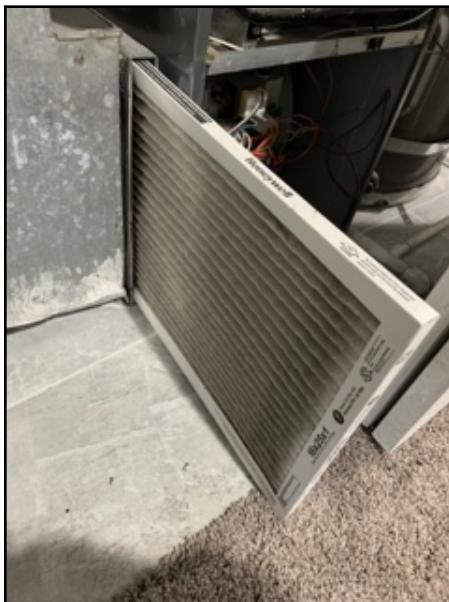
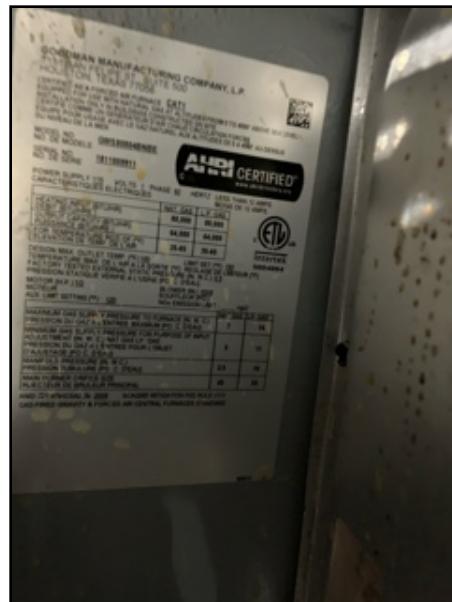
Comment 15:
General, good condition.

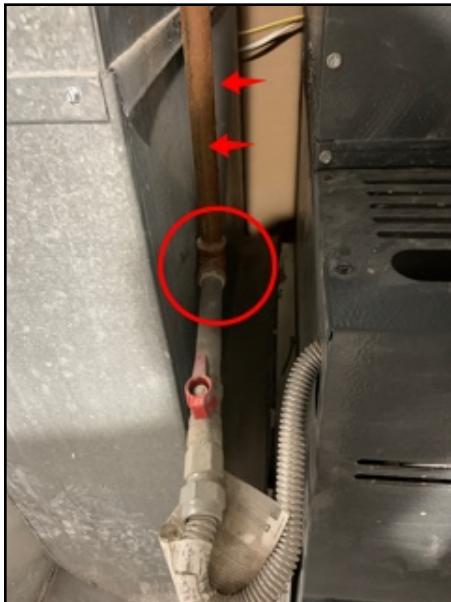
Figure 16-1

Heavy rust on main fuel source pipe next to furnace. Slight smell of gas observed as well. Recommend repair or replacement.

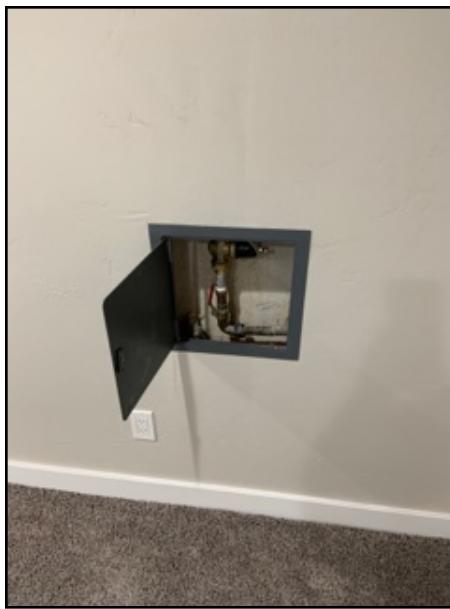
Figure 17-1

Comment 17:
General, good condition .

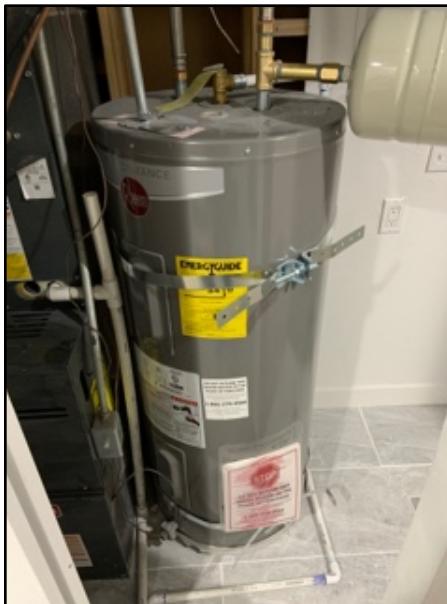
Figure 18-1

Comment 18:
General, good condition.

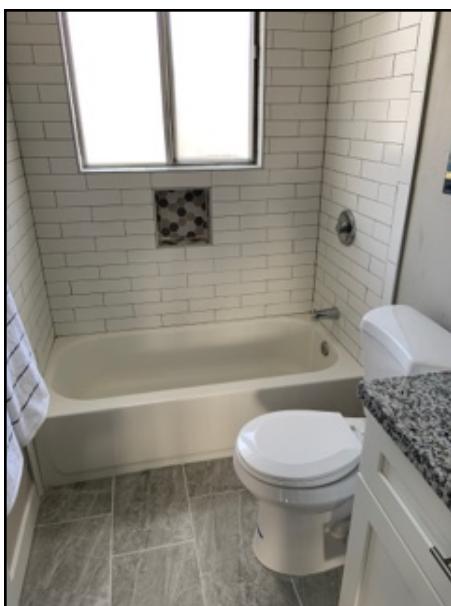
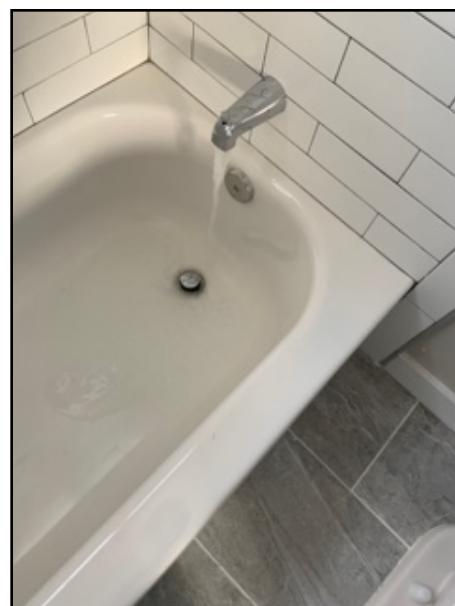
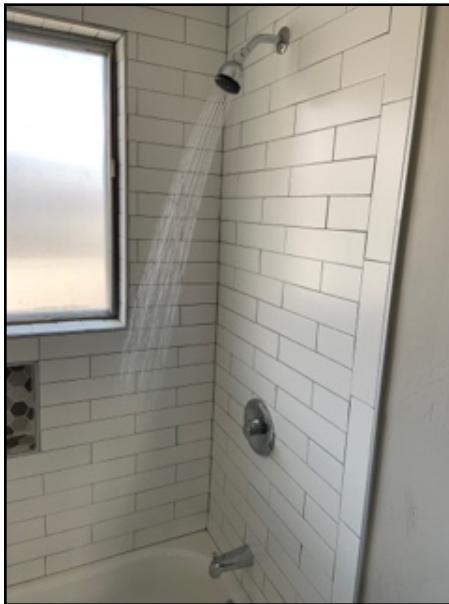
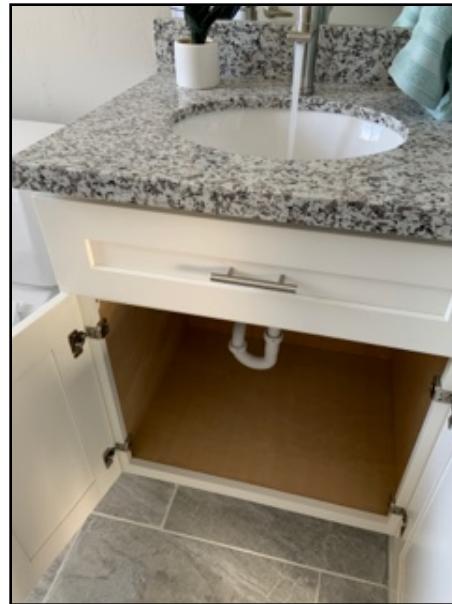
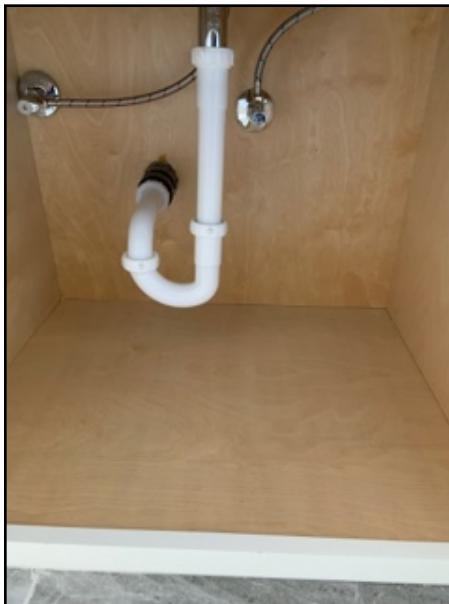
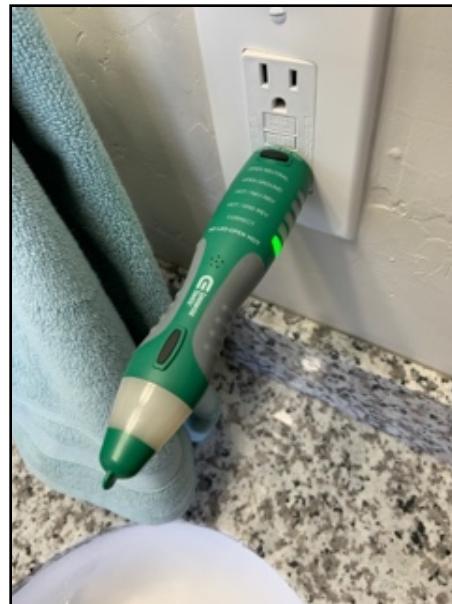
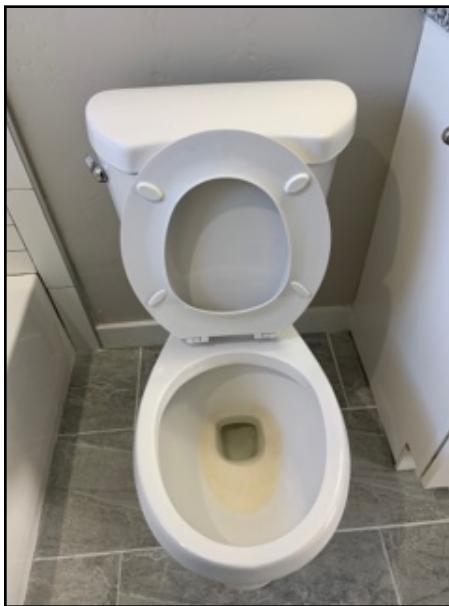
Genera good condition.

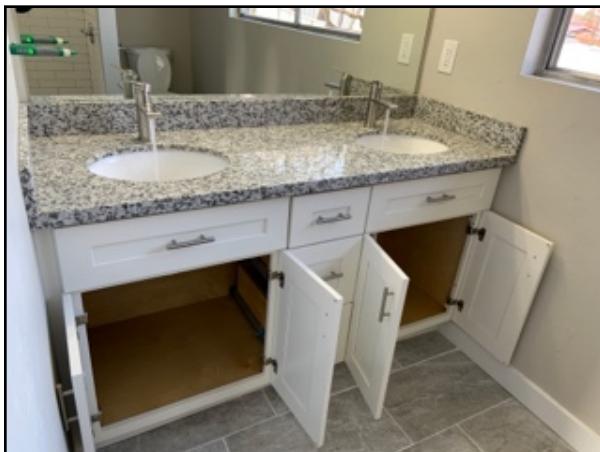
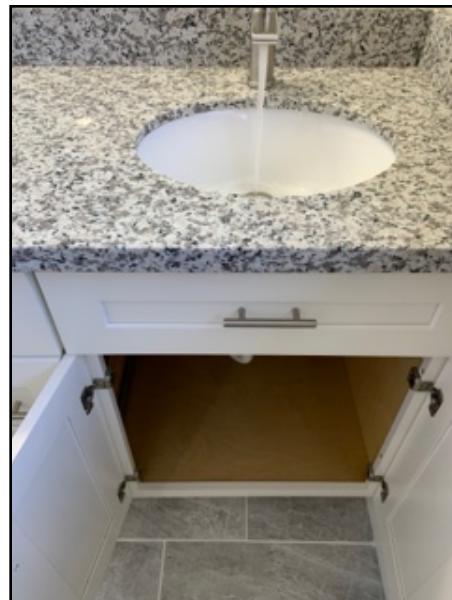
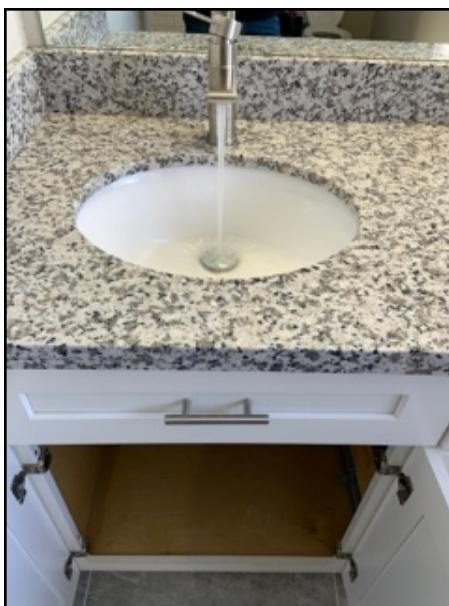
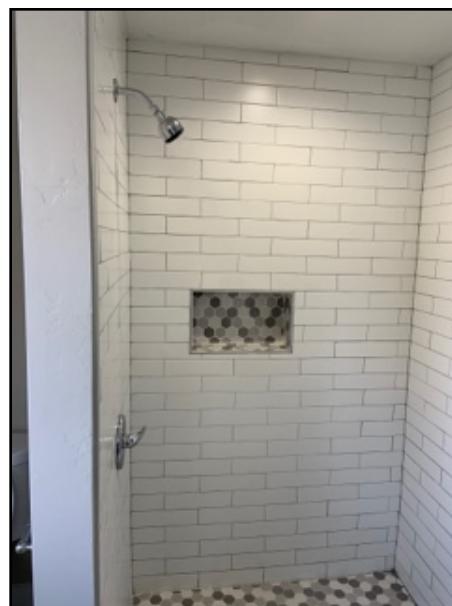
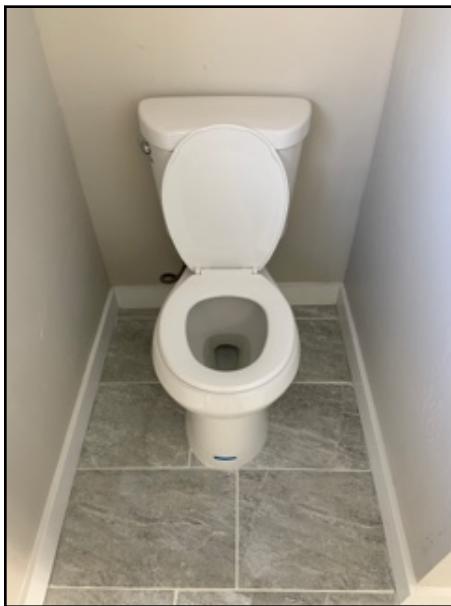
General, good condition.

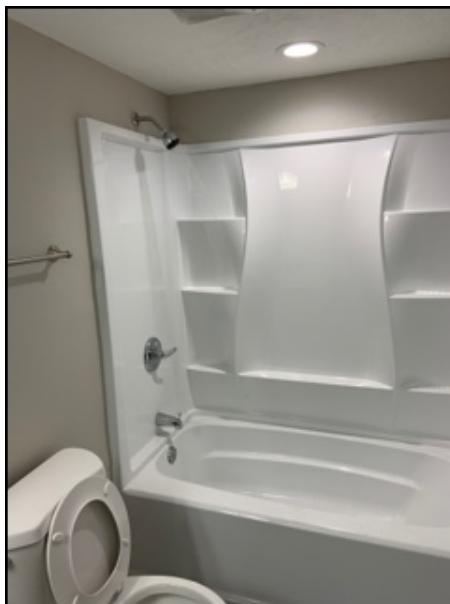
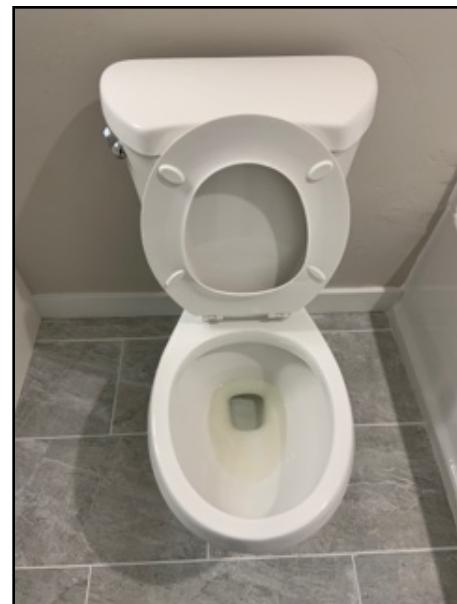
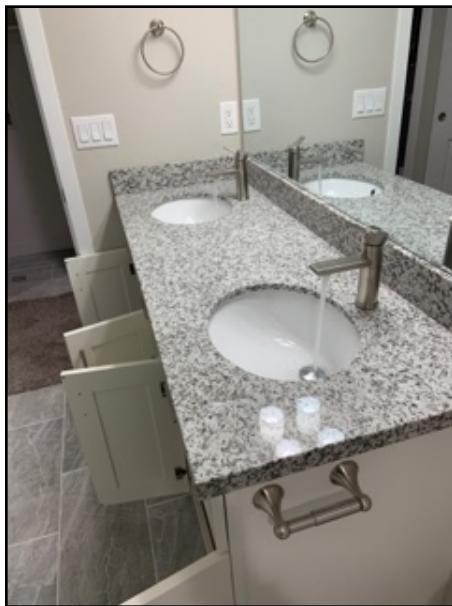
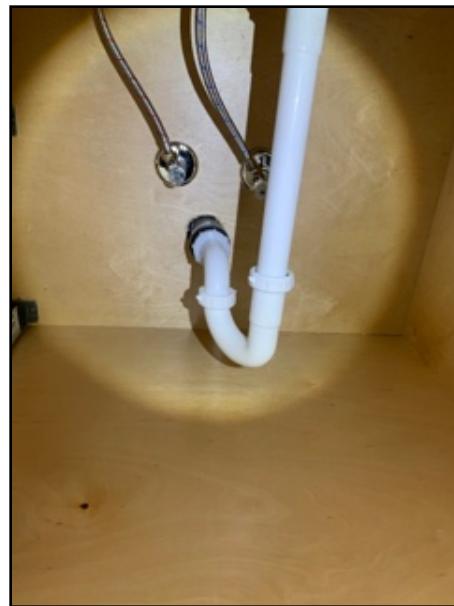
Comment 24:
General, good condition.

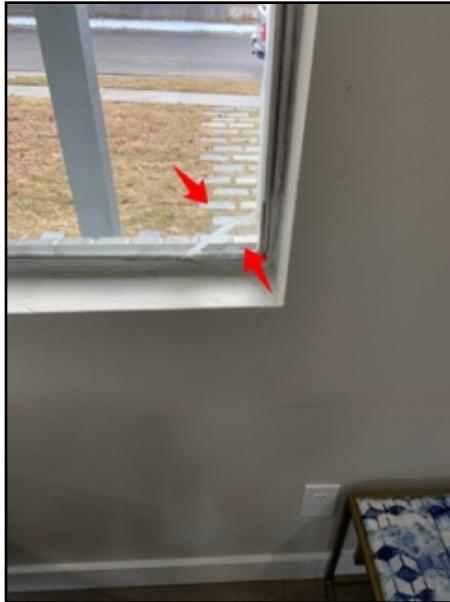
Figure 26-1

Window in living room has observed crack in lower corner. Recommend repair or replacement.

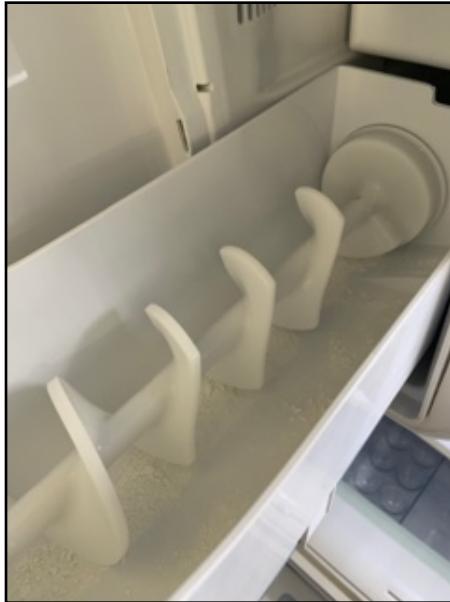
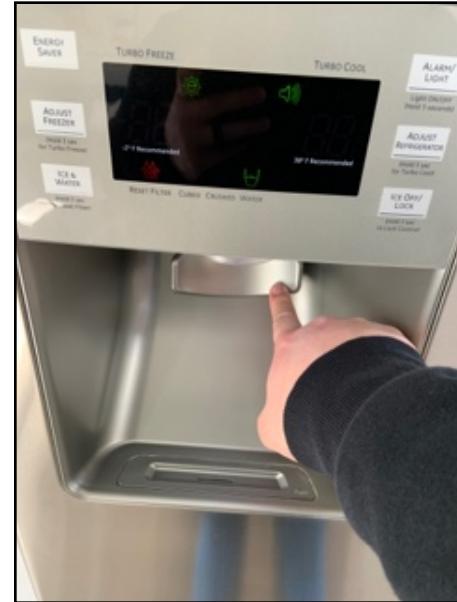
No ice observed in ice maker. Tested water and it was not turned on at time of inspection.

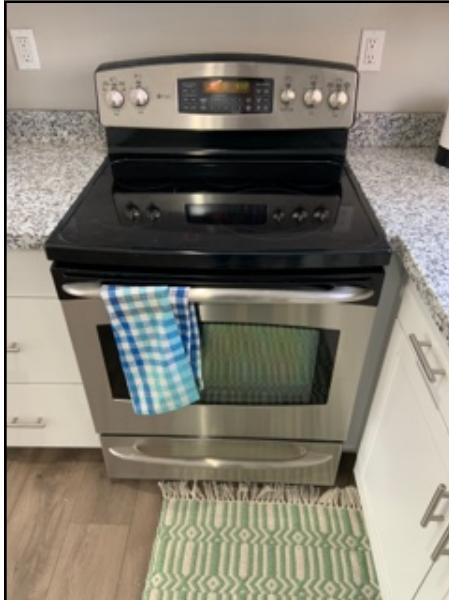
Figure 28-1

Comment 28:
General, good condition.

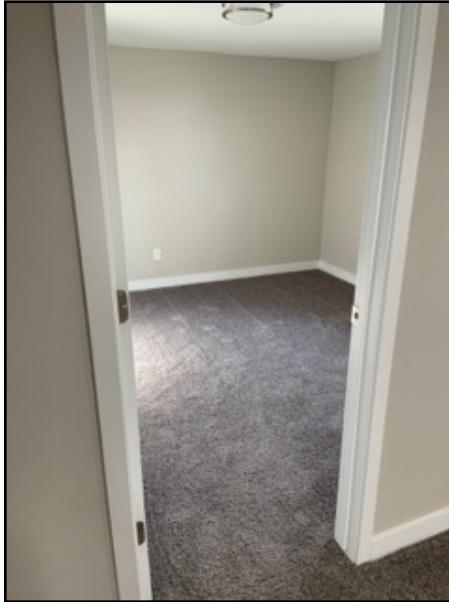
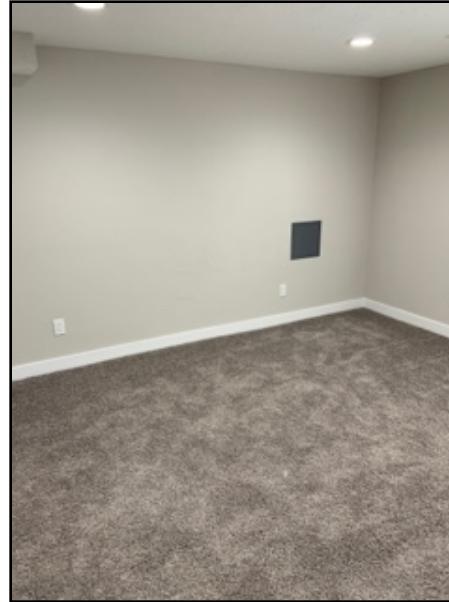
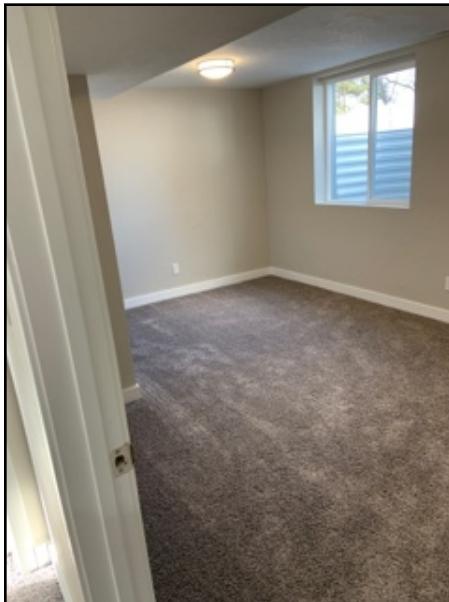
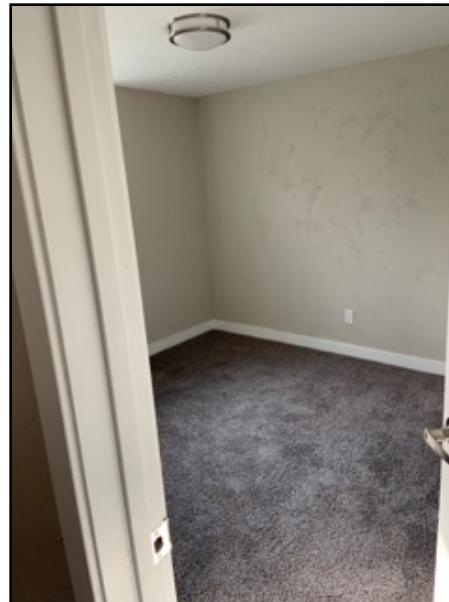
Comment 29:
General, good condition.

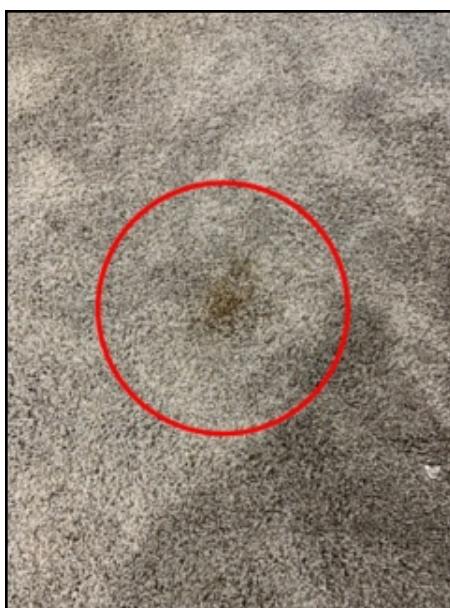
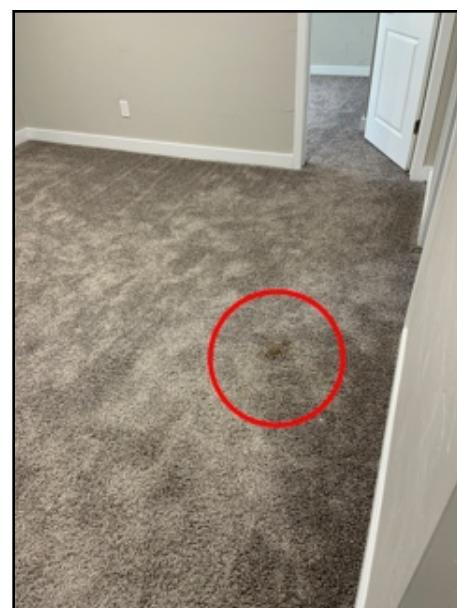
Area in basement living space has observed stain.

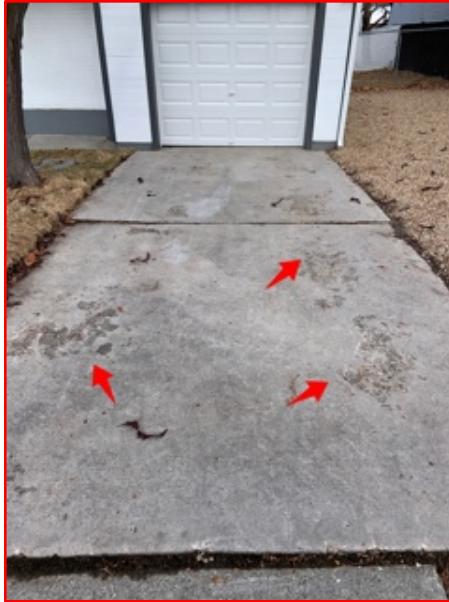
- 1) Minor cracking and chipping on driveway recommend resealing to avoid further cracking.

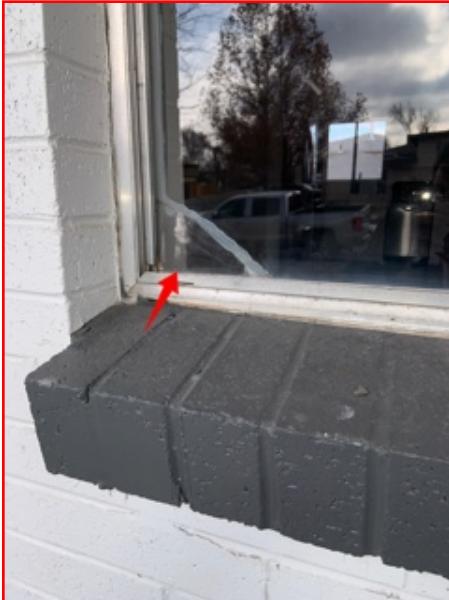
2) Multiple windows with cracked glass recommend repair or replacement .

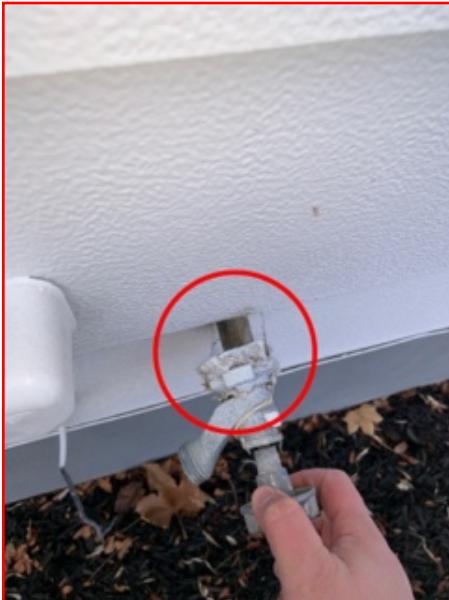
Figure 4-1

3) Exterior spout is loose recommend repair or replacement.

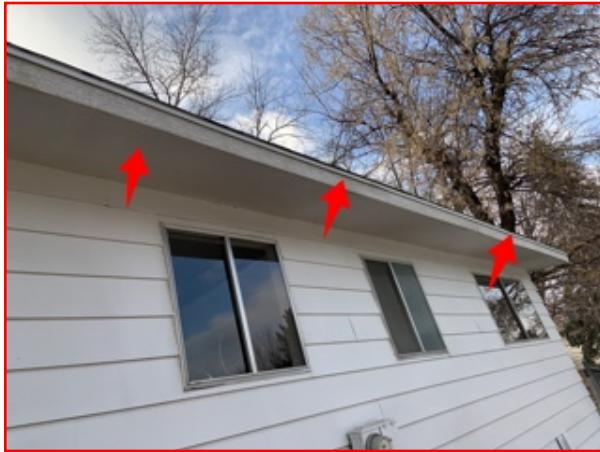
Figure 5-1

4) Missing flashing on north side of house recommend repair or replacement.

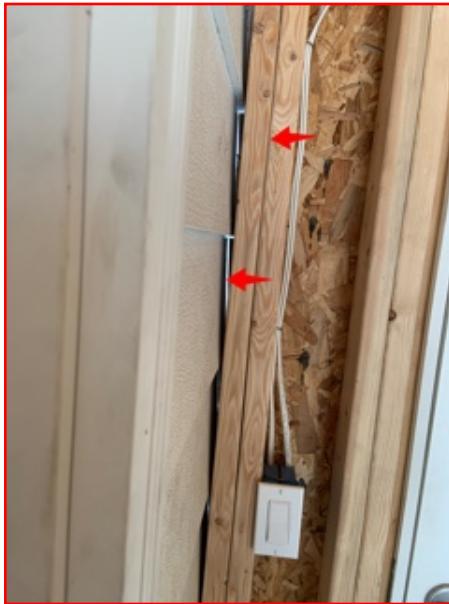
5) Multiple areas observed with gaps in the wall. Recommend sealing.

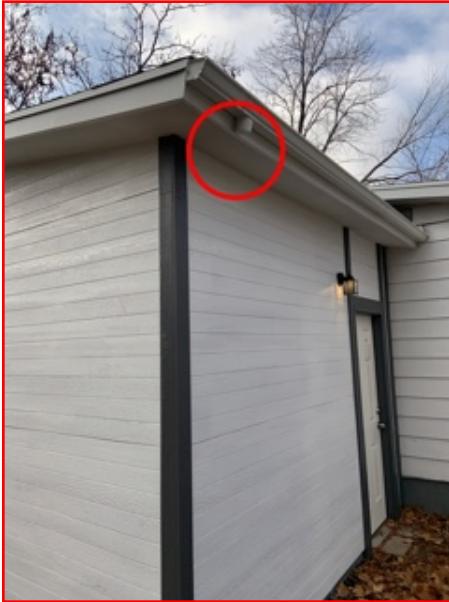
Figure 9-1

7) Missing downspout recommend replacement.

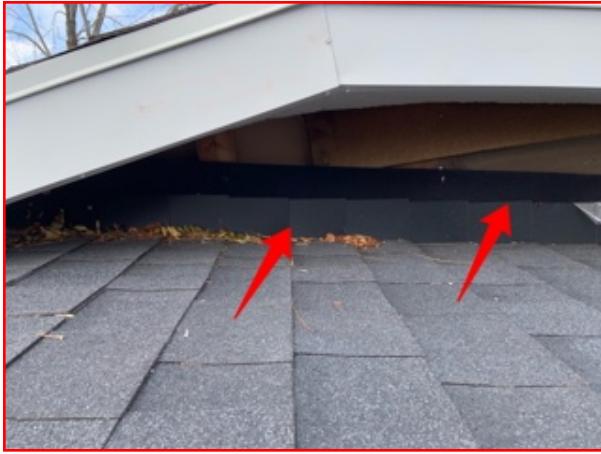
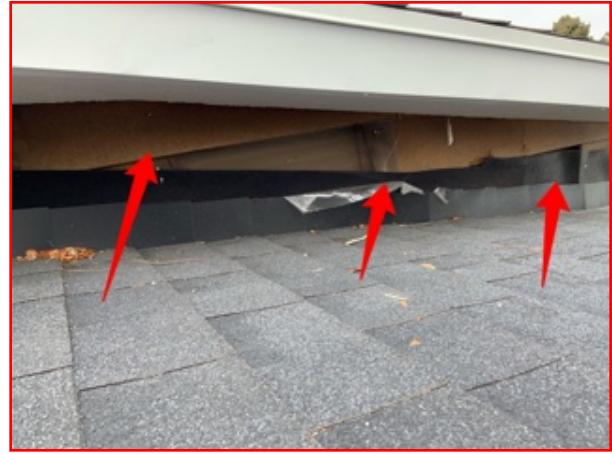
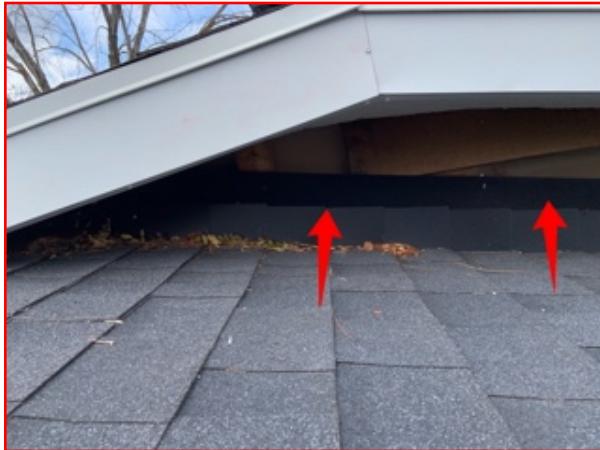
8) Area near the garage attachment observed missing fascia and flashings. Recommend repair and replacement.

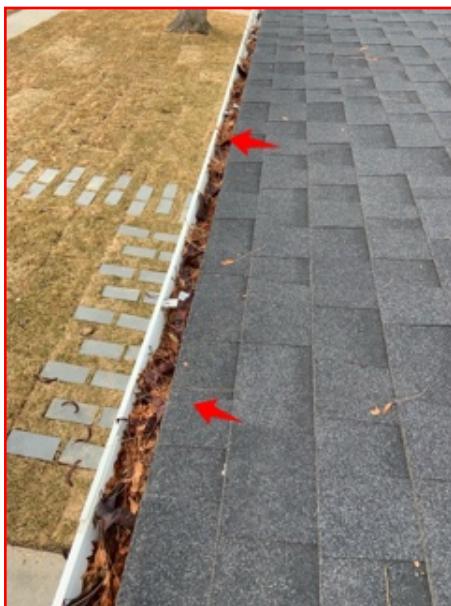
- 9) Gutters near trees on front and rear have build up/blockage observed. Recommend cleaning out. As well as keeping up on tree care.

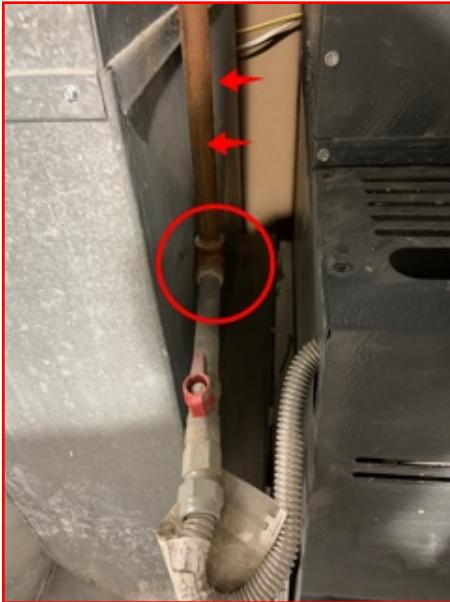
Figure 16-1

10) Heavy rust on main fuel source pipe next to furnace. Slight smell of gas observed as well. Recommend repair or replacement.

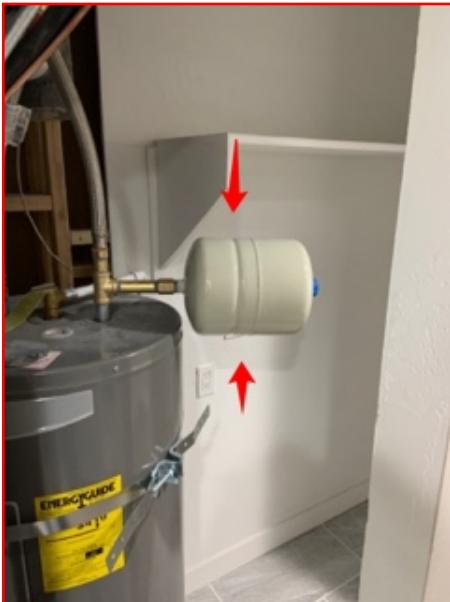
Figure 19-1

11) Overflow tank observed to not have a safety strap connected. Recommend adding a safety strap.

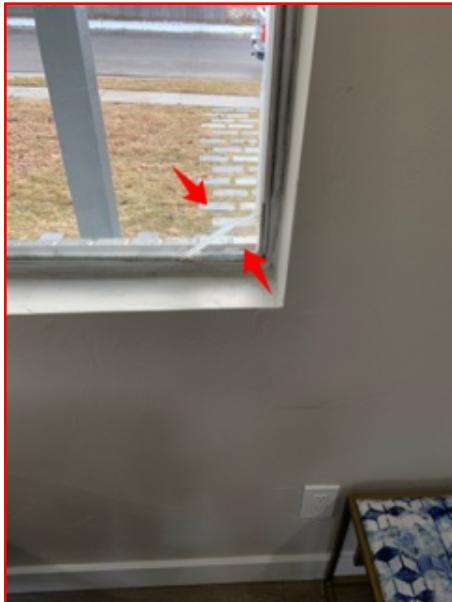
Figure 26-1

15) Window in living room has observed crack in lower corner. Recommend repair or replacement.

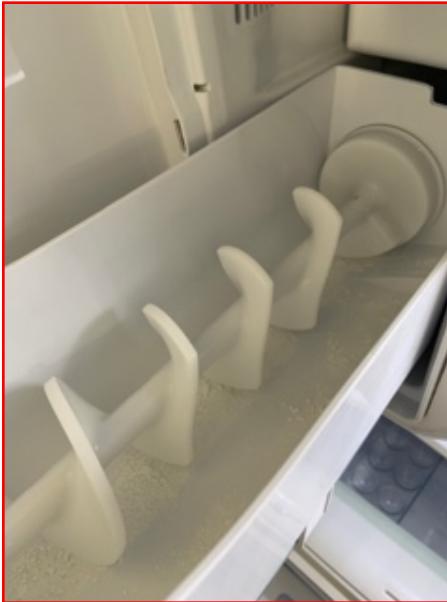
16) No ice observed in ice maker. Tested water and it was not turned on at time of inspection.

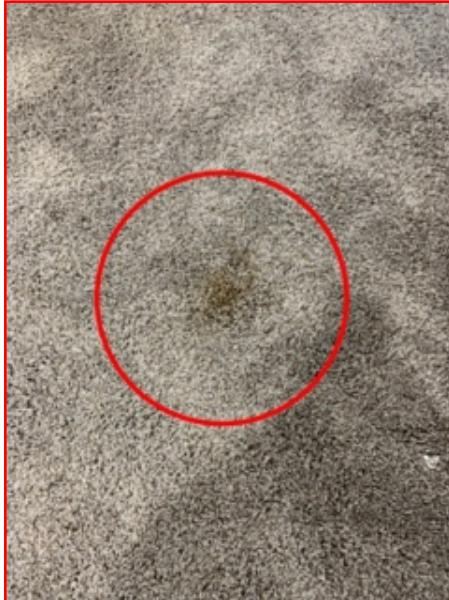
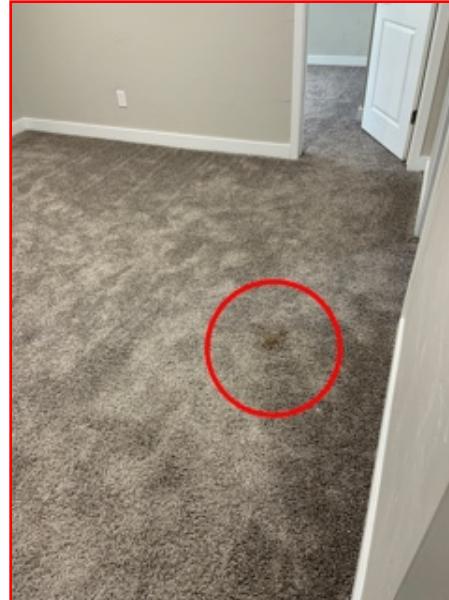
17) Area in basement living space has observed stain.

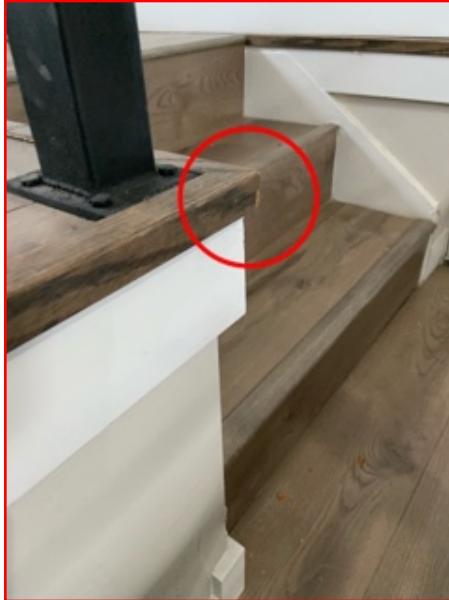
Figure 31-1

18) Observed crack on edge of kitchen flooring near garage door. Recommend repair.
