Dayton Shop (Fleet) F016

Howard County Risk & Safety Inspection

October 21, 2025

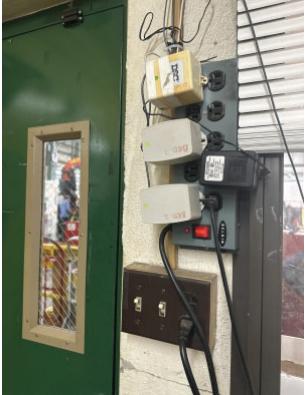
Finding No.: 01	Priority: Medium	Location: Fleet Office Area
Description: Mounted power strip

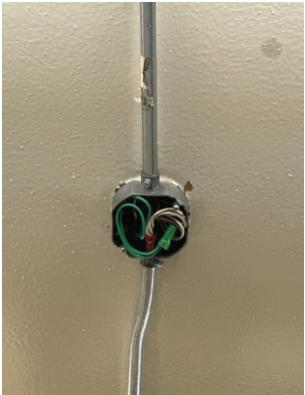
Finding No.: 02	Priority: Medium	Location: Fleet Parts Room Storage
Description: There are exposed or unsecured conductors and/or electrical components or the raceway/conduit is broken, and this can post a risk to accidental contact. AND/OR Cover plate(s) is/are missing on the receptacle outlet or raceway/conduit body.

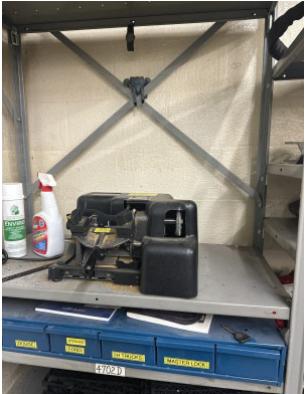
Fleet-Dayton-2025-03	Fleet Parts Room Storage	Medium	BMP	Best Management Practice	Key grinder - employee needs to wear eye protection when using machine	Add signage that says "eye protection required"	60			
Facilities Corrective Action List										
Fleet-Dayton-2025-04	Bay 4	High	OSHA 29CFR 1910.212(b)	Machines designed for a fixed location shall be securely anchored to prevent walking or moving.	Equipment/machinery (e.g., the vise, drill press, bench grinder, etc.) is/are not securely mounted to the working surface and could potentially lead to injury.	Properly secure the equipment/machinery to the working surface (e.g., the working table, or the wall) to ensure it becomes fixed.	Immediate			
Fleet-Dayton-2025-05	Fleet Breakroom	High	OSHA 29CFR 1910.304(b)(4)(ii)(B)	Where connected to a branch circuit supplying two or more receptacles or outlets, a receptacle may not supply a total cord- and plug-connected load (i.e., the ratio of max load and receptacle and circuit amperage) in excess of the maximum specified in Table S-4.	There is a potential that the circuit is overloaded and has too many items connected to it, creating a potential for fire. This includes appliances (e.g., fridge/mini-fridge or microwaves, etc.) or other large-energy draw equipment (e.g., printers, thermal laminators, etc.) being plugged into surge protectors or extension cords and not directly into a receptacle outlet.	1) Removable power taps (power strips) and extension cords are to not be utilized as permanent solutions. 2) Appliances are to be plugged directly into a receptacle outlet and not into a power strip.	30	Completed on Site	10/22/2025

Finding No.: 03	Priority: Medium	Location: Fleet Parts Room Storage
Description: Key grinder - employee needs to wear eye protection when using machine

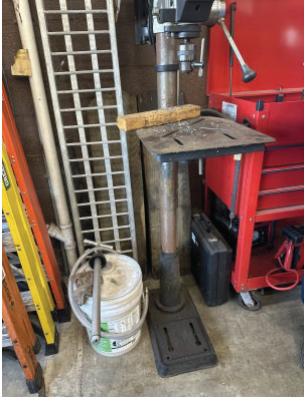
Finding No.: 04	Priority: High	Location: Bay 4
Description: <p>Equipment/machine is/are not securely mounted to the working surface and could potentially lead to injury.</p>

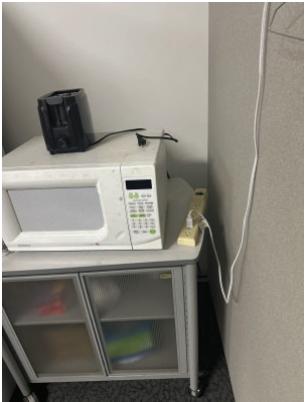
Finding No.: 05	Priority: Medium	Location: Fleet Breakroom
Description: <p>There is a potential that the circuit is overloaded and has too many items connected to it, creating a potential for fire. This includes appliances or other large-energy draw equipment (e.g., printers, thermal laminator, etc.) being plugged into surge protectors or extension cords and not directly into a receptacle outlets</p>

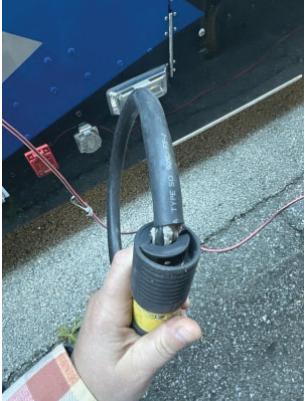
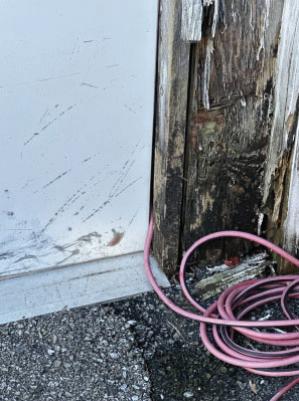
Finding No.: 06	Priority: Medium	Location: Police Mobile Bus
Description: <p>Exposed electrical wires</p>

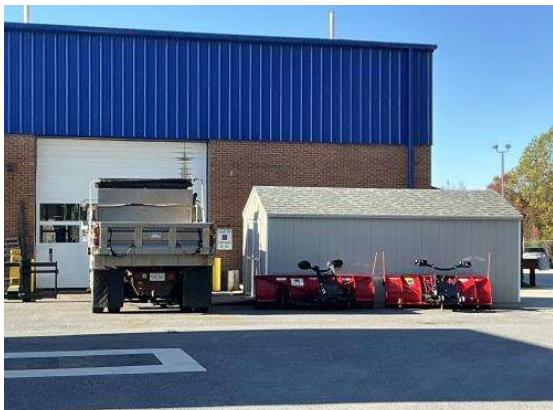
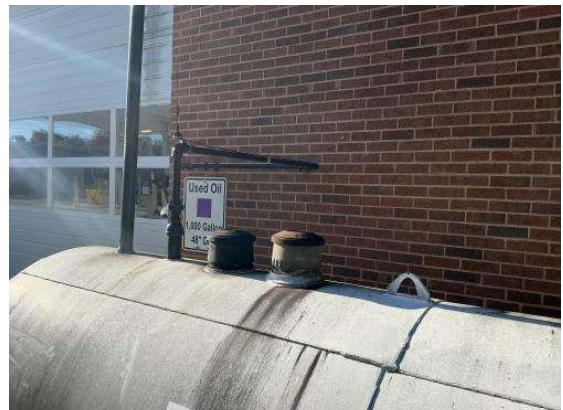
1.1 -
60.5.1.8.1.3.

N/A	Floor 1	Misc. Group 1	M.1 - Billing Address Verification
N/A	Floor 1	Misc. Group 1	M.2 - Square Footage Verification
Fail: NOTICE OF VIOLATION	Floor 1	MD - Howard Co NFPA 1 2021 Chapter 60 Hazardous Materials	60.5.1.8.1.3 - Maintenance. (see photo 1.1, 1.2)
Inspector Comments: ACTION REQUIRED: Raise "Used Oil" sign higher on building, above new shed, to increase visibility.			
Fail: NOTICE OF VIOLATION	Floor 1	MD - Howard Co NFPA 1 2021 Chapter 60 Hazardous Materials	60.5.1.8.2.1 - NFPA 704 Placard. (see photo 2.1, 2.2, 2.3)

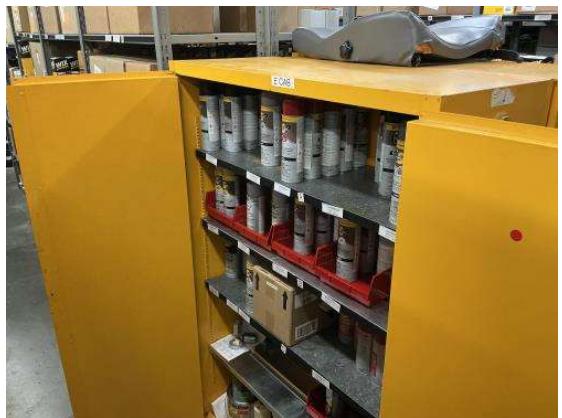
3.1 -
66.9.4.3.

Fail: NOTICE OF VIOLATION	Floor 1 Fleet	MD - Howard Co NFPA 1 2021 Chapter 66 Flammable and Combustible Liquids	66.9.4.3 - Excerpt: [Storage cabinets that meet at least one of the ...] (see photo 3.1)
Inspector Comments: ACTION REQUIRED: Remove cardboard boxes from cabinet "E"			
Fail: NOTICE OF VIOLATION	Floor 1 Fleet	MD - Howard Co NFPA 1 2021 Chapter 11 Building Services	11.1.8 - Electrical Plate Covers (see photo 4.1)
Inspector Comments: ACTION REQUIRED: Replace missing electrical cover in parts room.			
Fail: NOTICE OF VIOLATION	Floor 1 Fleet	MD - Howard Co NFPA 1 2021 Chapter 11 Building Services	11.1.5.6* - Extension cord usage. (see photo 5.1)
Inspector Comments: ACTION REQUIRED: Heavy appliances must be plugged directly into a wall outlet in Break/Bunk room. Recommend adding additional outlets to meet needs. (Photo 1)			
Fail: NOTICE OF VIOLATION	Floor 1 Highways	MD - Howard Co NFPA 1 2021 Chapter 11 Building Services	11.1.5.6* - Extension cord usage. (see photo 6.1)
