# Image Analysis Report

| Source | corrosion.jpg |
| Report ID | 00f31dc1-2467-4853-80d5-25bb6b52f9f5 |

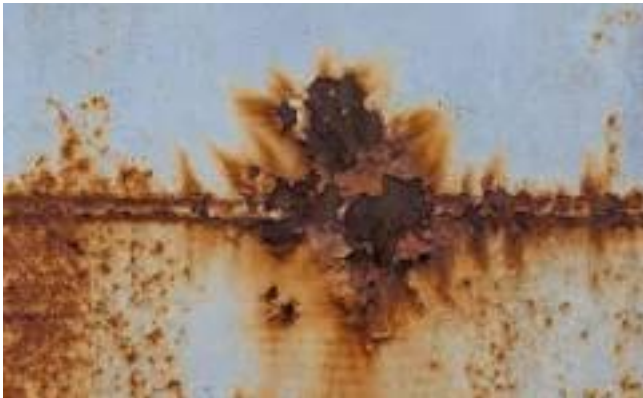
The assessment confirms a severe level of corrosion, characterized by deep localized scaling and preferential attack along a horizontal weld seam. Immediate NDT is required to quantify metal loss and determine the remaining structural integrity of the component.

| # | Finding |
|---|---|
| 1 | Heavy localized scaling and delamination of oxidized material in the central region of the image. |
| 2 | Corrosion is significantly concentrated along a horizontal linear feature, likely a weld seam or lap joint. |
| 3 | Extensive rust staining spreading vertically from the primary corrosion sites, indicating moisture runoff and active oxidation. |
| 4 | Visible failure of the original coating system with large areas of exposed and oxidized substrate. |
| 5 | Localized deep pitting is highly probable beneath the heavy scale buildup. |
| 6 | Actual remaining wall thickness and internal condition cannot be determined from this visual inspection alone. |

- Severe scaling (conf. 95%): x=0.340, y=0.150, w=0.320, h=0.680
- Linear corrosion (conf. 89%): x=0.000, y=0.420, w=1.000, h=0.150
- Coating failure (conf. 85%): x=0.000, y=0.550, w=0.300, h=0.400

| # | Recommendation |
|---|---|
| 1 | Perform Ultrasonic Thickness (UT) measurements at the center and along the horizontal seam within 72 hours to determine remaining wall thickness. |
| 2 | Execute abrasive blasting to SSPC-SP 10 (Near-White Metal) standards to remove all corrosion products for a detailed surface inspection. |
| 3 | Evaluate the need for weld repair or the installation of a reinforcement sleeve if wall loss exceeds the corrosion allowance. |
| 4 | Conduct a chloride test on the substrate after cleaning to ensure no salts are trapped, which could cause premature coating failure. |
| 5 | Apply a high-performance coating system consisting of a zinc-rich primer and a high-build epoxy mid-coat. |
| 6 | Implement a routine inspection program using NDT for the entire length of this joint to monitor for similar preferential corrosion. |
