## Image Analysis Report

| Source | Valve-Vorrosion.jpg |

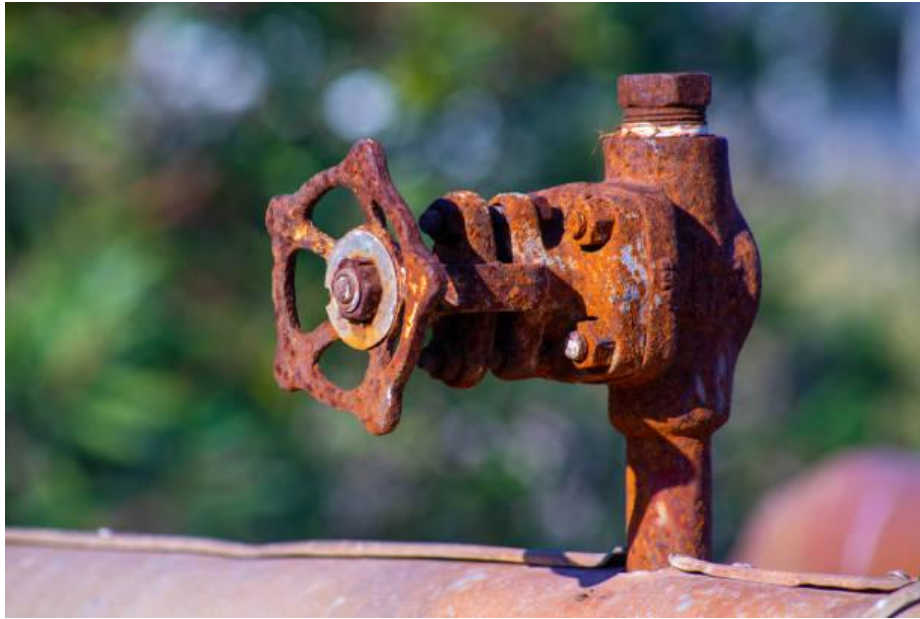
The valve assembly exhibits advanced, high-severity atmospheric corrosion characterized by significant oxide scale formation and material loss. The degradation is severe enough to likely compromise the mechanical integrity of the handwheel and fasteners, posing a risk of operational failure.

| # | Finding |
|---|---|
| 1 | Extensive atmospheric corrosion (rust) covering 100% of the visible valve and handwheel surfaces. |
| 2 | Significant scaling and flaking of corrosion products, indicating deep penetration and metal loss. |
| 3 | Bonnet bolts and nuts are heavily encrusted with corrosion, likely seizing the threads and preventing standard maintenance. |
| 4 | The valve handwheel shows signs of structural thinning, which may lead to failure if high torque is applied. |
| 5 | Surface corrosion is visible on the underlying pipe, though depth of penetration cannot be determined visually. |
| 6 | Heavy accumulation of corrosion products around the valve stem entry suggests the packing and stem are likely seized. |

- Corroded Handwheel (conf. 96%): x=0.280, y=0.220, w=0.200, h=0.480
- Severe Bonnet Corrosion (conf. 94%): x=0.440, y=0.300, w=0.350, h=0.320
- Pipe Surface Corrosion (conf. 89%): x=0.000, y=0.840, w=1.000, h=0.150

| # | Recommendation |
|---|---|
| 1 | Isolate the process line and schedule the replacement of the entire valve unit due to the severity of the corrosion. |
| 2 | Perform Ultrasonic Thickness (UT) testing on the adjacent piping to ensure the remaining wall thickness meets safety standards. |
| 3 | Do not attempt to operate the handwheel until the mechanical integrity is verified to prevent sudden fracture. |
| 4 | Utilize penetrating oils or induction heating for fastener removal if disassembly is required for further forensic analysis. |
| 5 | Apply a high-performance marine-grade coating system (e.g., zinc-rich primer and epoxy topcoat) to all new components. |
| 6 | Review the local environment for corrosive agents (e.g., salt spray or chemical fumes) that may have accelerated this degradation. |
| 7 | Establish a more frequent inspection interval for this specific location within the corrosion management program. |
