| 2 | Source File: corrosion.jpg |
| 4 | Report Title: Image Analysis Report |

# Image Analysis Report

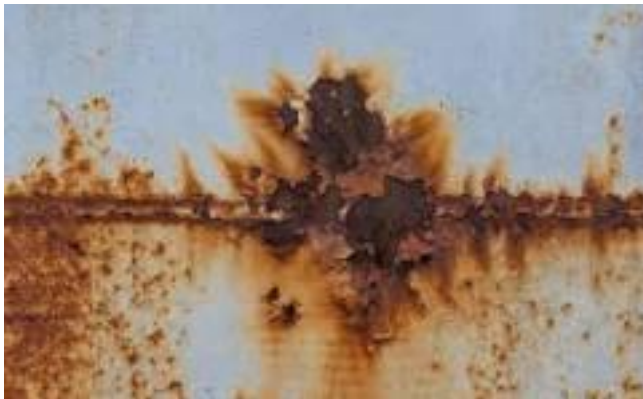
| 12 | Classification: Severe Corrosion |
| 15 | Notes: Significant localized corrosion observed. |

The image exhibits severe localized corrosion and significant coating failure, particularly concentrated along a horizontal seam. Given the visible metal delamination and scaling, the severity is high, posing a risk to structural integrity or pressure containment.

| # | Finding |
|---|---|
| 1 | Severe localized corrosion in the center with visible material delamination and 'rust scabbing'. |
| 2 | Preferential corrosion attack along a horizontal feature, likely a weld seam or lap joint. |
| 3 | Widespread coating breakdown leading to secondary atmospheric corrosion and rust staining. |
| 4 | Presence of heavy, dark iron oxide scale suggests a prolonged period of moisture retention and oxidation. |
| 5 | Surface pitting is suspected under the central scaled area but cannot be quantified without cleaning. |
| 6 | Visible vertical rust streaks indicating active corrosion run-off from the primary site. |

- Severe Scaling and Metal Loss (conf. 95%): x=0.350, y=0.150, w=0.380, h=0.650
- Seam Corrosion (conf. 88%): x=0.000, y=0.450, w=1.000, h=0.120

| # | Recommendation |
|---|---|
| 1 | Perform immediate Ultrasonic Thickness (UT) gauging at the center of the defect to assess remaining wall thickness. |
| 2 | Abrasive blast clean the area to SSPC-SP 10 (Near-White Metal) to fully expose the extent of metal loss. |
| 3 | Evaluate for a weld-on repair patch or structural reinforcement if wall loss exceeds the allowable limit (typically 12.5-20% depending on code). |
| 4 | Perform Dye Penetrant Inspection (DPI) or Magnetic Particle Inspection (MPI) on the horizontal weld seam to check for surface-breaking cracks. |
| 5 | Apply a high-build epoxy coating system specifically formulated for salt/industrial environments after surface preparation. |
| 6 | Establish a localized monitoring point and re-inspect within 6 months to ensure the repair/coating remains intact. |
| 7 | Ensure all personnel maintain a safe distance until the integrity of the component (if pressurized) is verified. |
