## Image Analysis Report

| Source | corrosion.jpg |

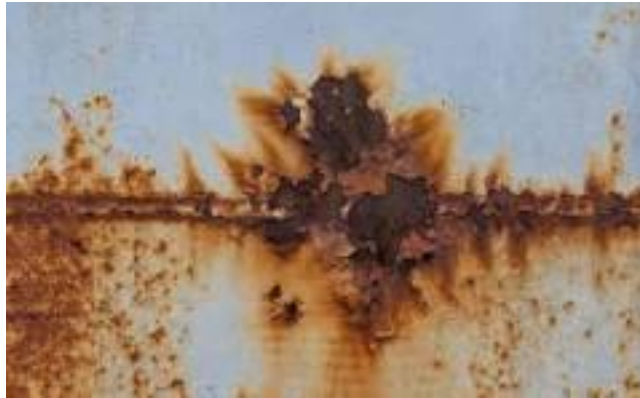
This image displays severe localized corrosion and complete coating breakdown along a horizontal weld seam, consistent with a high severity rating. The presence of heavy exfoliating scale indicates significant metal loss and potentially compromised structural integrity of the joint.

| # | Finding |
|---|---|
| 1 | Significant localized corrosion centered on a horizontal weld or joint interface. |
| 2 | Formation of heavy, brittle iron oxide scale (exfoliation) in the central area. |
| 3 | Complete failure of the protective coating system in affected zones. |
| 4 | Visible under-film corrosion creeping beneath the remaining paint edges. |
| 5 | Distinct vertical rust bleeding patterns suggesting active moisture ingress and corrosion. |
| 6 | Presence of pitting clusters in the immediate vicinity of the main corrosion site. |

- Severe Exfoliation (conf. 92%): x=0.340, y=0.120, w=0.400, h=0.720
- Corroded Weld Seam (conf. 88%): x=0.000, y=0.440, w=1.000, h=0.140

| # | Recommendation |
|---|---|
| 1 | Schedule immediate abrasive blast cleaning (SSPC-SP 10) to expose the bare metal substrate for assessment. |
| 2 | Perform Ultrasonic Thickness (UT) measurements to quantify the depth of pitting and overall wall loss. |
| 3 | Evaluate the structural integrity of the weld using Magnetic Particle Inspection (MPI) after cleaning to check for cracks. |
| 4 | Determine if remaining wall thickness is below minimum allowable (T-min) per engineering standards. |
| 5 | Implement a repair solution such as a weld overlay or flush patch if structural limits are exceeded. |
| 6 | Re-coat the surface using a high-performance system including a zinc-rich primer and epoxy mid-coat. |
