# Image Analysis Report

| Source | corrosion.jpg |
| Report ID | a5130cbe-0133-4e16-82a8-4b54d955a834 |

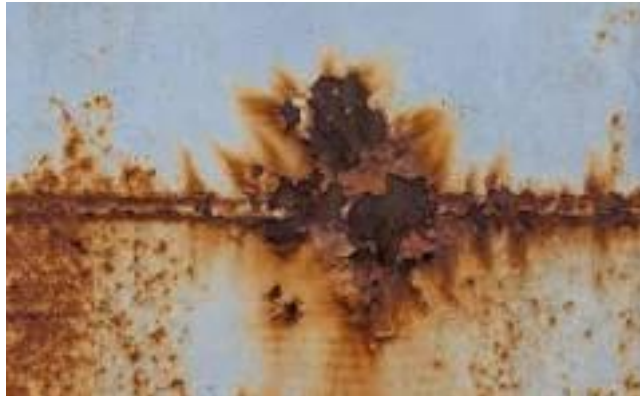
This assessment identifies severe (Level 4) localized corrosion with significant scaling and delamination of the protective coating. The corrosion is concentrated along a horizontal seam or weld, indicating preferential attack or crevice corrosion that may compromise structural integrity.

| # | Finding |
|---|---|
| 1 | Heavy scaling and localized metal loss in the central region, approximately 30-40% of the visible frame width. |
| 2 | Corrosion is highly concentrated along a horizontal feature, likely a weld seam or lap joint. |
| 3 | Complete coating failure with visible delamination and exposing the substrate to atmospheric moisture. |
| 4 | Extensive rust bleed and staining trailing vertically downward from the primary corrosion sites. |
| 5 | Presence of loose, flaky iron oxide (scale) suggesting active, advanced corrosion cells. |
| 6 | Exact depth of pitting and remaining wall thickness cannot be determined from this image alone without ultrasonic testing (UT). |
| 7 | Visible surface roughness indicates significant material degradation beneath the scale. |

- Heavy Scaling (conf. 92%): x=0.350, y=0.120, w=0.380, h=0.650
- Seam Corrosion (conf. 88%): x=0.000, y=0.440, w=1.000, h=0.120
- Coating Failure (conf. 85%): x=0.040, y=0.400, w=0.280, h=0.550

| # | Recommendation |
|---|---|
| 1 | Perform immediate Ultrasonic Thickness (UT) gauging on a 50mm x 50mm grid across the most affected central area. |
| 2 | Execute abrasive blasting to SA 2.5 (Near-White Metal) to remove all loose scale and assess the true extent of metal loss. |
| 3 | Conduct Pit Depth measurement using a needle gauge to quantify localized thinning against the original design thickness. |
| 4 | If remaining wall thickness is below the minimum allowable (T-min) per API 510/570, perform a weld overlay or install a structural patch plate. |
| 5 | Apply a high-build epoxy coating system with a zinc-rich primer once surface preparation is complete and structural integrity is confirmed. |
| 6 | Investigate the horizontal seam for crevice corrosion; if it is a lap joint, consider seal-welding if appropriate for the service. |
| 7 | Establish a 6-month monitoring frequency for this location until repairs are completed and verified. |
