# Image Analysis Report

| Source | 1737714419873.jpg |
| Report ID | d4c1fc3f-c697-4c80-950e-500c3f658a10 |

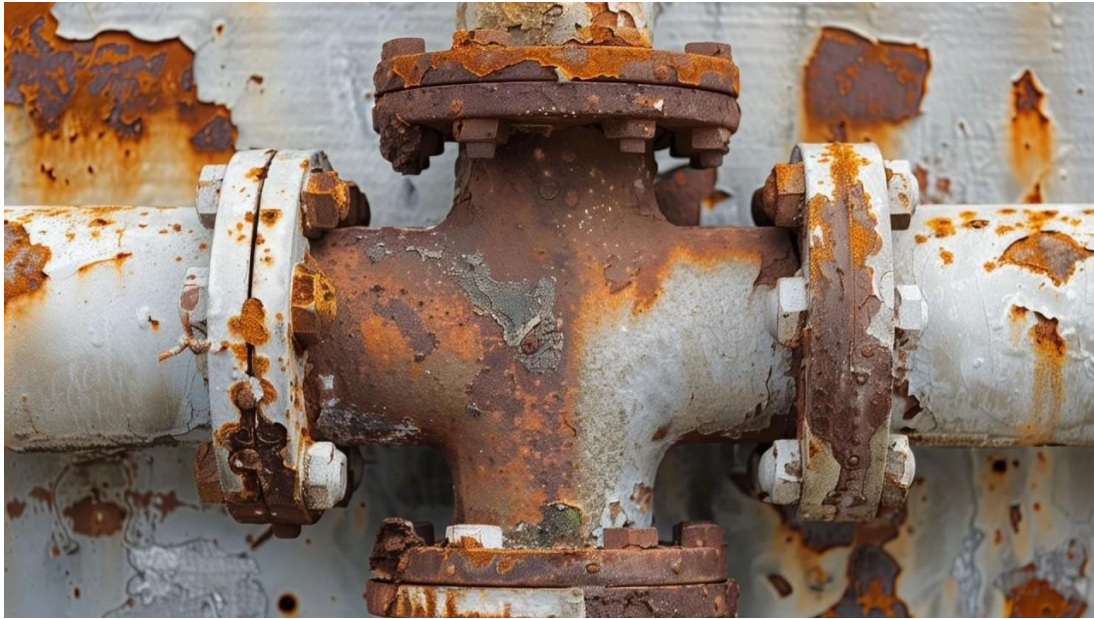
This piping assembly exhibits severe atmospheric corrosion and widespread coating system failure across the central cross and flange connections. The advanced state of material degradation on fasteners and the presence of thick, stratified rust scale suggest a high risk to both structural and pressure-containing integrity.

| # | Finding |
|---|---|
| 1 | Advanced stratified rust scale on the upper flange assembly indicating significant material loss. |
| 2 | Widespread coating delamination and peeling on the horizontal pipe runs and central body. |
| 3 | Heavy corrosion on fasteners with visible reduction in bolt head geometry on the left and right flanges. |
| 4 | Localized pitting and general surface metal loss on the central cross-fitting where the coating has failed. |
| 5 | Potential crevice corrosion at the flange-to-pipe and flange-to-flange interfaces. |
| 6 | Internal corrosion state and remaining wall thickness cannot be determined from this visual inspection alone. |

- Severe Flange Scale (conf. 95%): x=0.330, y=0.050, w=0.350, h=0.220
- Fastener Degradation (conf. 92%): x=0.160, y=0.230, w=0.160, h=0.630
- Fastener Degradation (conf. 92%): x=0.680, y=0.220, w=0.170, h=0.630
- Coating Failure (conf. 88%): x=0.840, y=0.320, w=0.160, h=0.400
- General Metal Loss (conf. 90%): x=0.280, y=0.250, w=0.420, h=0.600

| # | Recommendation |
|---|---|
| 1 | Perform Ultrasonic Testing (UT) to verify remaining wall thickness of the pipe and fitting against the design minimum. |
| 2 | Mechanically clean all surfaces to SSPC-SP 10 (Near-White Blast Cleaning) to reveal the true extent of pitting. |
| 3 | Replace all corroded bolts and nuts with new, high-grade coated fasteners (e.g., fluoropolymer or zinc-plated). |
| 4 | Apply a high-performance multi-coat industrial protection system, including a zinc-rich primer and epoxy mid-coat. |
| 5 | Inspect flange face sealing surfaces for corrosion damage once the joints are disassembled for bolt replacement. |
| 6 | Increase the frequency of visual inspections to quarterly until the remediation project is completed. |
