INVESTIGATION OF FAN FAULT PROBLEMS USING VIBRATION AND NOISE ANALYSIS

Selçuk ERKAYA

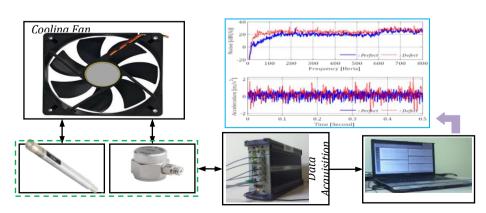
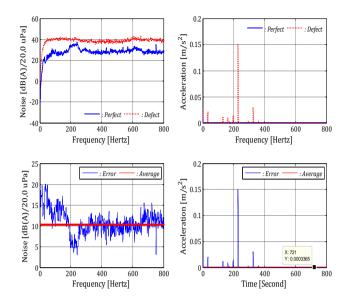
Fig. 4: Noise and vibration measurements for Case 2

It is clear from Fig. 4 that the increasing of hole diameter makes the vibration and noise characteristics worse. Both vibration amplitude and noise level increase. The results of noise and vibration measurements for Case 3 are outlined in Fig. 5,

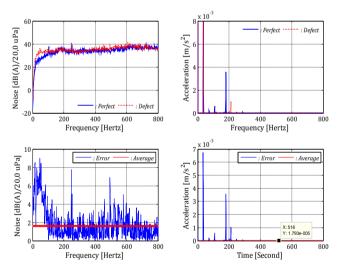
Fig. 5: Noise and vibration measurements for Case 3

As seen from Fig. 5, it is clear that, there is a certain difference between perfect and defect fans. Particularly, noise characteristic has a clear difference. So, it is said that noise measurement can be used effectively to detect this fault type in mechanical systems. For the Case 4, the results of noise and vibration measurements are given in Fig. 6.
