# Defect Detection Report (DDR)

This Defect Detection Report (DDR) is based on the inspection conducted on September 27, 2022, at Flat No. 203. The inspection was carried out by Krushna & Mahesh, and the report highlights the observed defects and their severity levels.

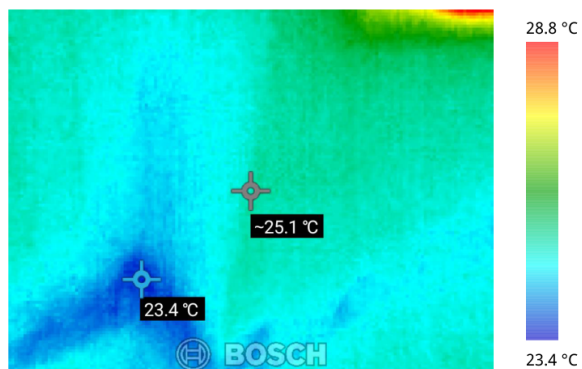
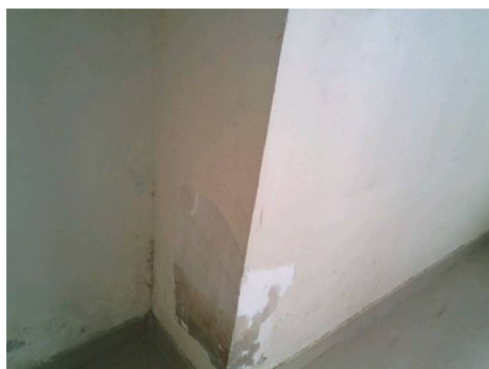
27/09/22

| Hotspot : | 28.8 °C |
| Coldspot : | 23.4 °C |

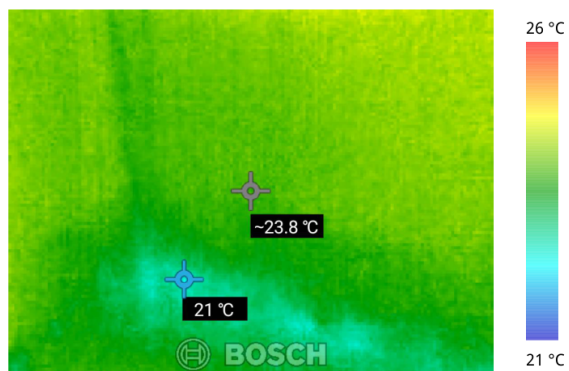
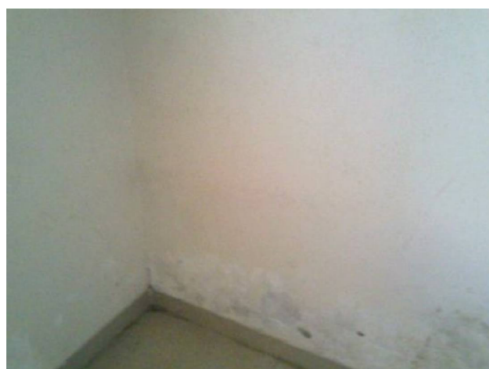
| 27/09/22 | | |

| 27/09/22 | | |
|---|---|---|
| | Hotspot : | 26 °C |
| | Coldspot : | 21 °C |

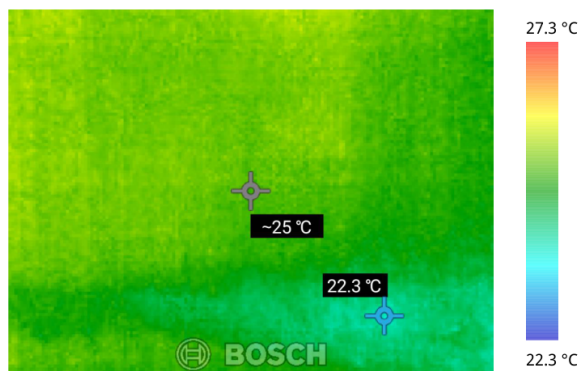
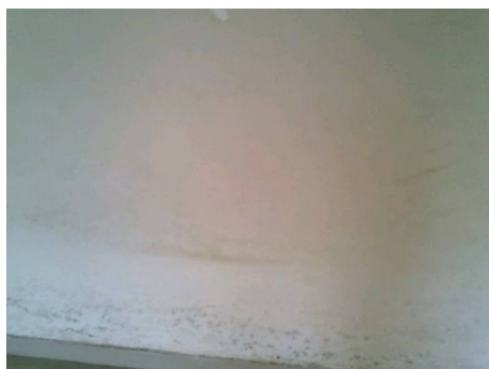
27/09/22

| | Hotspot : | 27.3 °C |
| | Coldspot : | 22.3 °C |
