## **L4 - Methods for Nondestructive Evaluation**

AE 417: Aerospace Structures and Instrumentation Laboratory

Embry-Riddle Aeronautical University

October 24, 2025

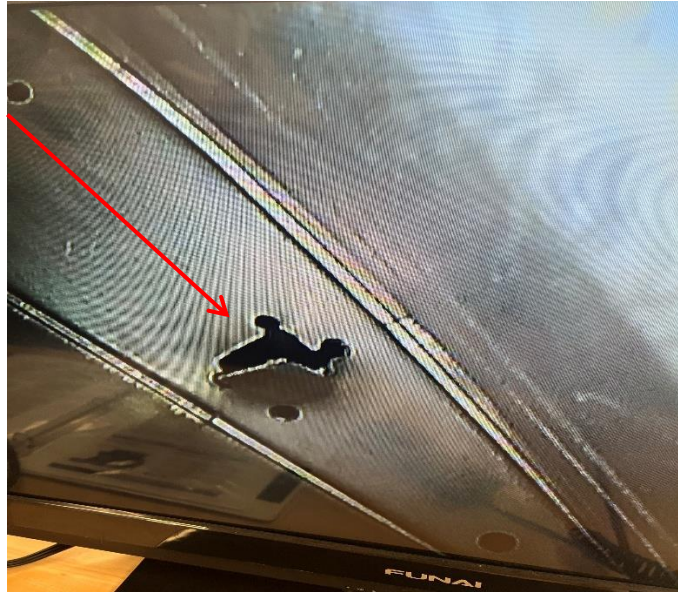
During inspection, the interior surface of the airfoil showed visible scratches and cracks, especially near the rivet holes. These damages are likely from handling, cyclic fatigue, or surface stress concentration. The borescope captured these features clearly and is presented in the following images. No corrosion or delamination was observed.

*Figure 5: Interior Surface Deformations – Surface Crack*

The damage found during the visual inspection is probably the result of fatigue damage. This is a common issue in wing structures when cyclic loading causes stress concentrations around fasteners. These surface defects are important because, if ignored, they might spread under repeated flight loads and ultimately result in material failure.

This lab demonstrated how visual inspection, particularly on vital aerodynamic structures like airfoils, can identify early-stage damage on accessible surfaces. However, follow-up techniques like liquid penetrant or ultrasonic inspection are necessary for a complete structural assessment because visual inspection is unable to detect underlying cracks.

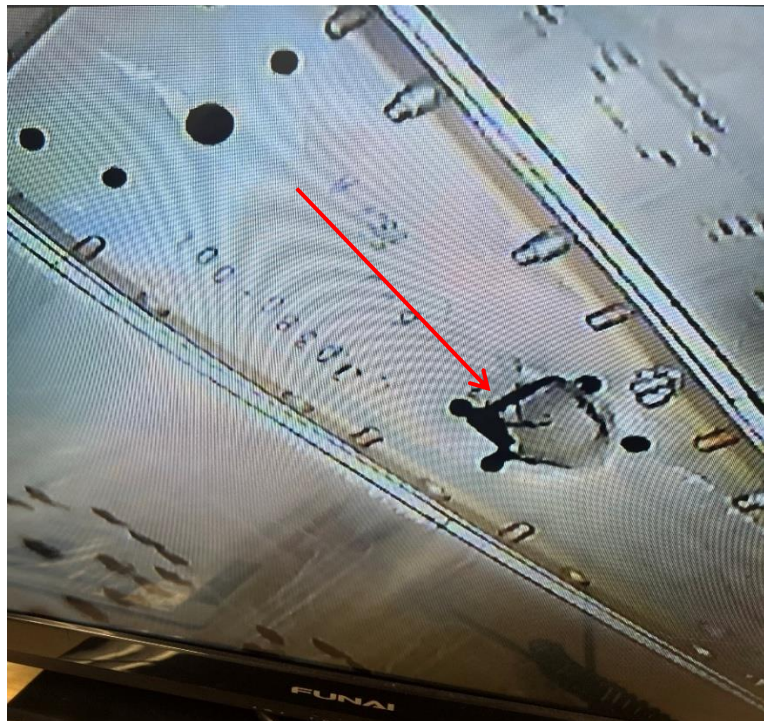
*Figure 6: Interior Surface Deformations – Surface Crack*

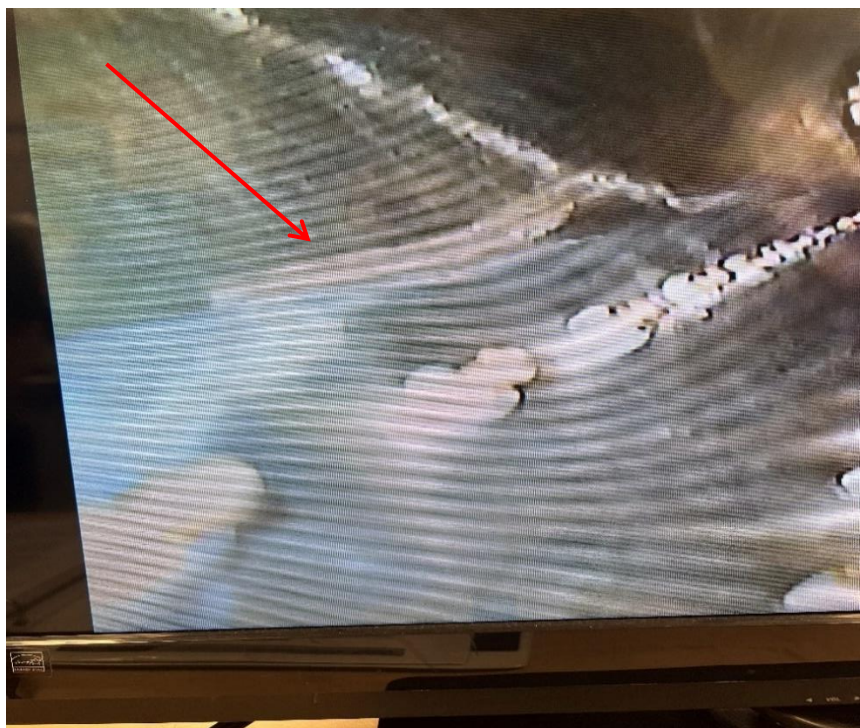
*Figure 7: Interior Surface Deformations – Surface Scratches*

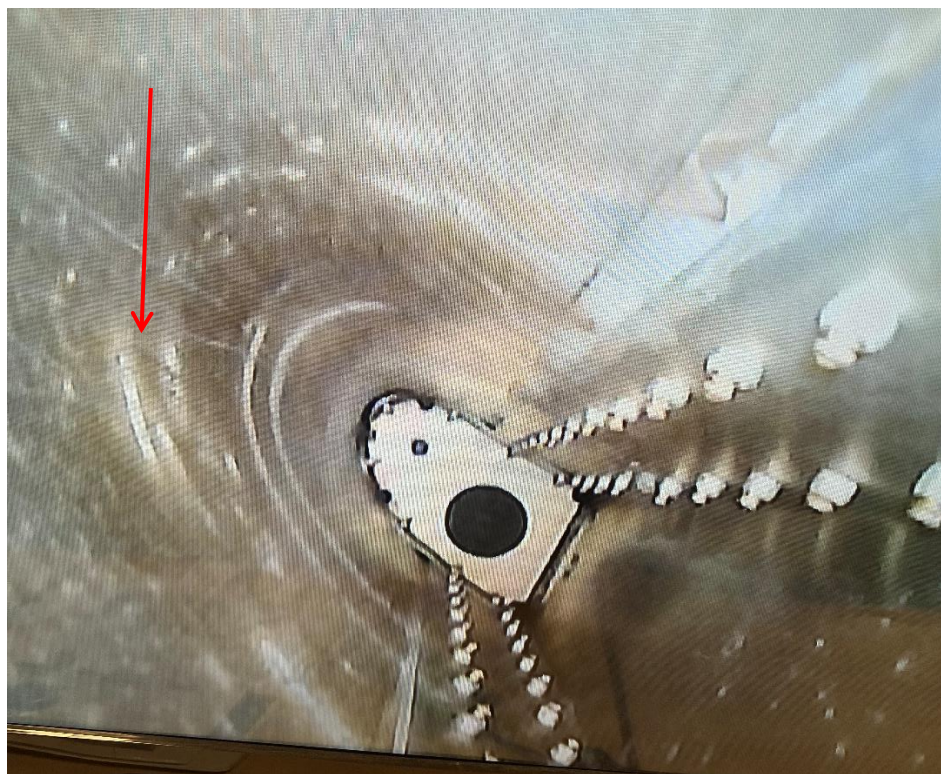
*Figure 8: Interior Surface Deformations – Surface Scratches*

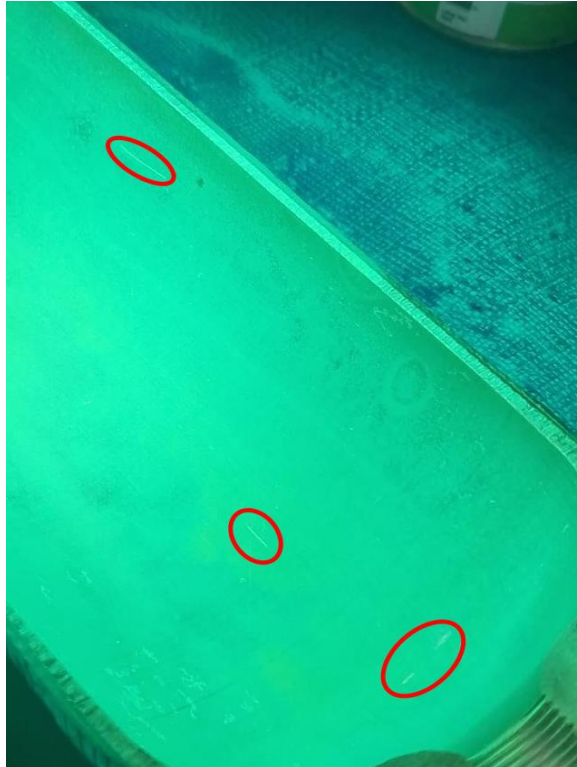
*Figure 23: Test surface under UV light showing three damage areas.*

Using the liquid penetrant the damaged areas are more visible while utilising UV light. They contrast the green of the penetrant showing a brighter color. On the tank test part there are at least 8 sections that have damage. The damage that the penetrant shows is primarily scratches and cracks.

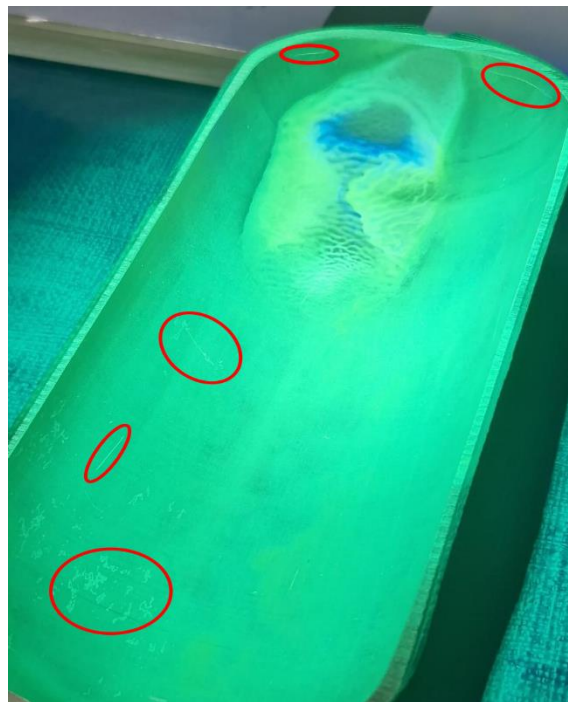
*Figure 24: Test surface under UV light showing five damage areas.*
