ECE 745 PROJECT BUG REPORT

GROUP 37

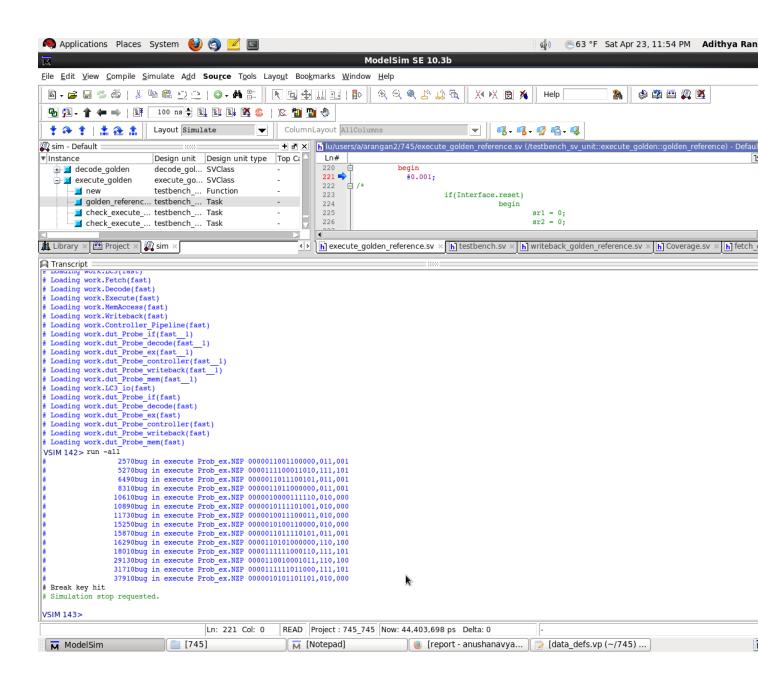
Bug5: EXECUTE

The NZP value in execute stage does not turn out to be the same in Golden Reference and DUT. This is because the middle bit of NZP value for BR instruction always seems to be stuck at 0 ie NZP[1]=0 always. Hence we get an error when the middle bit of NZP goes high in golden reference but instead it stays low in the buggy DUT.
