Bitlox first impressions and teardown

February 12, 2016

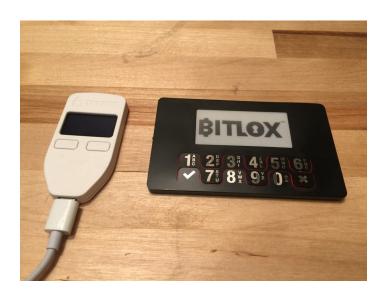
Nice large e-ink screen. About the height and width of a credit card, but about 4mm thick

But all that fades after the first press of one of those buttons. They are smushy beyond smushy, and the feel of the buttons at the left and right sides is far different than the ones in the middle. The '3', '4', '8', and '9' keys have a distinct point during the button travel where the press is activated, as you would expect a button to feel, but the buttons on either end have zero travel -- Zero! It feels like I'm pressing on a hard surface, and when some pressure threshold is exceeded, the button press is registered. I wouldn't want this behavior for any buttons, but this is especially terrible for the 'checkmark' button, presumably used for confirming actions such as Bitcoin transactions.

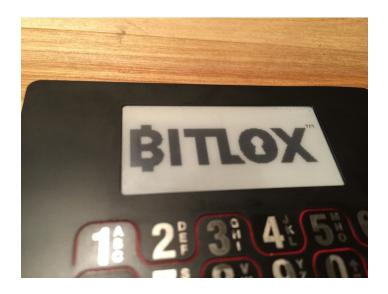
There's some goo in the upper right corner of the screen underneath the protective outer surface layer. This appears on both units.

The front surface of the Bitlox is bowed out quite a bit, which I believe contributes to the terrible feel of the keyboard. Here, It feels like they are trying to fit in a battery that's too thick, but are including it anyway. This isnt the case, but that's the impression I had before popping it open.

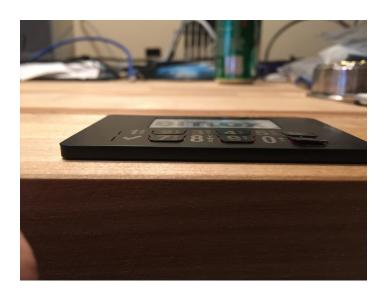
Its hard to capture how not flat the front surface of the Bitlox is. Also, look at those keys! They will catch on things in your pocket and bend out of position quite easily. I drink Mt. Dew.

In reality, its just a terrible keyboard design.

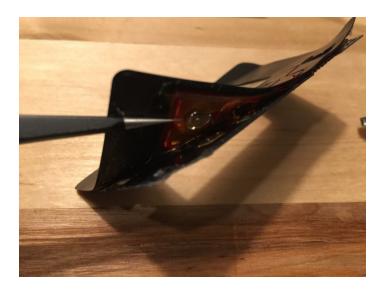
This is pretty terrible. I didnt test it, but I doubt this would be moisture/water resistant at all.

The connection between the keyboard and the pcb is a direct edge soldering that separated when prying the two pieces apart

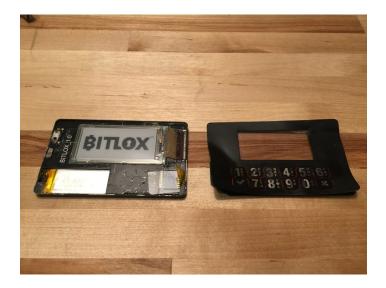
The connection between the two pieces is visible along the bottom edge of the left part, to the right of the shiny silver battery.

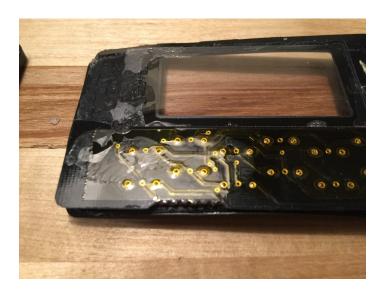
The back of the keyboard along with soldered edge connection

The components are on the bottom of the pcb, and there was no easy way to get the pcb out of the bottom of the case. There was much spudging, and once separated, it was clear why

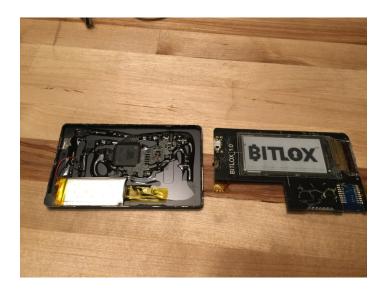
The space between the component side of the pcb and the rear shell is partially filled with a hardened black epoxy.

The black epoxy bonded the pcb to the rear shell tightly enough that come components were ripped off the board when I pried them apart.

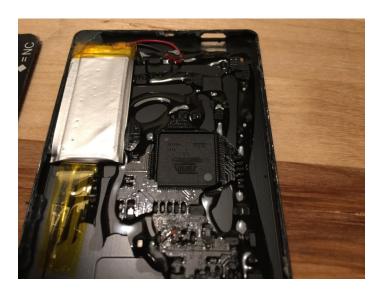
SMT components embedded in hardened black epoxy

And here's a view of the component side of the pcb. The bluetooth module appears to be an off-the-shelf module, there's an ARM chip from Atmel, and another small atmel mcu - likely a USB-to-serial bridge.

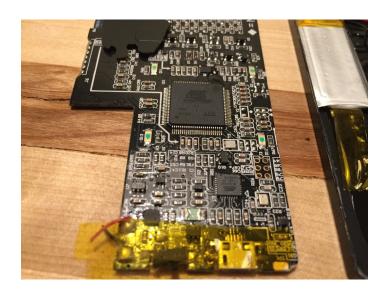
That's alot of passives. There's also what looks like a jtag/debugging header over there on the right side. This board is dead due to parts being embedded in the epoxy, but I could imagine that a hole could be carefully drilled right at that location on a working device to get access to that header to test to see if its enabled. I'd check the firmware source code, but its not available.

Another thing, the header on the right in that photo is for flashing the firmware of the 16u2 that runs the USB connection. The JTAG headers for the main board were removed from the layout.
