# Property inspection report.

Illustrative residential property, Nagpur

01 October 2026 (example date) · Fictional scope and findings

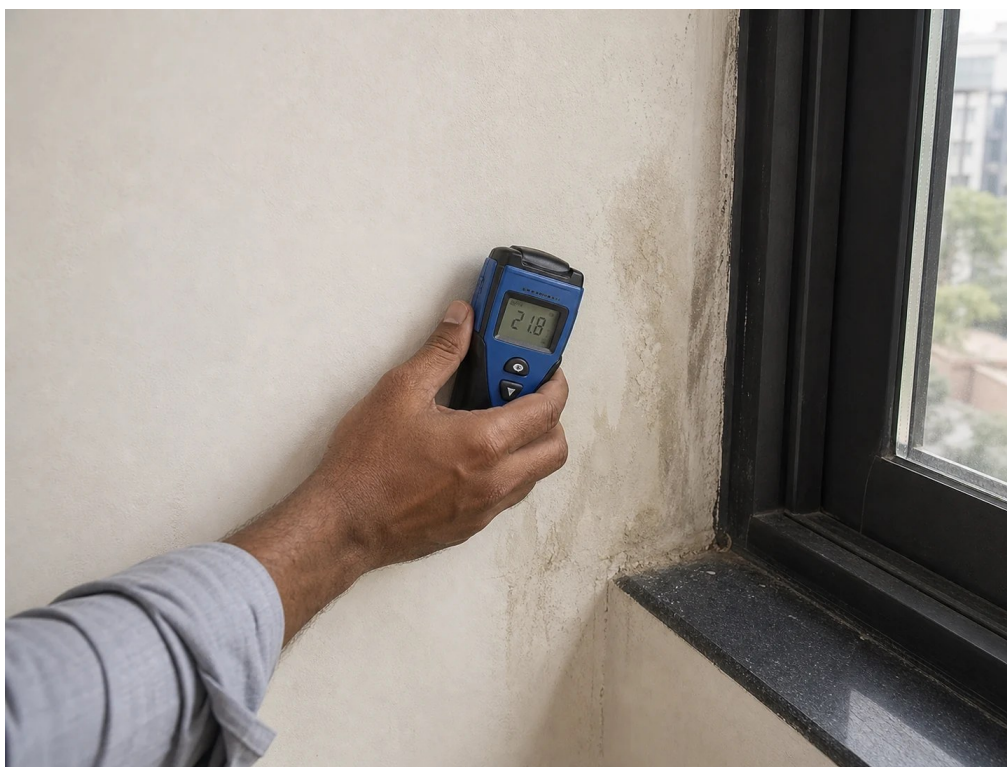
D03 · Living room · Moisture at the window reveal

**MAJOR** — Significant defect requiring corrective action.

Dampness indicators are noted at the wall-window junction in the illustrative scenario.

Investigate the source and agree rectification before repainting.

Recommended next step: Investigate the source and agree rectification before repainting.
