NESMA
INFRASTRUCTURE
& TECHNOLOGY

MITC Committee Warehouse and Project Site Visit Report

Eastern and Central Regions

December 23, 2025

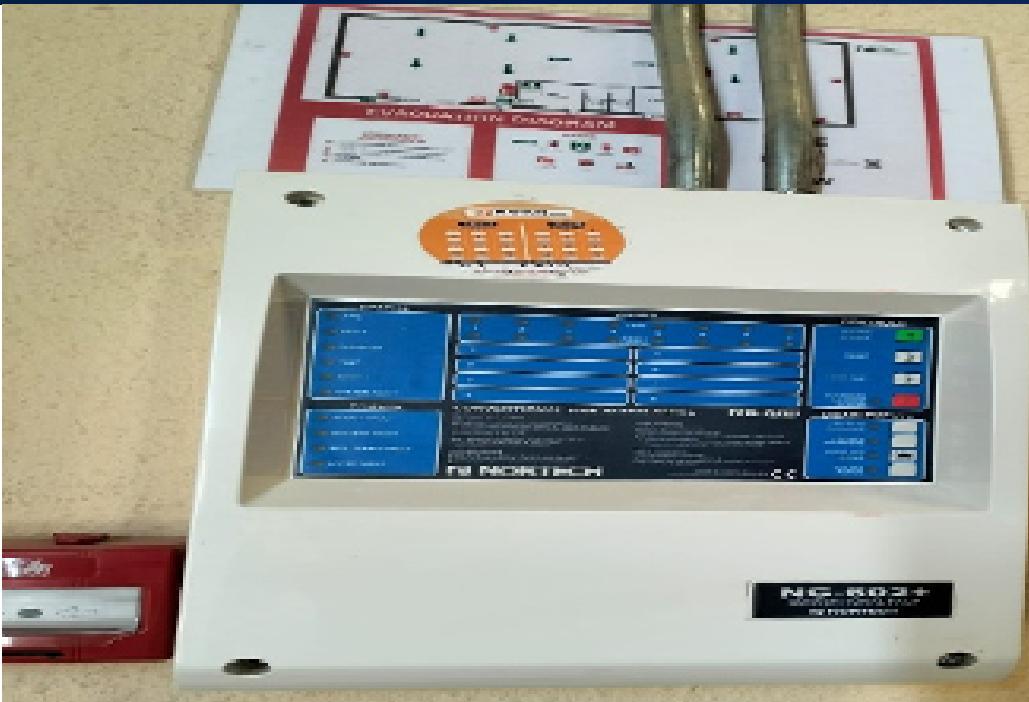
Tuwaiq Warehouses

Firefighting system not working

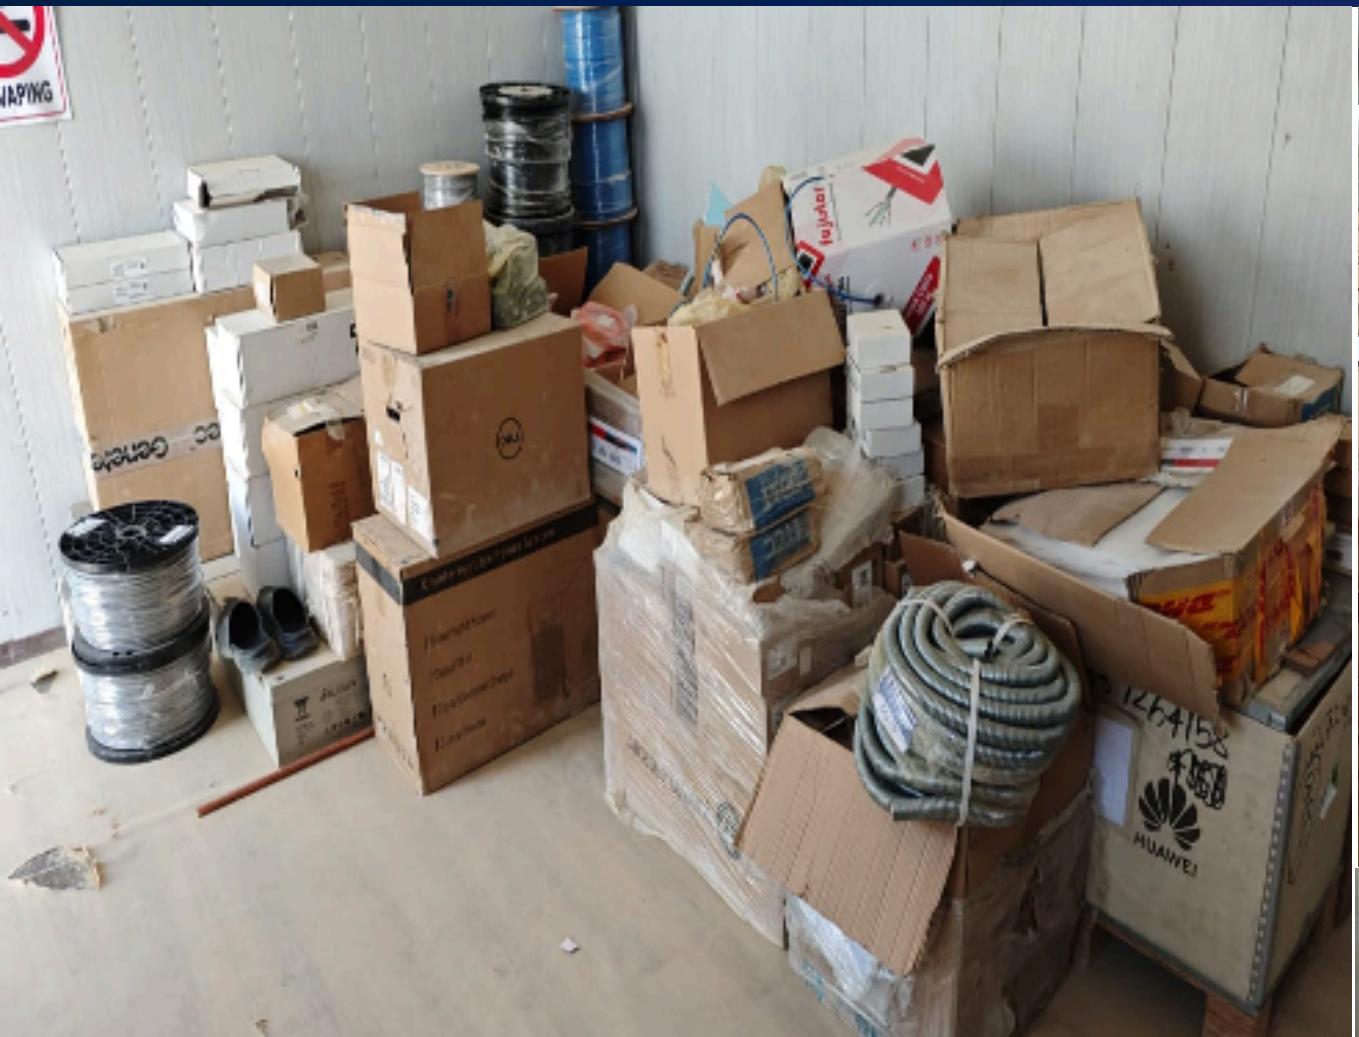
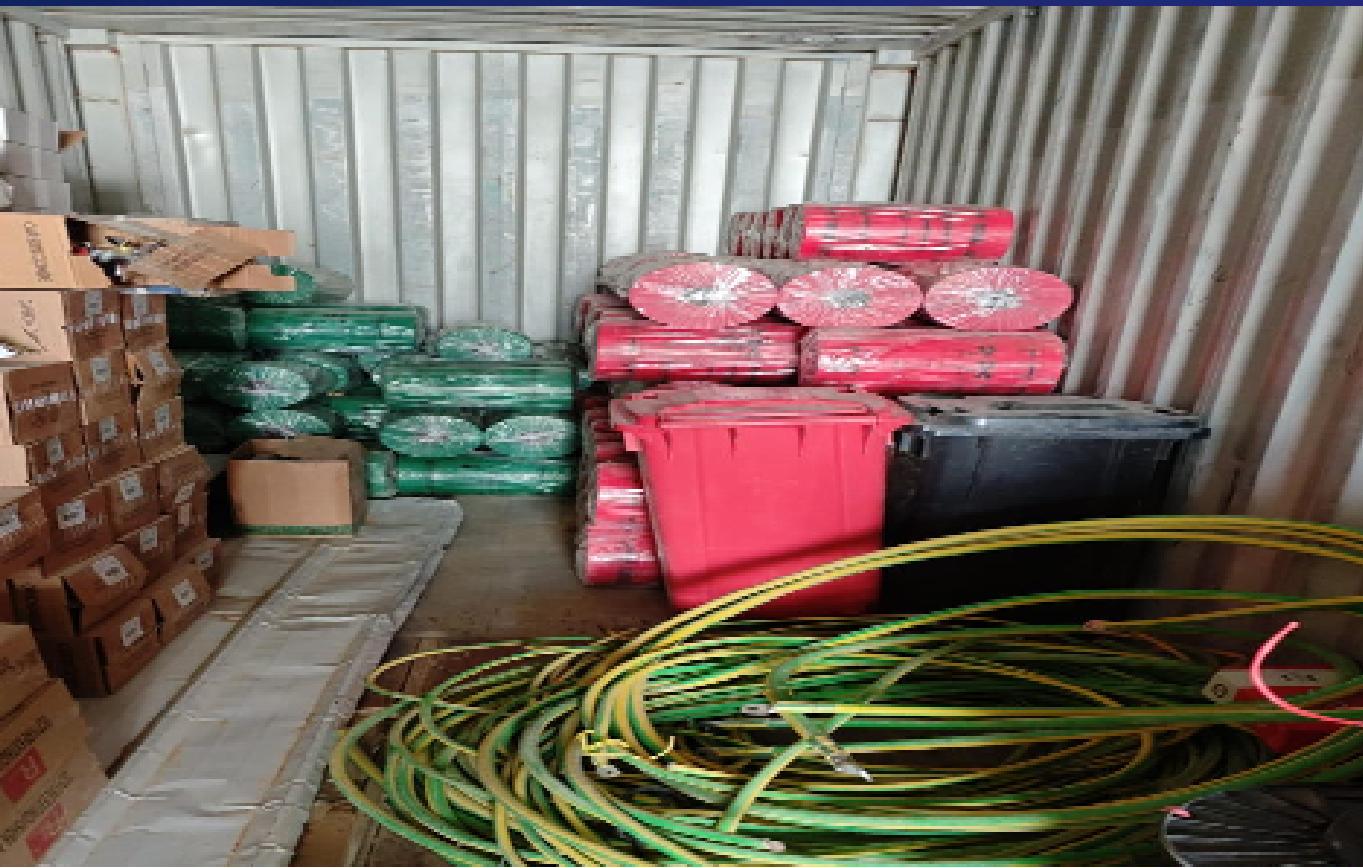
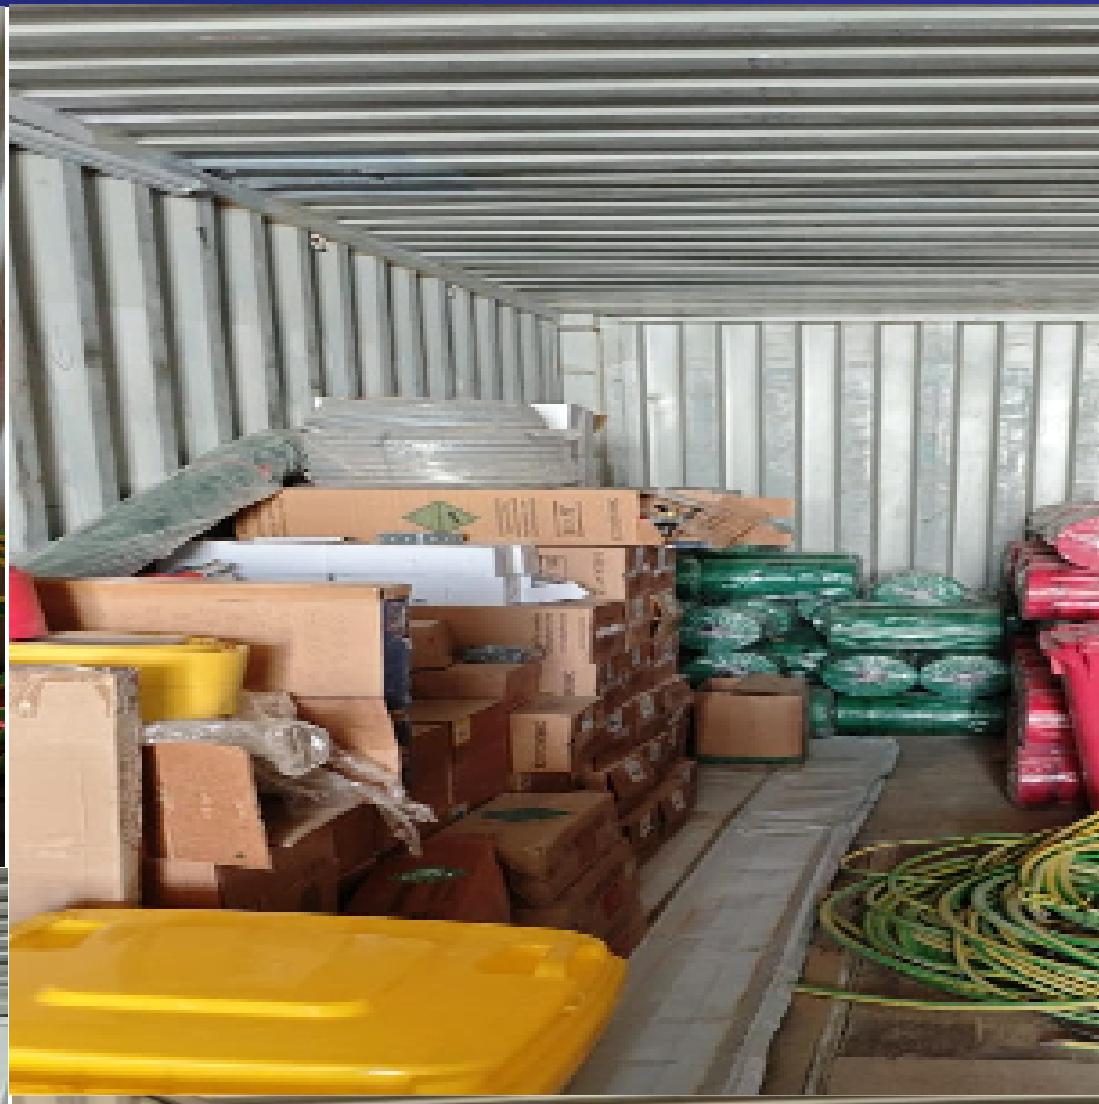
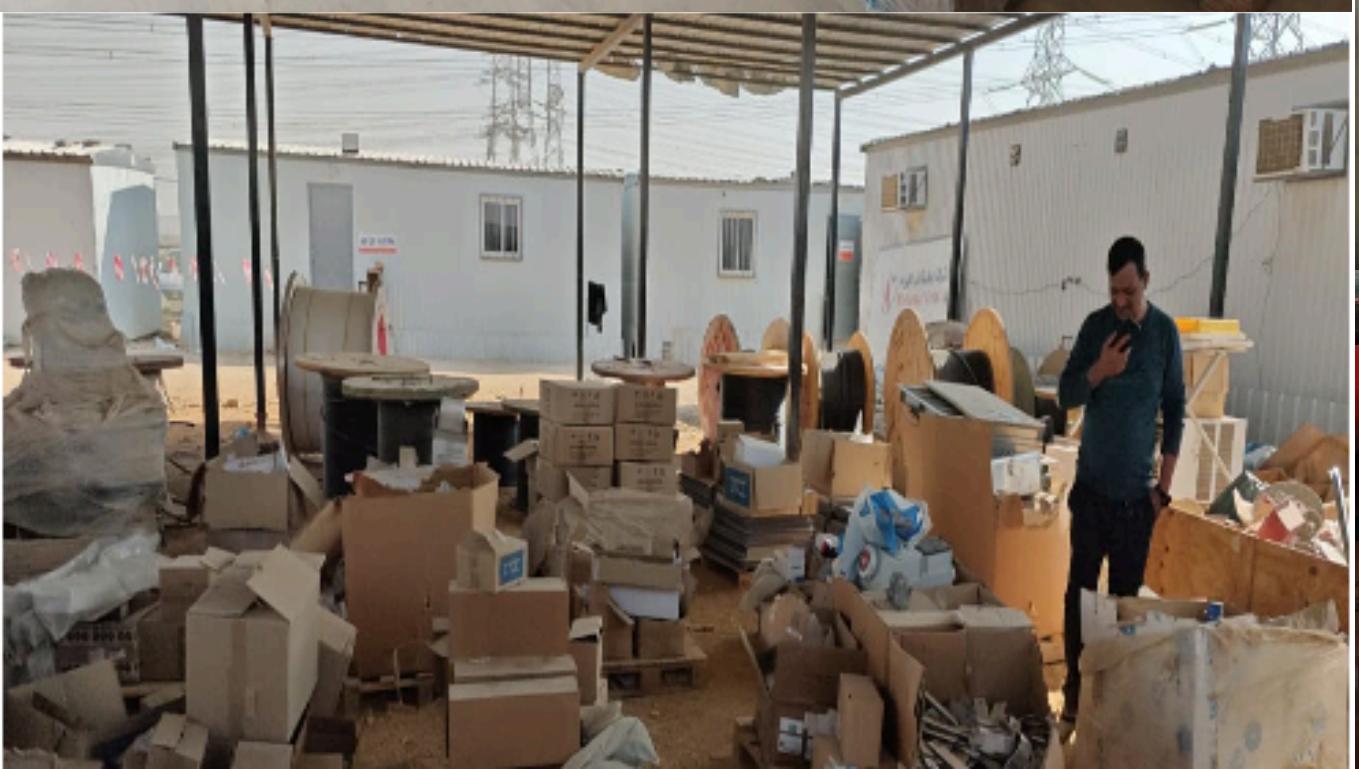
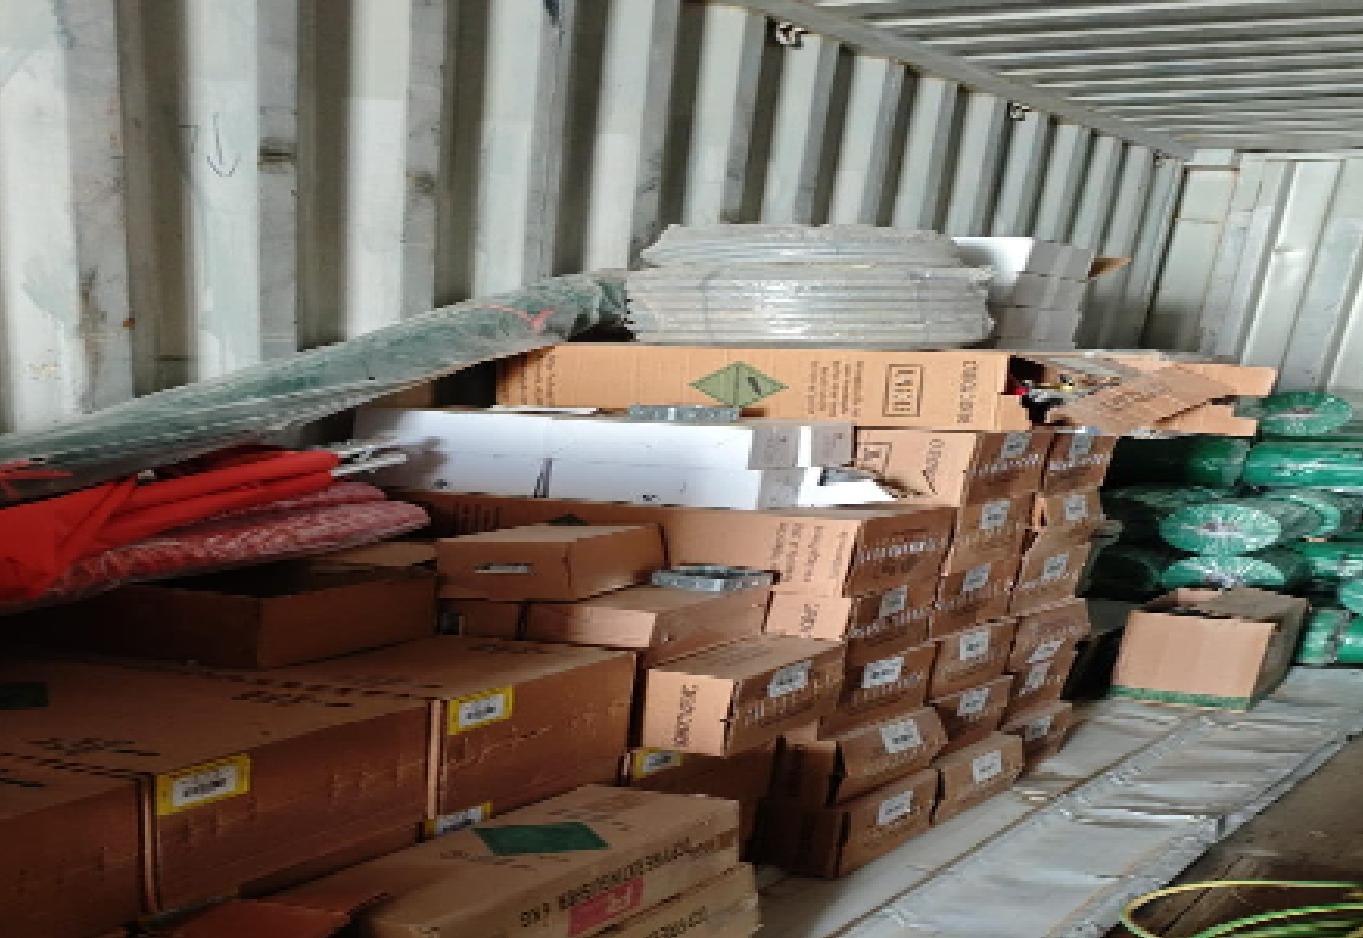
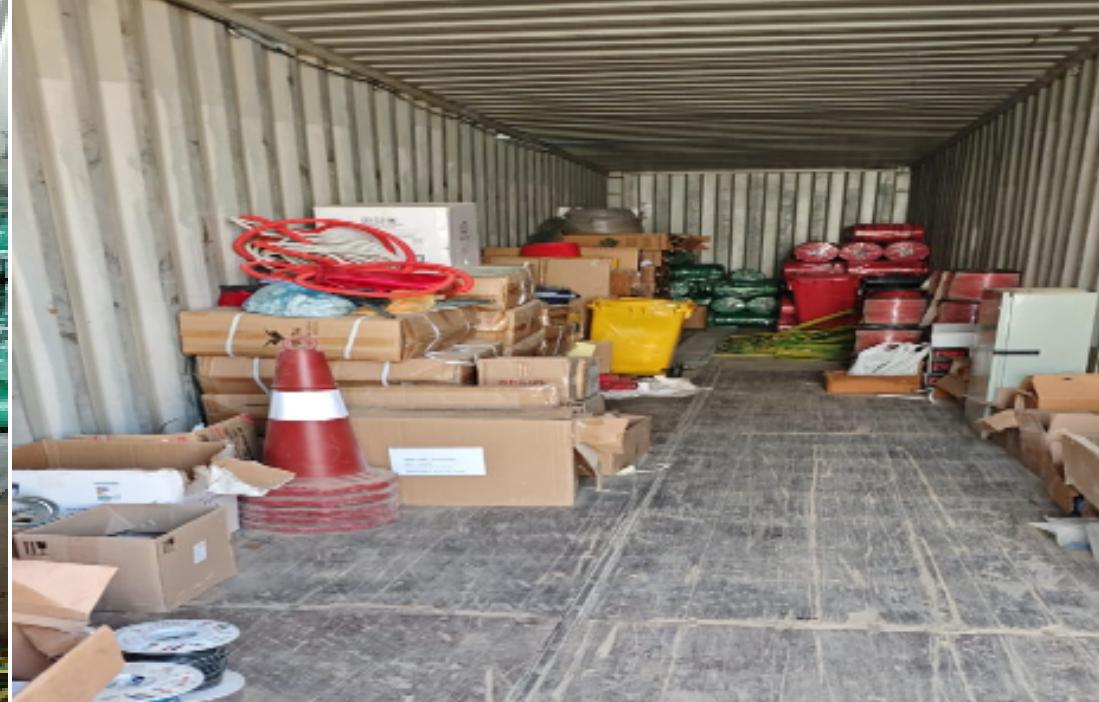
Al-Marjan Site

Many materials on-site are not needed for current project requirements, creating unnecessary storage burden.

Example of disorganized material storage at Al-Marjan

Addressing these issues could free up significant storage space and allow for material redistribution, reducing costs and improving inventory efficiency.

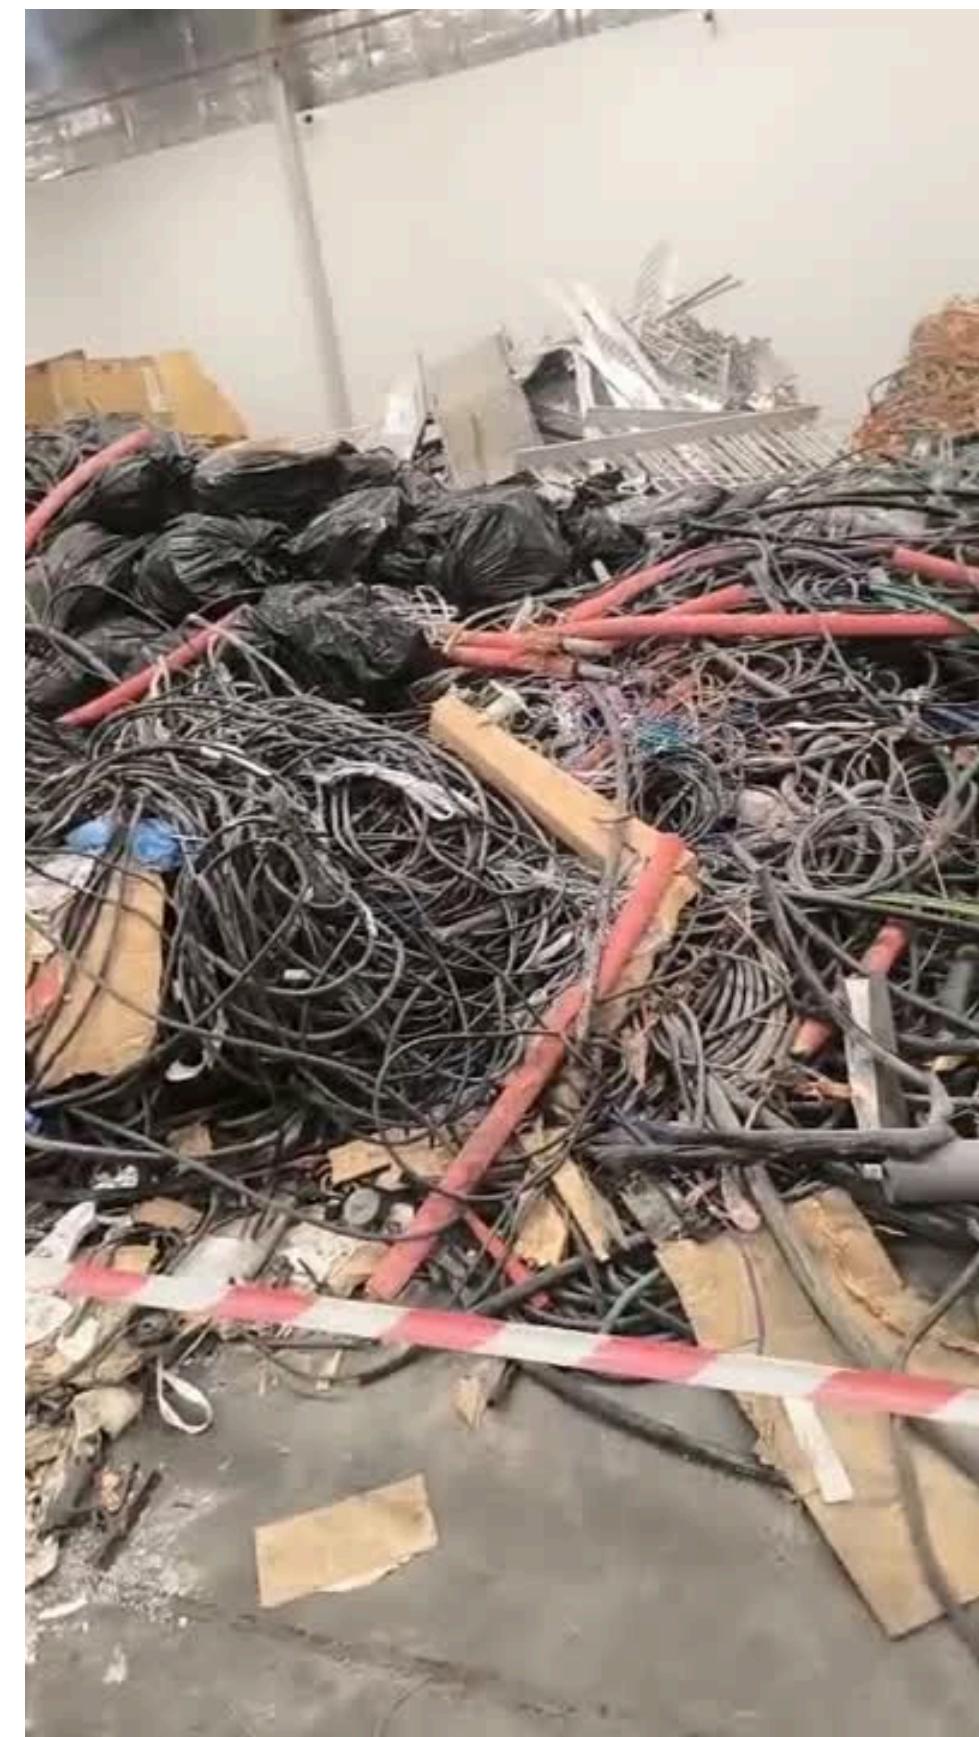
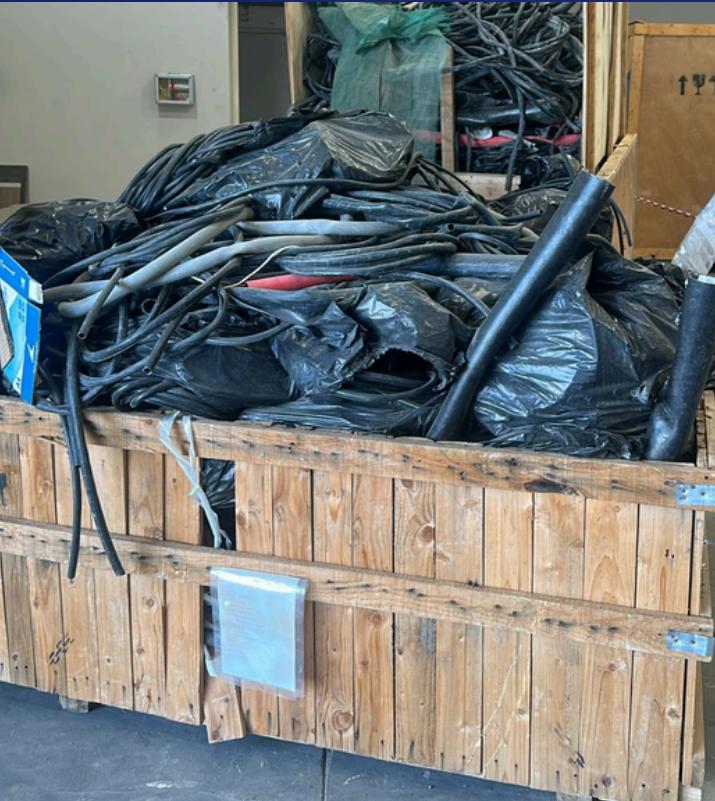
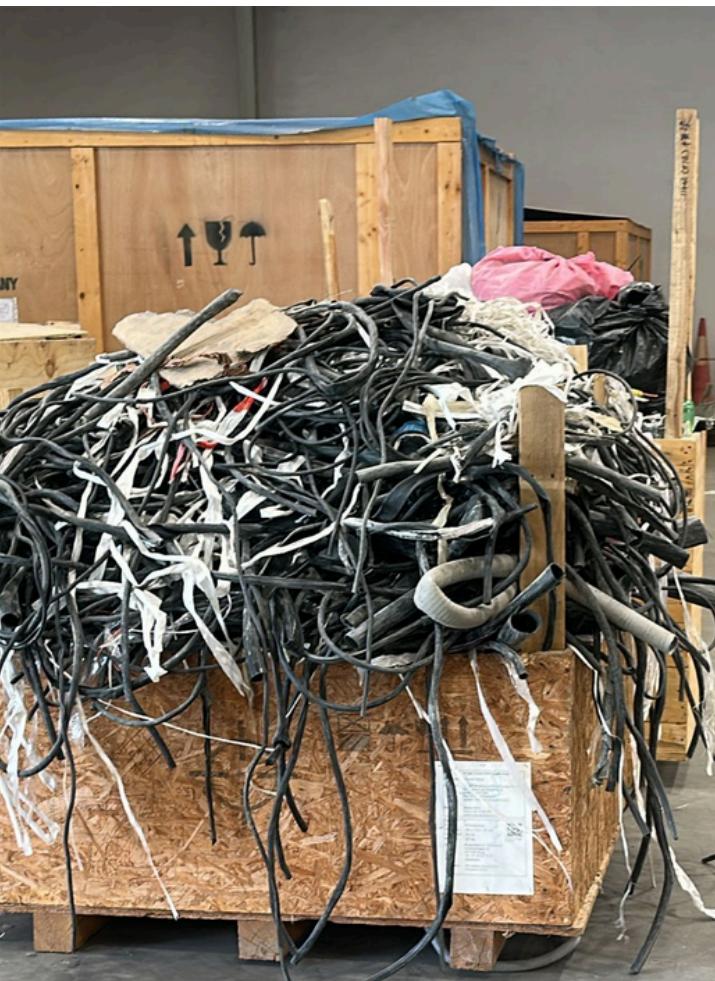
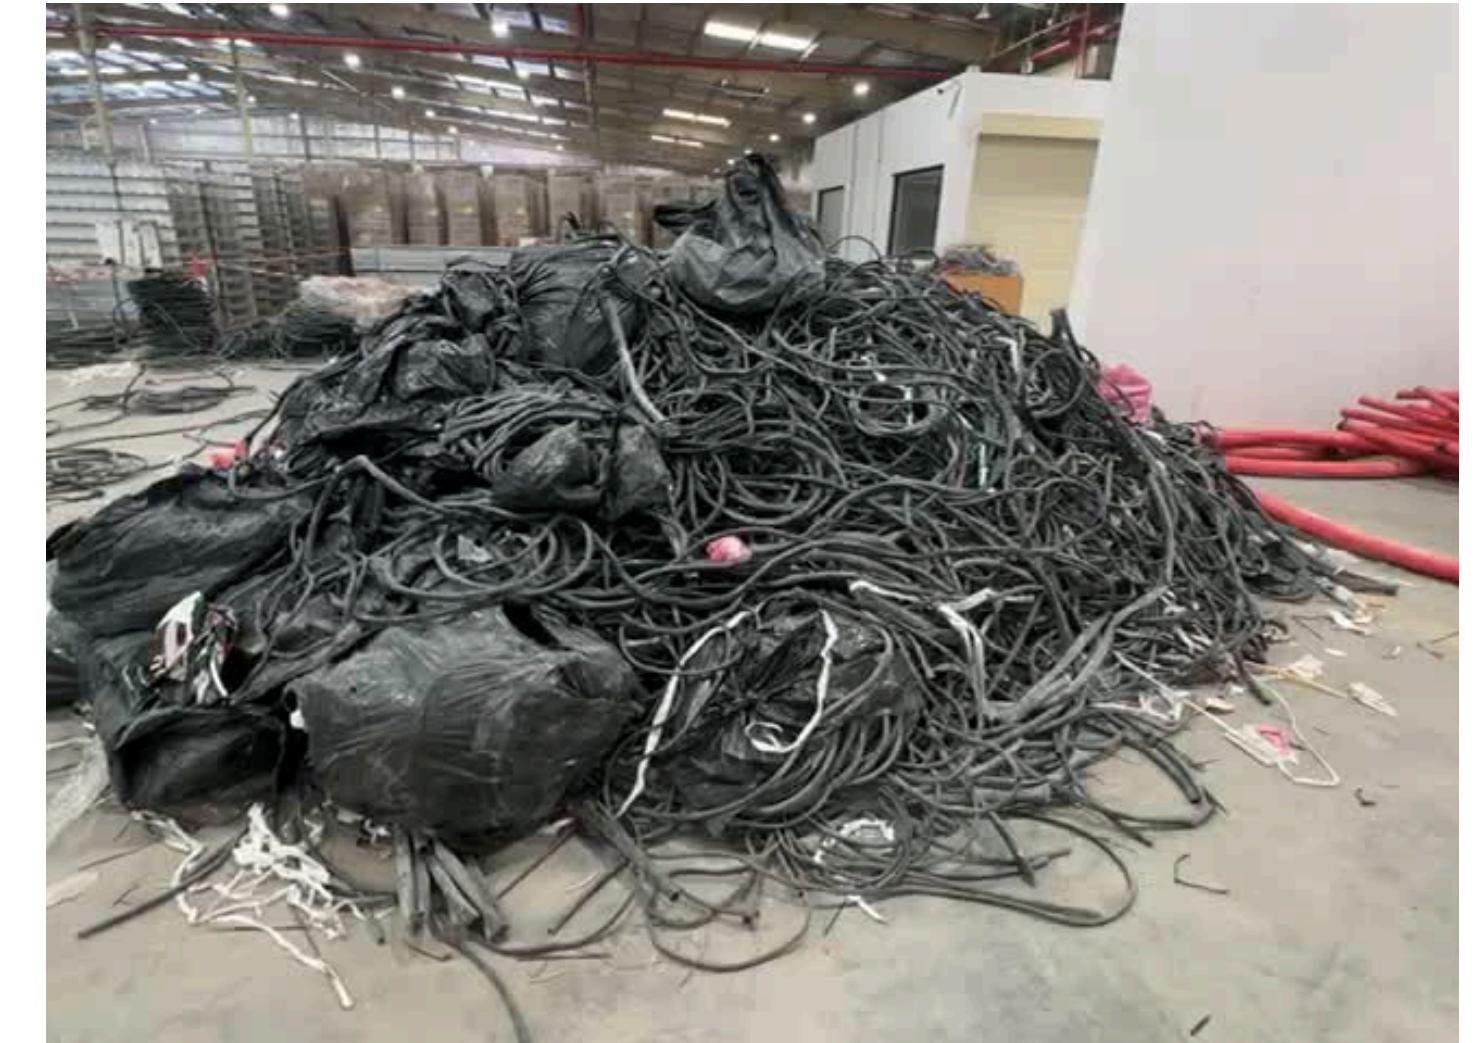
Damam Warehouses

Significant accumulation of scrap cables and metals occupying valuable storage space in warehouses, particularly in Dammam and Tuwaiq.

- Immediate repair of the faulty door to address security concerns
- Prompt disposal or recycling of scrap materials
- Implement enhanced security measures for valuable inventory
