SAFETYVISION AI

INDUSTRIAL VISUAL SAFETY INSPECTION AUDIT REPORT

| Inspection ID: INS-20261006-407F64 | Date/Time: 2026-10-06 21:49:01 |
| Equipment Type: Industrial Angle Grinder | Model Version: 0.1.0 |

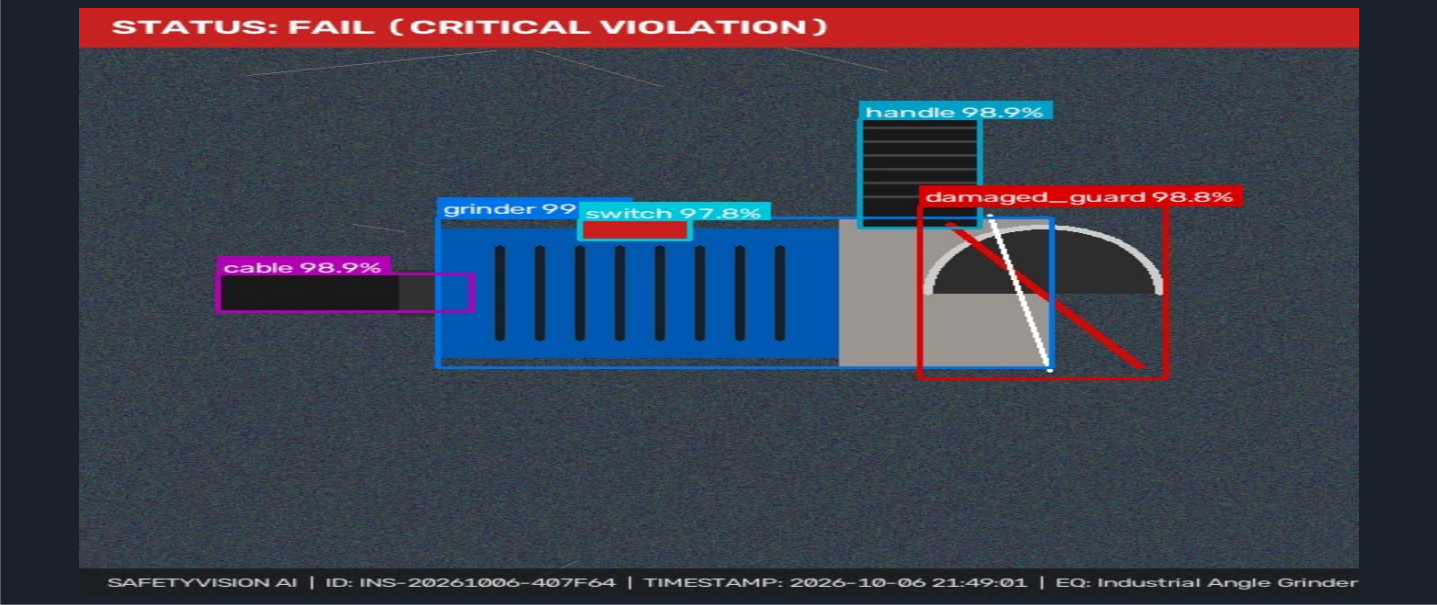
VISUAL EVIDENCE ARTIFACT

OVERALL RESULT: FAIL — CRITICAL VIOLATION

| Component | Mandatory | Detection Status | Confidence | Severity | Audit Finding |
|---|---|---|---|---|---|
| Damaged / Cracked Guard | NO | FAIL | 98.8% | CRITICAL | Protective guard exhibits visible deformation... |
| Protective Wheel Guard | YES | FAIL | N/A | CRITICAL | Abrasive wheel guard is missing. Operating wi... |

**Root Evaluation:** FAIL — Missing mandatory components: guard; Structural damage observed: damaged\_guard.

**Recommended Action:** Do NOT operate tool. Lockout/tagout equipment immediately and schedule a certified competent-person mechanical and electrical safety inspection.
