# SAFETYVISION AI

INDUSTRIAL VISUAL SAFETY INSPECTION AUDIT REPORT

| Inspection ID: INS-20261006-6E9143 | Date/Time: 2026-10-06 21:48:54 |
| Equipment Type: Industrial Angle Grinder | Model Version: 0.1.0 |

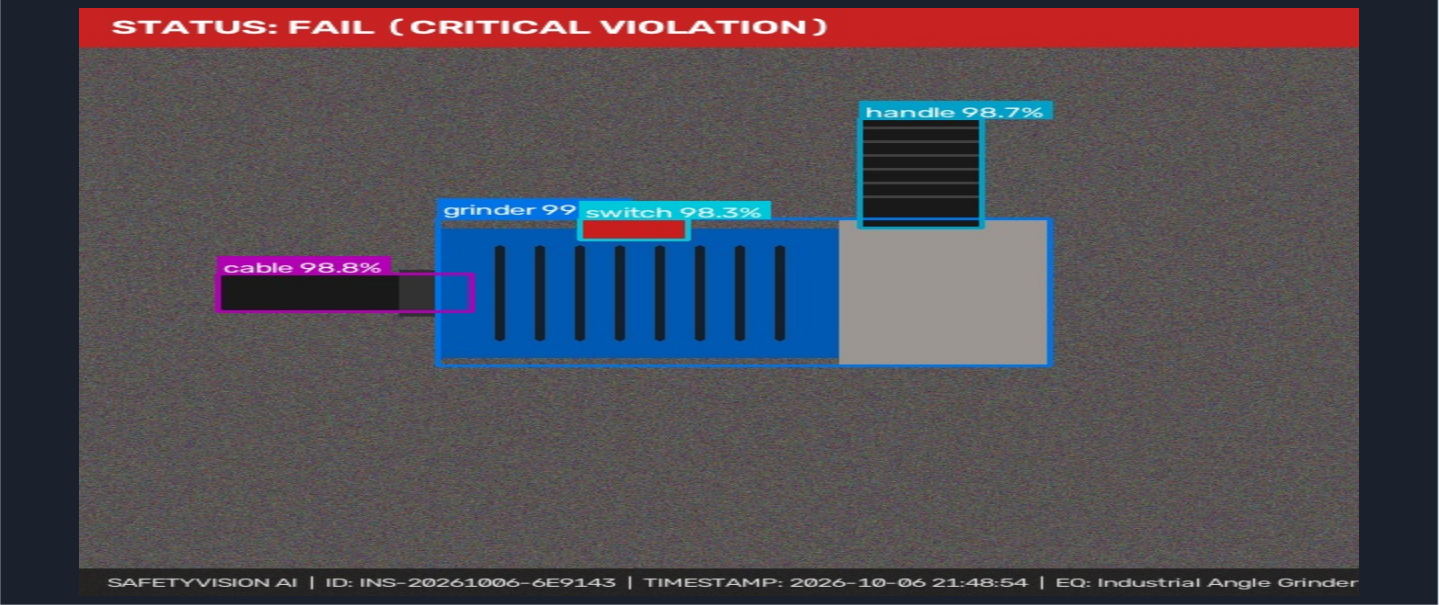
## VISUAL EVIDENCE ARTIFACT

OVERALL RESULT: FAIL — CRITICAL VIOLATION

| Component | Mandatory | Detection Status | Confidence | Severity | Audit Finding |
|---|---|---|---|---|---|
| Protective Wheel Guard | YES | FAIL | N/A | CRITICAL | Abrasive wheel guard is missing. Operating wi... |

**Root Evaluation:** FAIL — Missing mandatory components: guard.

**Recommended Action:** Do NOT operate tool. Lockout/tagout equipment immediately and schedule a certified competent-person mechanical and electrical safety inspection.
