# SAFETYVISION AI

INDUSTRIAL VISUAL SAFETY INSPECTION AUDIT REPORT

| Inspection ID: INS-20261006-9B376F | Date/Time: 2026-10-06 18:40:16 |
| Equipment Type: Industrial Angle Grinder | Model Version: 0.1.0 |

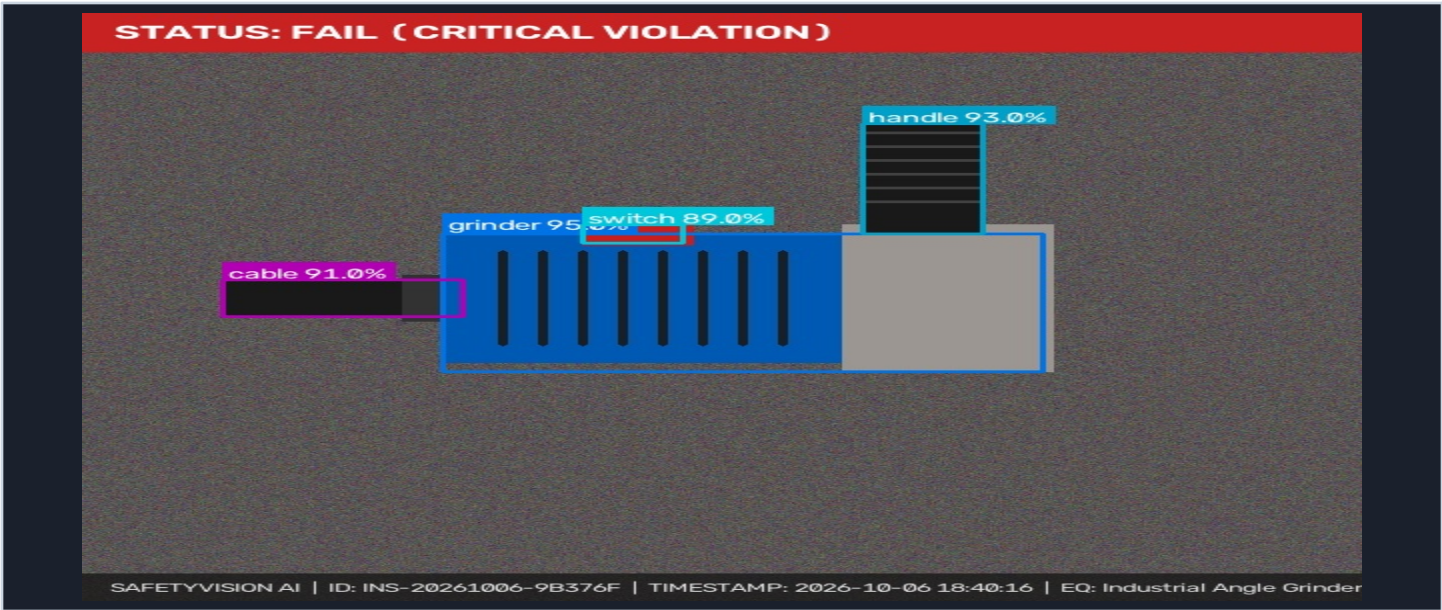
OVERALL RESULT: FAIL — CRITICAL VIOLATION

| Component | Mandatory | Detection Status | Confidence | Severity | Audit Finding |
|---|---|---|---|---|---|
| Protective Wheel Guard | YES | FAIL | N/A | CRITICAL | Abrasive wheel guard is missing. Operating wi... |

**Root Evaluation:** FAIL — Missing mandatory components: guard.

**Recommended Action:** Do NOT operate tool. Lockout/tagout equipment immediately and schedule a certified competent-person mechanical and electrical safety inspection.
