# SAFETYVISION AI

INDUSTRIAL VISUAL SAFETY INSPECTION AUDIT REPORT

| Inspection ID: INS-20261006-D9B6DA | Date/Time: 2026-10-06 18:11:06 |
| Equipment Type: Industrial Angle Grinder | Model Version: 0.1.0 |

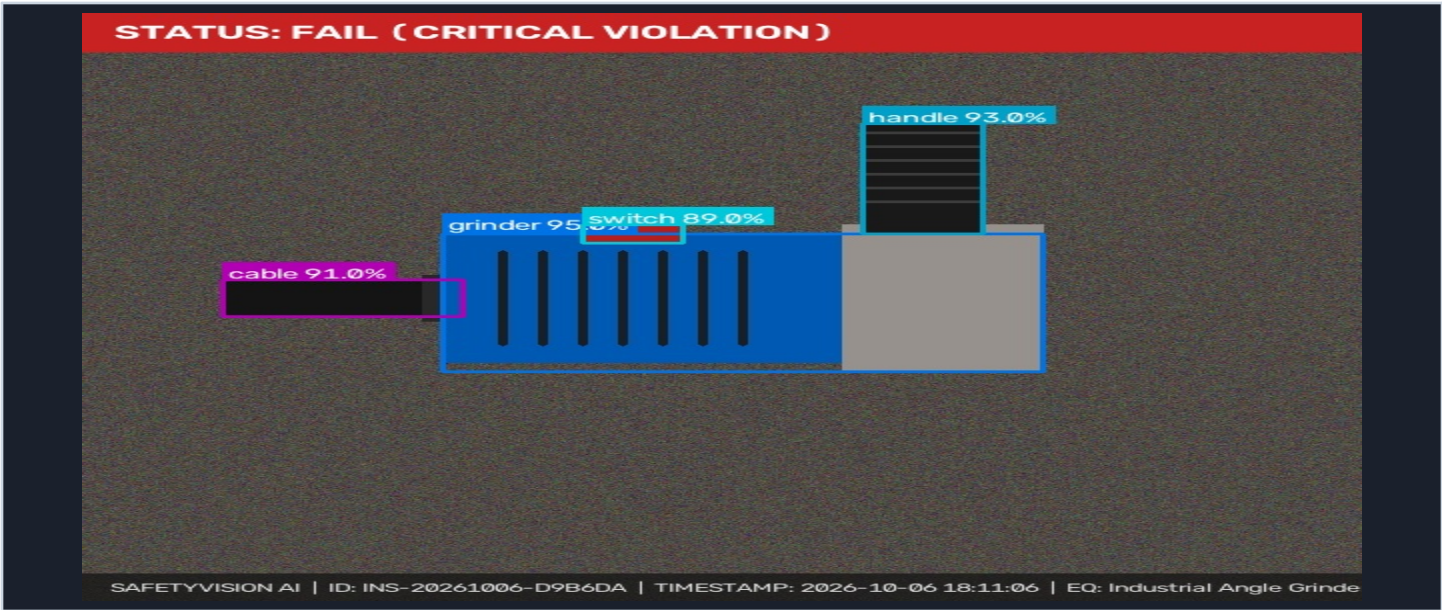
OVERALL RESULT: FAIL — CRITICAL VIOLATION

| Component | Mandatory | Detection Status | Confidence | Severity | Audit Finding |
|---|---|---|---|---|---|
| Protective Wheel Guard | YES | FAIL | N/A | CRITICAL | Abrasive wheel guard is missing. Operating wi... |

**Root Evaluation:** FAIL — Missing mandatory components: guard.

**Recommended Action:** Do NOT operate tool. Lockout/tagout equipment immediately and schedule a certified competent-person mechanical and electrical safety inspection.
