# SAFETYVISION AI

INDUSTRIAL VISUAL SAFETY INSPECTION AUDIT REPORT

| Inspection ID: INS-20261007-10B538 | Date/Time: 2026-10-07 07:55:56 |
| Equipment Type: Industrial Angle Grinder | Model Version: 0.1.0 |

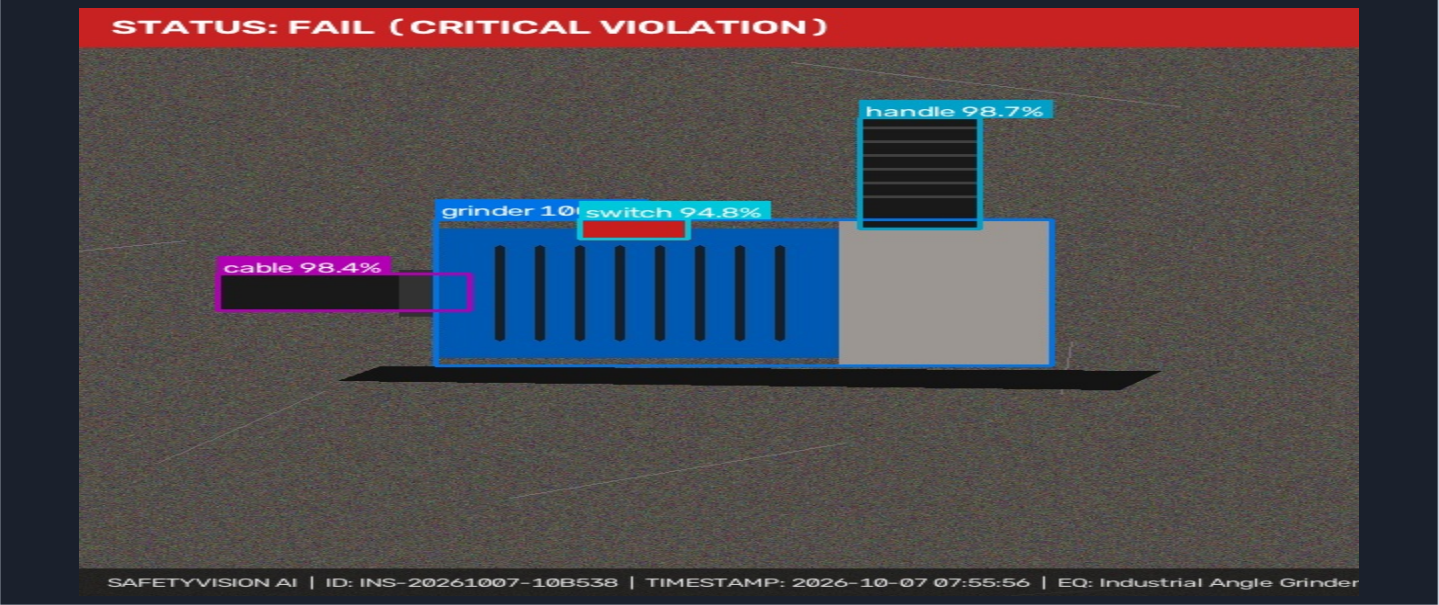
OVERALL RESULT: FAIL — CRITICAL VIOLATION

| Component | Mandatory | Detection Status | Confidence | Severity | Audit Finding |
|---|---|---|---|---|---|
| Protective Wheel Guard | YES | FAIL | N/A | CRITICAL | Abrasive wheel guard is missing. Operating wi... |

**Root Evaluation:** FAIL — Missing mandatory components: guard.

**Recommended Action:** Do NOT operate tool. Lockout/tagout equipment immediately and schedule a certified competent-person mechanical and electrical safety inspection.
