INDUSTRIAL VISUAL SAFETY INSPECTION AUDIT REPORT

| Inspection ID: INS-20261007-374E56 | Date/Time: 2026-10-07 07:56:02 |
| Equipment Type: Industrial Angle Grinder | Model Version: 0.1.0 |

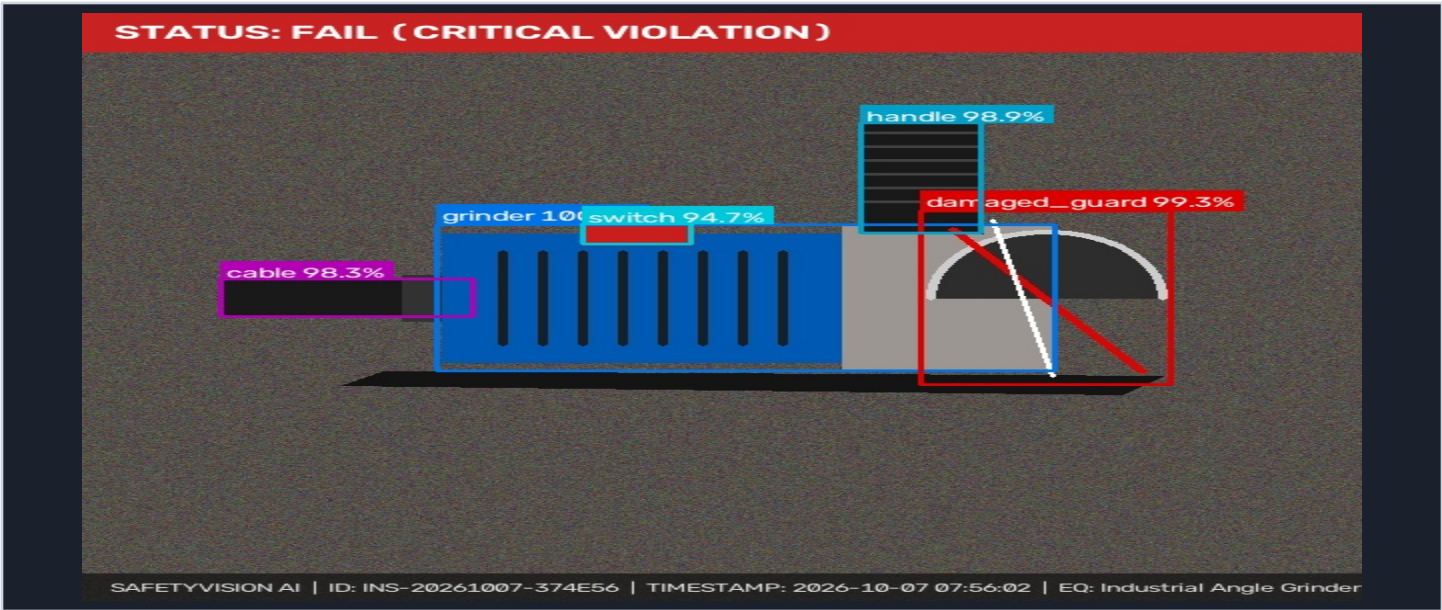
VISUAL EVIDENCE ARTIFACT

OVERALL RESULT: FAIL — CRITICAL VIOLATION

| Component | Mandatory | Detection Status | Confidence | Severity | Audit Finding |
|---|---|---|---|---|---|
| Damaged / Cracked Guard | NO | FAIL | 99.3% | CRITICAL | Protective guard exhibits visible deformation... |
| Protective Wheel Guard | YES | FAIL | N/A | CRITICAL | Abrasive wheel guard is missing. Operating wi... |

**Root Evaluation:** FAIL — Missing mandatory components: guard; Structural damage observed: damaged\_guard.

**Recommended Action:** Do NOT operate tool. Lockout/tagout equipment immediately and schedule a certified competent-person mechanical and electrical safety inspection.
